P O R T A G E C O U N T Y

EURASIAN WATER MILFOIL ASSESSMENT

**Springville Pond  
Thomas Lake  
Lake Joanis**

Summary: 2003 - 2006

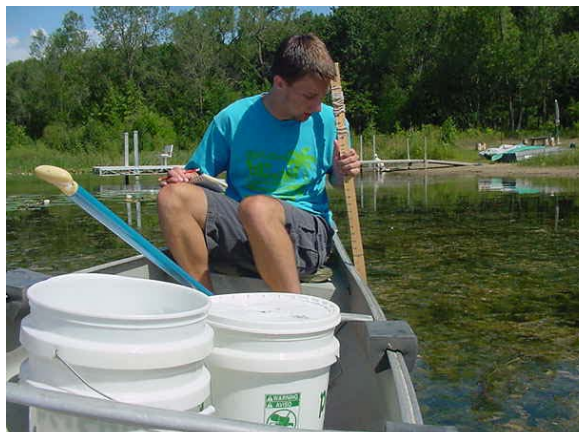
*Measuring freeboard at Thomas Lake.*

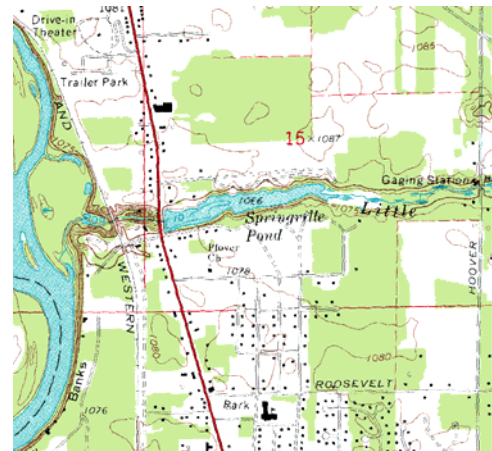
Springville Pond on USGS topographic map.

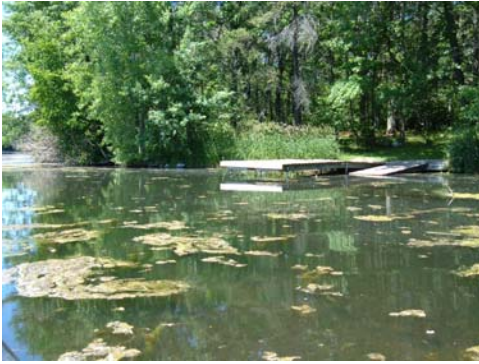
**Above:** Former Bed D - In 2003-04, this area was a solid weed mat of EWM, covered with a layer of algae. Weevil counts were an astronomical 4.43 weevils per stem. On June 21<sup>st</sup>, 2005, the weevils had reduced the weed bed to a few, scattered stems. Ugly blobs of algae remain.

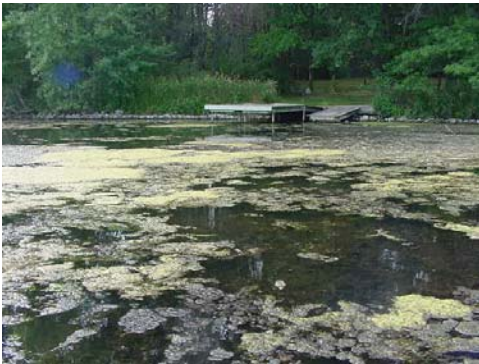
**Below:** Former Bed D, Aug. 5<sup>st</sup>, 2005. EWM still minimal, but algae is abundant due to hot growing conditions.

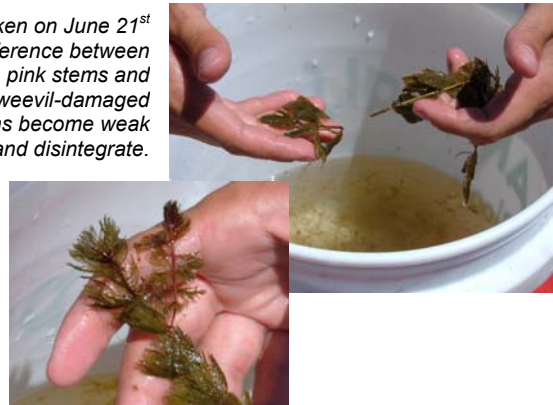
Photos taken on June 21<sup>st</sup> show the difference between healthy, pink stems and black, weevil-damaged stems. Stems become weak and disintegrate.

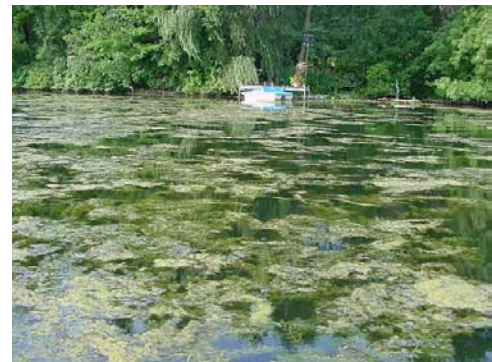
Photo taken on August 5<sup>th</sup> of Bed 4, a dense, new EWM bed that sprang up in the summer heat, just west of Former Bed D.

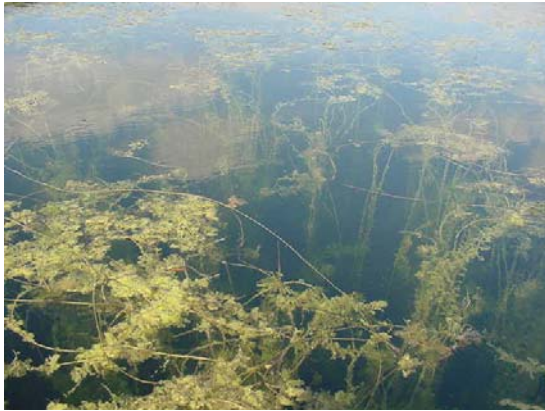
Observations in September 2006 noted unusual "leaf stripping" in Bed 2, primarily around the stocking location. The stems appeared healthy and buoyant, but the leaves were absent. Because weevils need healthy, bushy EWM to thrive, final weevil stockings were done at up to 25- or 30-feet from the buoy, in order to find healthy EWM stems to release the weevils onto.

*A close-up view of the stocking area in Bed 2 on 9/15/06. EWM exhibited stripped stems with algae still clinging at the water surface. Stripped stems are indicative of feeding damage by Phytobius.*

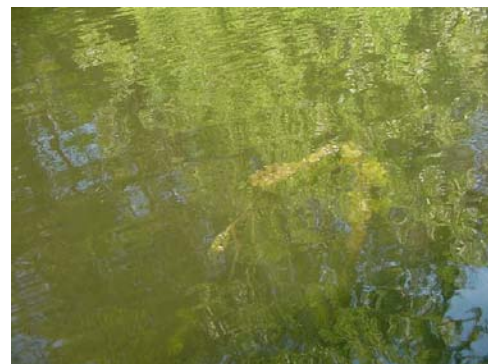
Hand-pulling area, 9/15/06. The area stayed mostly clear, with just the occasional straggler.

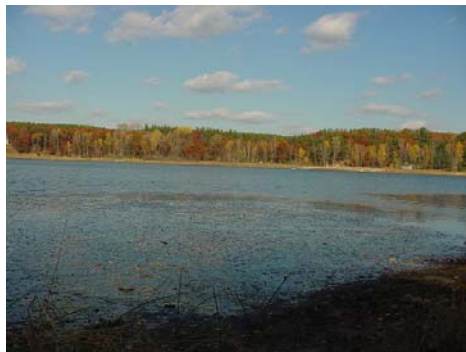
Thomas Lake with mats of aquatic vegetation visible at water surface.

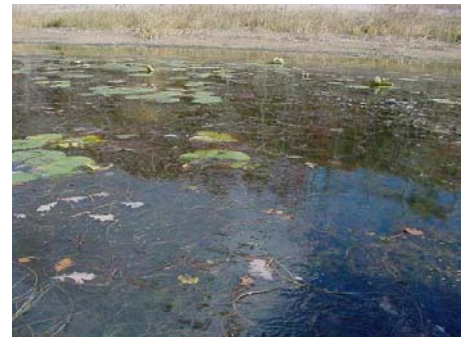
Dense mats of EWM visible at water surface, entire circumference of lake.

Field mapping on October 22, 2003 found the EWM growth to be mostly limited to a depth of 10 or 12 feet or less. The total surface area of the infestation is approximately 10.0 acres. (See Figure 5.) An infestation of this size cannot be eradicated by methods currently available, however *control* may be possible.

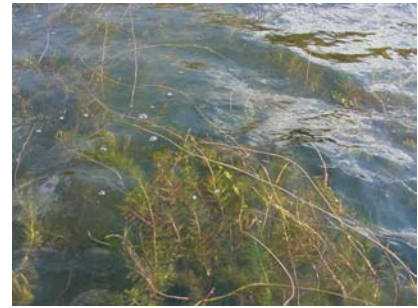
A closer view of dense EWM growth in Thomas Lake.

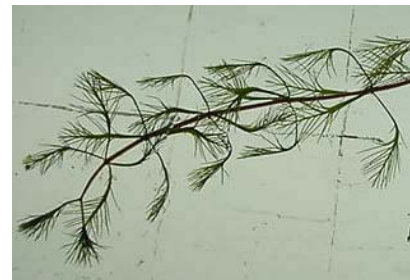
Other notes: A very common leaf deformity (fused lower leaflets) was seen in the Thomas Lake stem samples. It is unknown whether this deformity may affect weevil success. Also, hardening of nodes and easy breakage of stems – stems beginning auto-fragmentation naturally, or early auto-fragmentation due to refrigeration? This was not seen in other samples, which were refrigerated under same conditions.

Common leaf deformity observed in Thomas Lake stem samples.

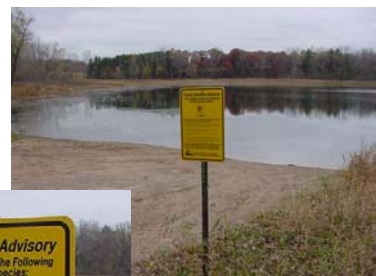
*Exotic Species Advisory sign at Thomas Lake boat landing*

A well-placed and highly visible sign is currently in place at the boat landing. This sign should be maintained in good condition to help prevent boaters from bringing *additional* exotic species into Thomas Lake or transferring EWM to other lakes.

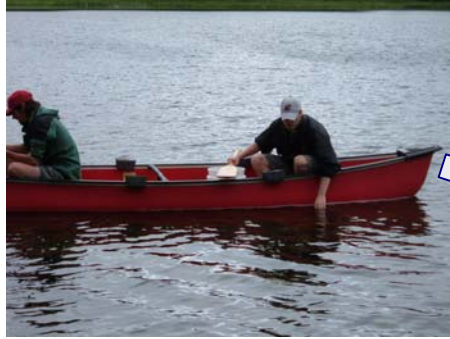
*Field personnel searched Lake Thomas for EWM stems with weevils on/in them.*

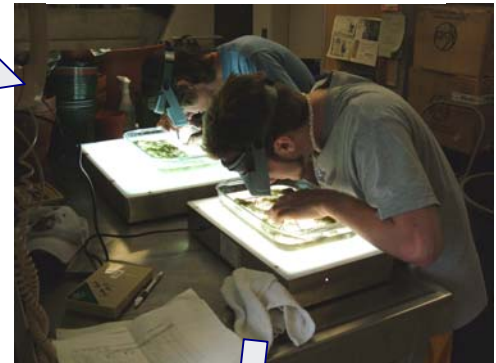
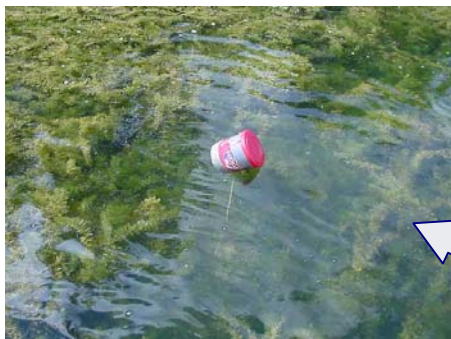
*Weevil-containing stems were inspected in the UWSP greenhouse to count the number of weevils on/in them, then bundled together with healthy stems and bound to a rock.*

*On the scheduled release date, stems were inspected to count the number of weevils. Weevil-containing stems were taken to the stocking site and entwined around existing EWM so weevil larvae could easily move to new stems to feed.*

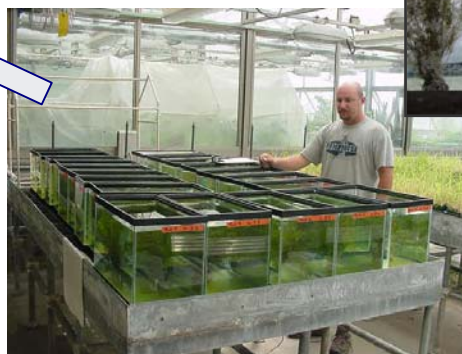
*The bundles were placed in a 10-gallon aquarium or 5-gallon bucket in the UWSP greenhouse. Weevils were held for 13-21 days to reproduce in a predator-free environment.*

Some observations were made for improvements to the rearing techniques. Firstly, the use of five-gallon buckets as rearing tanks should be eliminated. Experimentation with buckets was intended to cut expenses, however, our average return rate from buckets was 0.63 whereas the tanks provided a 3.95 return rate. When this trend of lower productivity became apparent, use of the buckets was discontinued.

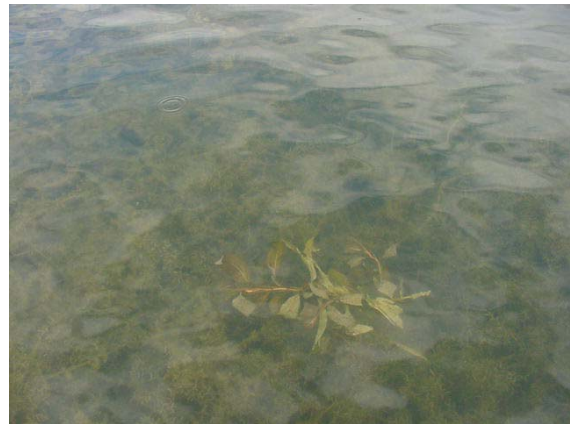
*Native vegetation thrives in an area where EWM has been manually controlled by a Thomas Lake resident. Photo taken 8/9/06.*

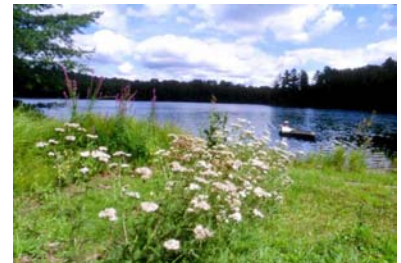
*Natural vegetation helps milfoil weevils, adds beauty, protects water quality and attracts wildlife, too! A buffer zone of 35 feet is good, but MORE IS BETTER!*

- ✓ **Provide Habitat.** Create "Buffer Zones" along the lakeshore, where vegetation and leaf litter within 35 feet of shore is left natural and **not mowed, raked or removed**. This will provide milfoil weevils with good winter habitat for hibernation and help keep the lake healthy, too! If tidy lawns are your preference, you can still provide winter habitat for weevils by refraining from mowing or raking from Labor Day to Memorial Day. If you don't live on the water, you can still advocate for lake health by encouraging your local park department to use buffer zones!

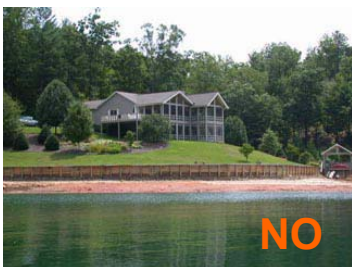
*Sandy beaches, sea-walls, rip-rap and mowed lawns do NOT offer good winter habitat for milfoil weevils or protection of water quality.*
