EQUIPMENT RECORDING SONAR MAPPED JUNE 1975

Source: Wisconsin Department of Natural Resources 608-266-2621
Chute Pond – Oconto County, Wisconsin DNR Lake Map
Date - Jun 1975 - Historical Lake Map - Not for Navigation
A Public Document - Please Identify the Source when using it.

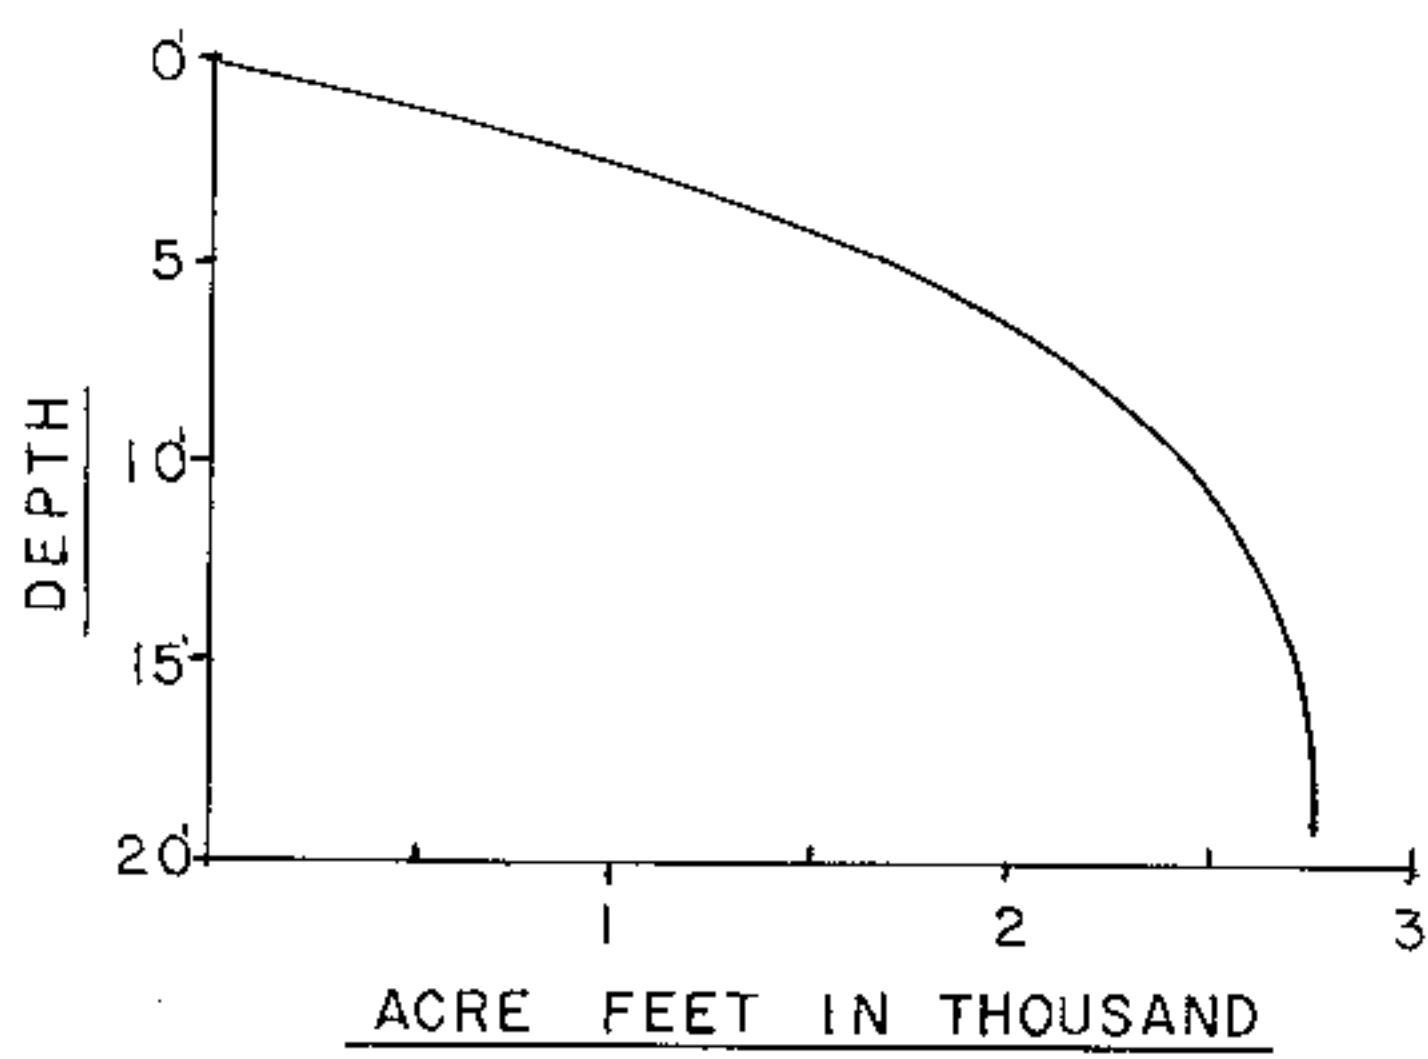
B.M. 'X' Located top of east wing of dam on south east end of lake
Assumed Elevation 100.00'
Water Elevation 94.00'

WATER AREA 421.6 ACRES
 UNDER 3 FT. 17 %
 OVER 20 FT. 0 %
 MAX. DEPTH 19 FEET.
 TOTAL ALK. 103 P.P.M.
 VOLUME 2,759.1 ACRE FT.
 MAIN SHORELINE 8.230 MI.
 ISLAND SHORELINE 1.510 MI.
