LAKE SURVEY MAP

Lost Canoe Lake
249 Acres
41' Max. depth

Source: Wisconsin Department of Natural Resources 608-266-2621
Escanaba Lake - Vilas County, Wisconsin DNR Lake Map
Date – Jul 1972 - Historical Lake Map - Not for Navigation
A Public Document - Please Identify the Source when using it.

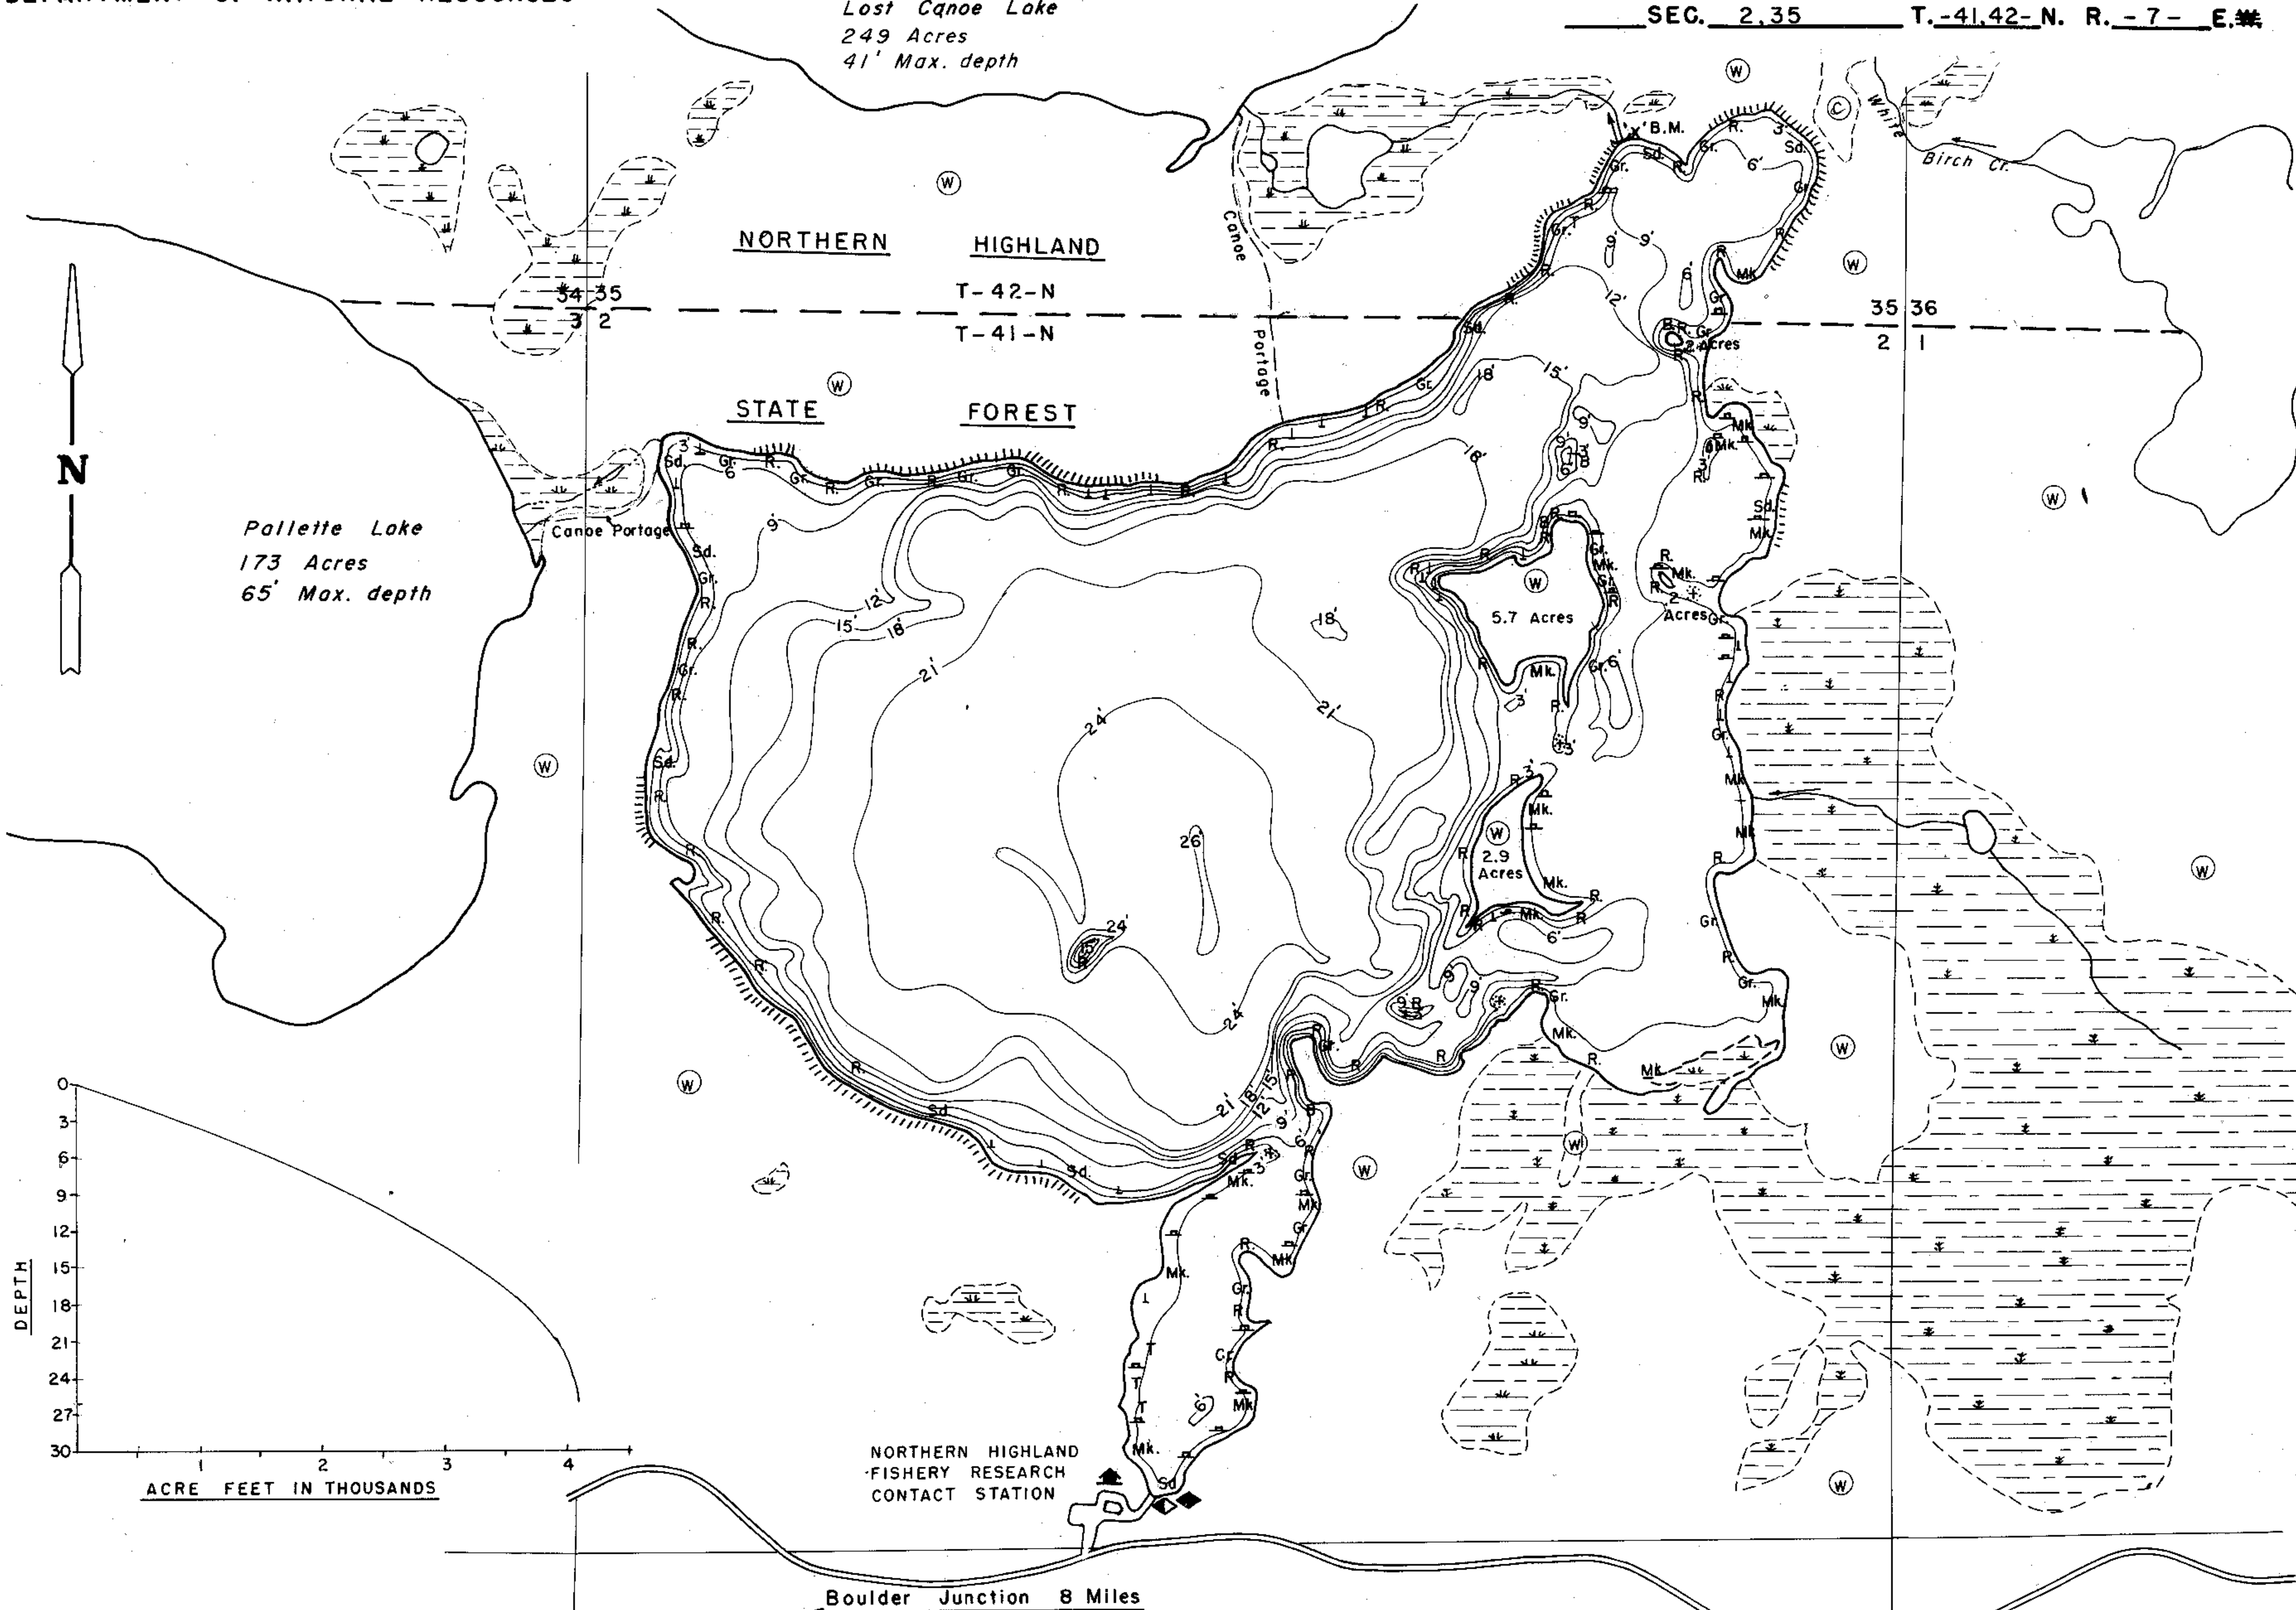
EQUIPMENT RECORDING SONAR MAPPED JULY 1972

B.M. 'X' 1129-H IS A BRONZE TABLET MARKED P.S.C. SET IN A CONCRETE POST FLUSH WITH GROUND, 23.5' EAST OF DAM, 8.8' WEST OF CLUMP OF 4 OAK TREES, 16' FROM SHORE ON NORTH END OF LAKE
ELEVATION 103.15'
WATER ELEV. 98.92'

WATER AREA 293.00 ACRES
 UNDER 3 FT. 8 %
 OVER 20 FT. 20 %
 MAX. DEPTH 26 FEET.
 TOTAL ALK. 20 P.P.M.
 VOLUME 4,108.3 ACRE FT.
 SHORELINE 4.37 MILES
 WITH ISLANDS 5.22 MILES
