LAKE SURVEY MAP

PICTURE LAKE BAYFIELD COUNTY
SEC. 31 T. 44 N. R. 7 W.

Source: Wisconsin Department of Natural Resources 608-266-2621
Picture Lake – Bayfield County, Wisconsin DNR Lake Map
Date – Jun 1970 - Historical Lake Map - Not for Navigation
A Public Document - Please Identify the Source when using it.

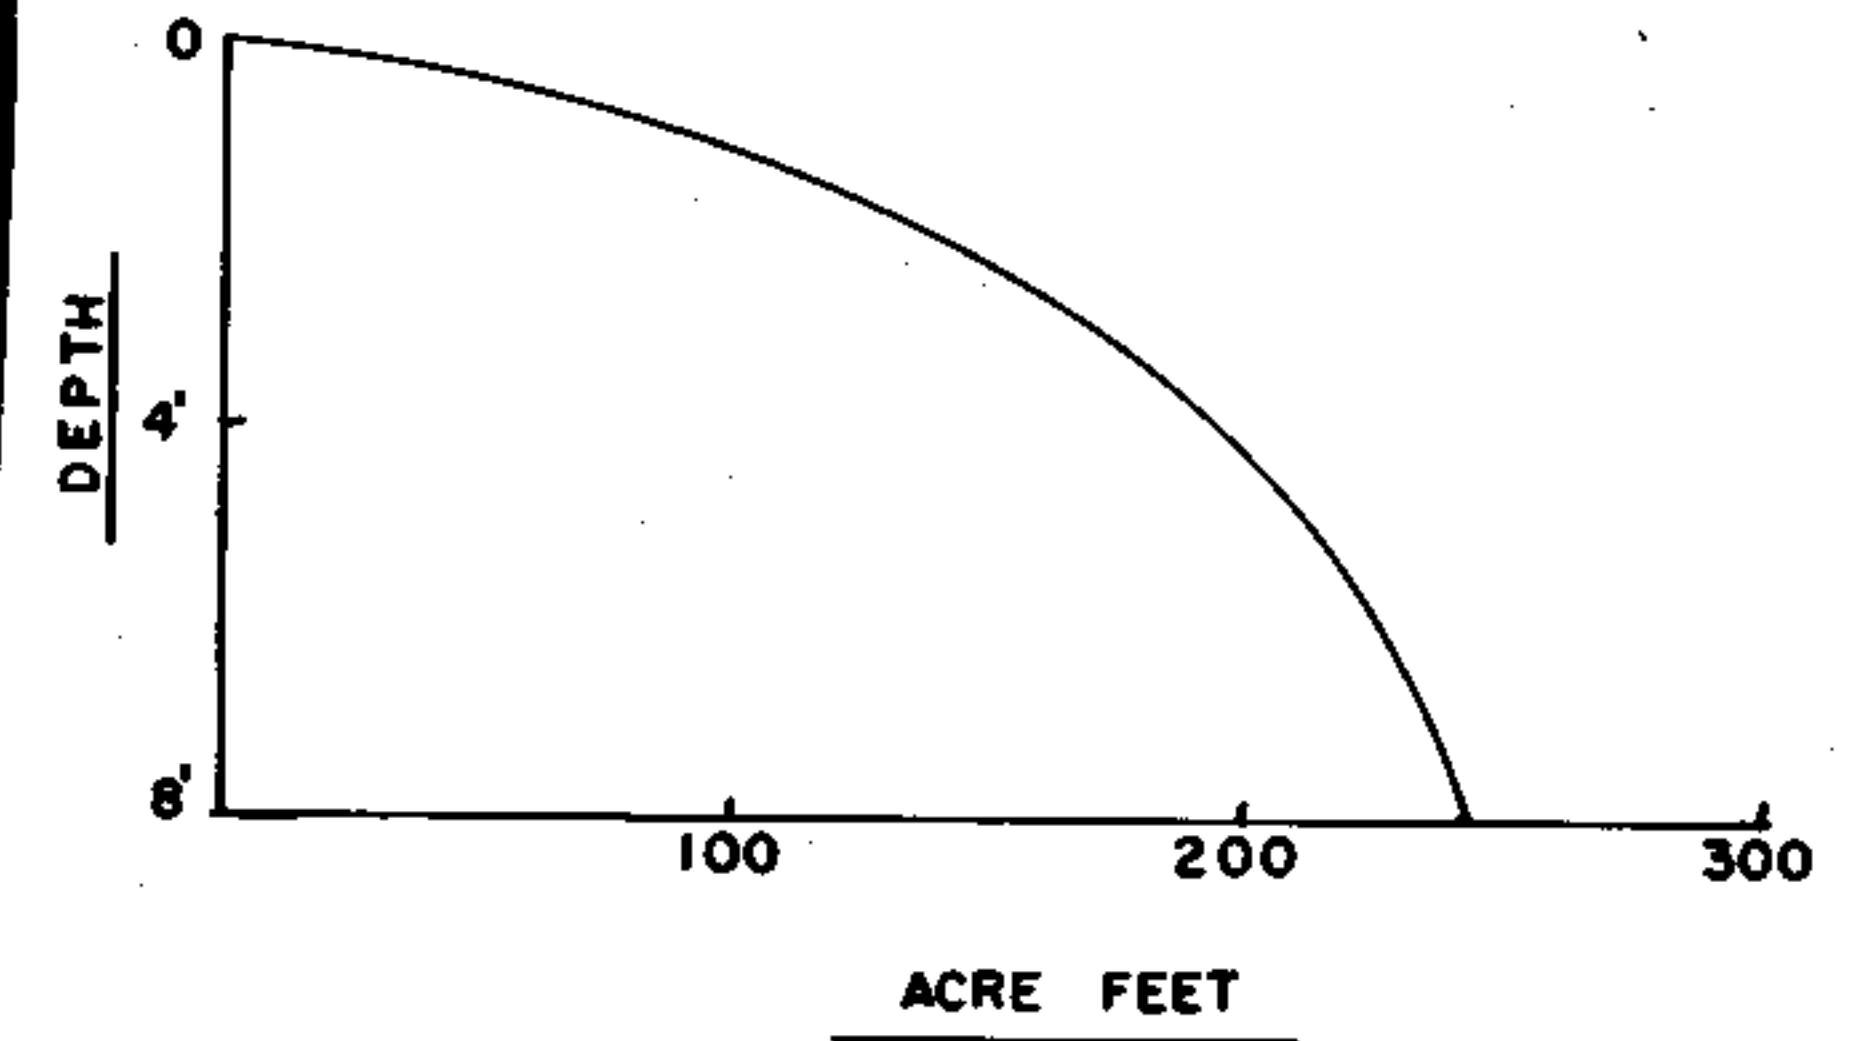
2.4a
3' max. depth

D.N.R., B.M. 1270-A, is a chiseled sq. in a 2' X 3' boulder on the W. side of lake, 12' W. of water's edge, 6' E. of power pole and 47' E. of centerline of road.
Assumed elev. 100.00'
Water level 95.94'
High watermark observed 97.75'

WATER AREA 58.0 ACRES
UNDER 3 FT. 29 %
OVER 20 FT. 0 %
MAX. DEPTH 8 FEET.
TOTAL ALK. 8 P.P.M.
VOLUME 242.5 ACRE FT.
SHORELINE 2.78 MILES
WITH ISLANDS 3.00 MILES

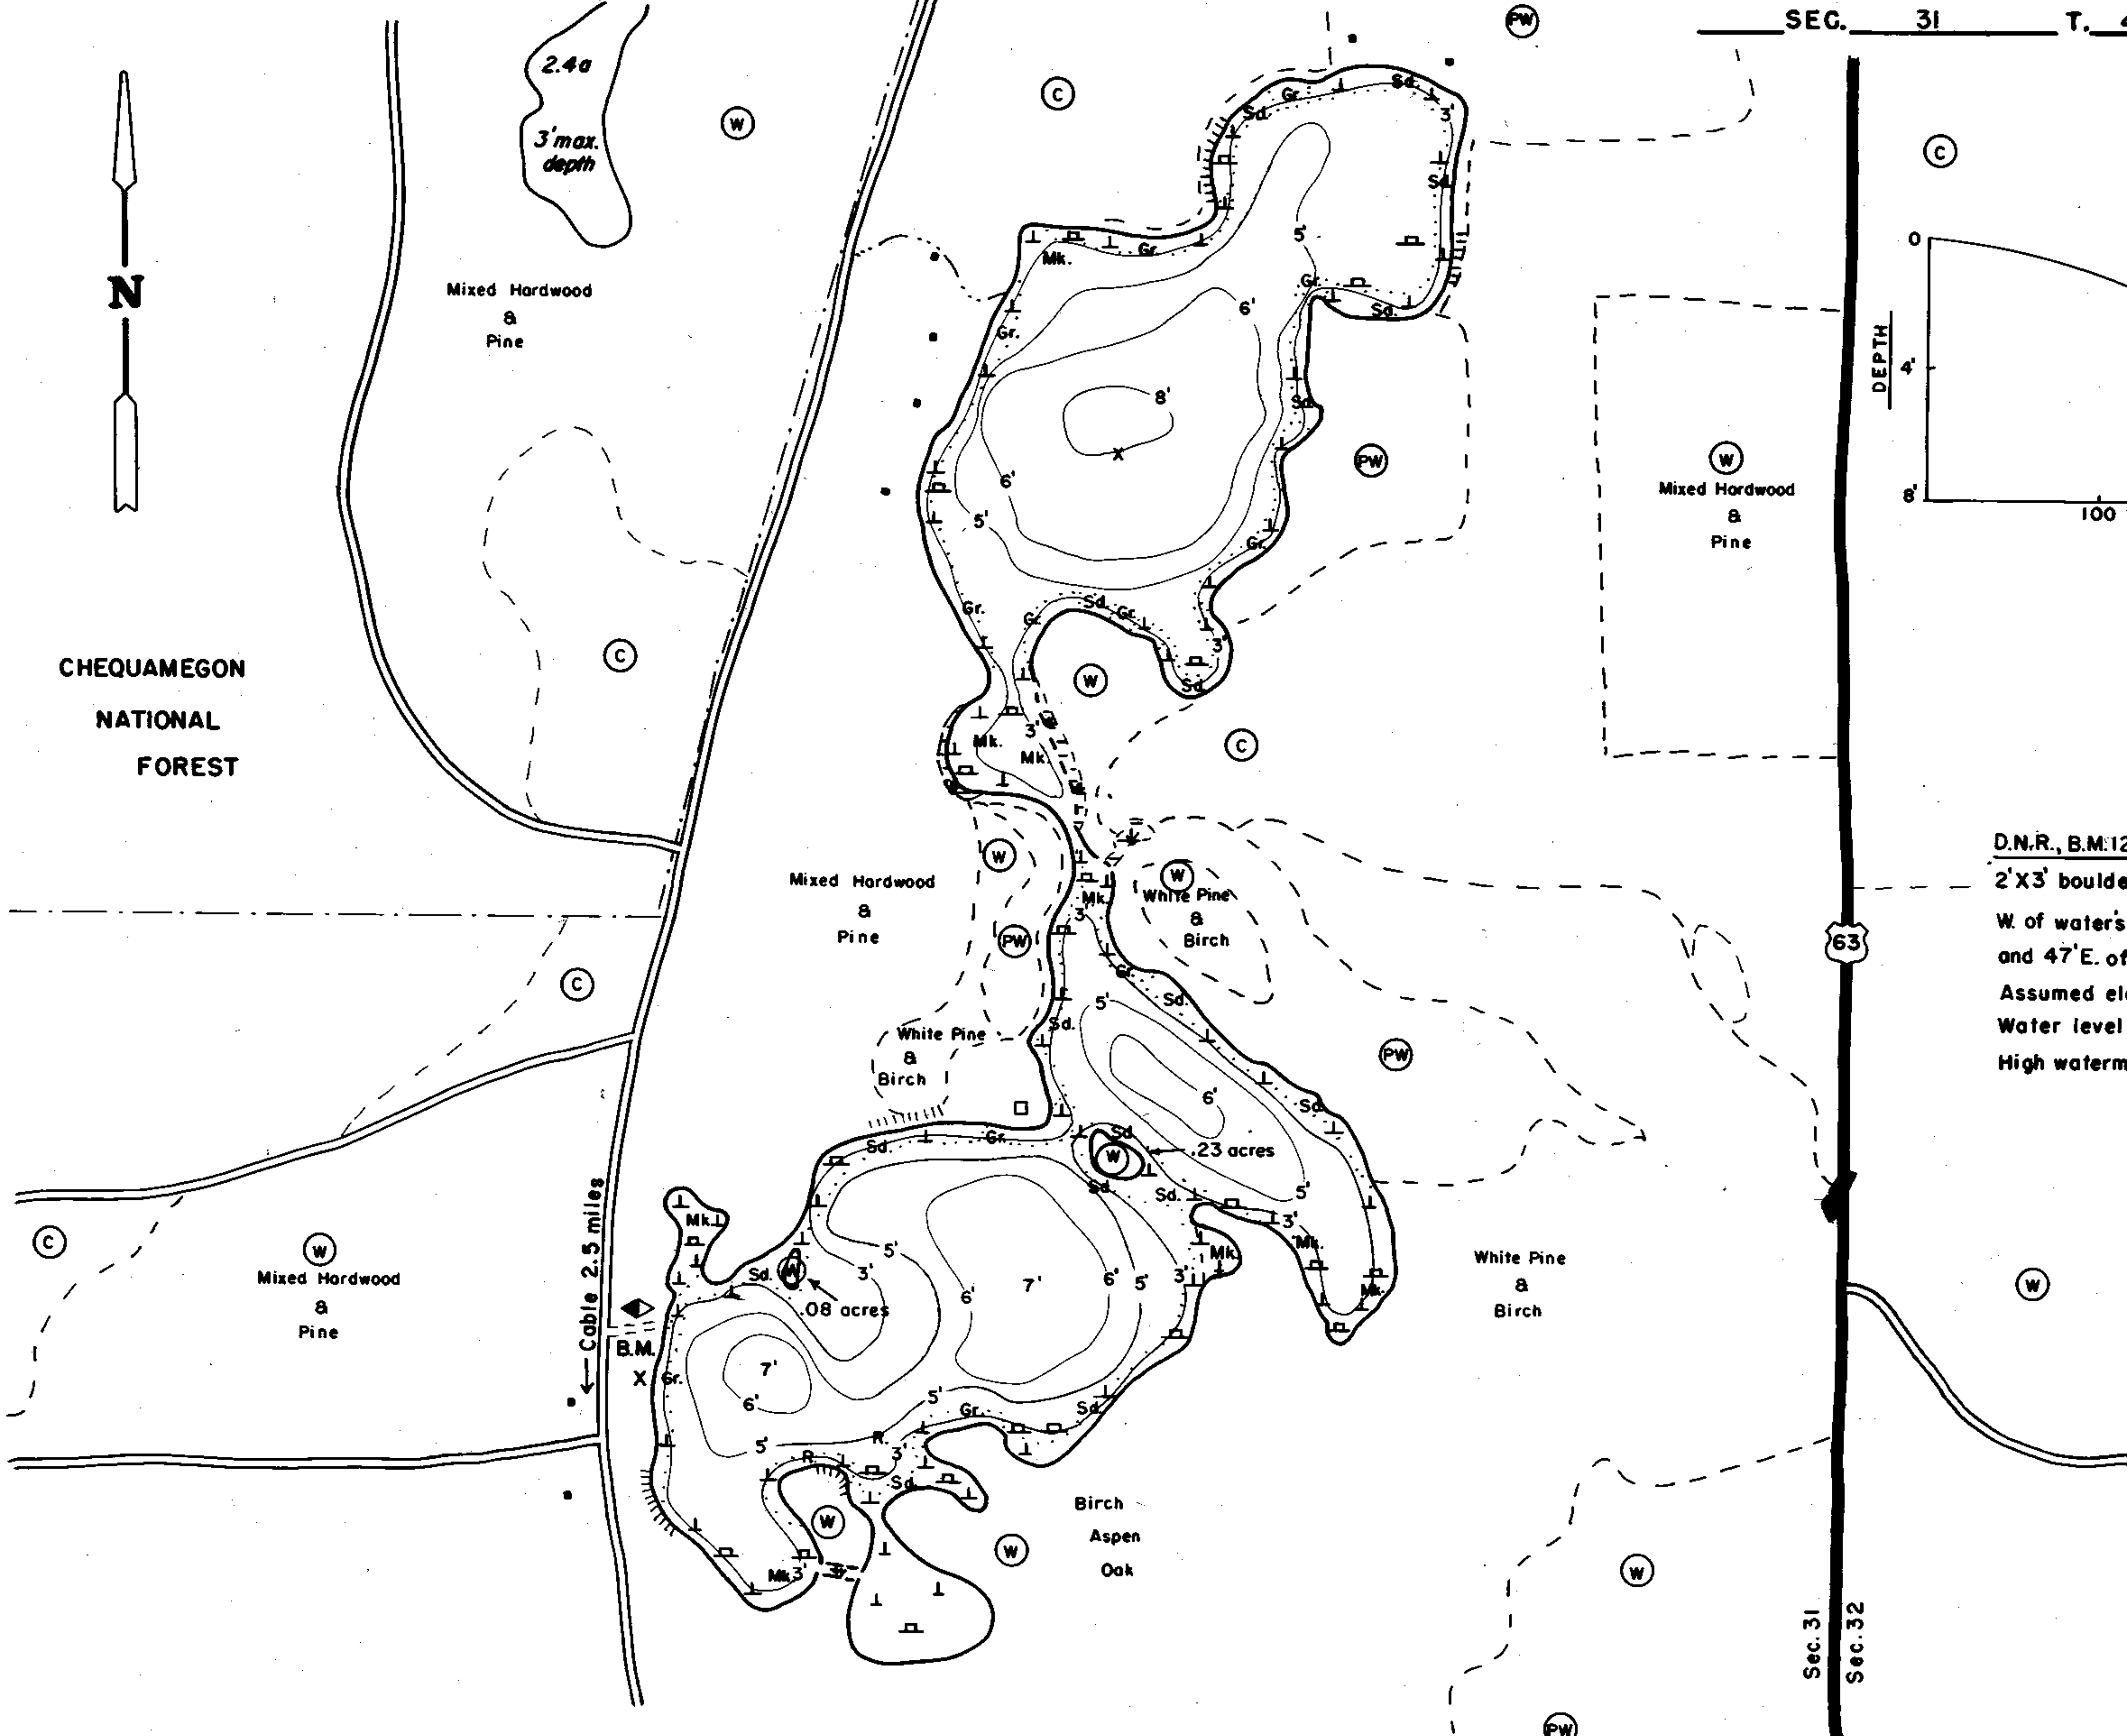
EQUIPMENT RECORDING SONAR MAPPED JUNE 1970
MONTH YEAR
LAKE BOTTOM SYMBOLS
