EQUIPMENT RECORDING SONAR MAPPED JUNE 1970

BAYFIELD COUNTY

Source: Wisconsin Department of Natural Resources 608-266-2621
Crooked Lake – Bayfield County, Wisconsin DNR Lake Map
Date – Jun 1970 - Historical Lake Map - Not for Navigation
A Public Document - Please Identify the Source when using it.

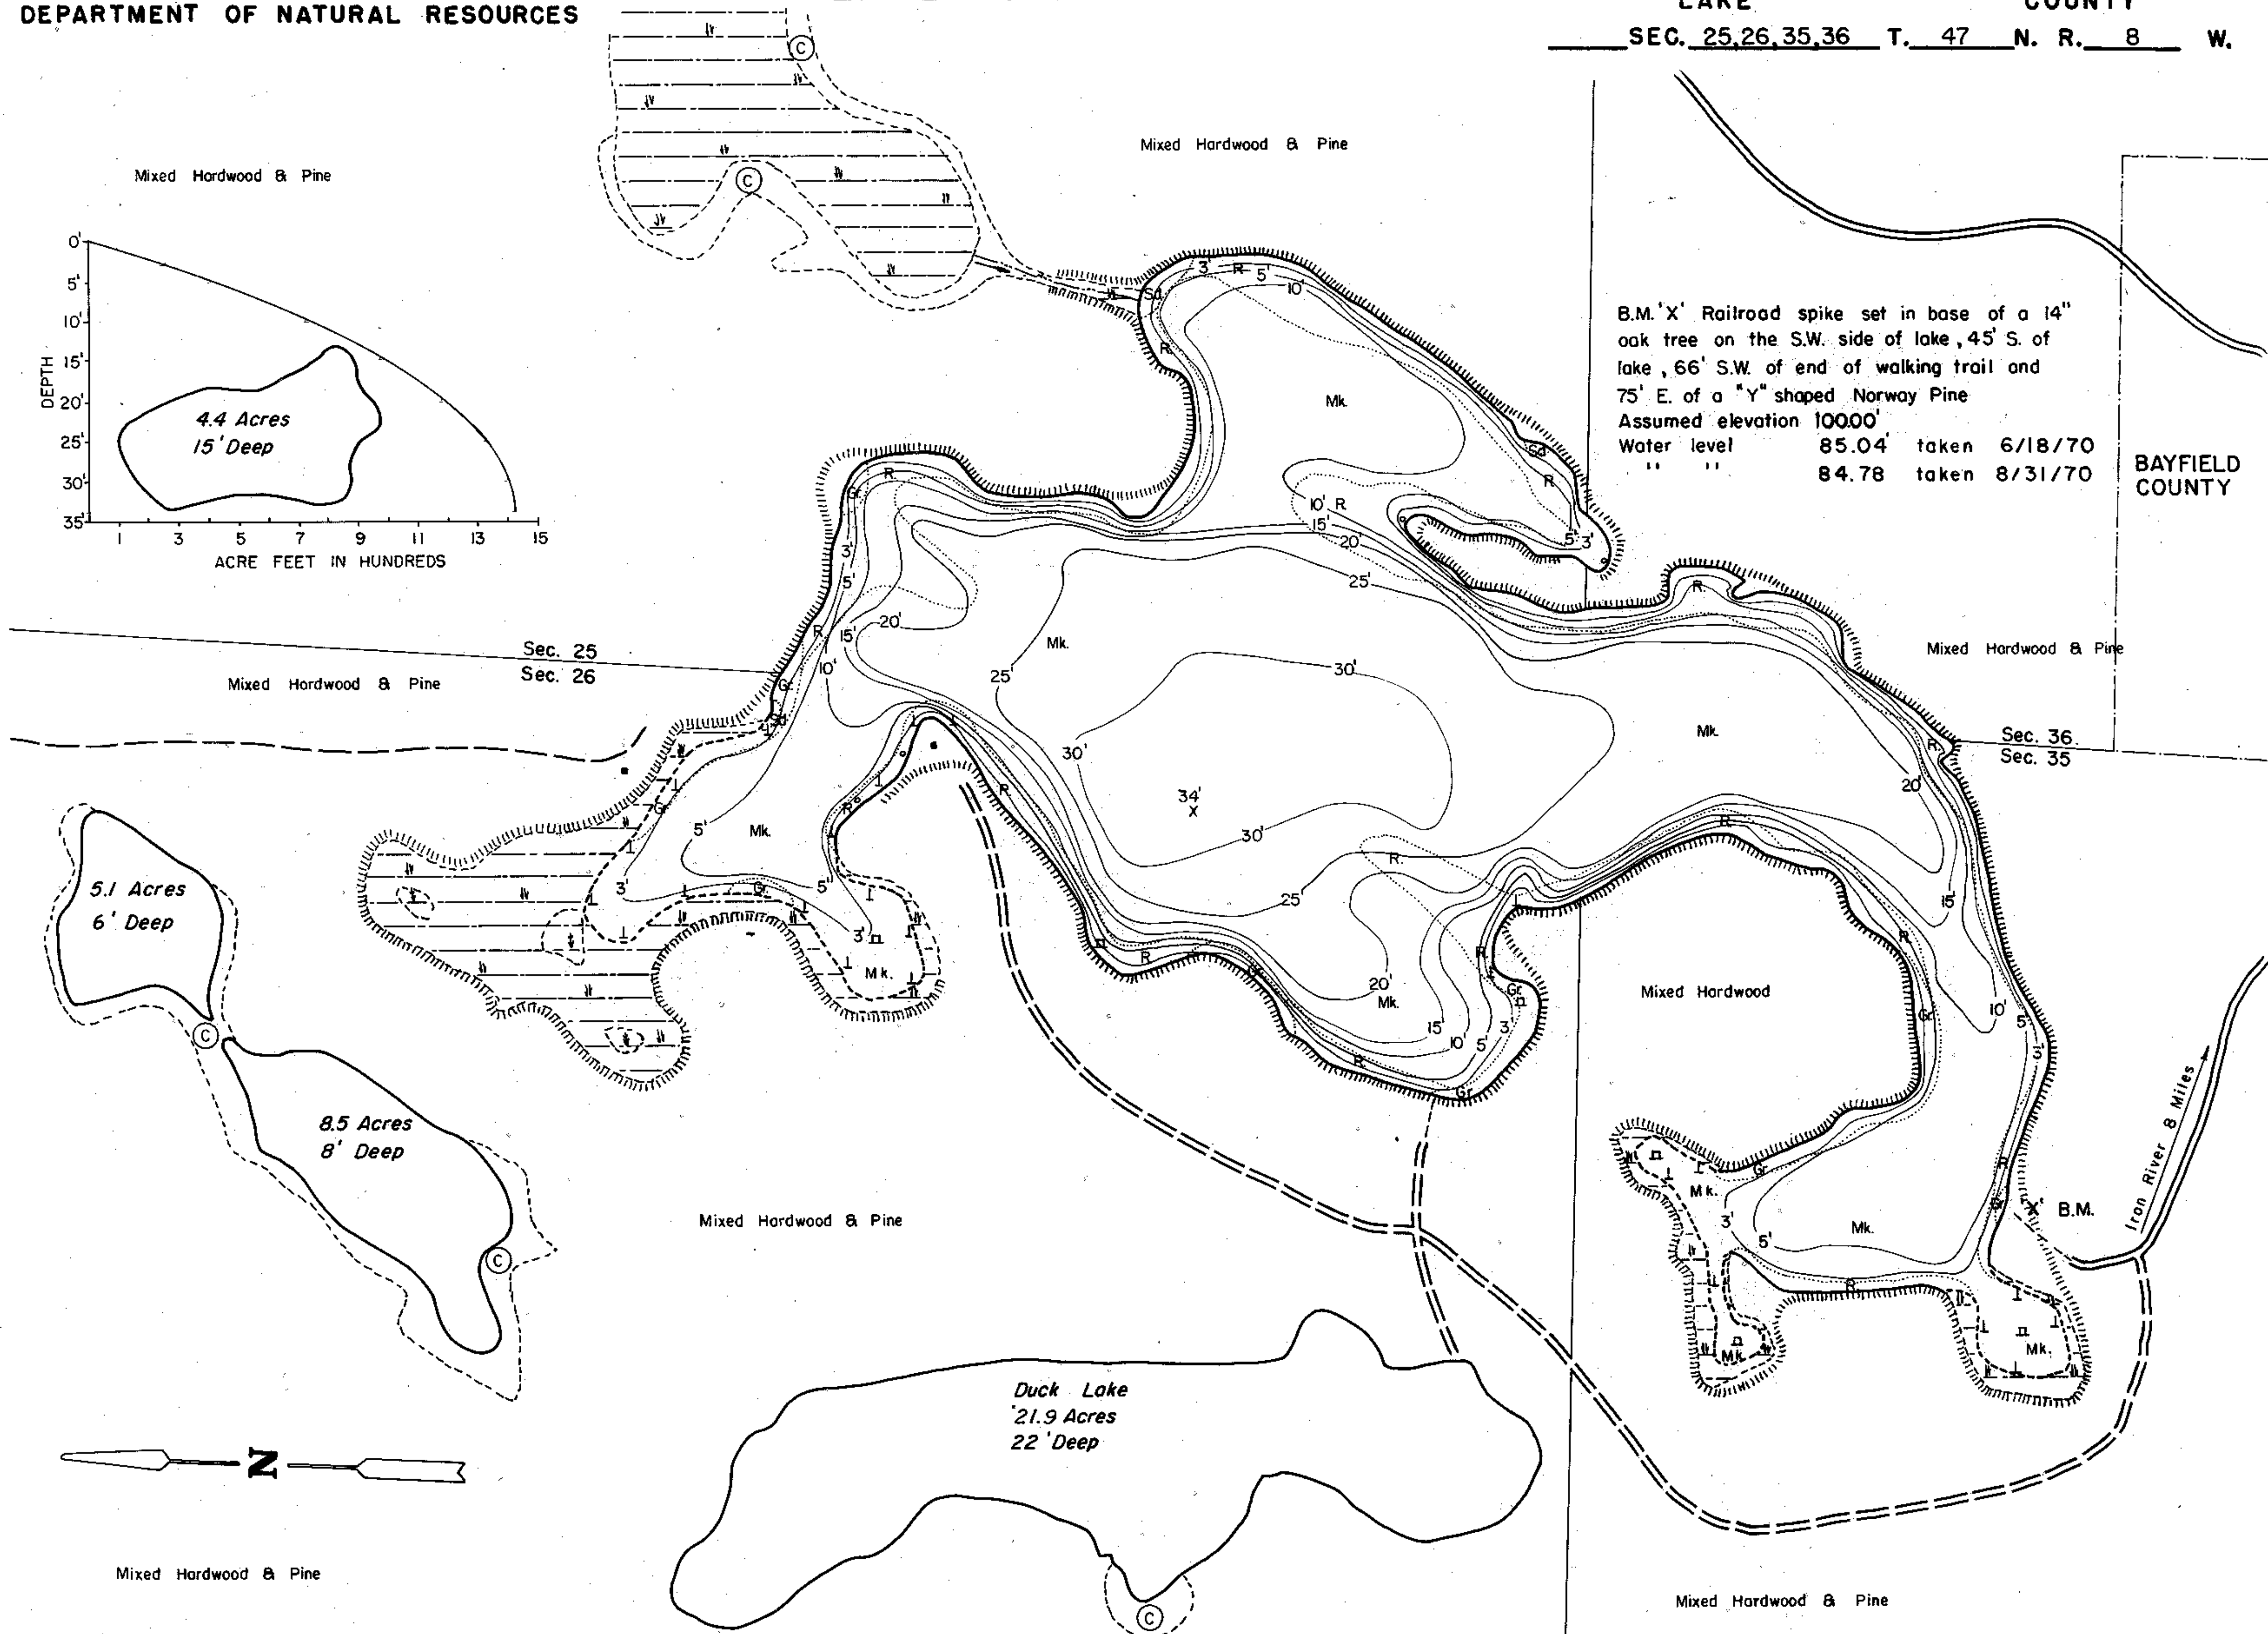
B.M. 'X' Railroad spike set in base of a 14" oak tree on the S.W. side of lake, 45' S. of lake, 66' S.W. of end of walking trail and 75' E. of a 'Y' shaped Norway Pine
Assumed elevation 10000'
Water level 85.04 taken 6/18/70
" " 84.78 taken 8/31/70

WATER AREA 92.7 ACRES
UNDER 3 FT. 15 %
OVER 20 FT. 40 %
MAX. DEPTH 34 FEET.
TOTAL ALK. 44 P.P.M.
VOLUME 1411 ACRE FT.
SHORELINE 3.15 MILES
