Source: Wisconsin Department of Natural Resources 608-266-2621
Horsehead Lake - Vilas County, Wisconsin DNR Lake Map
Date – Sep 1967 - Historical Lake Map - Not for Navigation
A Public Document - Please Identify the Source when using it.

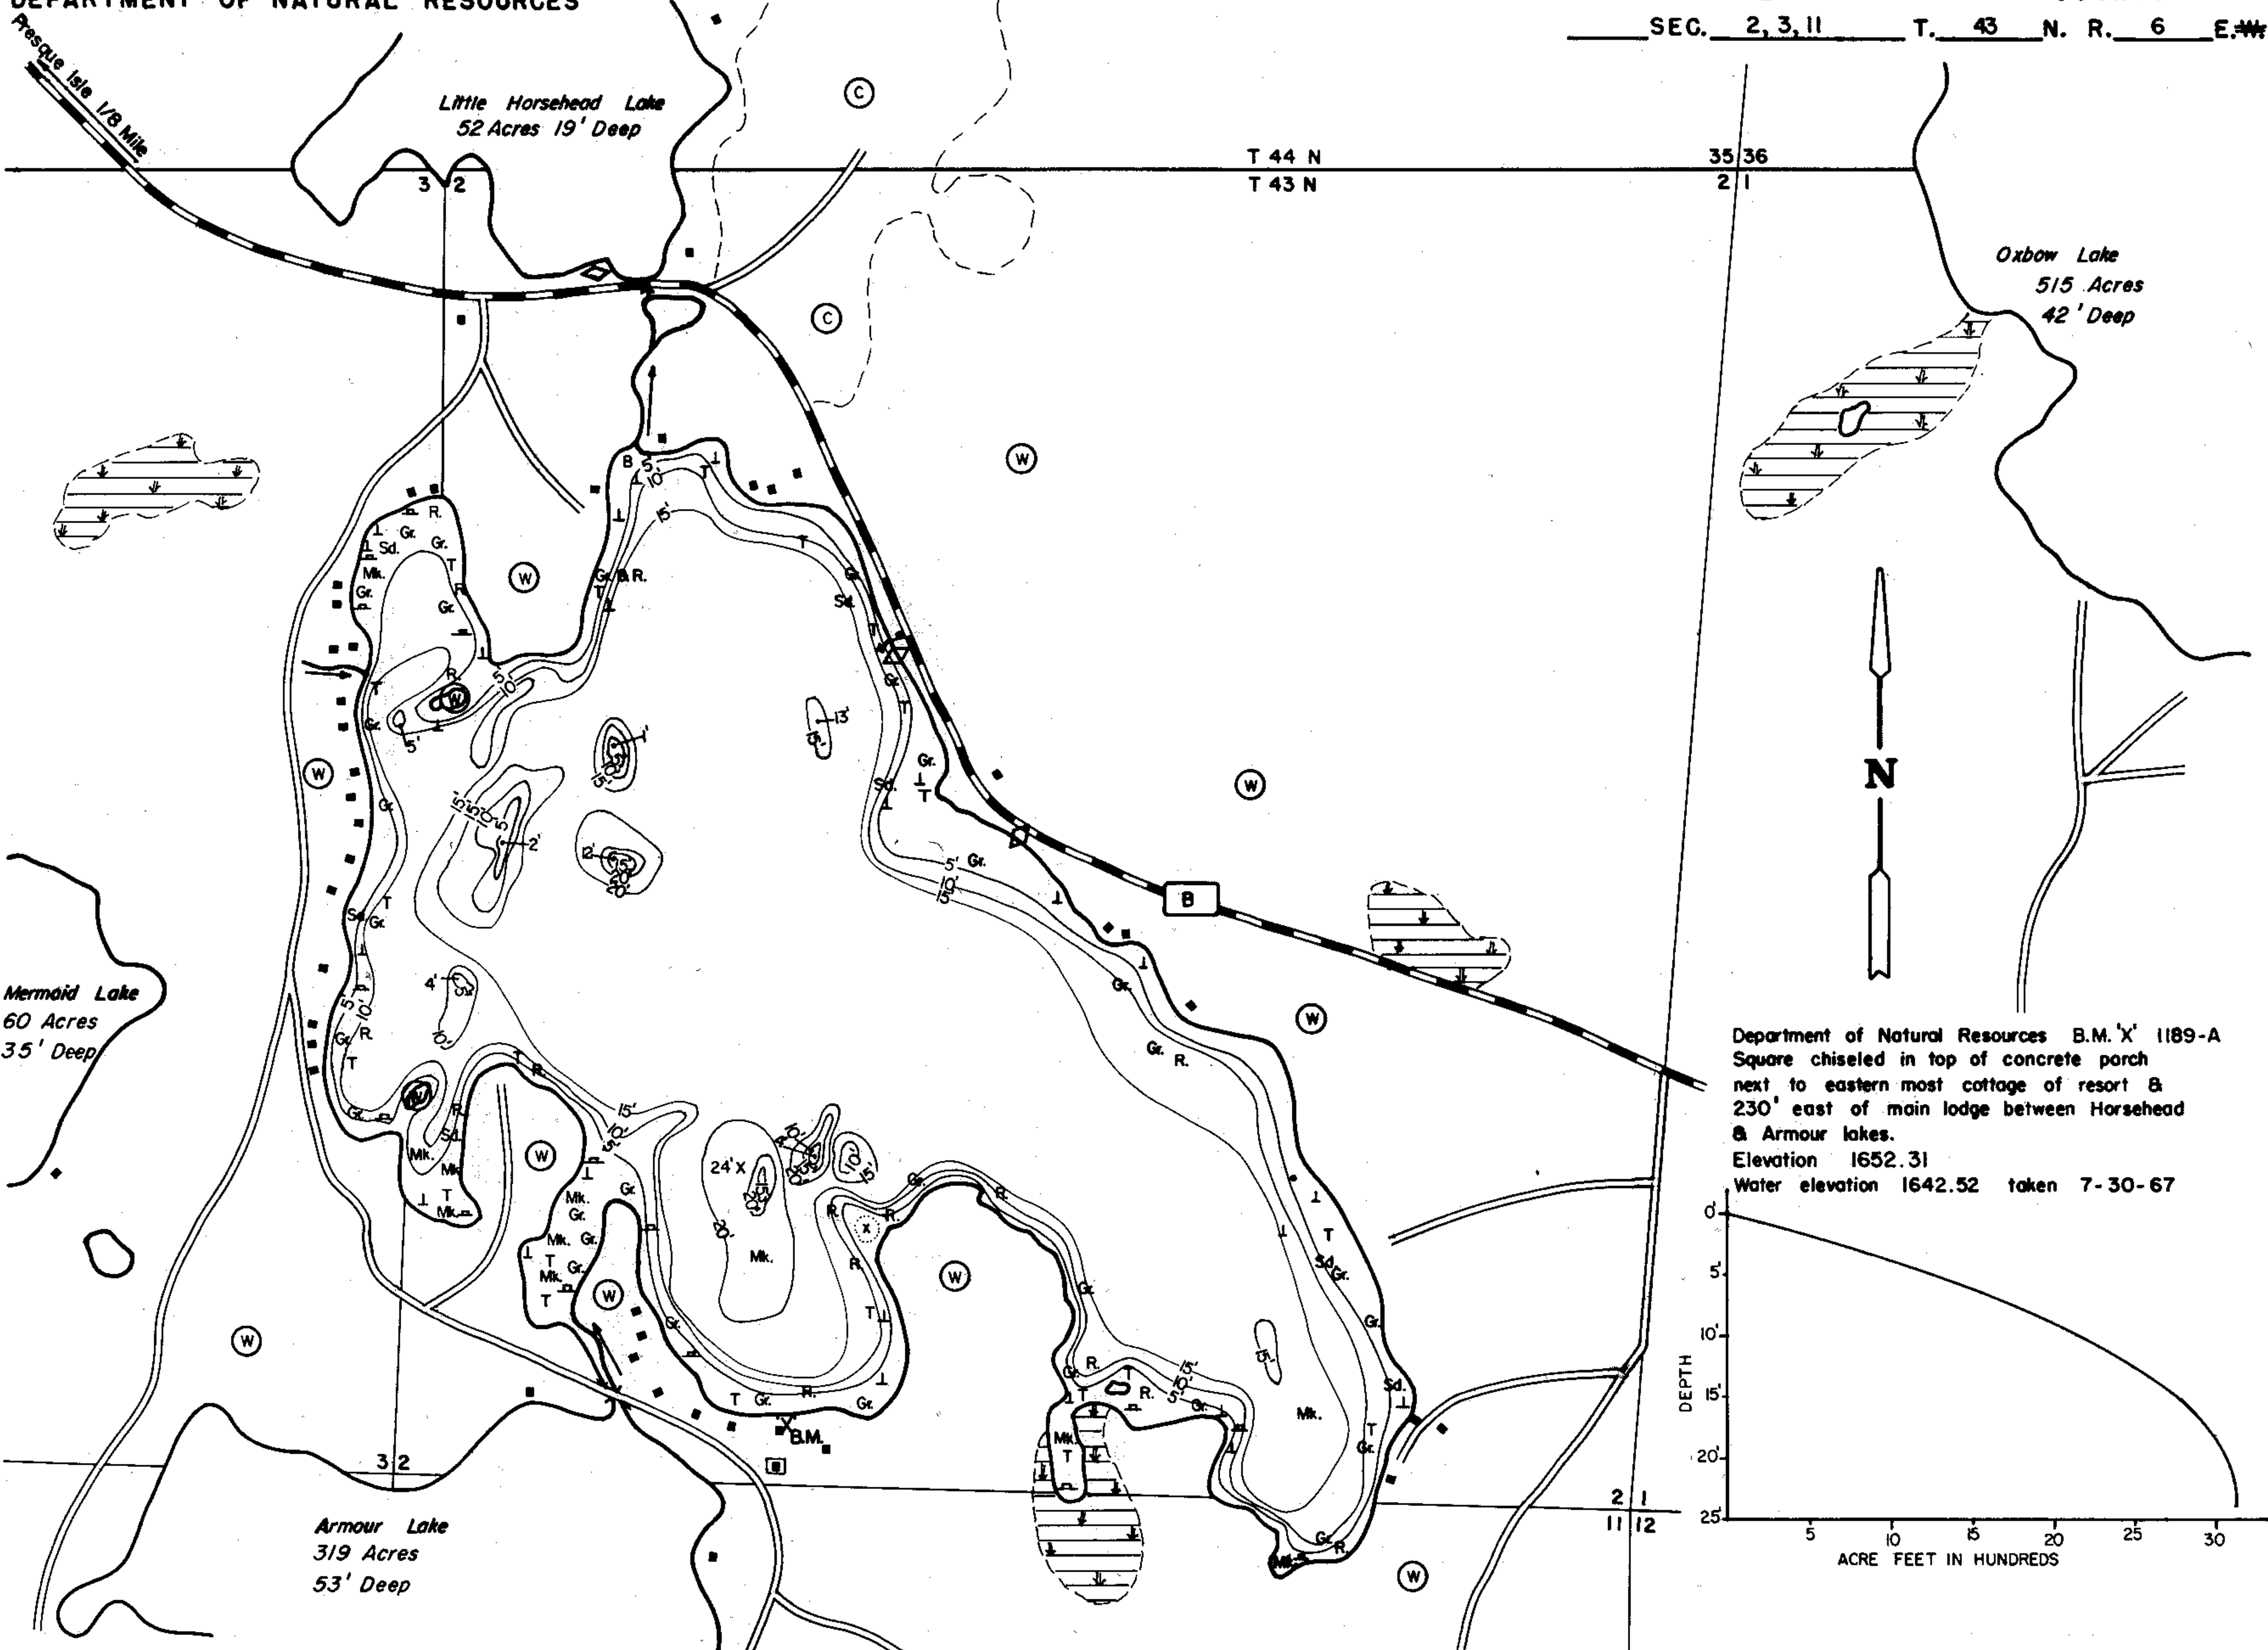
Department of Natural Resources B.M. 'X' 1189-A
Square chiseled in top of concrete porch
next to eastern most cottage of resort &
230' east of main lodge between Horsehead
& Armour lakes.
Elevation 1652.31
Water elevation 1642.52 taken 7-30-67

WATER AREA 234.3 ACRES
UNDER 3 FT. 10 %
OVER 20 FT. 4 %
MAX. DEPTH 24 FEET.
TOTAL ALK. 31 P.P.M.
VOLUME 3115.1 ACRE FT.
SHORELINE 4.07 MILES

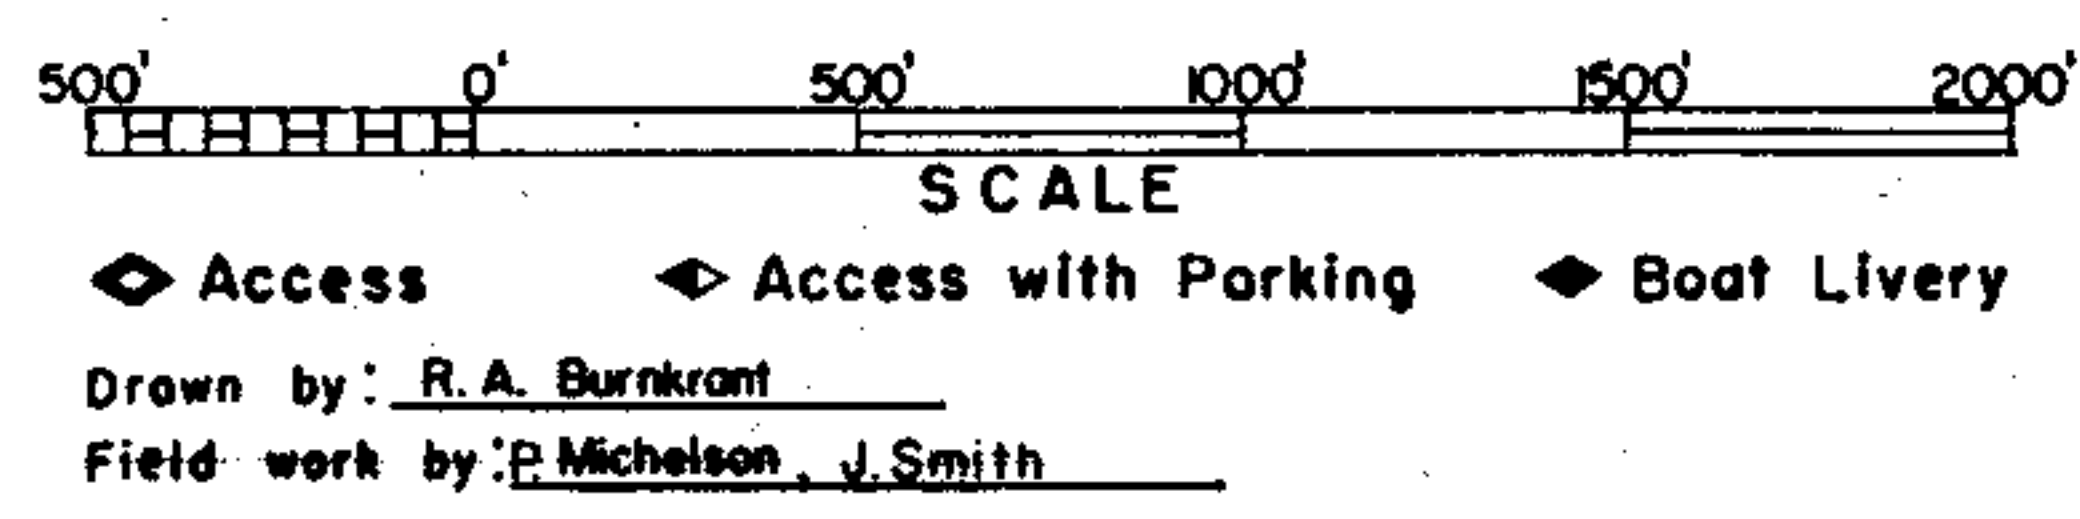
EQUIPMENT RECORDING SONAR MAPPED		SEPT. 1967	
TOPOGRAPHIC SYMBOLS		MONTH YEAR LAKE BOTTOM SYMBOLS	
(B) Brush	Steep slope	P. Peat	B Boulders
(PW) Partially wooded	- - - Indefinite shoreline	Mk. Muck	⊙ Stumps & Snags
(W) Wooded	⊞ Marsh	C. Clay	⊙ Rock danger to navigation
(C) Cleared	⊞ Spring	M. Marl	T Submergent vegetation
(P) Pastured	⊞ Intermittent stream	Sd. Sand	⊥ Emergent vegetation
(A) Agricultural	⊞ Permanent inlet	St. Silt	⊞ Floating vegetation
B.M. Bench Mark	⊞ Permanent outlet	Gr. Gravel	⊞ Brush shelters
■ Dwelling	⊞ Dam	R. Rubble	
⊞ Resort	D.N.R. State owned land	Br. Bedrock	
⊞ Camp
