# LAKE SURVEY MAP

Source: Wisconsin Department of Natural Resources 608-266-2621  
Tenderfoot Lake – Vilas County, Wisconsin DNR Lake Map  
Date – Jul 1969 - Historical Lake Map - Not for Navigation  
A Public Document - Please Identify the Source when using it.

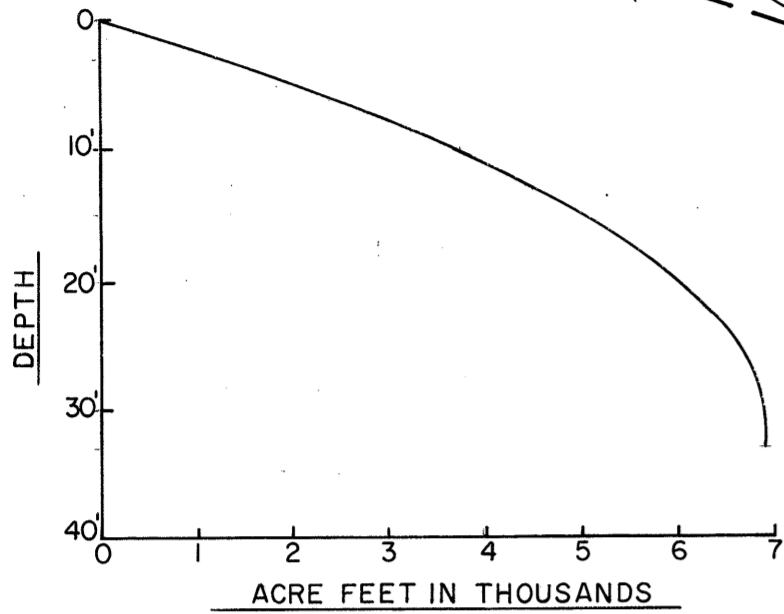
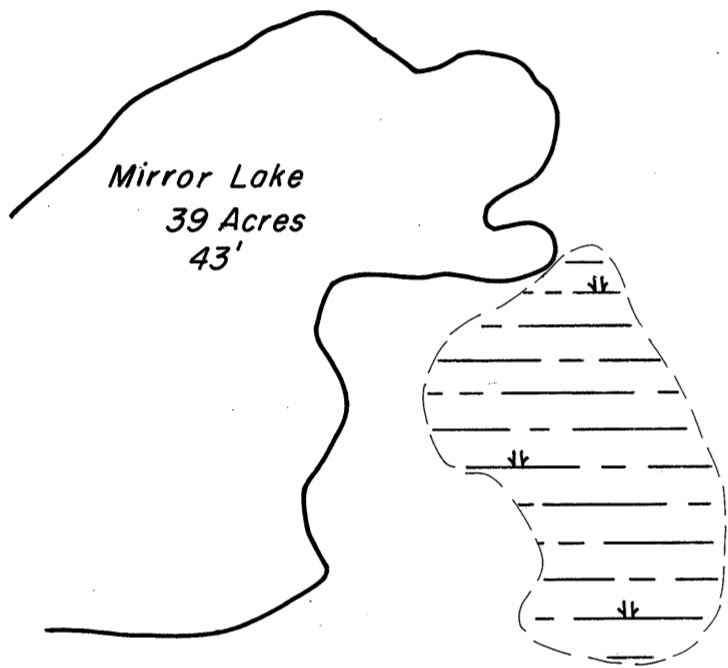
Department of Natural Resources Bench Mark.  
Nail in 3.5" diameter elm, 10' from water, on  
south side of small island in west-central part  
of lake.  
Assumed Elevation 100.00'  
Water Elevation 97.40' taken July 1969

EQUIPMENT RECORDING SONAR MAPPED JULY 1969

WATER AREA 437.0 ACRES  
 UNDER 3 FT. 8 %  
 OVER 20 FT. 37 %  
 MAX. DEPTH 33 FEET.  
 TOTAL ALK. 42 P.P.M.  
 VOLUME 6,914.2 ACRE FT.  
 SHORELINE 6.6 MILES  
 6.2 MILES OF SHORELINE  
 EXCLUDING ISLANDS
