**AQUATIC PLANT MANAGEMENT PLAN**

**ANVIL LAKE  
VIALS COUNTY, WISCONSIN**

October 17, 2007  
Revised September 28, 2009

Northern Environmental Technologies, Incorporated  
1203 Storbeck Drive  
Waupun, Wisconsin 53963

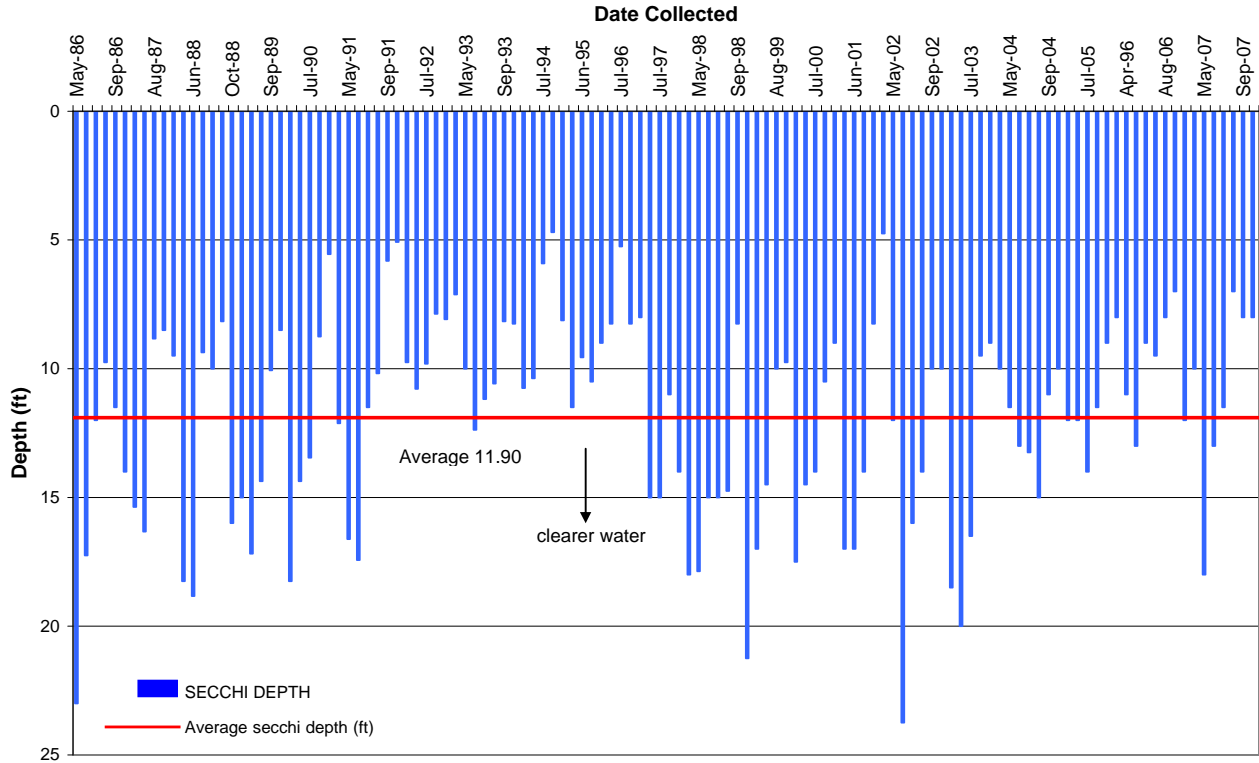
**Anvil Lake Secchi Readings**

The historical water clarity average based on Secchi Disk readings is 11.90 feet (3.63 meters) and ranges from 4.7 to 23.75 feet. The Wisconsin average Secchi Disk reading in 2005 was 10 feet (Larry Bresina, The Secchi Disk and Our Eyes - Working Together To Measure Clarity of Our Lakes; internet document). The following graph illustrates the historical water clarity measurements on Anvil Lake.

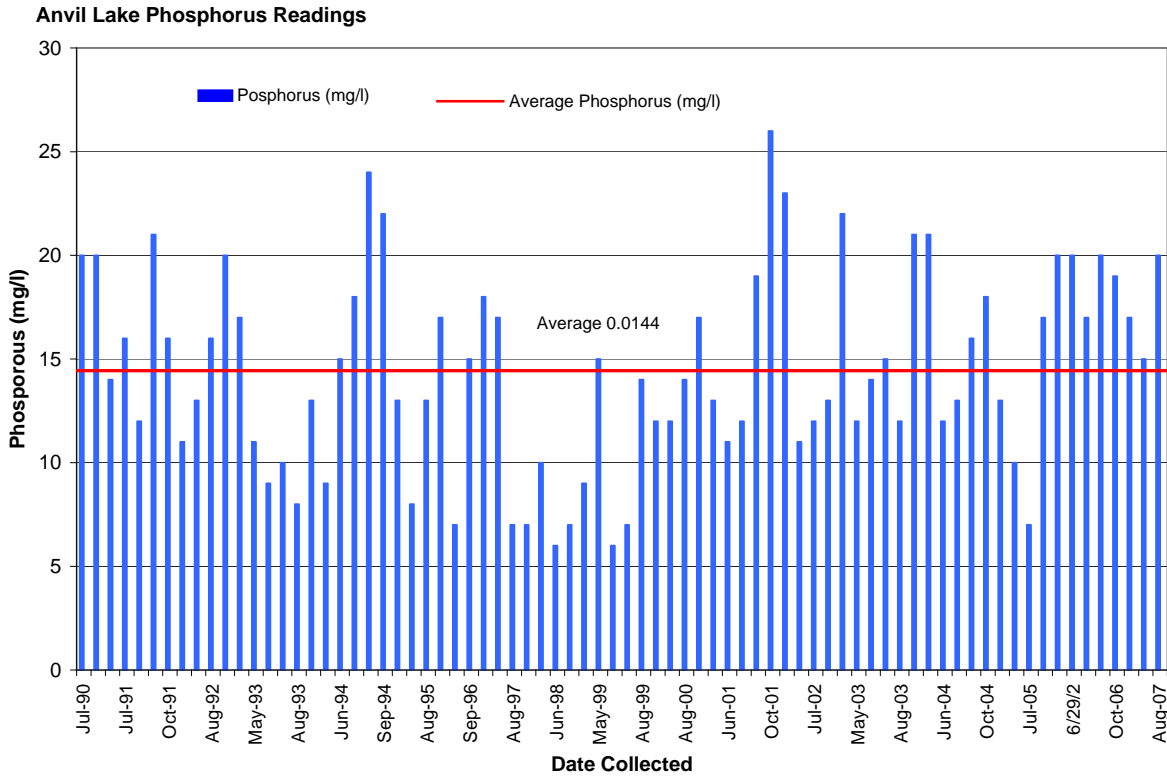
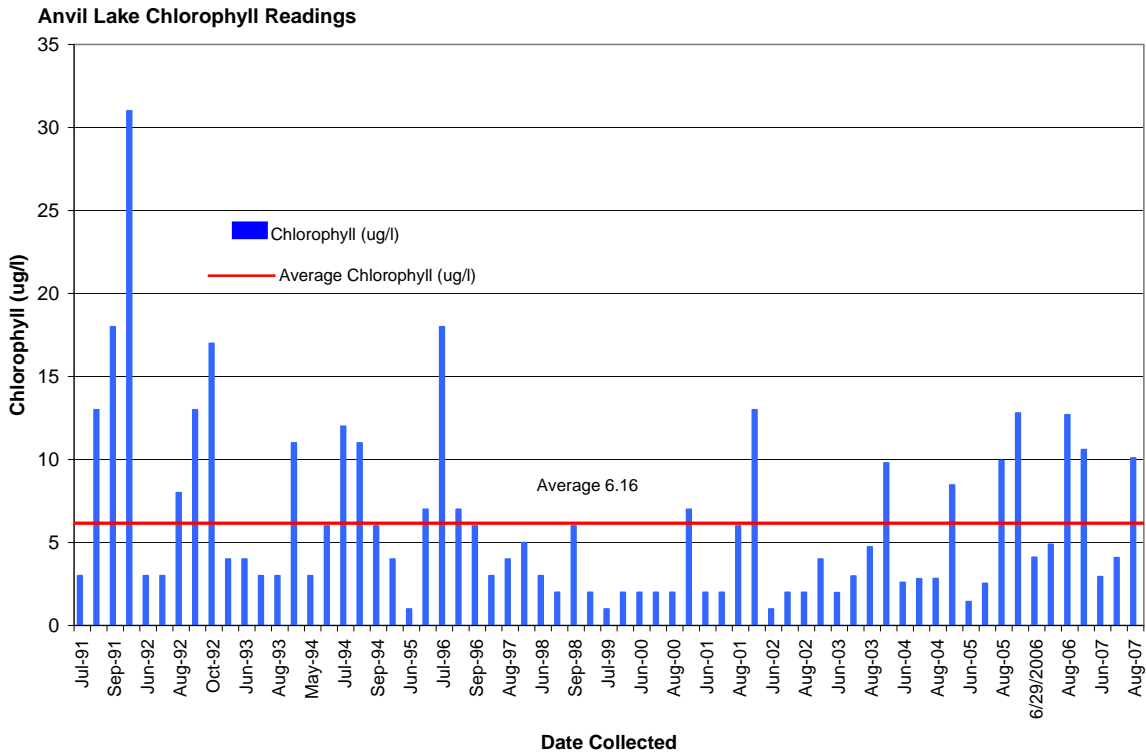
**3.3.2 Total Phosphorus and Chlorophyll *a***

Historically, Anvil Lake has an average phosphorus reading of .0144 milligrams per liter (mg/L - parts per million). The total phosphorus has varied from 0.006 mg/L to 0.026 mg/L. Chlorophyll *a* data has an average of 6.16 micrograms per liter (ug/L - parts per billion). Data ranged from 1.0 ug/L to 31.0 ug/L. The following graphs illustrate phosphorus and chlorophyll *a*, respectively.

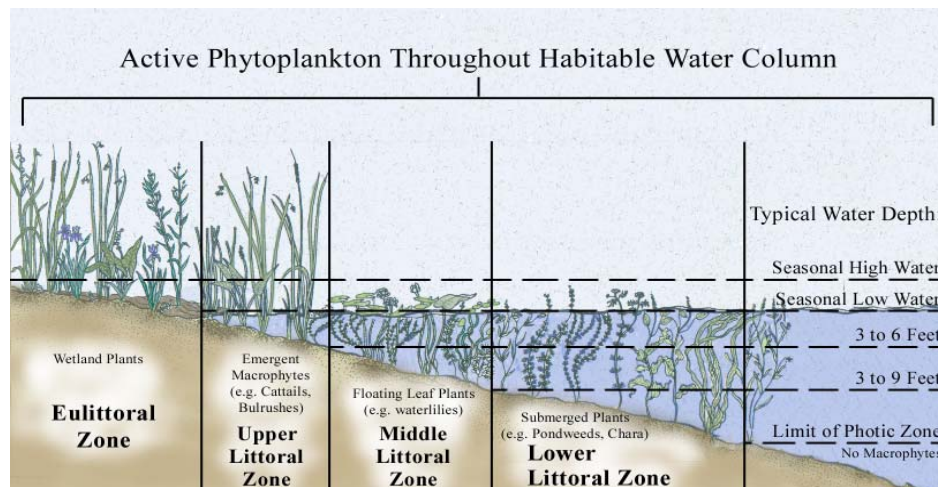
**Aquatic Plant Communities Schematic**

- Eulittoral Zone:** Includes the area between the highest and lowest seasonal water levels, and often contains many wetland plants.
- Upper Littoral Zone:** Dominated by emergent macrophytes and extends from the shoreline edge to water depths between 3 and 6 feet.
- Middle Littoral Zone:** Occupies water depths of 3 to 9 feet, extending deeper from the upper littoral zone. The middle littoral zone is often dominated by floating-leaf plants.
- Lower Littoral Zone:** Extends to a depth equivalent to the limit of the photic zone, which is the maximum depth that sufficient light can support photosynthesis. This area is dominated by submergent aquatic plant types.

The following illustration depicts these particular zones and aquatic plant communities.
