# Curly-leaf pondweed (*Potamogeton crispus*) Pre/Post Herbicide Treatment Surveys Big Chetac Lake – WBIC: 2113300 Sawyer County, Wisconsin

Survey Conducted by and Report Prepared by:  
Endangered Resource Services, LLC  
Matthew S. Berg, Research Biologist  
St. Croix Falls, Wisconsin  
May 18-19 and June 17-18, 2013

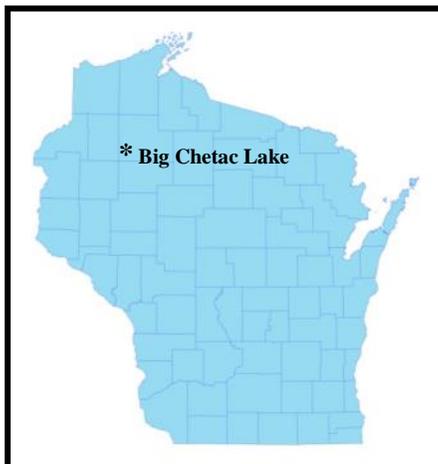
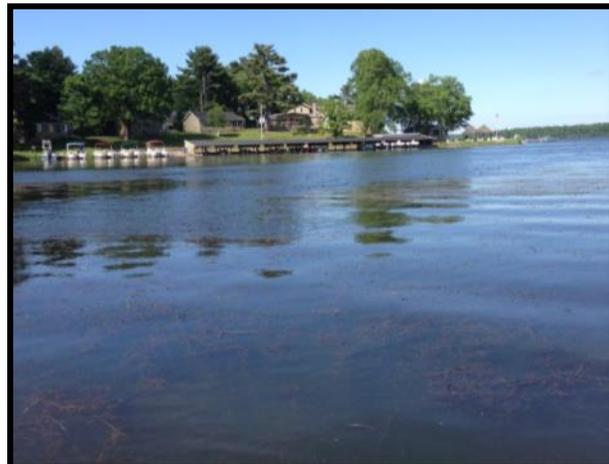
Solid Canopied Curly-leaf Pondweed Mat in the Control Area Bay

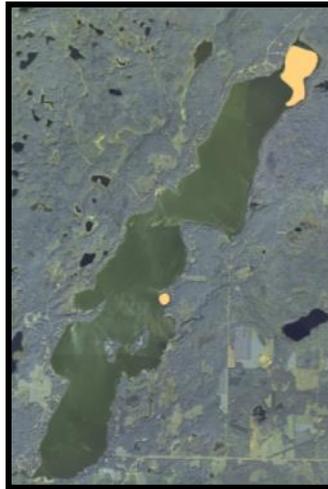
**Figure 1: Proposed 2013 Spring CLP Treatment Areas**

In 2013, after years of study and discussion among board members, residents, local businesses, and the WDNR, the Big Chetac Chain Lake Association applied for and received a 3 year WDNR exotic species control grant to begin actively managing CLP chemically and manually. After evaluating the 2008 maps, it was determined the expansive beds in the north bay and the boat landing bay would be chemically treated. Combined, these areas totaled 105 surface acres (Figure 1).

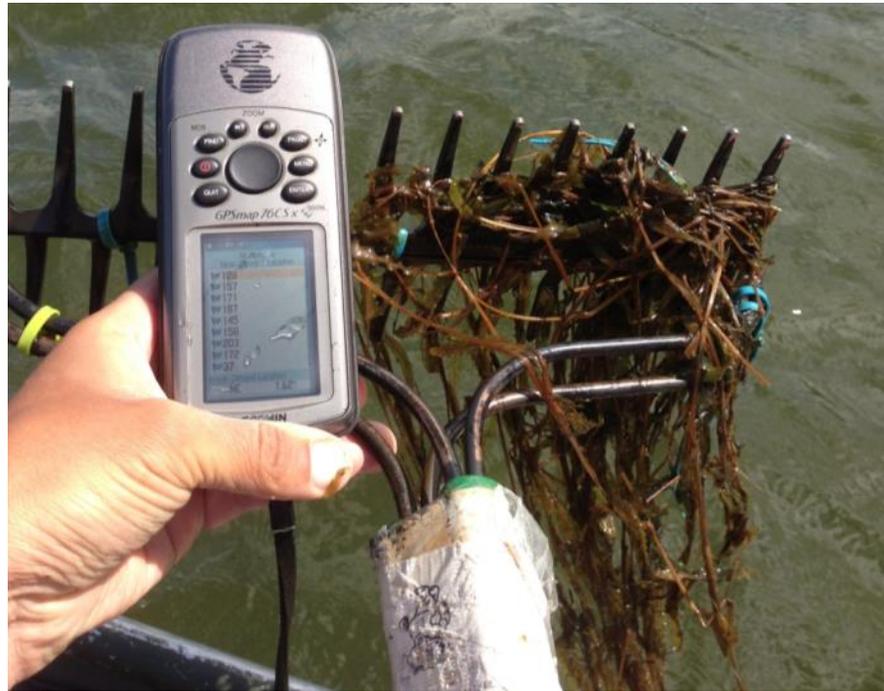
**Figure 17: CLP Impacted by Herbicide at the South End of the Upper Basin**

With a project goal being to significantly reduce CLP prior to beginning the restoration of native plants (BCABLA 2010), the 2013 herbicide application has to be considered a success. By starting the restoration process on the upstream/north end of the lake, the treatment provided the additional benefit of preventing recolonization of CLP from turions washing in from elsewhere, as well as providing residual control as the herbicide moved downstream. We noted that CLP was completely eliminated as much as one mile downstream from the southern border of the treatment area. In fact, the herbicide provided enough of a jolt to CLP throughout the entire upper basin that, although not killed outright, these plants did not appear to be healthy enough to set flowers/seeds or turions (Figure 17). As the project moves into its second year, all data from 2013 along with the 2014 pretreatment survey will be used to finalize 2014 treatment areas as we continue to work towards these goals.
