Amacoy Lake Aquatic Plant Management Plan

Amacoy Lake has a rich tradition of angling, recreation and aesthetic value, which is linked to good water quality and a healthy plant and animal community. Recent studies of Amacoy Lake indicate the presence of curly-leaf pondweed, degradation to shoreline habitat, erosion, blue-green algae, a loss of water quality, and issues with development pressure. As the lake is widely used by recreators and thus susceptible to further infestations, degradation, and safety issues, an aquatic plant management plan is needed.

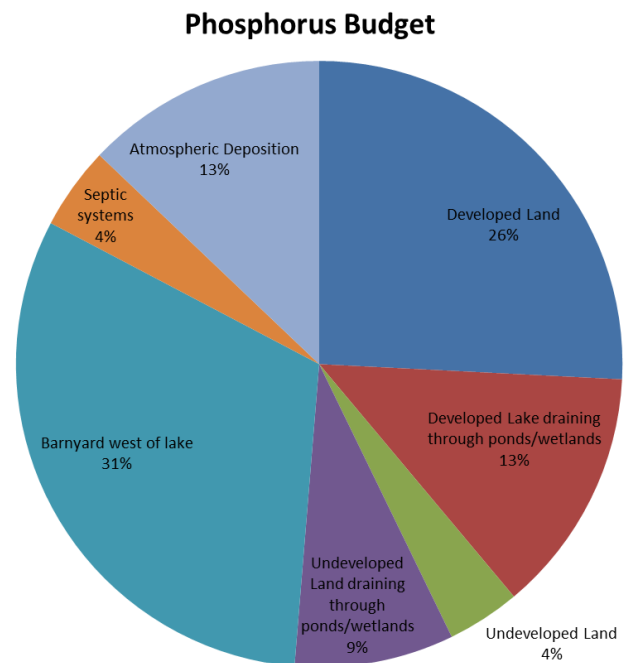
Figure 5. The external loading phosphorus budget of Amacoy Lake watershed includes, in descending order, the following sources: Barnyard (31%), Developed land (26%), Atmosphere (13%), Developed wetlands (13%), Undeveloped wetlands (9%), Undeveloped lands (4%), Septic systems (4%).(Roesler, 1995)

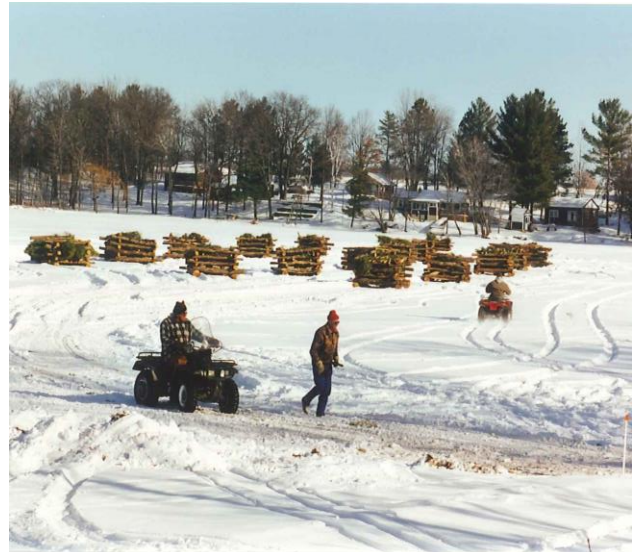
Figure 6. Fish cribs being installed on Amacoy Lake during the winter.

ALPOA has been committed to trying to improve the in-lake habitat for fish. From 1999 – 2001 eighty-four conventional log fish cribs were installed in deep water at various locations around the lake (Figure 6.). In March 2003, WRA and ALPOA worked together to specifically enhance walleye habitat. They received donated field stone (8-20 inches in diameter) and spread it out along portions of the east shore to increase walleye spawning habitat. This project was approved by the WDNR. Scheirer (2013) noted that “the shoreline rock blanket had no positive effect on walleye reproductive success” due to lack of evidence of walleye recruitment. In 2003, the DNR conducted a

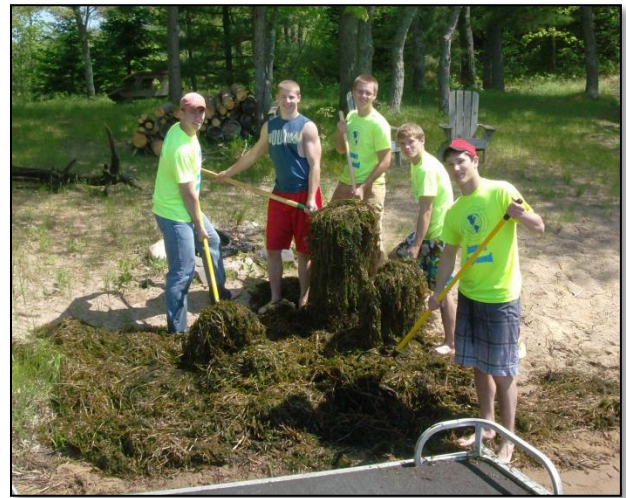
Figure 7. Local youth assisting with manual removal of CLP from Amacoy Lake in 2012.

Manual control has been employed by lake users after chemical treatments to help tidy up missed CLP plants. This has been helpful and will continue each year until CLP is not found in the lake.

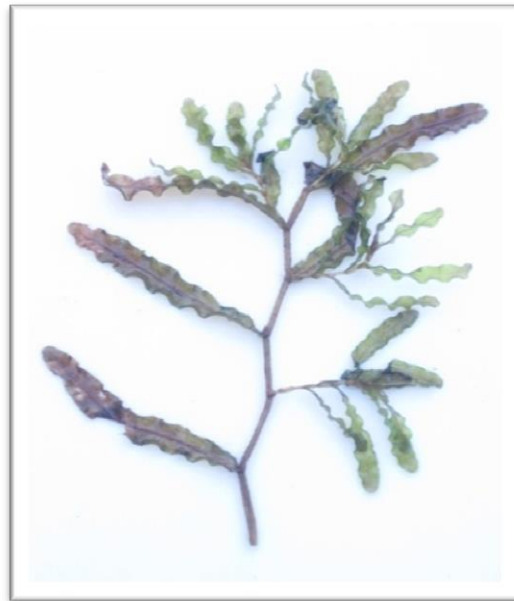
Figure 8. Invasive curly-leaf pondweed found in Amacoy Lake.

Curly-leaf pondweed (Figure 8.) was discovered in Amacoy Lake in 1994, but the lake group was unaware of its presence until 2008. ALPOA will design a plan to:

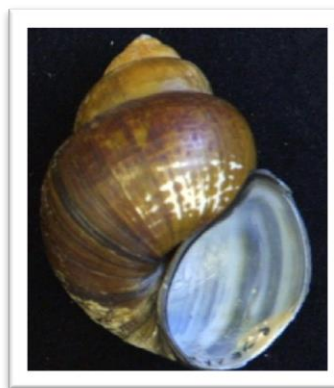
Figure 9. Chinese mystery snail, present in Amacoy Lake, is as wide as it is tall.

Chinese mystery snails (CMS, Figure 9.) (*Bellamya chinensis*) were originally sold in Chinese food markets in San Francisco in the late 1800s. Introduction to the wild was likely due to specimens released from aquariums into the Niagara River between 1931 and 1942 (Mills et al.1993). Recent research shows that CMS were present in 50% of lakes surveyed throughout northern Wisconsin (Solomon et al. 2009). Chinese mystery snails were found in Amacoy Lake sometime between 2007 and 2013. At this

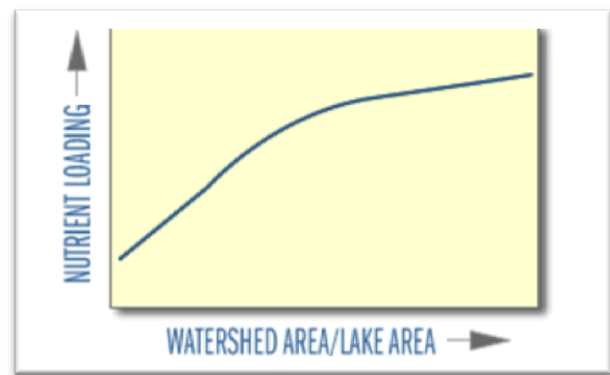
Figure 10. General pattern of nutrient loading associated with increasing watershed size relative to lake area. <http://www.waterontheweb.org/>

quality typically decreases as the watershed area to lake area increases (Figure 10.). The greater that ratio is, the greater the amount of nutrients that are entering the system from various sources. The watershed to lake ratio of over 16 to 1 is higher than the average for natural lakes in Wisconsin, and indicates that watershed characteristics have a potentially large impact on water quality in Amacoy Lake. However, the ratio is low enough that water quality improvement can be achieved with a comprehensive package of best management practices (BMPs) and restoration alternatives. The potential for successful lake restoration efforts is generally considered good in cases where the watershed to lake ratio is less than 20:1.

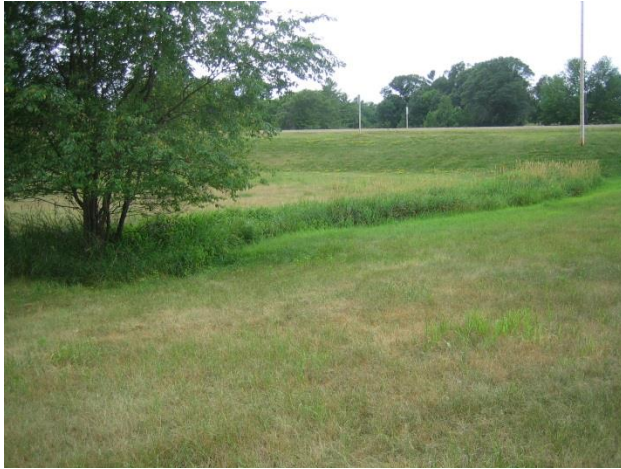
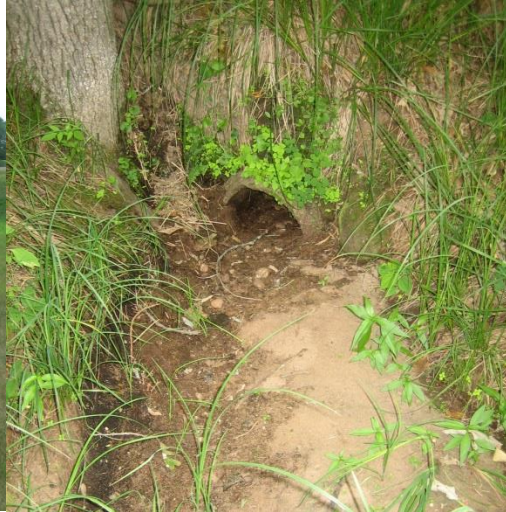
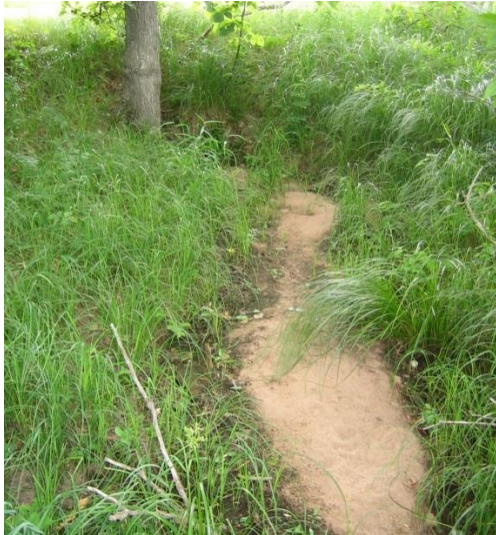
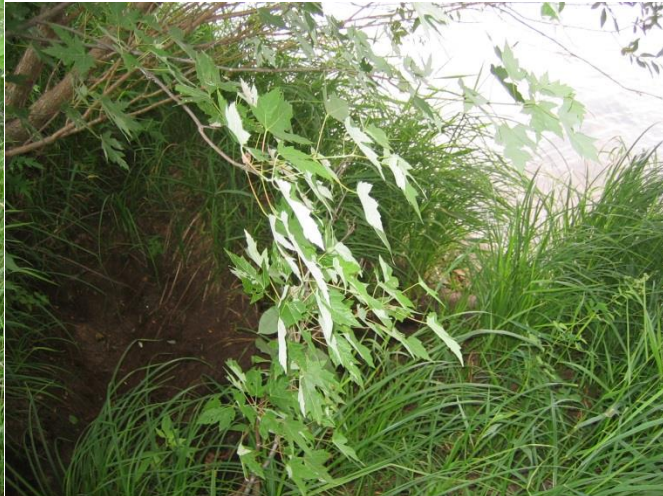
Appendix A – Amacoy Inlet #3

Pictures of INL-3 to Amacoy Lake. Clockwise from upper left: 1.) water runs under Hwy 40 in the distance to an underground culvert at the tree; 2.) water then comes out of the culvert 10 m away from the lake; 3.) water runs above ground in a swellway; 4.) water enters south side of lake above ground.

INL-3. INL-3 at one time entered directly over land into Amacoy Lake from the southwest. Currently, water travels under Hwy 40 from the west and then over land until 20 meters from the lake and then goes below ground through a culvert and resurfaces 3 meters from the lake and enters the lake (see *Appendix A* for photos). It appears that this inlet is intermittent, depending on precipitation.
