Presque Isle Wilderness Waters Program

Aquatic Plant Management Plan – Beaver Lake

Date: March 2014

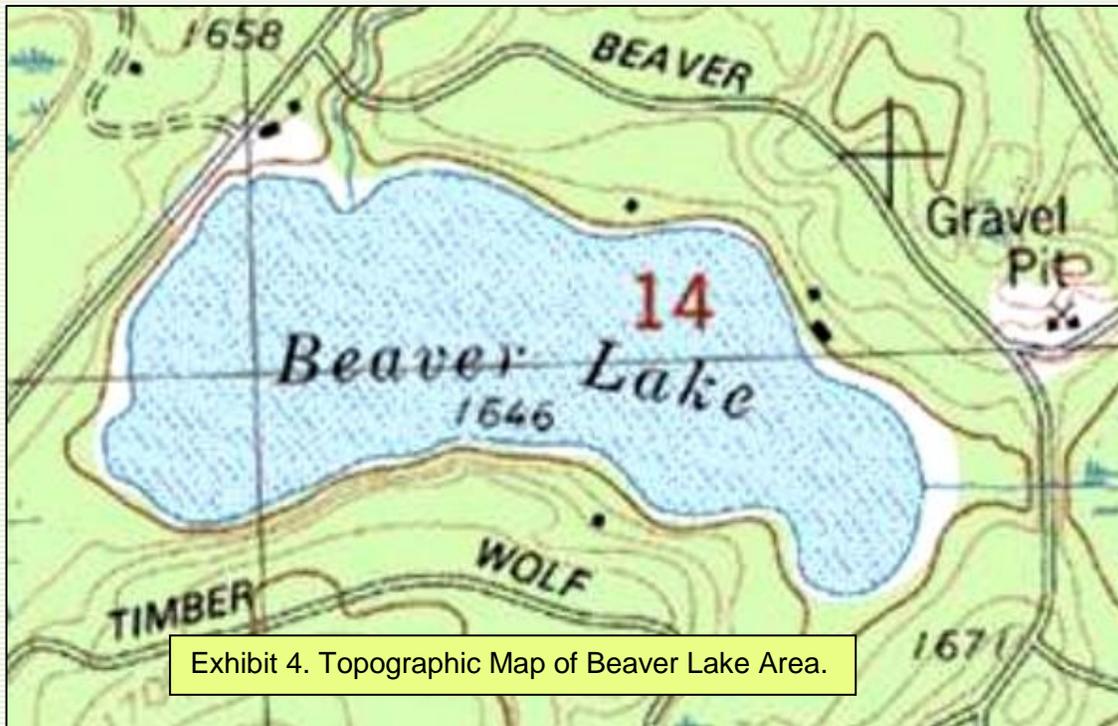
Exhibit 4. Topographic Map of Beaver Lake Area.

Beaver Lake has no public access site. We observe a total of 19 piers on the shoreline of Beaver Lake from a 2011 aerial photograph or about 11.7 piers per mile of shoreline. The riparian area consists of both upland and wetland areas (Exhibit 4).

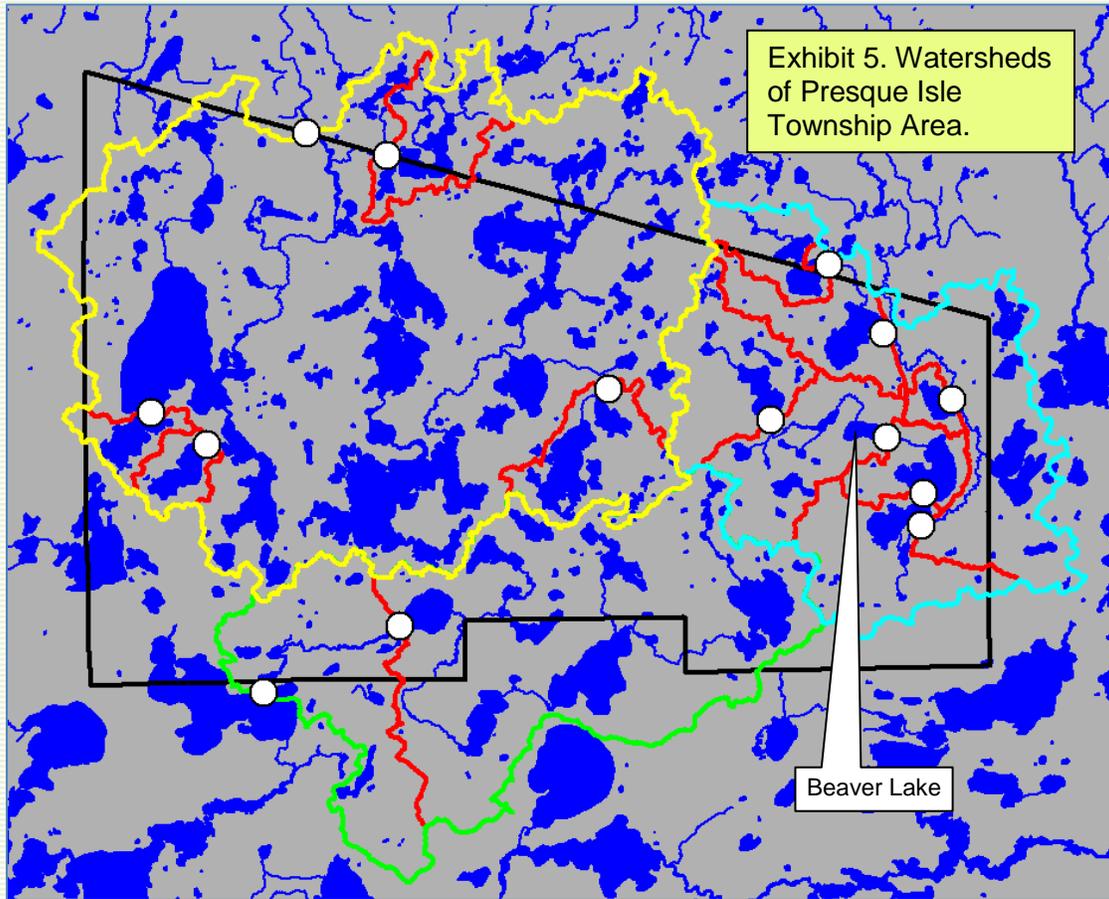
Description: Portions of 3 federal hydrologic sub-watersheds are illustrated: (1) S.Br. Presque Isle River (bounded by yellow), (2) Pomeroy Cr-E.Br. Presque Isle River (bounded by blue and yellow), and (3) Rice Cr. (bounded by green, yellow, and blue). Also shown are the smaller watersheds of individual water bodies subject to the Wilderness Waters studies (bounded by red). White dots show outlet points for the smaller watersheds.

The Presque Isle Township waterscape sits on a large-scale watershed divide. Some of the water drains north through the Presque Isle River system and eventually enters Lake Superior. Some of the water drains into the Wisconsin River system to the Mississippi River and to the Gulf of Mexico. In fact there are two federal hydrologic sub-basins (designated by 8-digit HUC codes) that include Presque Isle Township. The Black-Presque Isle Rivers sub-basin (HUC#04020101) drains north to Lake Superior and the Flambeau River sub-basin (HUC#0705002) drains southwesterly to the Mississippi River. The Black-Presque Isle Rivers sub-basin contains two federal hydrologic sub-watersheds within Presque Isle Township: the South Branch Presque Isle River sub-watershed (HUC#040201010303) and the Pomeroy Creek-East Branch Presque Isle River sub-watershed (HUC#040201010301). The Flambeau River sub-basin contains one sub-watershed within Presque Isle Township: the Rice Creek sub-watershed (HUC#07050020103). Exhibit 5 illustrates these watersheds and the watersheds of the water bodies subject to the Wilderness Waters Program studies. Beaver Lake is contained within the Pomeroy Creek-East Branch Presque Isle River sub-watershed (Exhibit 5).

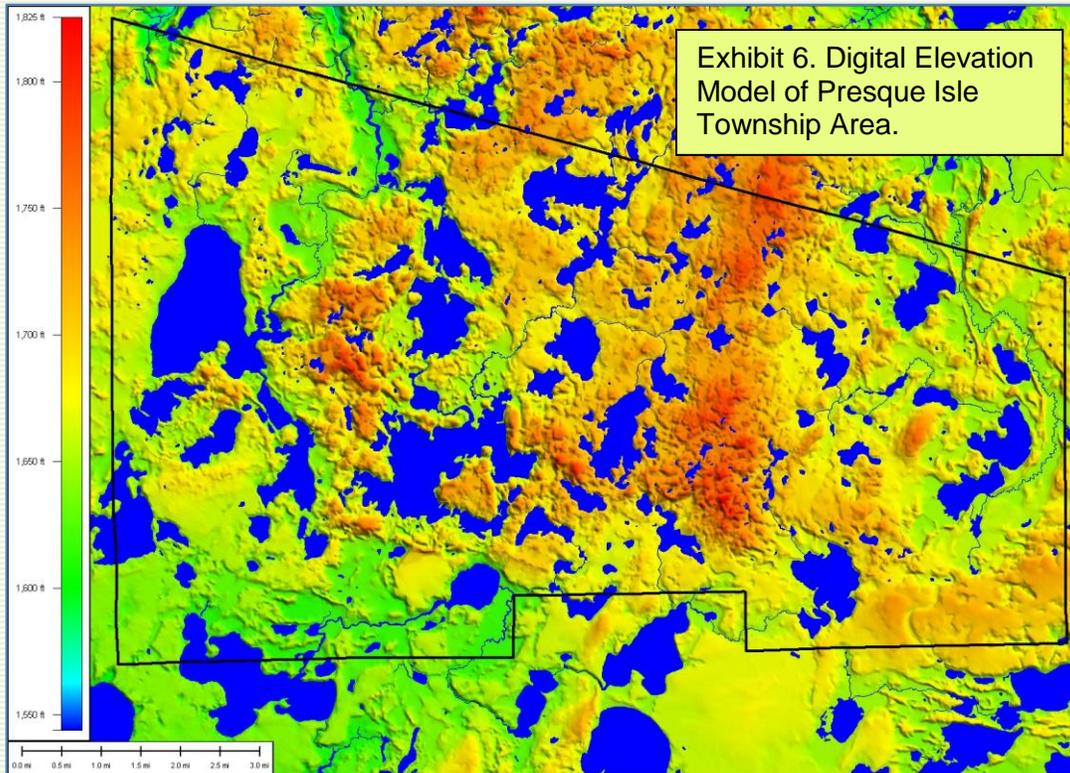
The elevation in Presque Isle Township ranges from around 1,550 feet above sea level to 1,750 feet above sea level. A digital elevation model is provided as Exhibit 6 and shows the relative elevations for the area with orange areas of the landscape being the highest elevations and greens and blues being the lowest elevations.

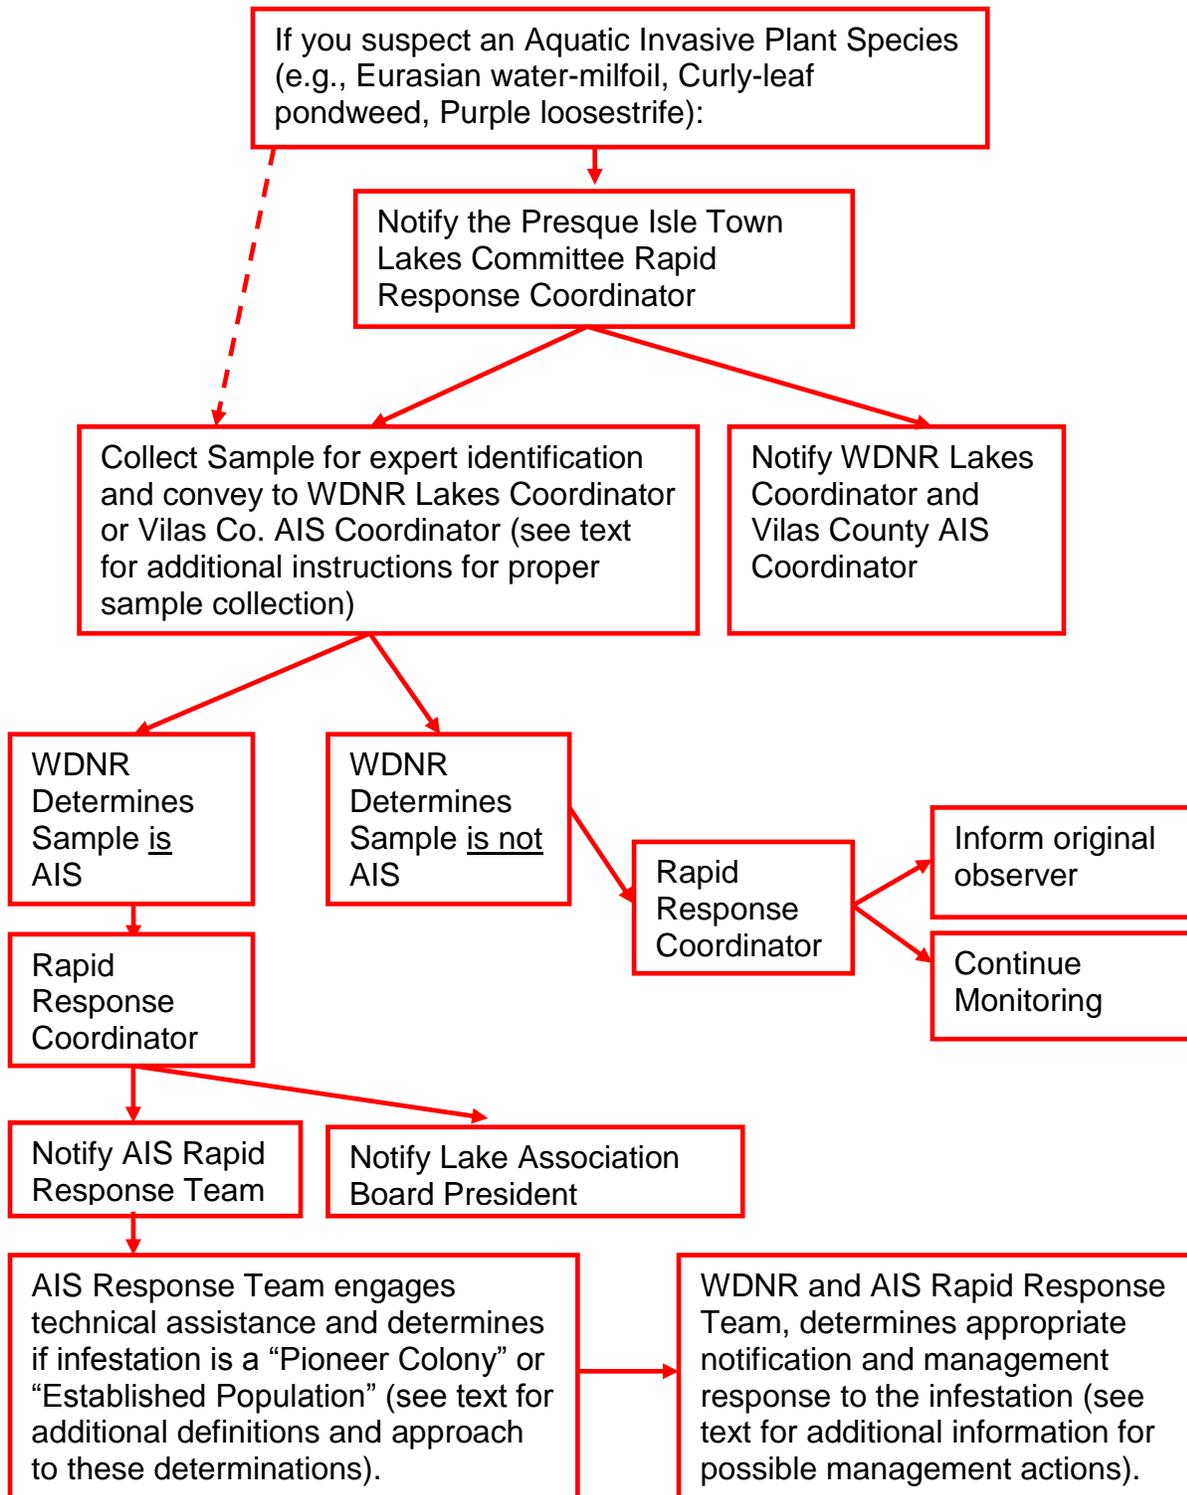
Exhibit 8. Aquatic Invasive Plant Species Rapid Response

When a suspect aquatic invasive plant species is found, either the original observer or a member of the Rapid Response Team (likely the coordinator) should collect an entire plant specimen including roots, stems, and flowers (if present). The sample should be placed in a sealable bag with a small amount of water to keep it moist. Place a label in the bag written in pencil with date, time, collector’s name, lake name, location, town, and county. Attach a lake

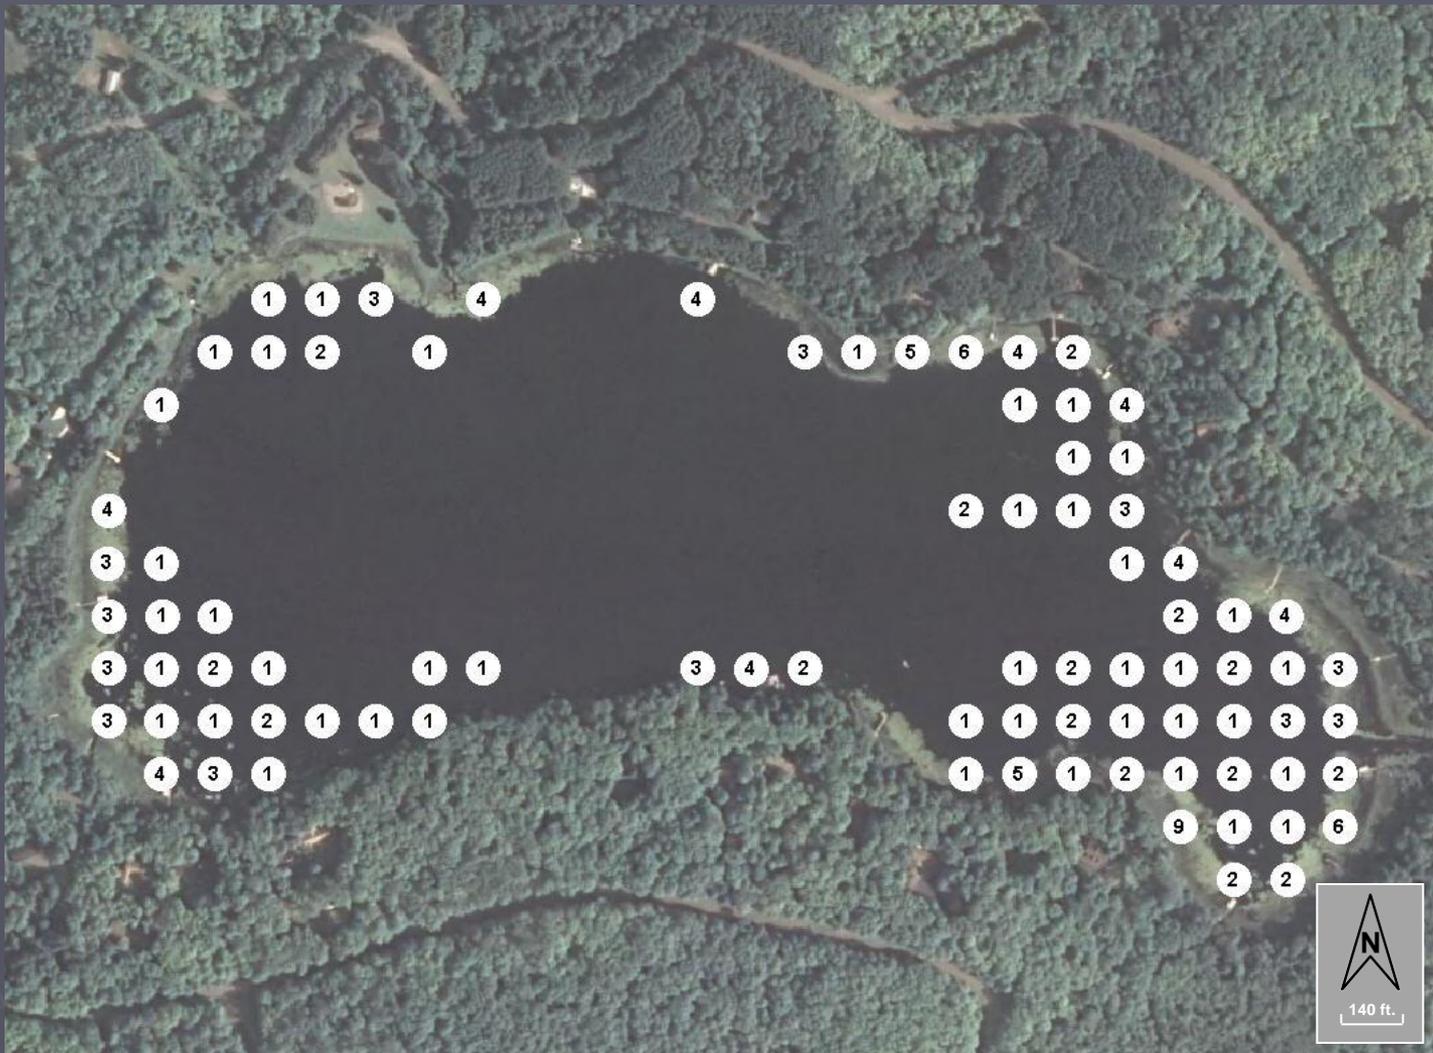
Figure 1. Number of plant species recorded at Beaver Lake sample sites (2011).

Species richness refers to the total number of species recorded. We recorded 28 species of aquatic plants. Of these, 26 were collected at sampling sites and the others were observed from the boat. Table 1 displays summary statistics for the survey. Table 2 provides a list of the species encountered, including common and scientific name along with summarizing statistics.² The number of species encountered at any given sample point ranged from 0 to 9 and 84 sample points were found to have aquatic vegetation present. The average number of species encountered at these vegetated sites was 2.10. The actual number of species encountered at each of the vegetated sites is graphically displayed on Figure 1. Plant density is estimated by a “rake fullness” metric (3 being the highest possible density). These densities (considering all species) are displayed for each sampling site on Figure 2.

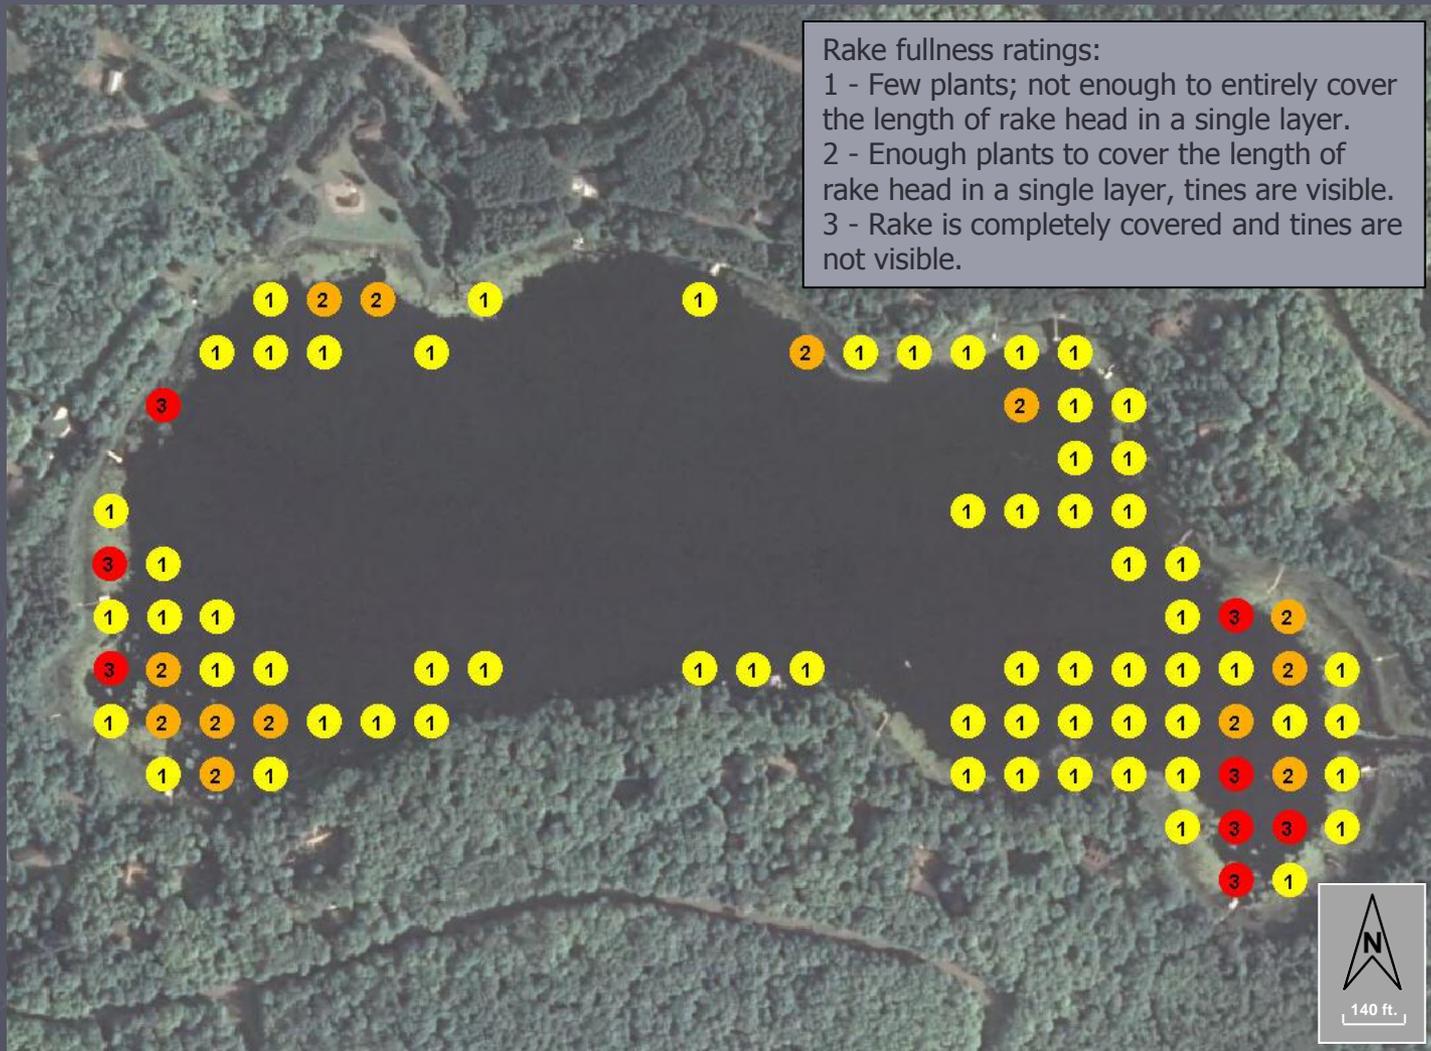
Figure 2. Rake fullness ratings for Beaver Lake sample sites (2011).

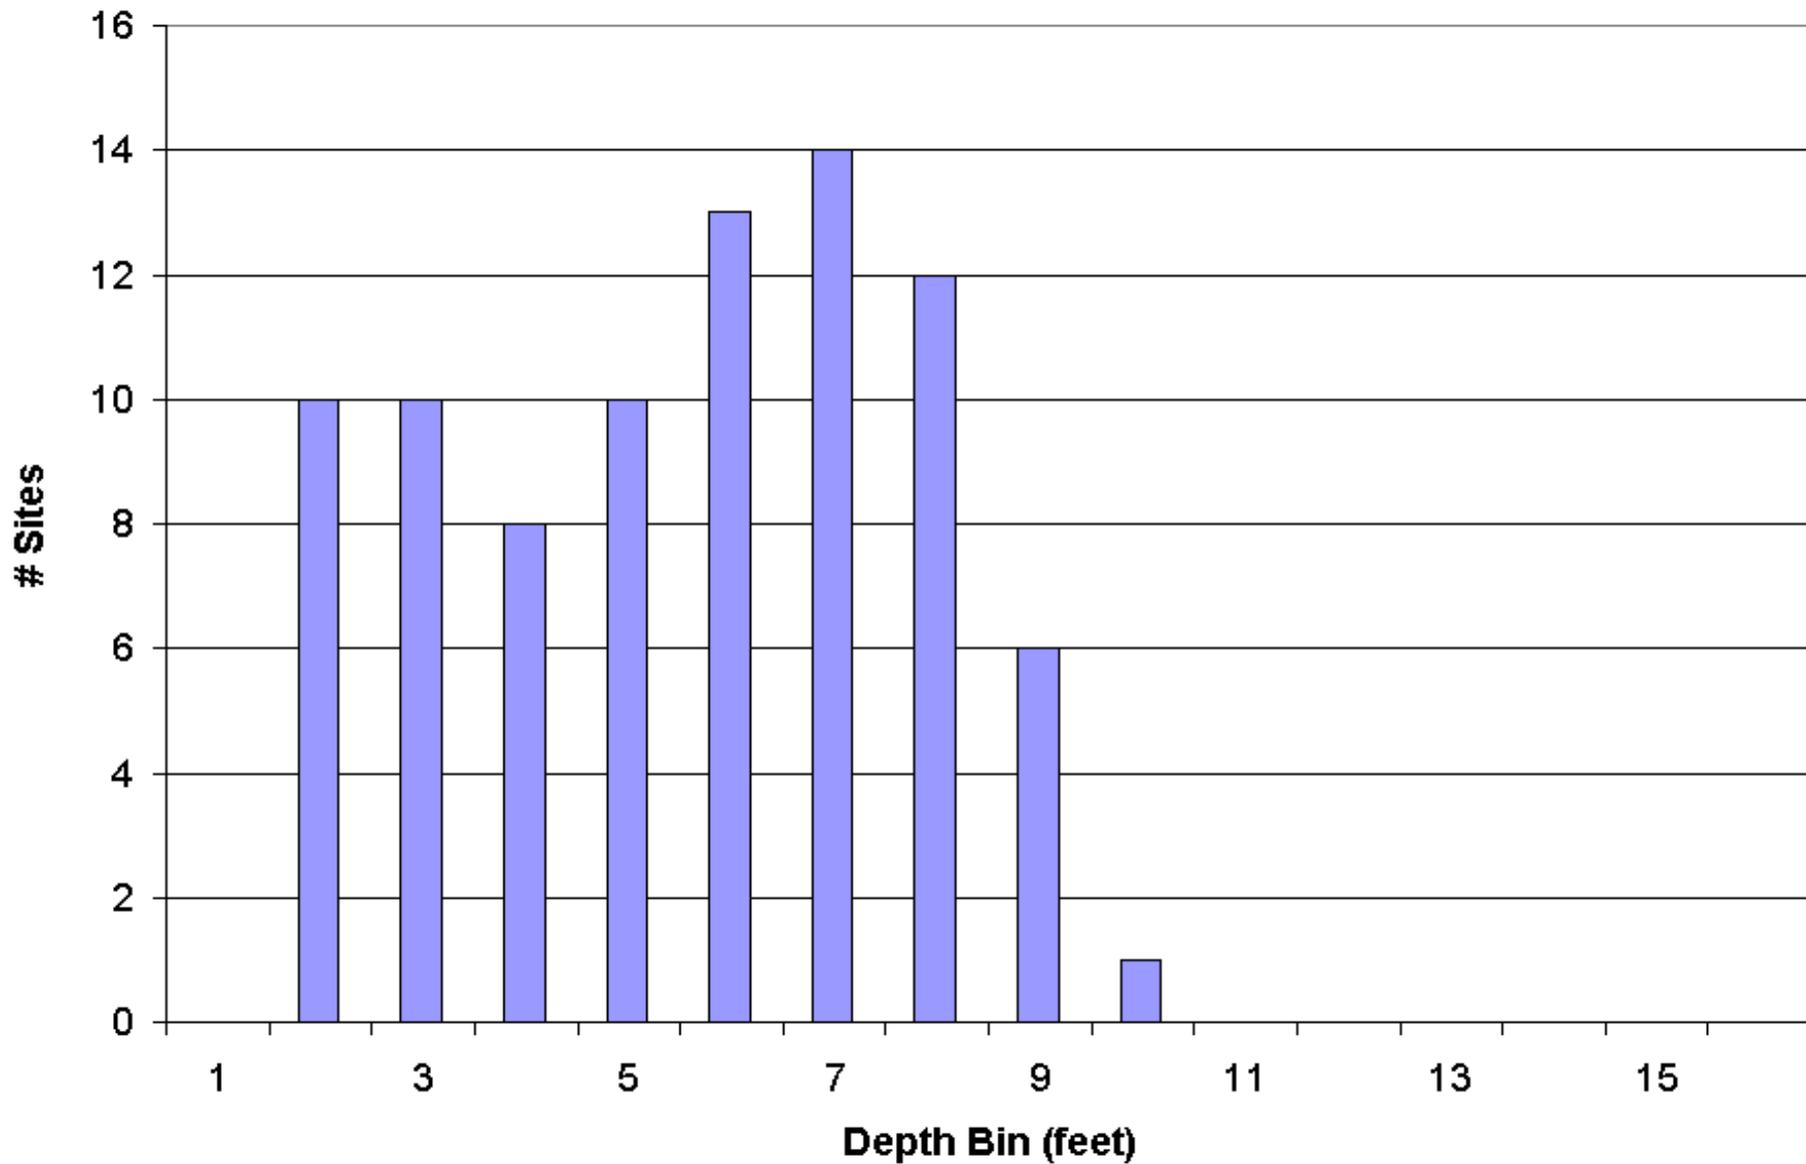
Figure 3. Maximum Depth of Plant Colonization in Beaver Lake.

The maximum depth of plant colonization is 10 feet (Table 1 and Figure 3). Rooted vegetation was found at 84 of the 184 sample sites with depth \leq the maximum depth of plant colonization (68.3% of sites). These sites are displayed as a black dot within a circle on Figure 4. This indicates that although availability of appropriate depth may limit the distribution of plants, it is not the only habitat factor involved. Substrate is another feature that influences plant distribution (e.g., soft substrate often harbors more plants than hard substrate). Figure 5 presents the substrates encountered during the aquatic plant survey (mud, sand, or rock).

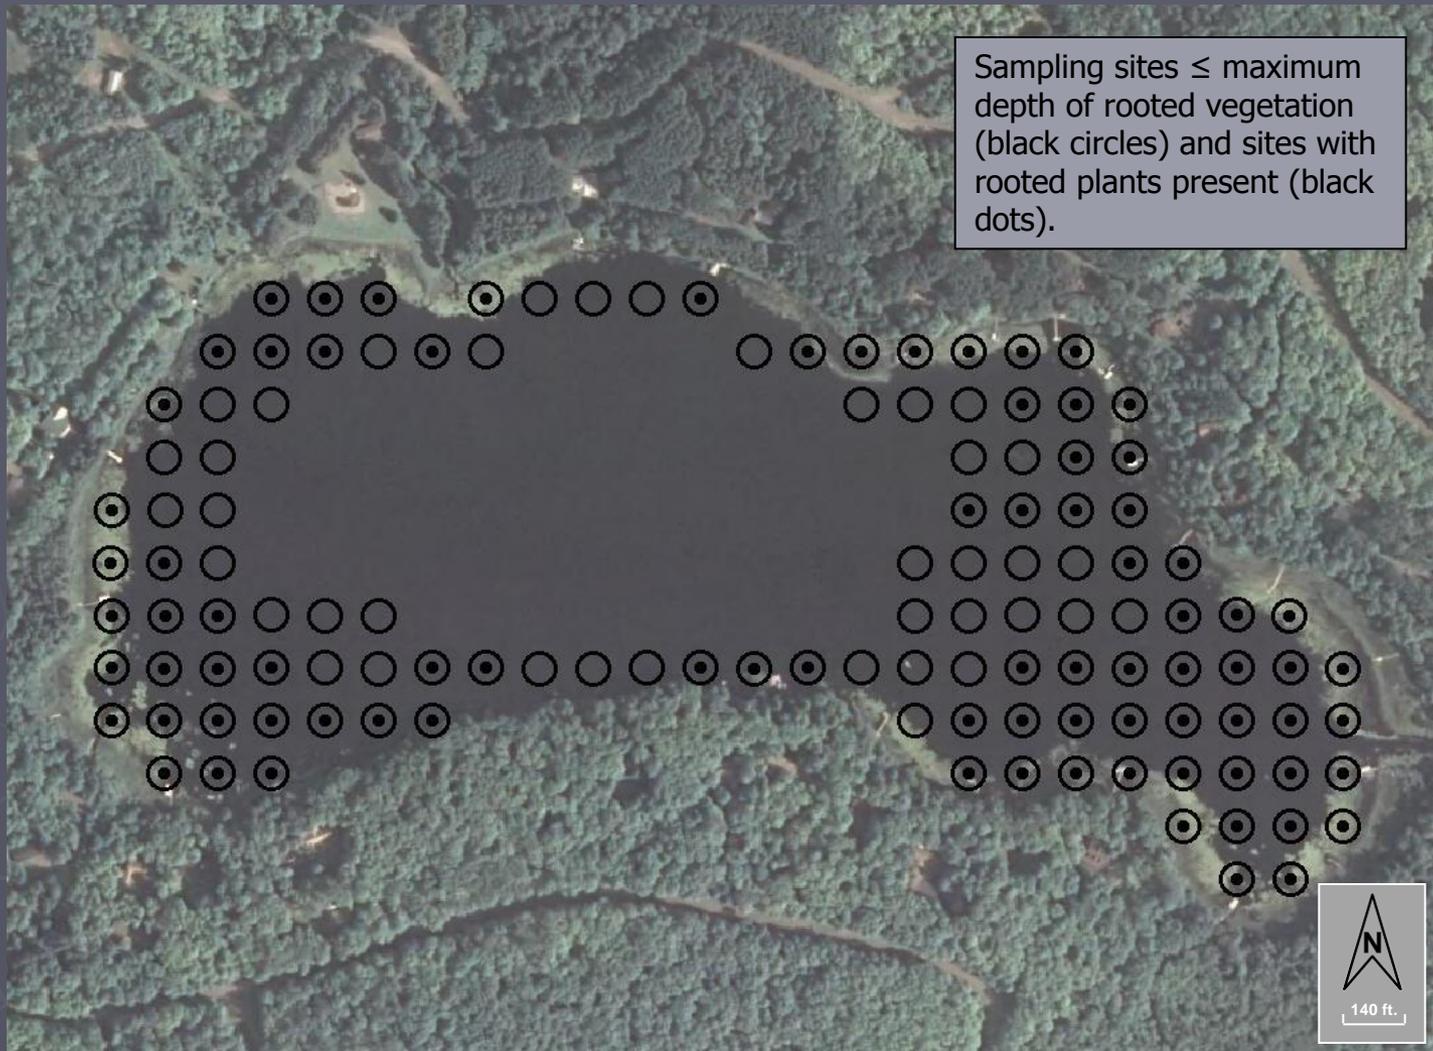
Figure 4. Beaver Lake sampling sites less than or equal to maximum depth of rooted vegetation (2011).

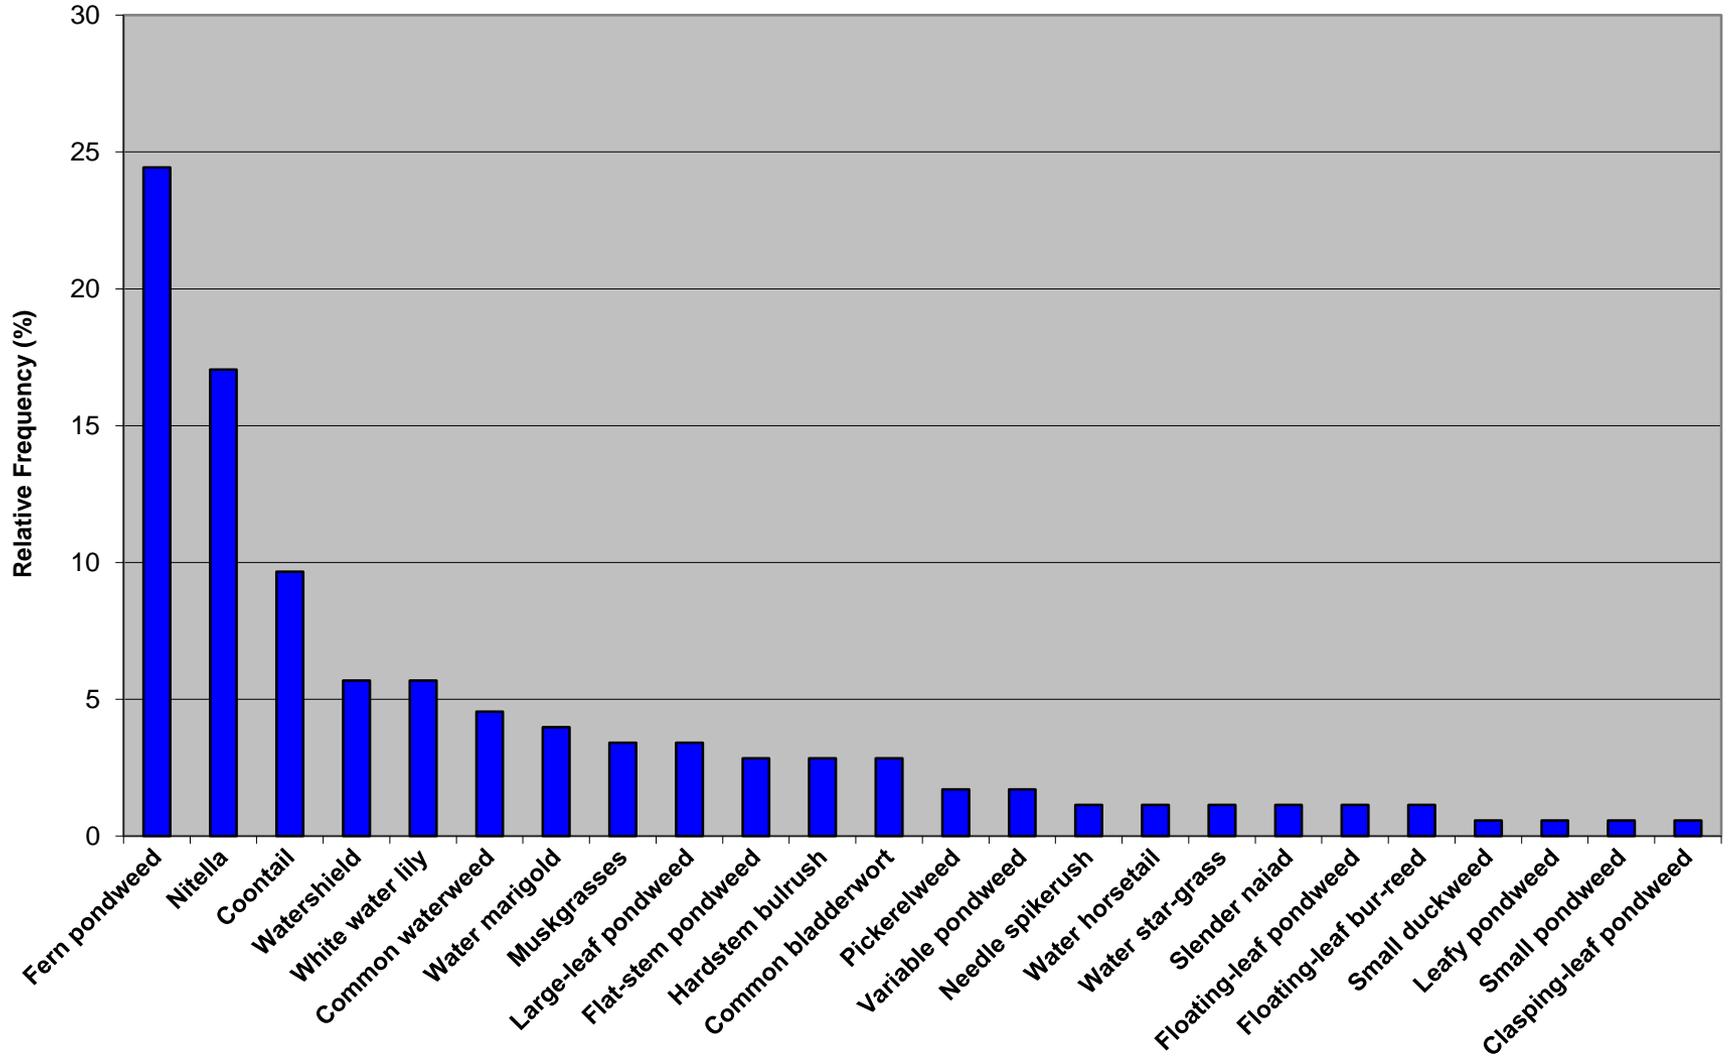
Figure 6. Beaver Lake aquatic plant occurrences for 2011 point-intercept survey data.

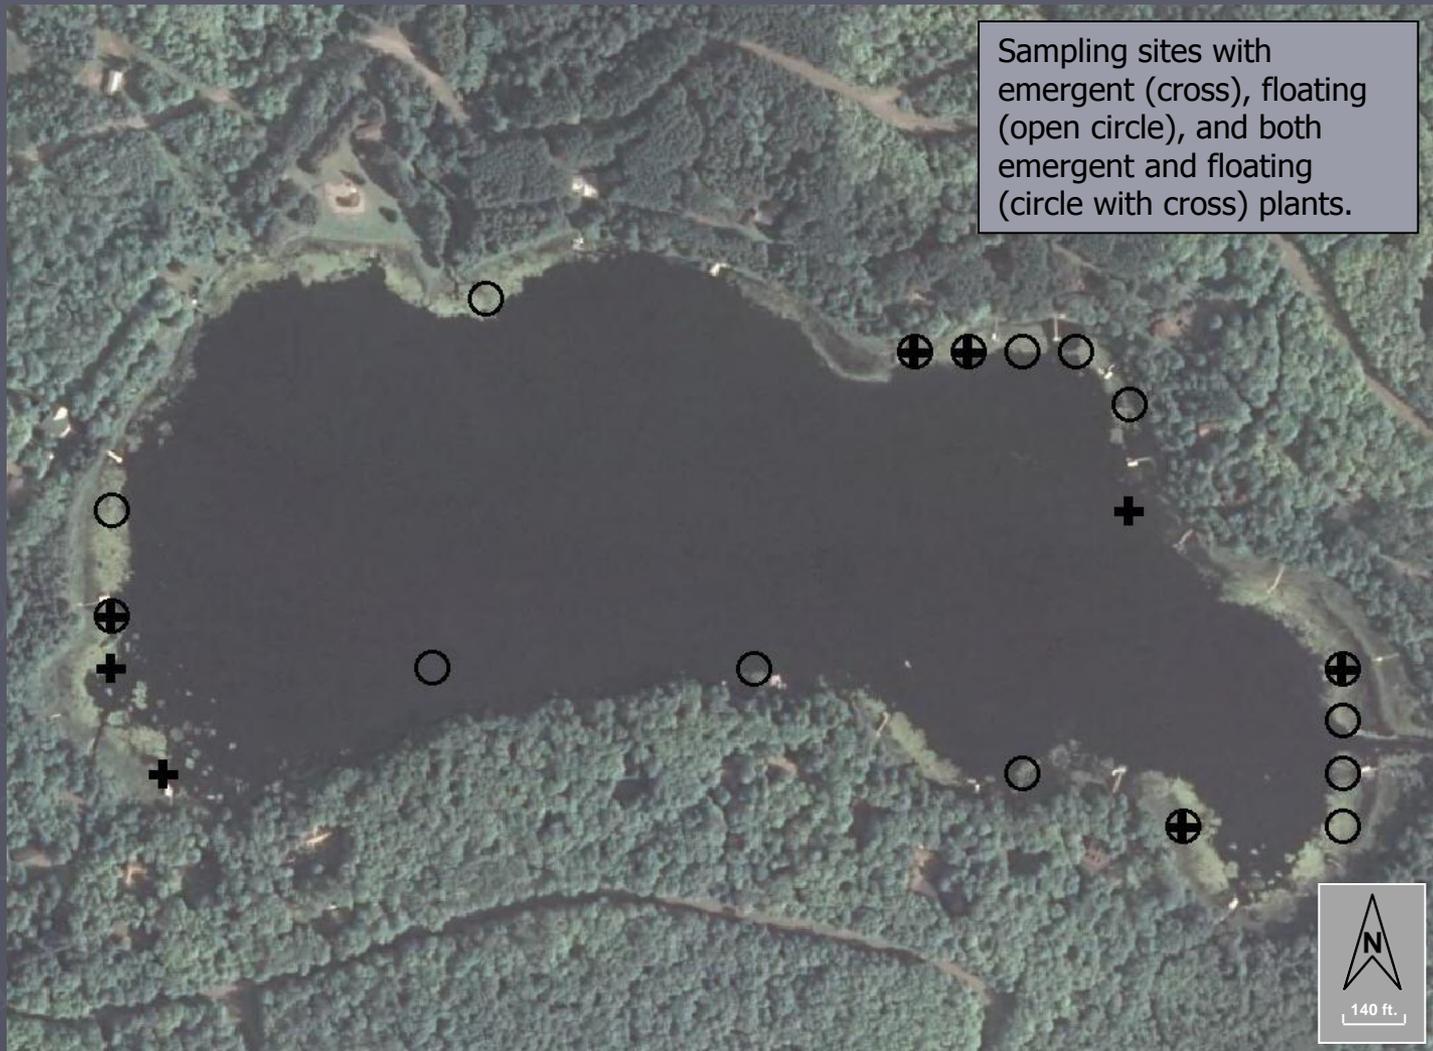
Figure 7. Beaver Lake point-intercept plant sampling sites with emergent and floating aquatic plants (2011).

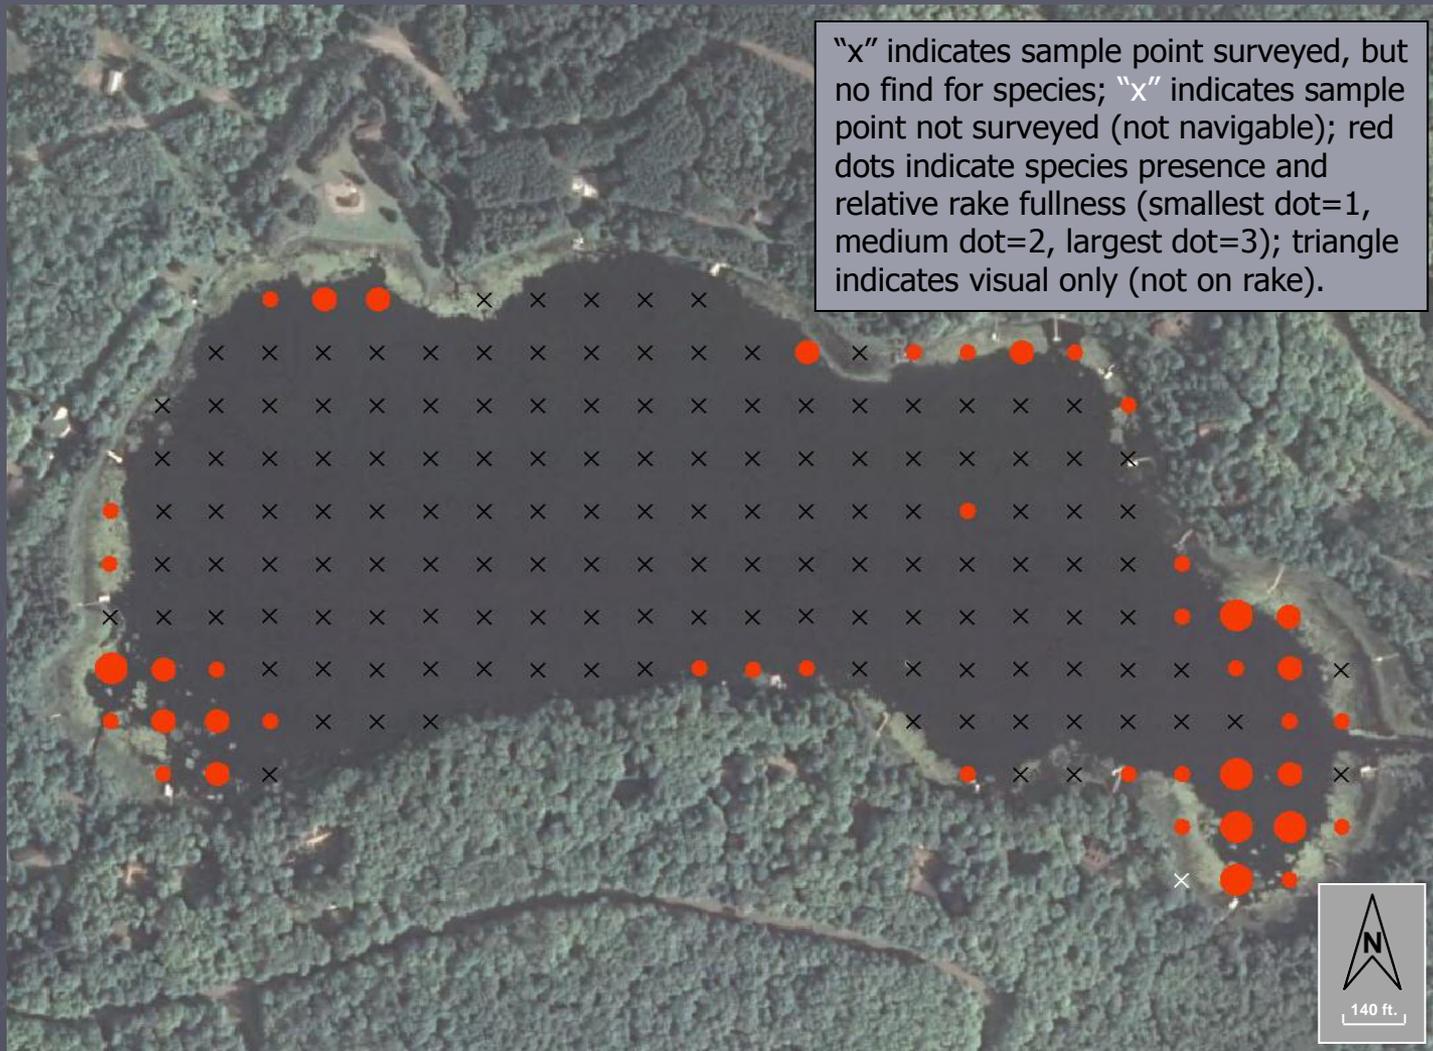
Figure 8. Distribution of plant species, Beaver Lake (2011).

Potamogeton robbinsii (Fern pondweed)

Table 2 provides information about the frequency of occurrence of the plant species recorded in the lake. Several metrics are provided, including total number of sites in which each species was found and frequency of occurrence at sites \leq the maximum depth of rooted vegetation. This frequency metric is standardized as a “relative frequency” (also shown in Table 2) by dividing the frequency of occurrence for a given species by the sum of frequency of occurrence for all plants and multiplying by 100 to form a percentage. The resulting relative frequencies for all species total 100%. The relative frequencies for the plant species collected with a rake are graphically displayed in descending order on Figure 6. This display shows that *Potamogeton robbinsii* (Fern pondweed) had the highest relative frequency followed by *Nitella* sp. (*Nitella*). The lowest relative frequencies are at the far right of the graph. Figure 7 displays the distribution sampling sites where plants classified as “emergent” or “floating” were recorded. As examples of individual species distributions, we show the occurrences of a few of the most frequently and least frequently encountered plants in Figures 8-14.

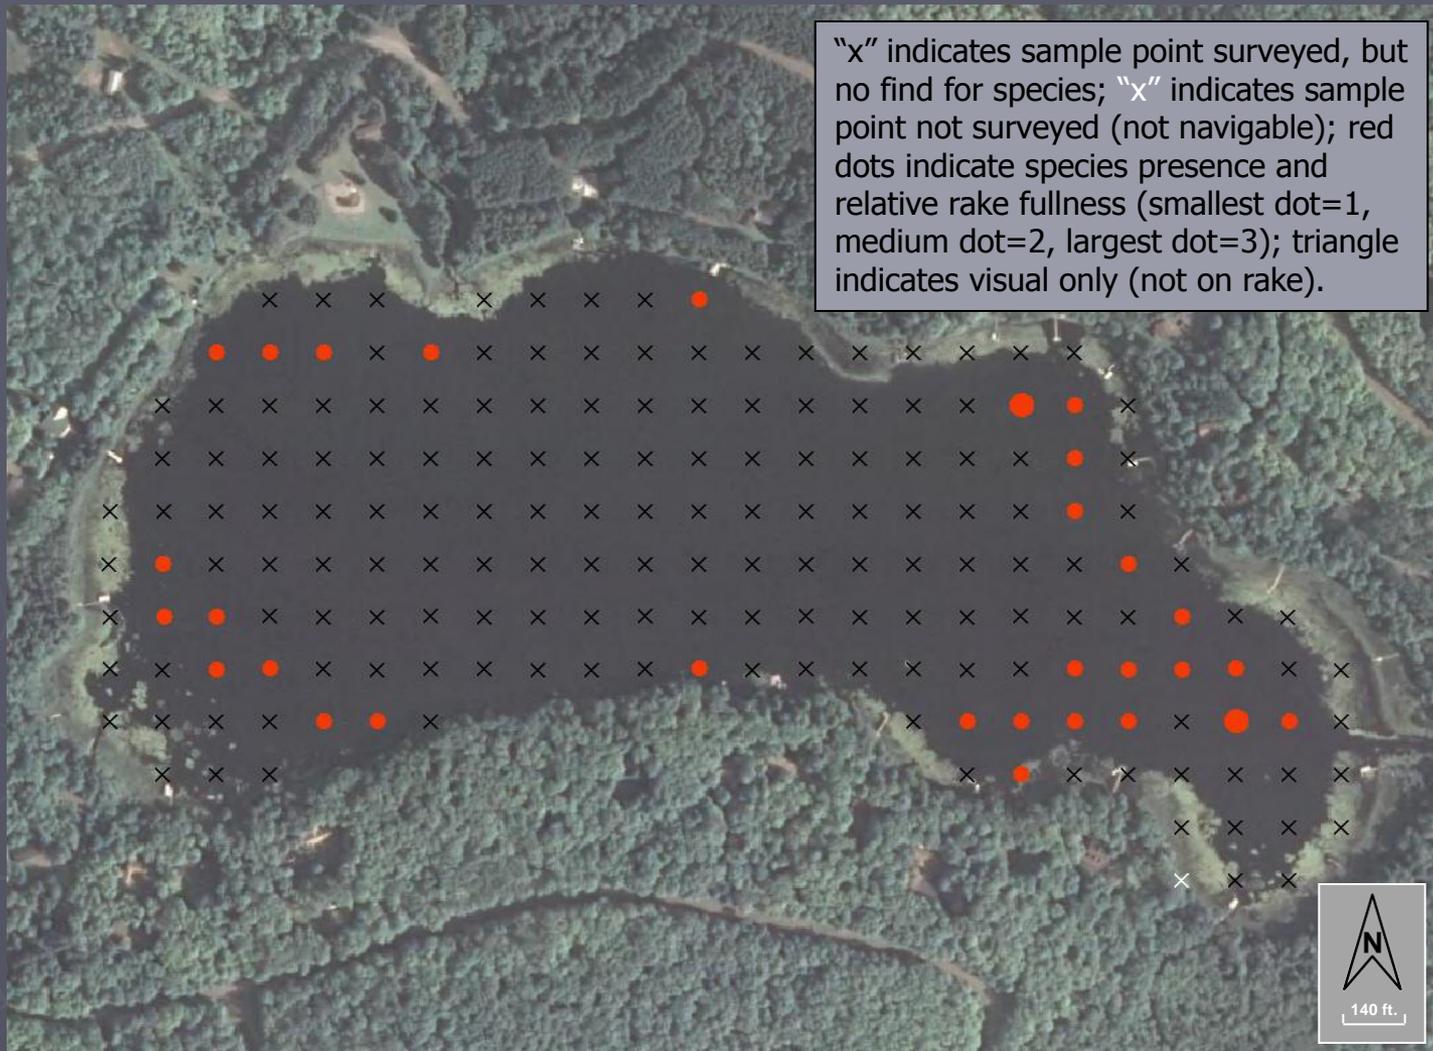
Figure 9. Distribution of plant species, Beaver Lake (2011).

Nitella sp. (Nitella)

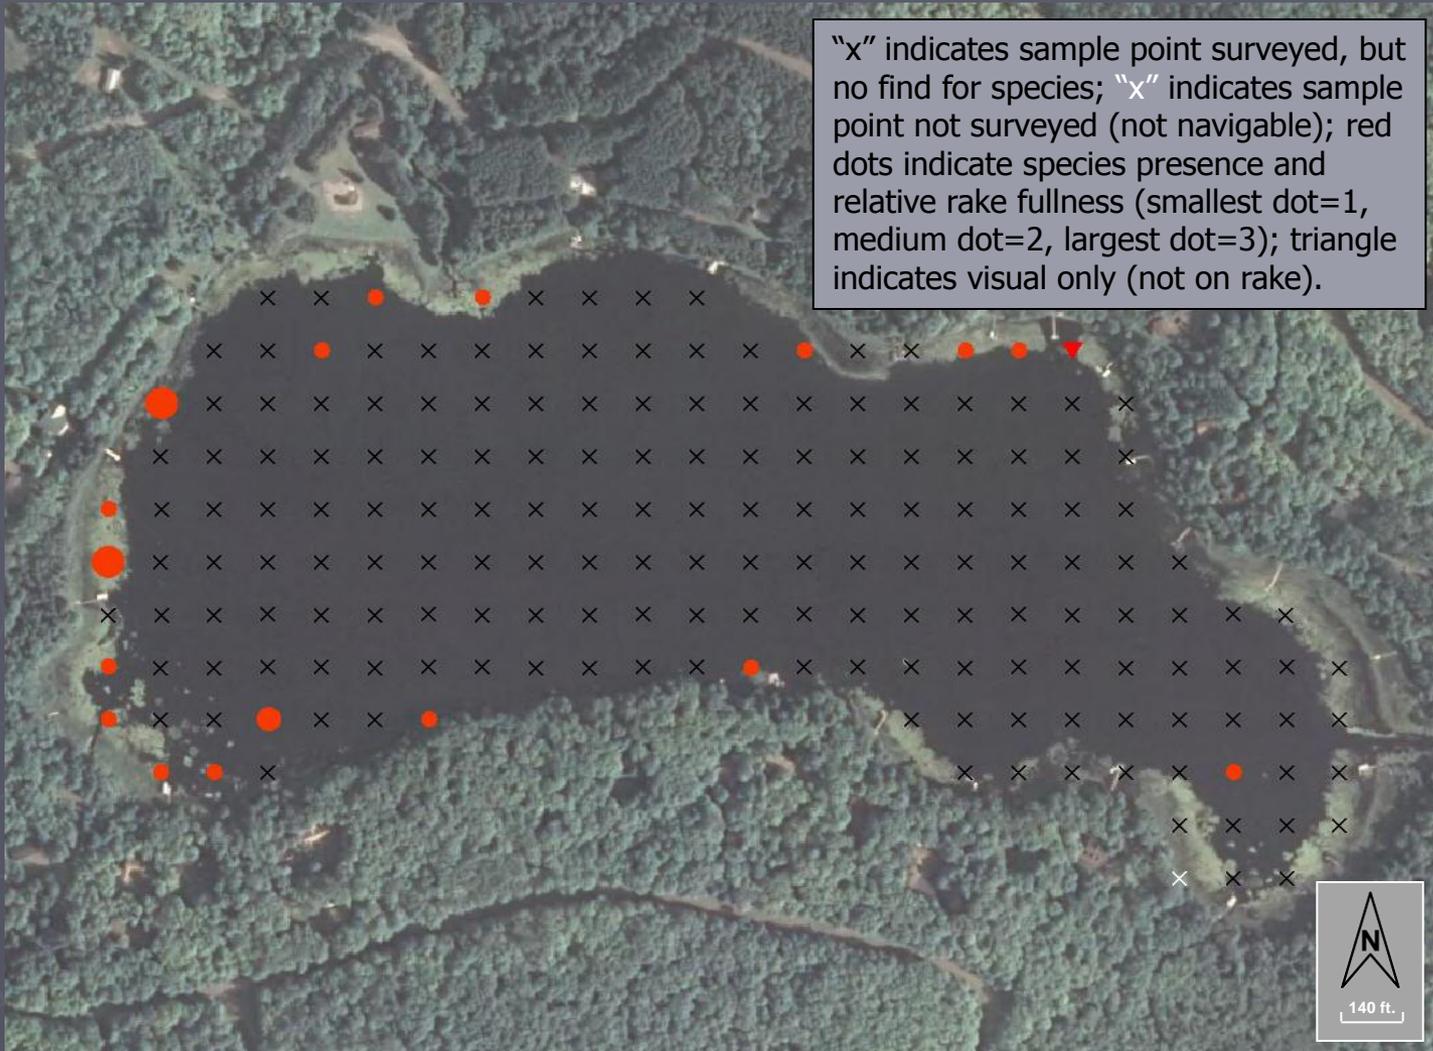
Figure 10. Distribution of plant species, Beaver Lake (2011).

Ceratophyllum demersum (Coontail)

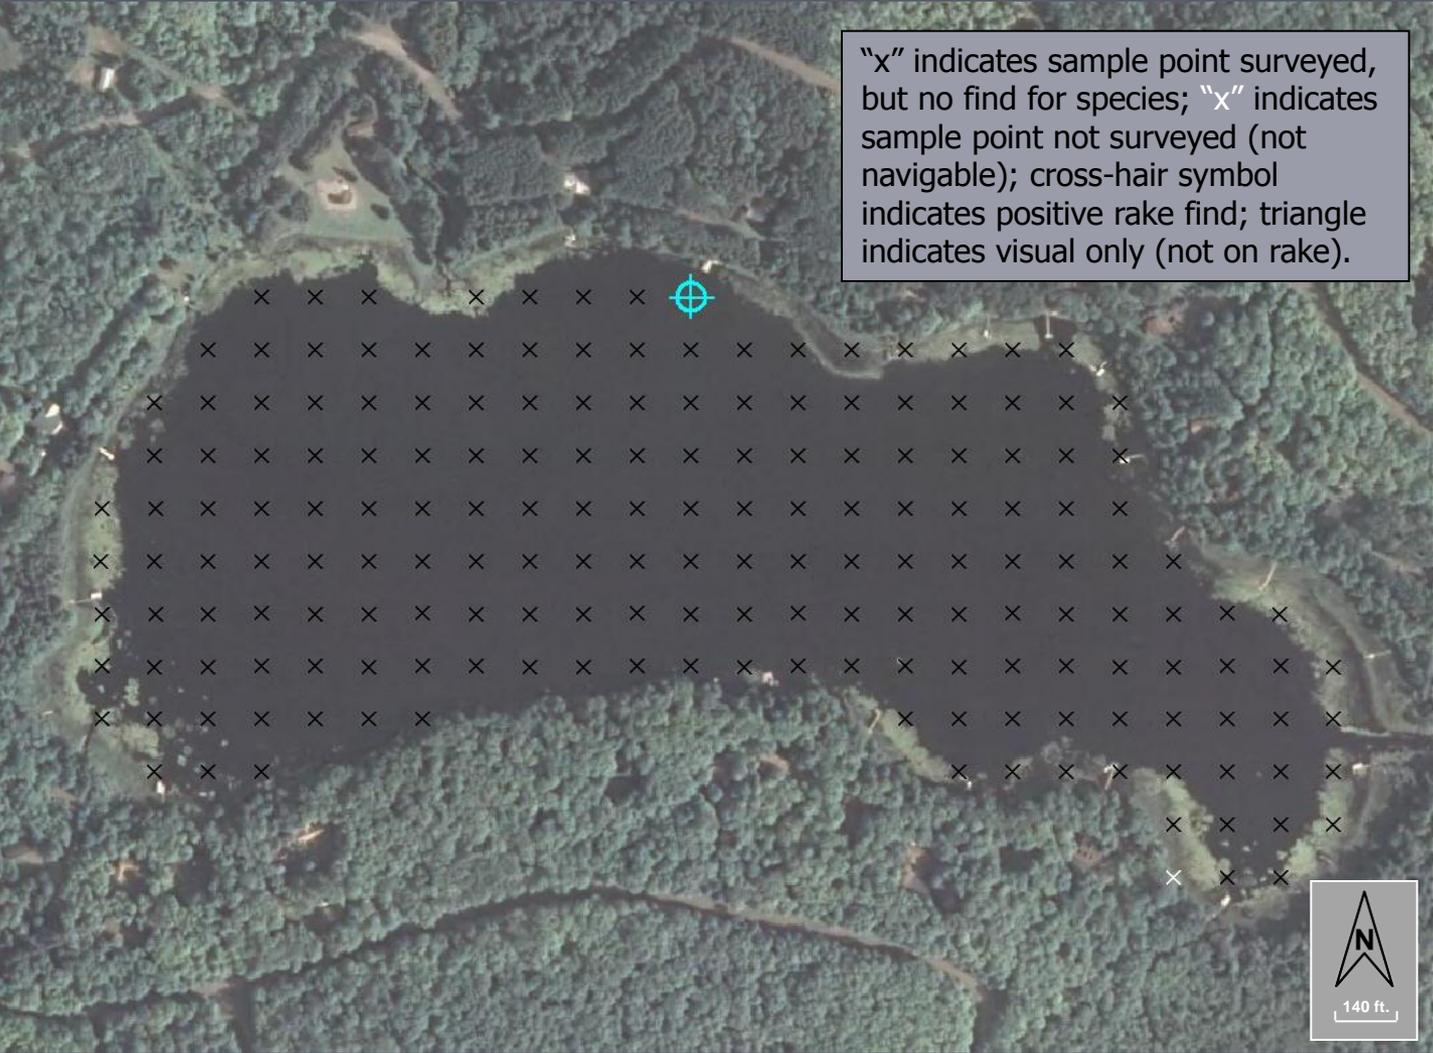
Figure 11. Distribution of plant species, Beaver Lake (2011).

Lemna minor (Small duckweed)
