Presque Isle Wilderness Waters Program

Aquatic Plant Management Plan – Beaver Lake

Date: March 2014

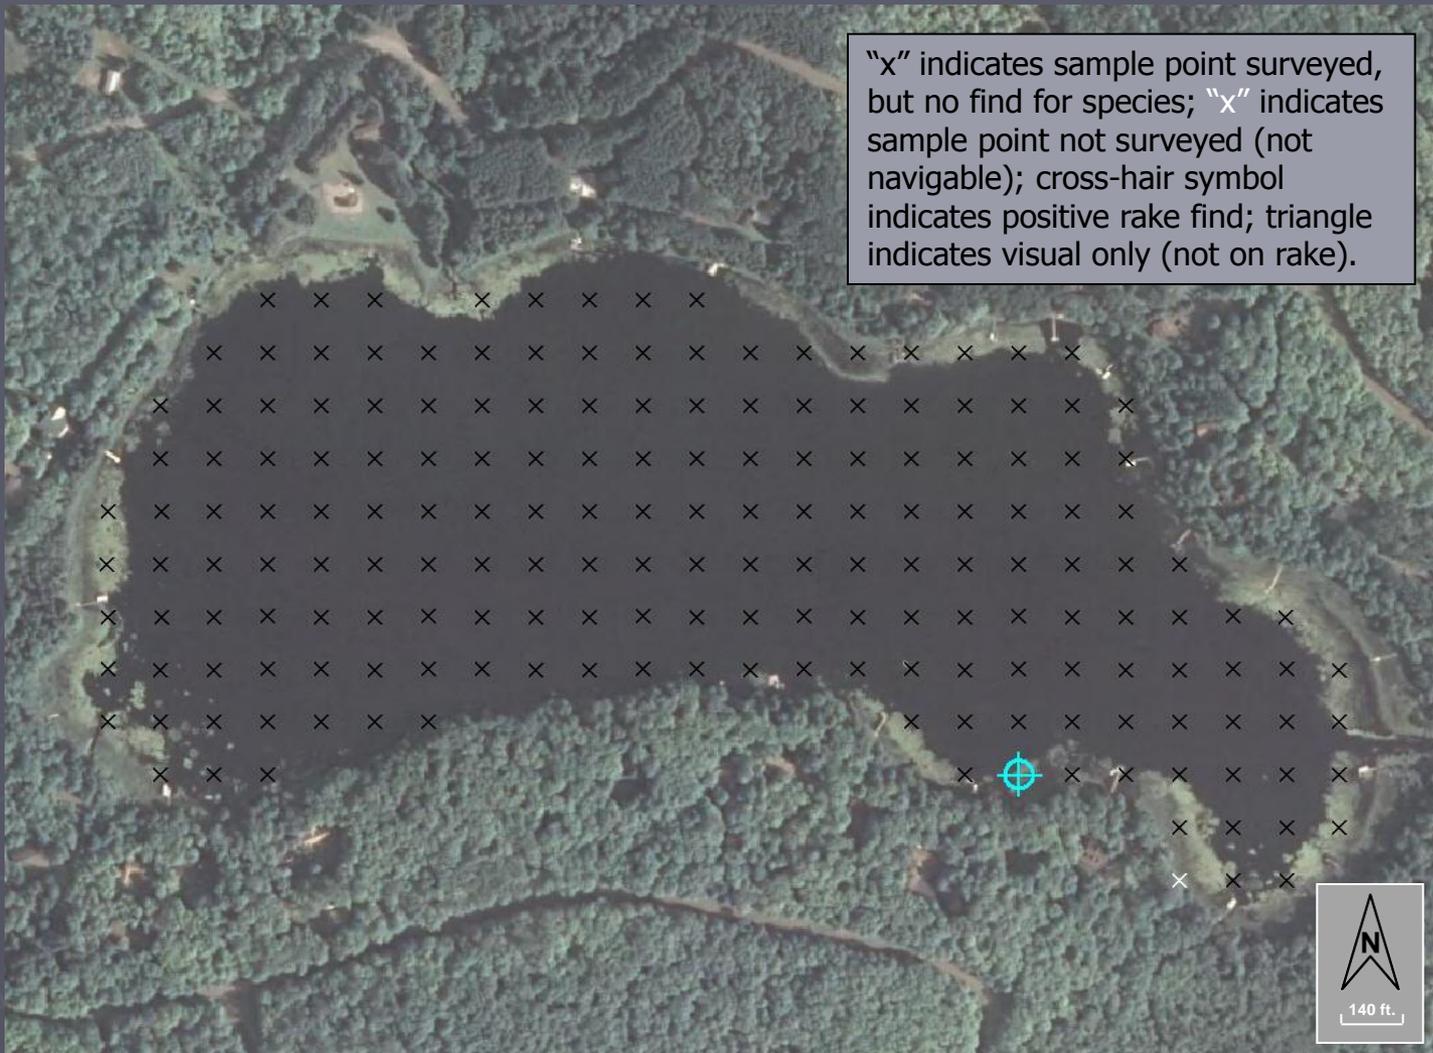
Figure 12. Distribution of plant species, Beaver Lake (2011).

Potamogeton foliosus (Leafy pondweed)

Table 2 provides information about the frequency of occurrence of the plant species recorded in the lake. Several metrics are provided, including total number of sites in which each species was found and frequency of occurrence at sites \leq the maximum depth of rooted vegetation. This frequency metric is standardized as a “relative frequency” (also shown in Table 2) by dividing the frequency of occurrence for a given species by the sum of frequency of occurrence for all plants and multiplying by 100 to form a percentage. The resulting relative frequencies for all species total 100%. The relative frequencies for the plant species collected with a rake are graphically displayed in descending order on Figure 6. This display shows that *Potamogeton robbinsii* (Fern pondweed) had the highest relative frequency followed by *Nitella* sp. (*Nitella*). The lowest relative frequencies are at the far right of the graph. Figure 7 displays the distribution sampling sites where plants classified as “emergent” or “floating” were recorded. As examples of individual species distributions, we show the occurrences of a few of the most frequently and least frequently encountered plants in Figures 8-14.

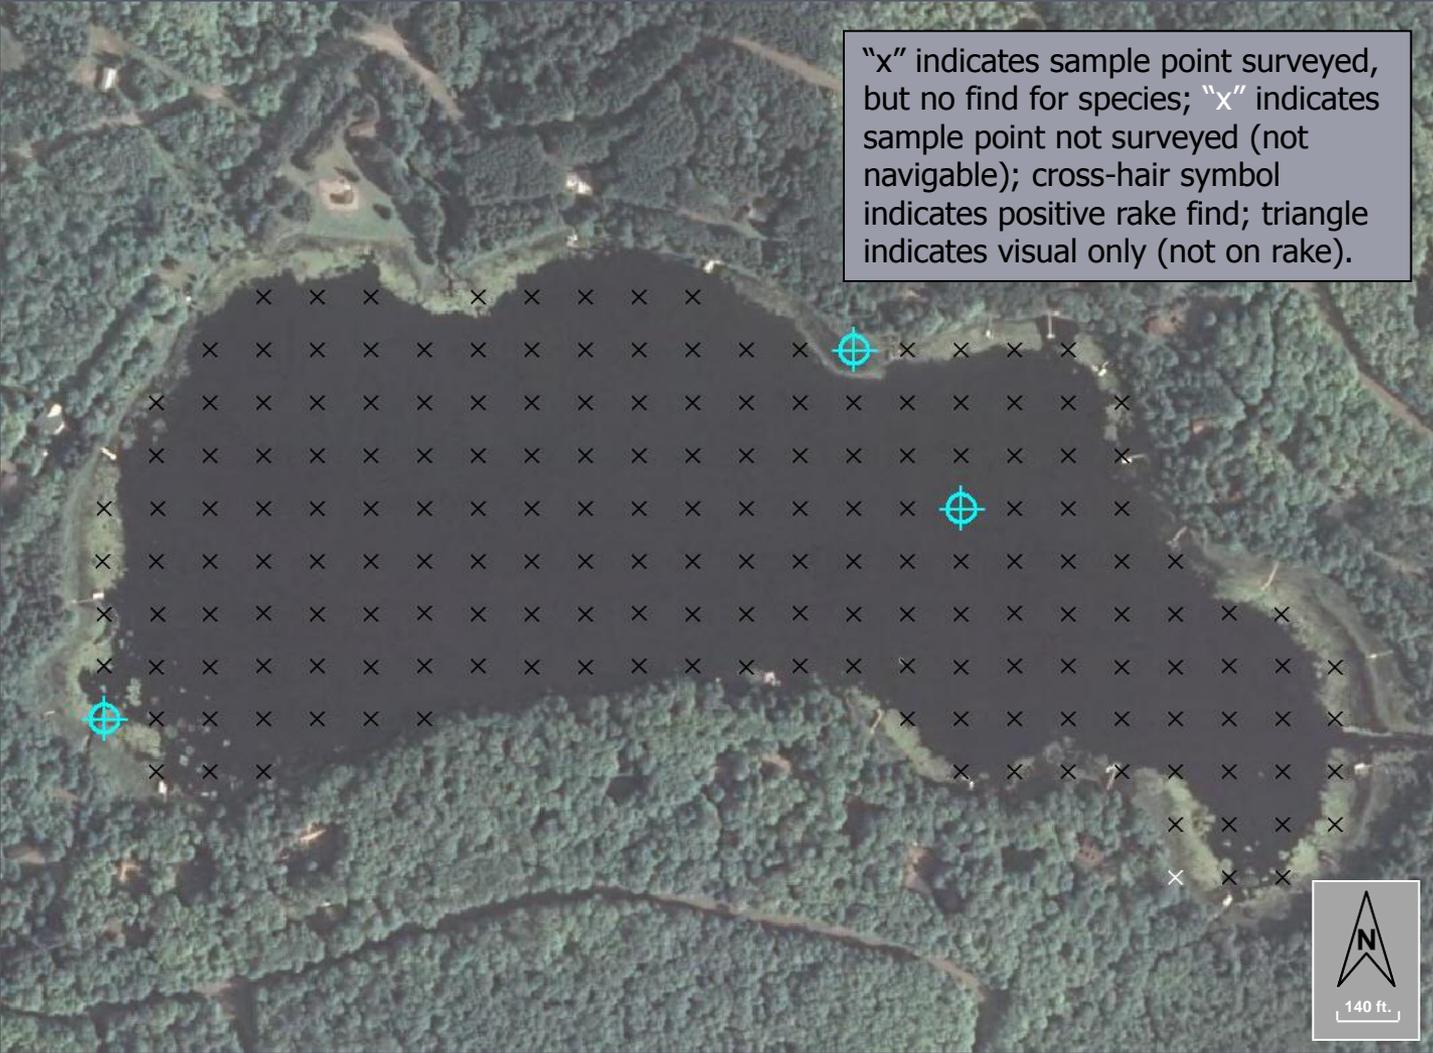
Figure 13. Distribution of plant species, Beaver Lake (2011).

Potamogeton pusillus (Small pondweed)

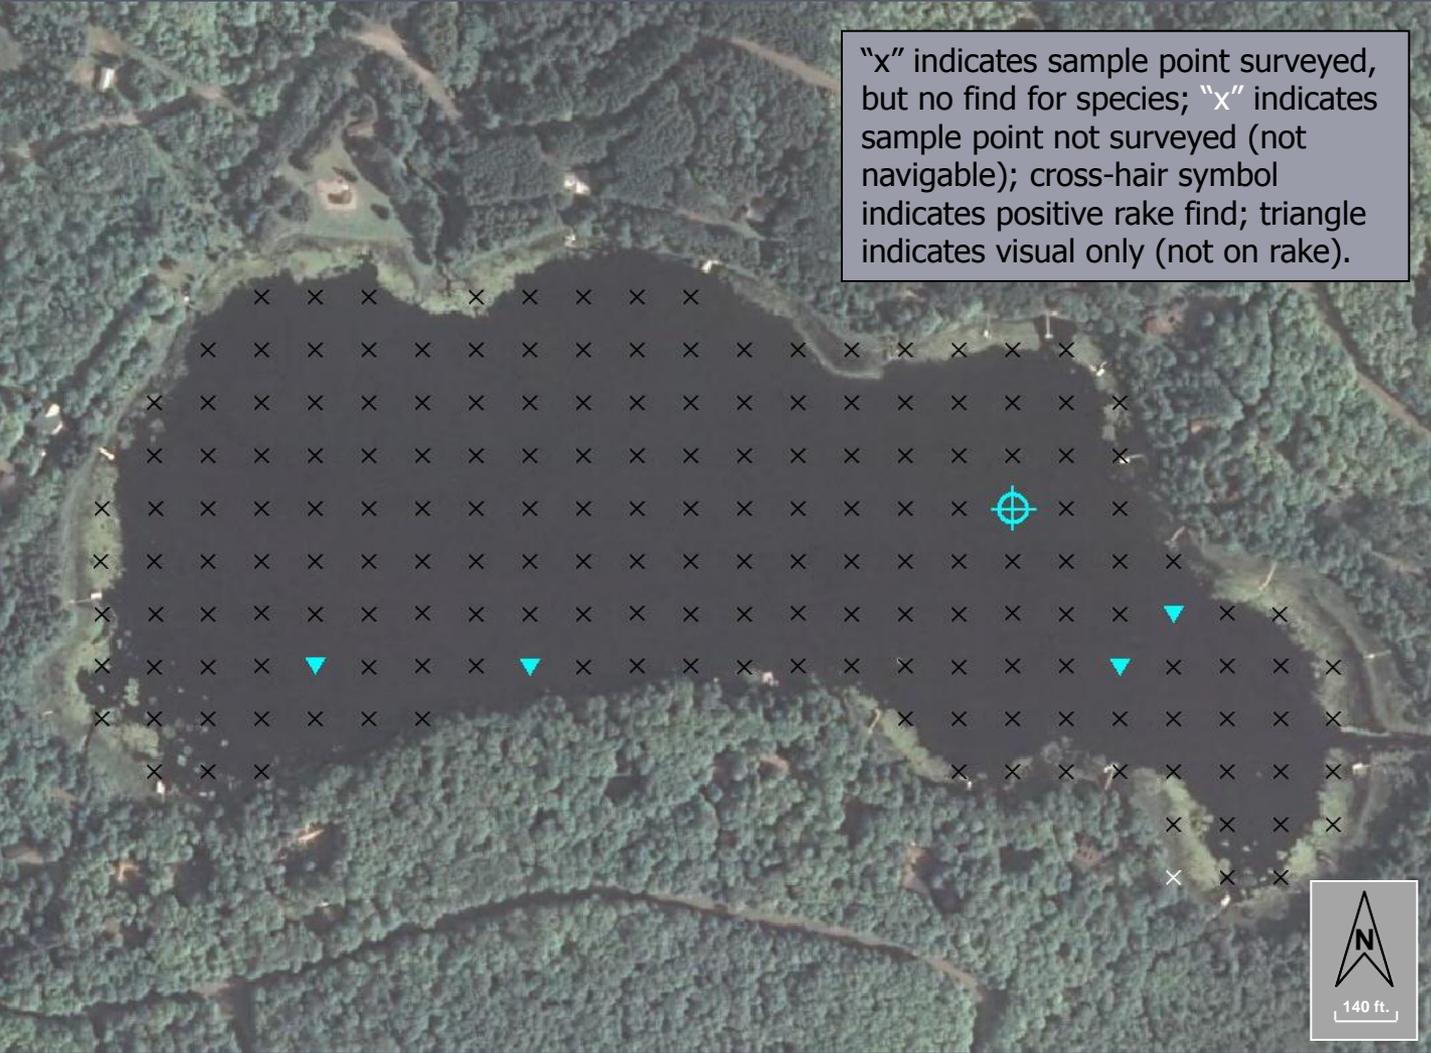
Figure 14. Distribution of plant species, Beaver Lake (2011).

Potamogeton richardsonii (Clasping-leaf pondweed)

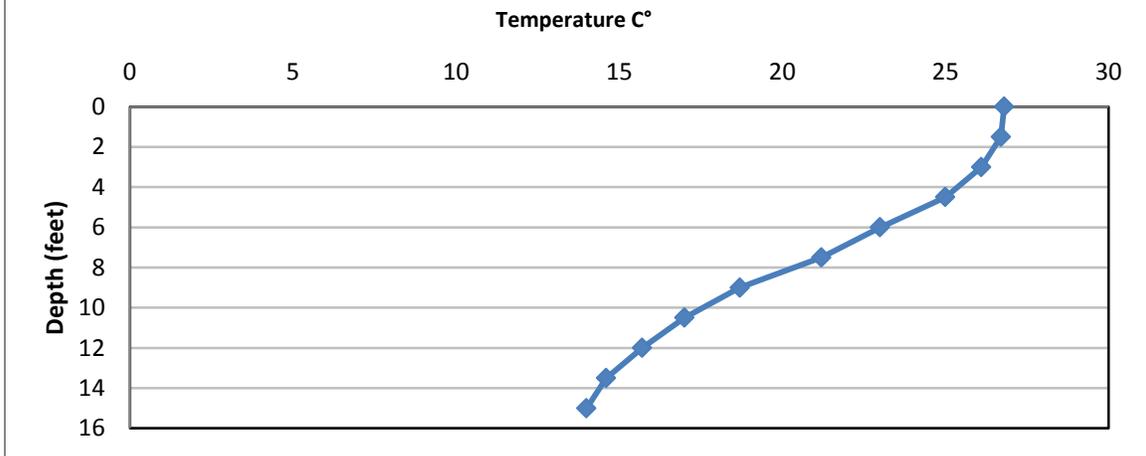
Measuring the temperature of a lake at different depths will determine the influence it has on the physical, biological, and chemical aspects of the lake. Lake water temperature influences the rate of decomposition, nutrient recycling, lake stratification, and dissolved oxygen (D.O.) concentration. Temperature can also affect the distribution of fish species throughout a lake. Temperature was taken from May to September in 2007 (Figure 1). Figure 2 indicates that Beaver Lake stratified between 3 and 9 feet in July, 2011.

**Figure 2. Beaver Lake temperature profile
July, 2011.**

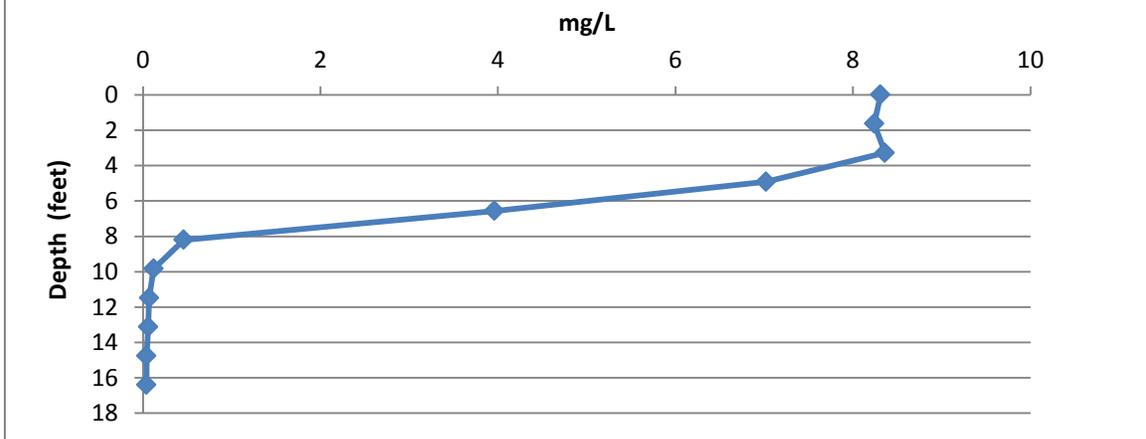
The dissolved oxygen content of lake water is vital in determining presence of fish species and other aquatic organisms. Dissolved oxygen also has a strong influence on the chemical and physical conditions of a lake. The amount of dissolved oxygen is dependent on the water temperature, atmospheric pressure, and biological activity. Oxygen levels are increased by aquatic plant photosynthesis, but reduced by respiration of plants, decomposer organisms, fish, and invertebrates. The amount of dissolved oxygen available in a lake, particularly in the deeper parts of a lake, is critical to overall health. Figure 3 shows that the dissolved oxygen content is near zero at 8.2 feet deep.

**Figure 3. Beaver Lake dissolved oxygen
profile July, 2011.**

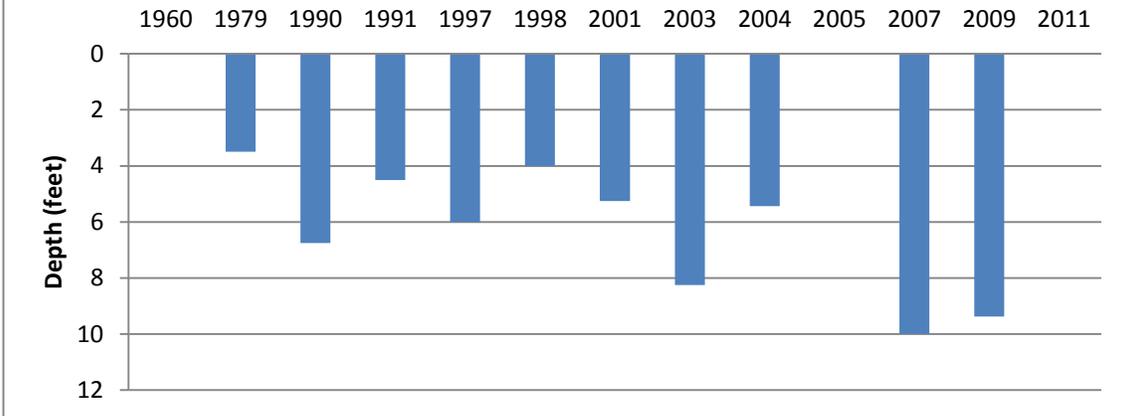
Figure 5. Beaver Lake average Secchi depth, August.

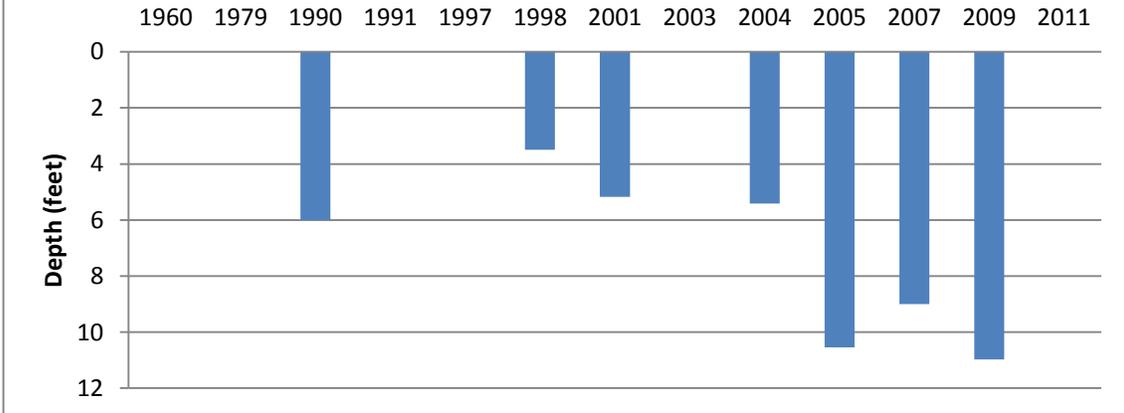
Figure 6. Beaver Lake average Secchi depth, September.

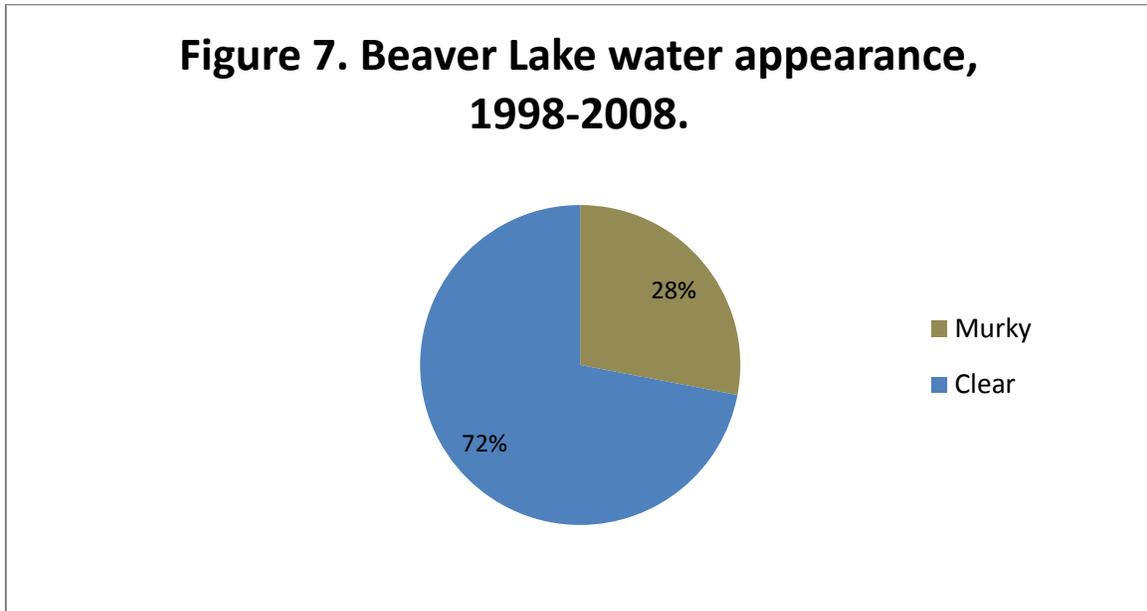
“clear” or “murky.” In sampled years, 72% said Beaver Lake’s water appeared “clear,” while the rest said it appeared “murky” (Figure 7).

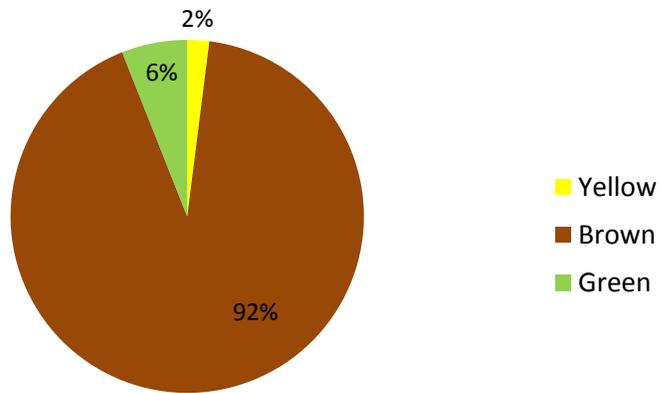
Color of lake water is related to the type and amount of dissolved organic chemicals. Its main significance is aesthetics, although it may also influence light penetration and in turn affect aquatic plant and algal growth. Many lakes have naturally occurring color compounds from decomposition of plant material in the watershed (Shaw et al., 2004). Units of color are determined from the platinum-cobalt scale and are therefore recorded as Pt-Co units. Shaw states that a water color between 0 and 40 Pt-Co units is low. There has not been any water samples collected, but when the CLMN volunteers surveyed, they looked at the color of the lake and recorded which color the water appears to be. In sampled years, 92% of volunteers said the water appeared “brown” (Figure 8).

Figure 8. Beaver Lake visual water color, 1990-2008.

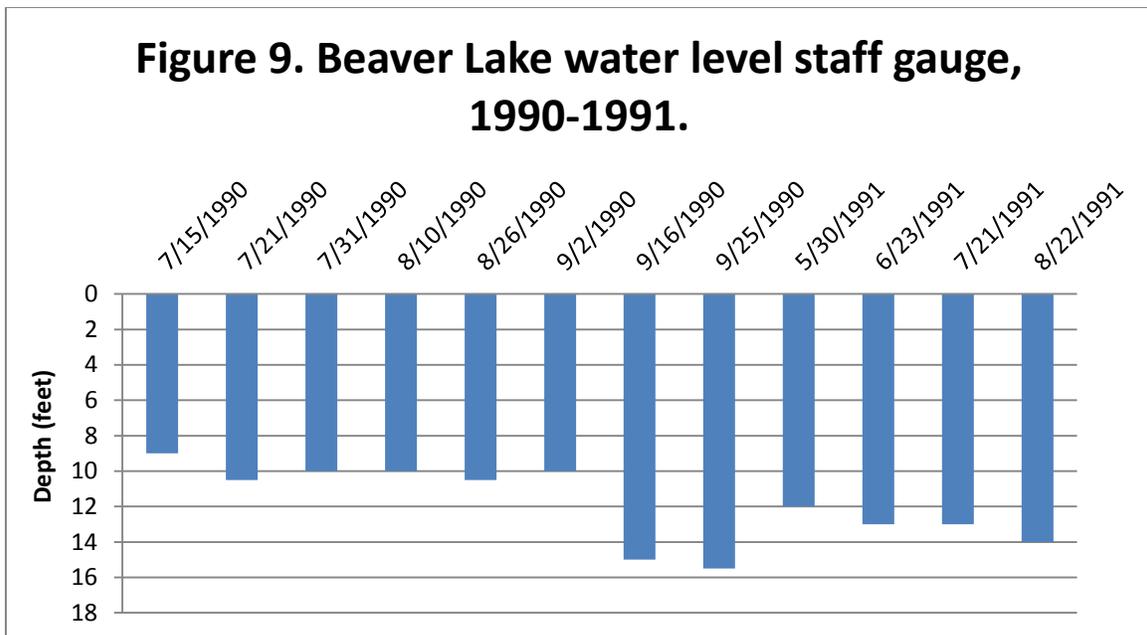
In 1990 and 1991, water levels were collected. Levels were highest in late September, 1990 (Figure 9).

Figure 9. Beaver Lake water level staff gauge, 1990-1991.

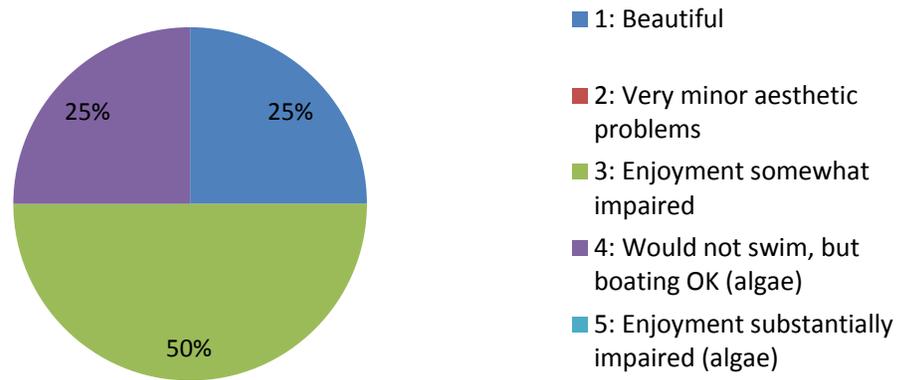
Figure 10. Beaver Lake aesthetic quality, July (1990, 1991, 2001, 2005).

appearance also decreases. These perceptions of recreational suitability are displayed by month in Figures 10-12. In July and August (Figure 10 and 11), 50% of volunteers thought “enjoyment somewhat impaired.” In September (Figure 12), 34% of volunteers perceived Beaver Lake’s aesthetic quality as “beautiful,” while another 33% each saw the quality as “enjoyment somewhat impaired,” and “would not swim, but boating OK (algae).”

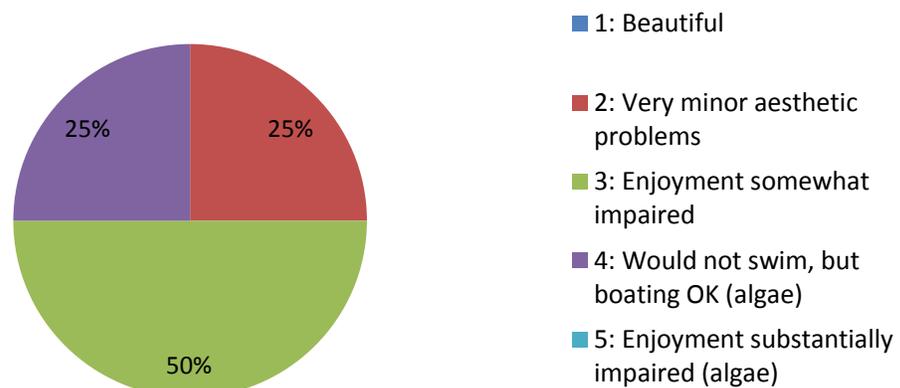
Figure 11. Beaver Lake aesthetic quality, August (1990, 1991, 1998, 2001).

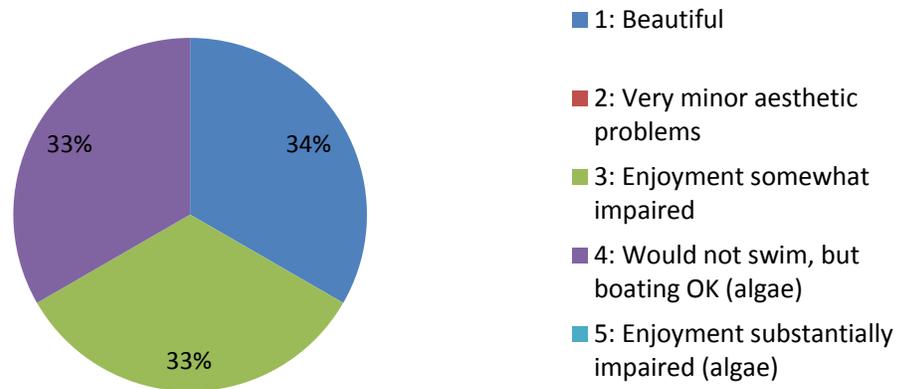
Figure 12. Beaver Lake aesthetic quality, September (1990, 1998, 2001).

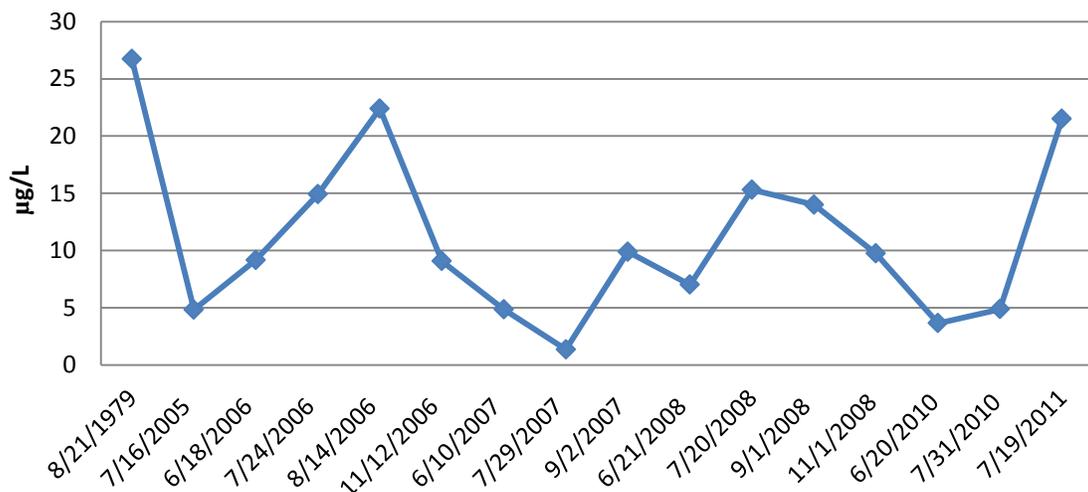
Chlorophyll *a* is the photosynthetic pigment that makes plants and algae green. Chlorophyll *a* in lake water is therefore an indicator of the amount of algae. Chlorophyll *a* concentrations greater than 10 µg/L are perceived as a mild algae bloom, while concentrations greater than 20 µg/L are perceived as a nuisance. Beaver Lake’s chlorophyll *a* has fluctuated over the years (Figure 13). On many occasions the chlorophyll *a* levels were above 10 µg/L, and on three occasions (August 21, 1979; August 14, 2006; and July 19, 2011) the values were above 20 µg/L and could be considered as nuisance conditions.

Figure 13. Beaver Lake chlorophyll *a*.

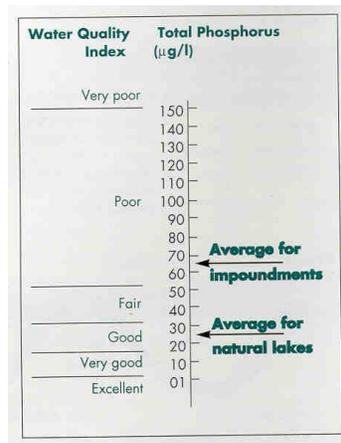
Figure 15. Total phosphorus concentrations for Wisconsin’s natural lakes and impoundments (Shaw et al., 2004).

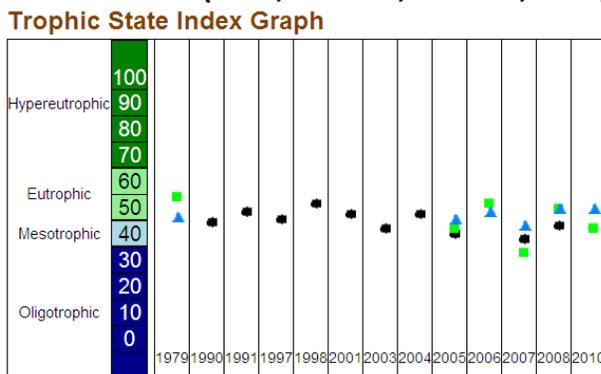
Trophic state was calculated by the WDNR using total phosphorus, chlorophyll *a*, and Secchi depth (Figure 16). The Trophic State Index (TSI) for Beaver Lake is considered “mesotrophic” to “mildly eutrophic” (Table 2).

Figure 16. Beaver Lake Trophic State Index (1979, 1990-91, 1997-98, 2001, 2003-06, and 2010).

♦ = Secchi ■ = Chlorophyll ▲ = Total Phosphorus	
TSI(Chl) = TSI(TP) = TSI(Sec)	It is likely that algae dominate light attenuation.
TSI(Chl) > TSI(Sec)	Large particulates, such as Aphanizomenon flakes dominate
TSI(TP) = TSI(Sec) > TSI(Chl)	Non-algal particulate or color dominate light attenuation
TSI(Sec) = TSI(Chl) >= TSI(TP)	The algae biomass in your lake is limited by phosphorus
TSI(TP) > TSI(Chl) = TSI(Sec)	Zooplankton grazing, nitrogen, or some factor other than phosphorus is limiting algae biomass
