# Presque Isle Wilderness Waters Program

## Aquatic Plant Management Plan – Carlin Lake

**Date: March 2014**

**Cite as:** Premo, Dean, Angie Stine, Caitlin Clarke and Kent Premo. 2014. Presque Isle Wilderness Waters Program: Carlin Lake Aquatic Plant Management Plan. White Water Associates, Inc.

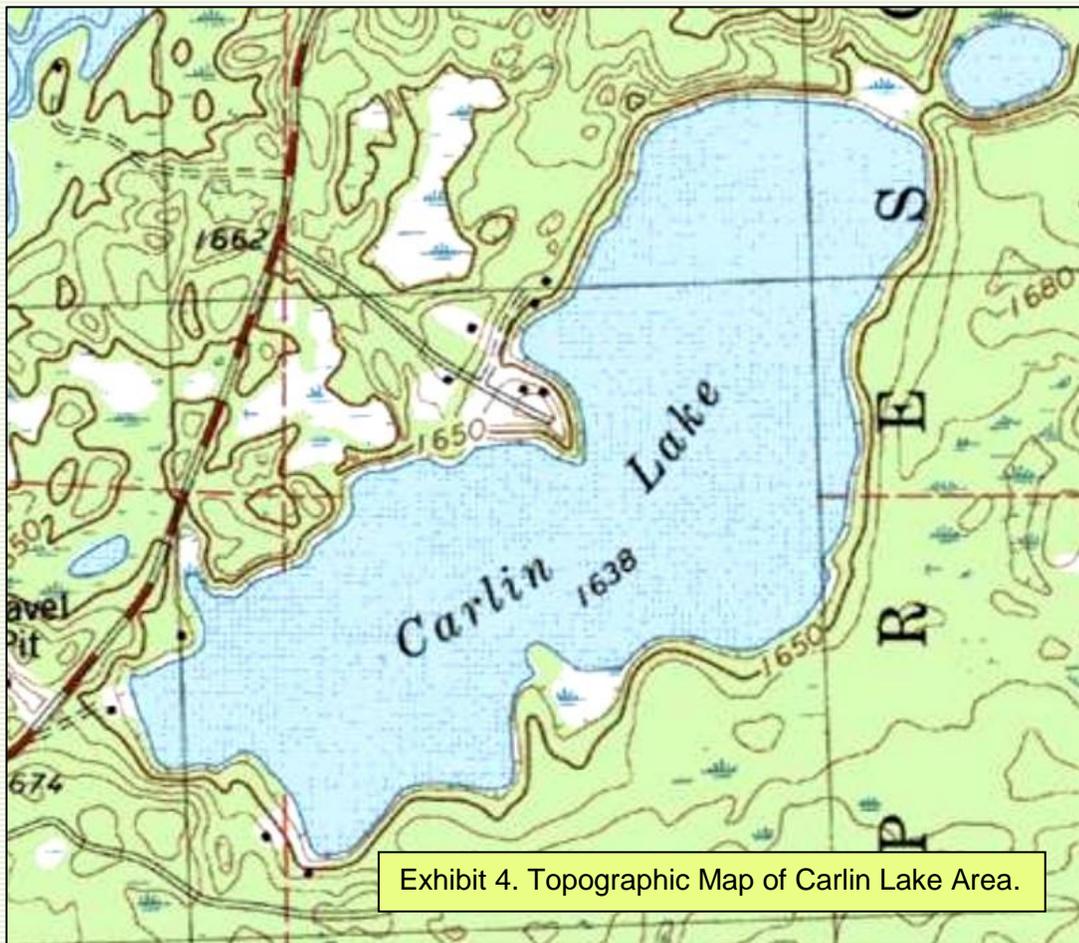
Exhibit 4. Topographic Map of Carlin Lake Area.

Carlin Lake has no public access site. We observe a total of 31 piers on the shoreline of Carlin Lake from a 2011 aerial photograph or about 11.3 piers per mile of shoreline. The riparian area consists of both upland and wetland areas (Exhibit 4).

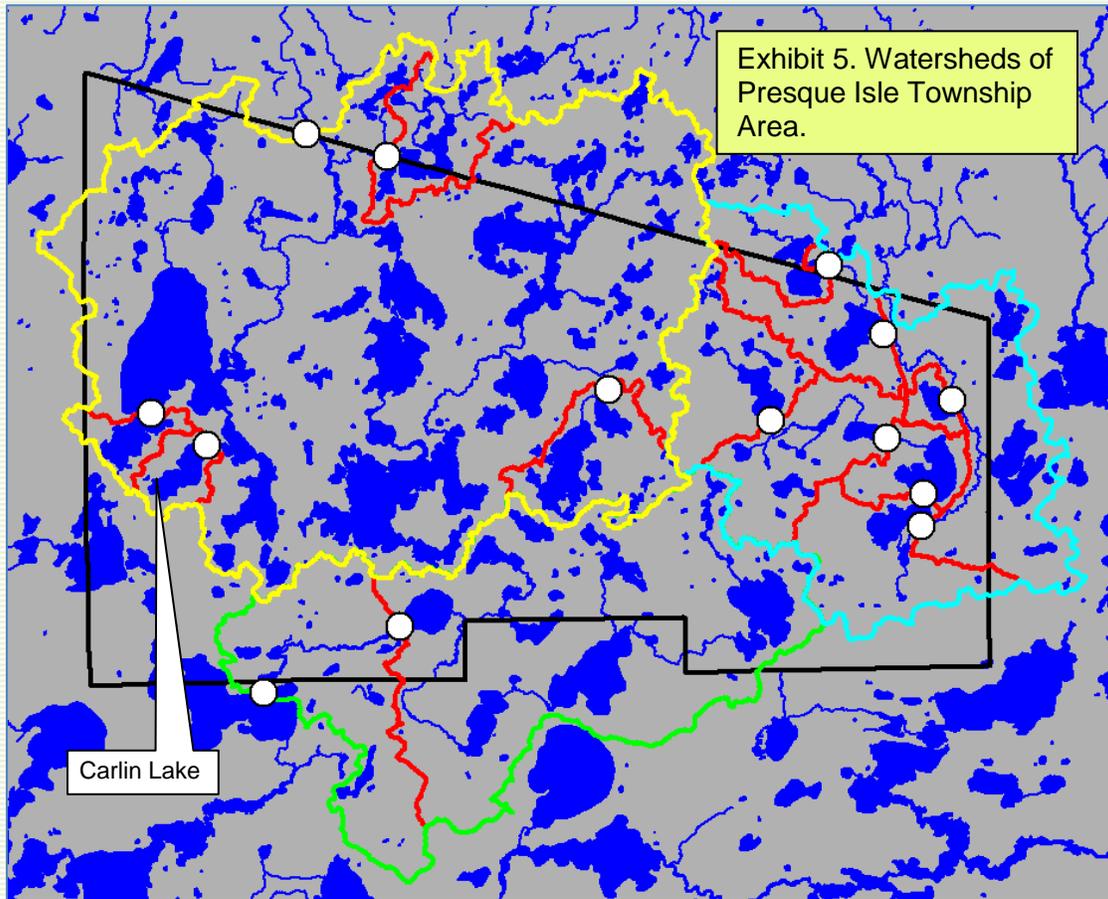
Description: Portions of 3 federal hydrologic subwatersheds are illustrated: (1) S.Br. Presque Isle River (bounded by yellow), (2) Pomeroy Cr-E.Br. Presque Isle River (bounded by blue and yellow), and (3) Rice Cr. (bounded by green, yellow, and blue). Also shown are the smaller watersheds of individual water bodies subject to the Wilderness Waters studies (bounded by red). White dots show outlet points for the smaller watersheds.

The Presque Isle Township waterscape sits on a large-scale watershed divide. Some of the water drains north through the Presque Isle River system and eventually enters Lake Superior. Some of the water drains into the Wisconsin River system to the Mississippi River and to the Gulf of Mexico. In fact there are two federal hydrologic sub-basins (designated by 8-digit HUC codes) that include Presque Isle Township. The Black-Presque Isle Rivers sub-basin (HUC#04020101) drains north to Lake Superior and the Flambeau River sub-basin (HUC#0705002) drains southwesterly to the Mississippi River. The Black-Presque Isle Rivers sub-basin contains two federal hydrologic sub-watersheds within Presque Isle Township: the South Branch Presque Isle River sub-watershed (HUC#040201010303) and the Pomeroy Creek-East Branch Presque Isle River sub-watershed (HUC#040201010301). The Flambeau River sub-basin contains one sub-watershed within Presque Isle Township: the Rice Creek sub-watershed (HUC#07050020103). Exhibit 5 illustrates these watersheds and the watersheds of the water bodies subject to the Wilderness Waters Program studies. Carlin Lake is contained within the South Branch Presque Isle River sub-watershed (Exhibit 5).

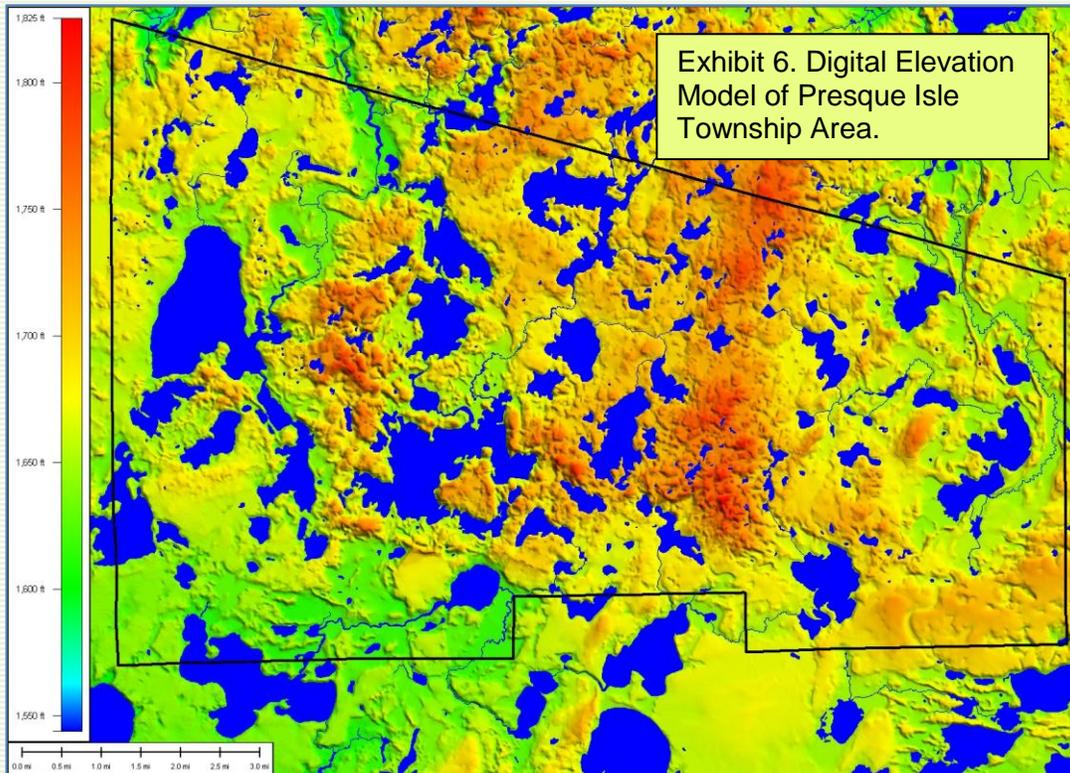
The elevation in Presque Isle Township ranges from around 1,550 feet above sea level to 1,750 feet above sea level. A digital elevation model is provided as Exhibit 6 and shows the relative elevations for the area with orange areas of the landscape being the highest elevations and greens and blues being the lowest elevations.

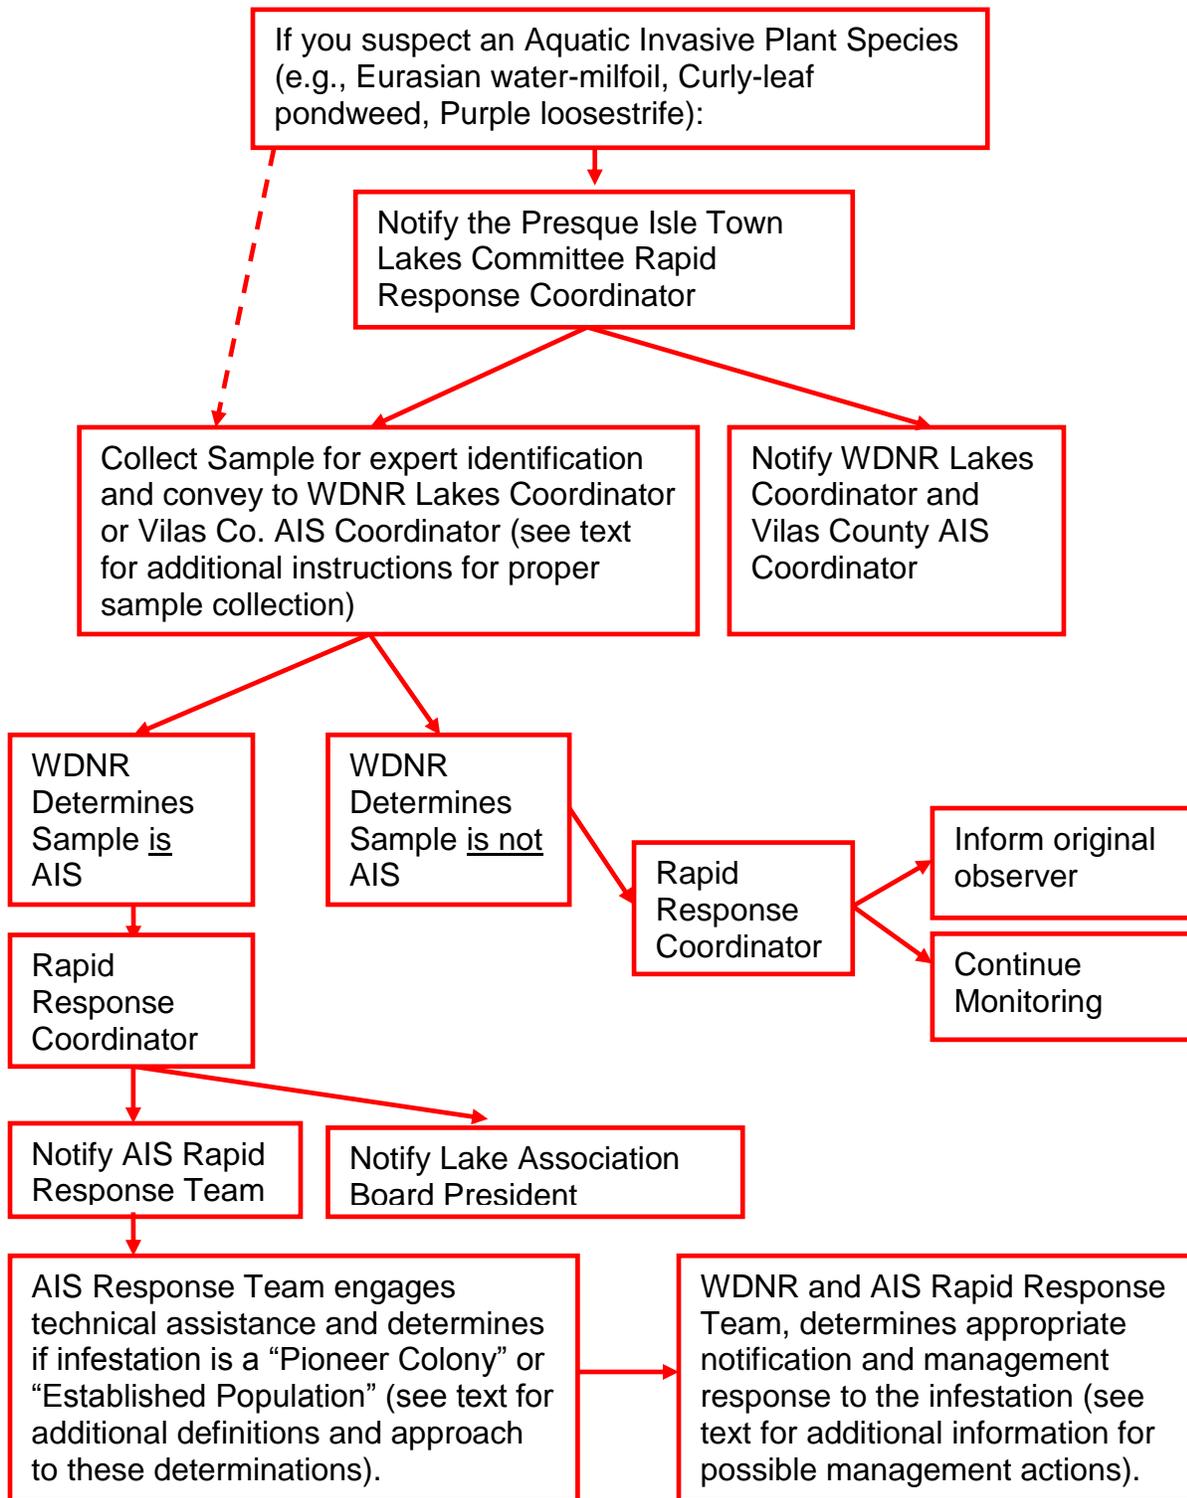
**Exhibit 8. Aquatic Invasive Plant Species Rapid Response**

When a suspect aquatic invasive plant species is found, either the original observer or a member of the Rapid Response Team (likely the coordinator) should collect an entire plant specimen including roots, stems, and flowers (if present). The sample should be placed in a sealable bag with a small amount of water to keep it moist. Place a label in the bag written in pencil with date, time, collector’s name, lake name, location, town, and county. Attach a lake

Once the Rapid Response Team is organized, one of its first tasks is to develop a list of contacts and associated contact information (phone numbers and email addresses). At a minimum, this contact list should include: the Rapid Response Coordinator, members of the Rapid Response Team, County AIS Coordinator, WDNR Lakes Management Coordinator, Lake Association Presidents (or other points of contact), local WDNR warden, local government official(s), other experts, chemical treatment contractors, and consultant(s).

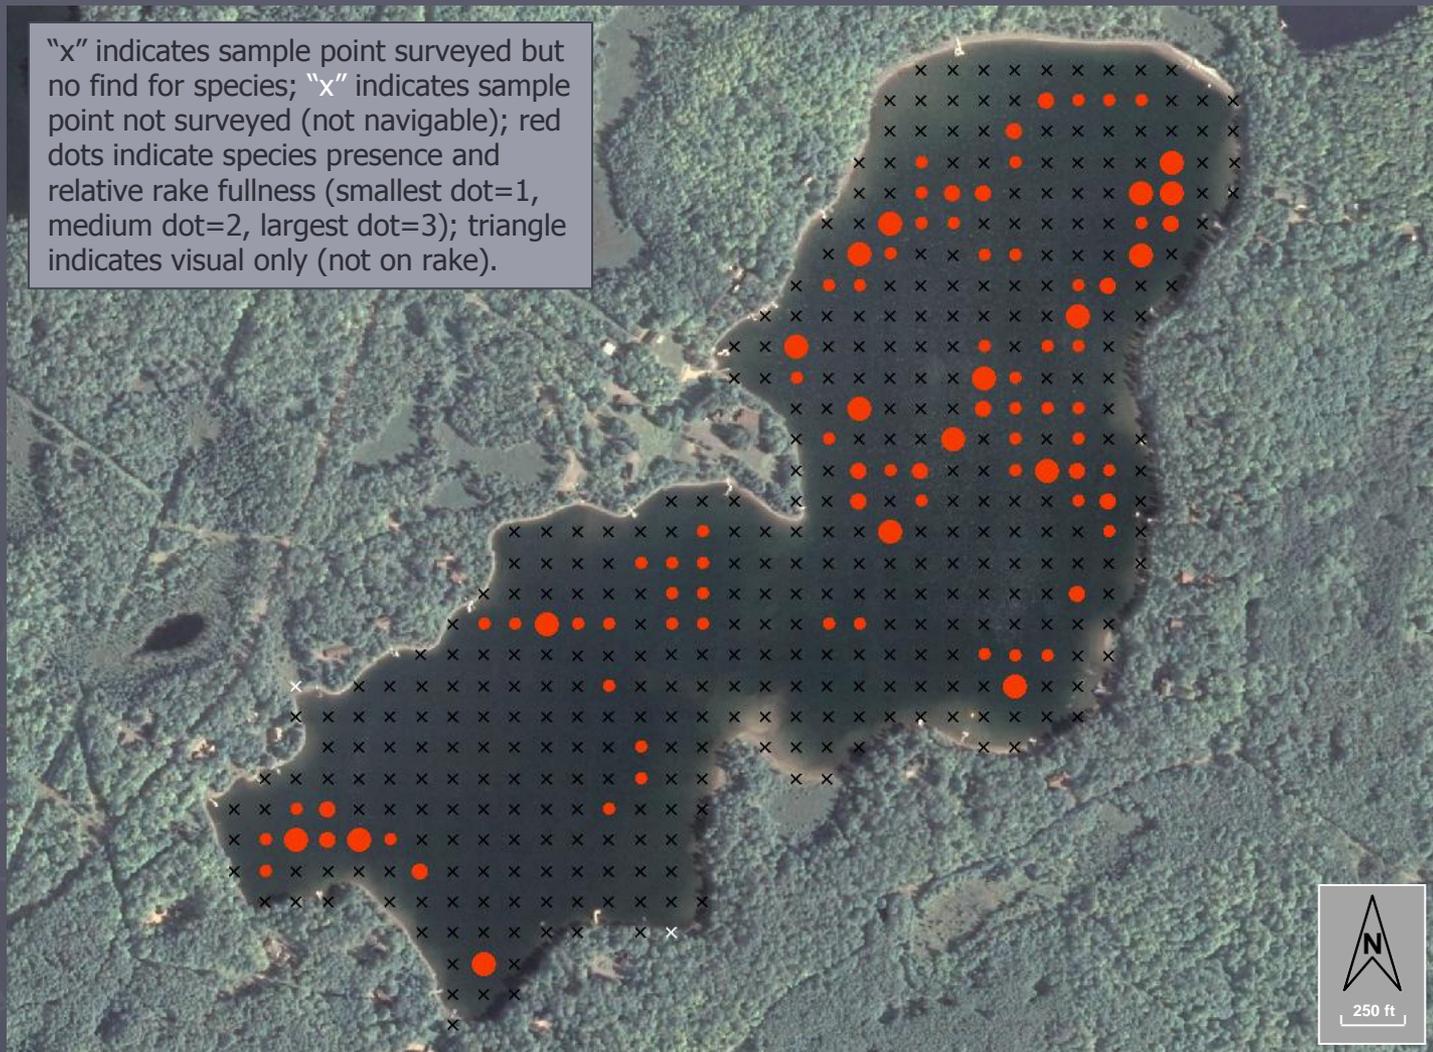
Figure 7. Distribution of plant species, Carlin Lake (2010)

*Nitella sp.*

Table 2 provides information about the frequency of occurrence of the plant species recorded in the lake. Several metrics are provided, including total number of sites in which each species was found and frequency of occurrence at sites  $\leq$  the maximum depth of rooted vegetation. This frequency metric is standardized as a “relative frequency” (also shown in Table 2) by dividing the frequency of occurrence for a given species by the sum of frequency of occurrence for all plants and multiplying by 100 to form a percentage. The resulting relative frequencies for all species total 100%. The relative frequencies for the plant species collected with a rake are graphically displayed in descending order on Figure 6. This display shows that *Nitella sp.* had the highest relative frequency followed by *Eleocharis acicularis* (Needle spikerush). The lowest relative frequencies are at the far right of the graph. As examples of individual species distributions, we show the occurrences of a few of the most frequently and least frequently encountered plants in Figures 7-12.

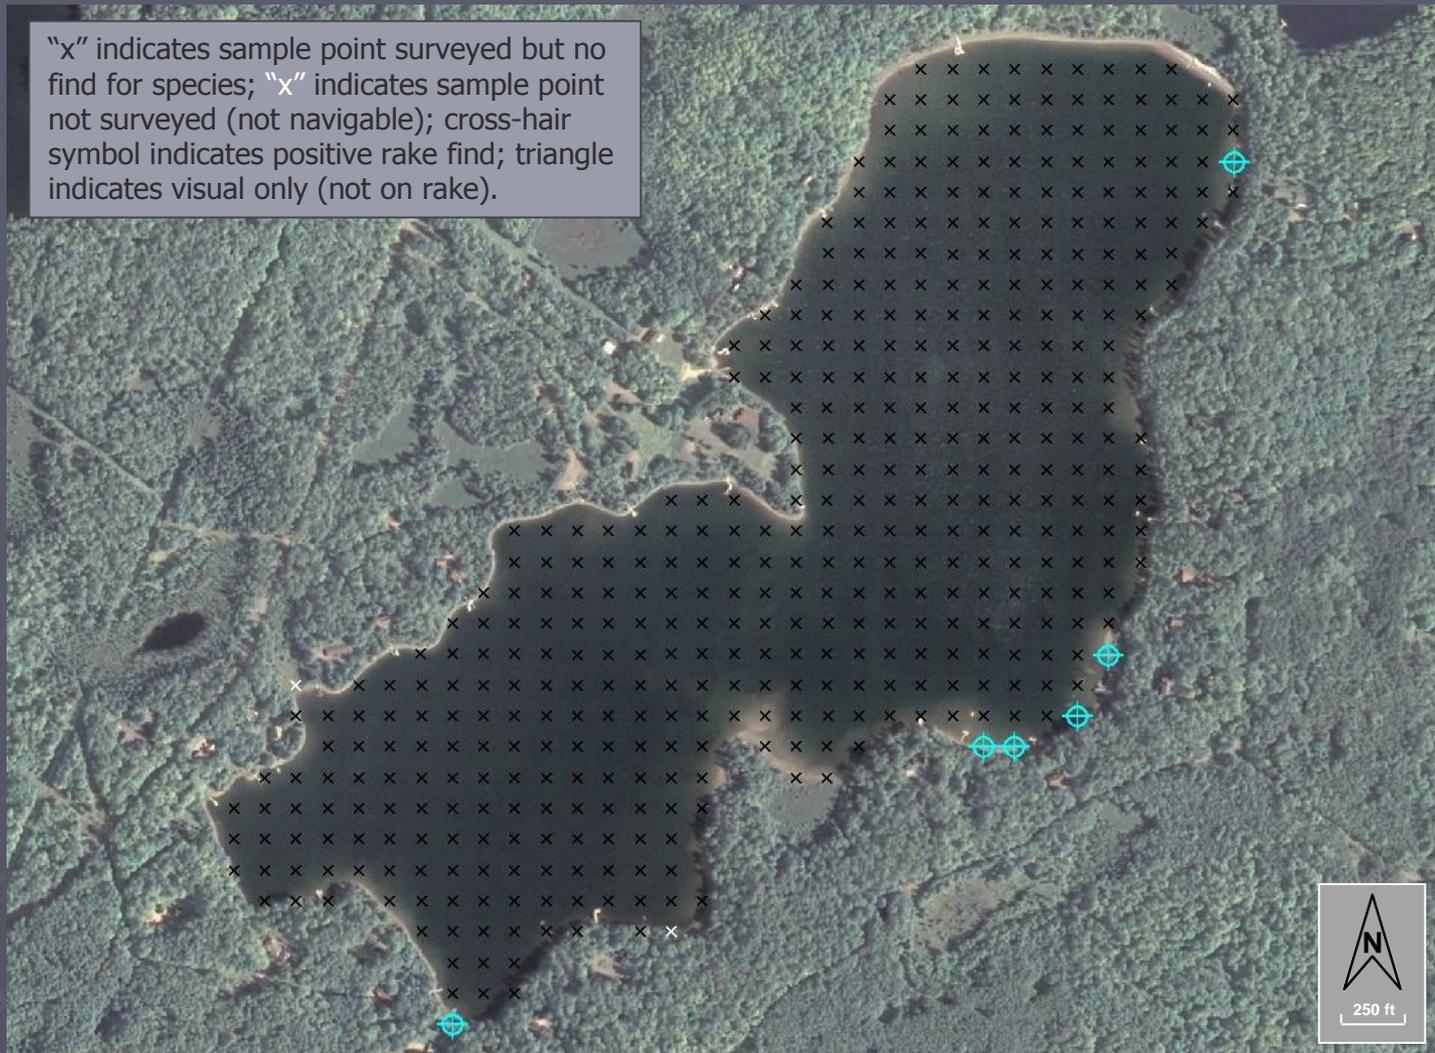
Figure 8. Distribution of plant species, Carlin Lake (2010)

*Eleocharis acicularis* (Needle spikerush)

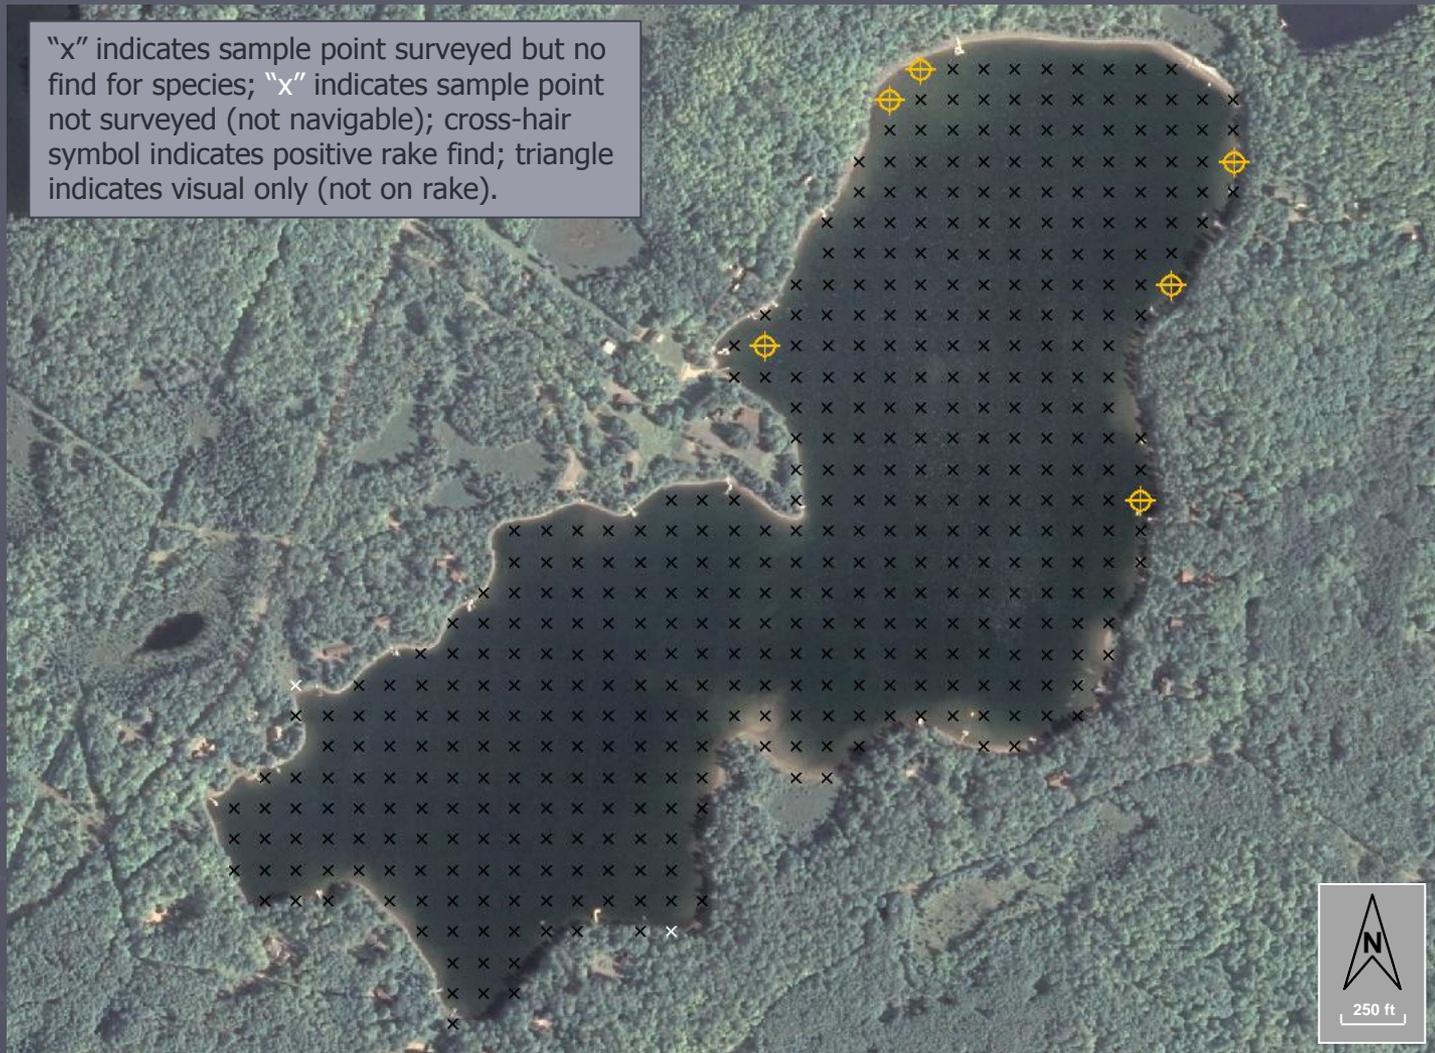
Figure 9. Distribution of plant species, Carlin Lake (2010)

*Isoetes lacustris* (Lake quillwort)

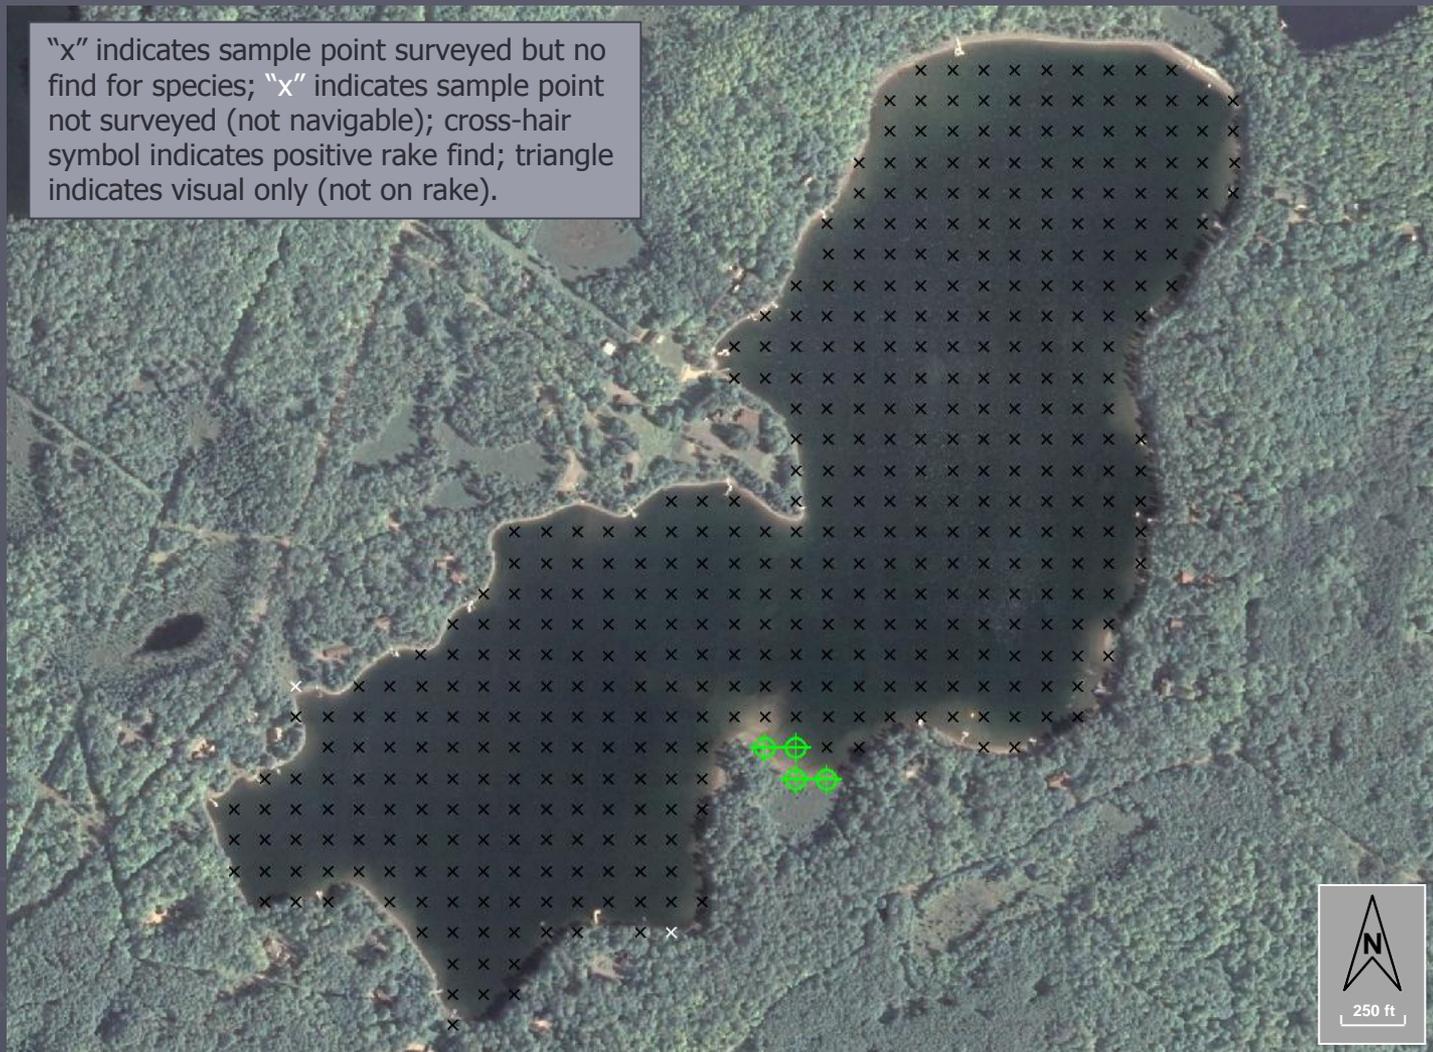
Figure 10. Distribution of plant species, Carlin Lake (2010)

*Myriophyllum tenellum* (Dwarf water-milfoil)

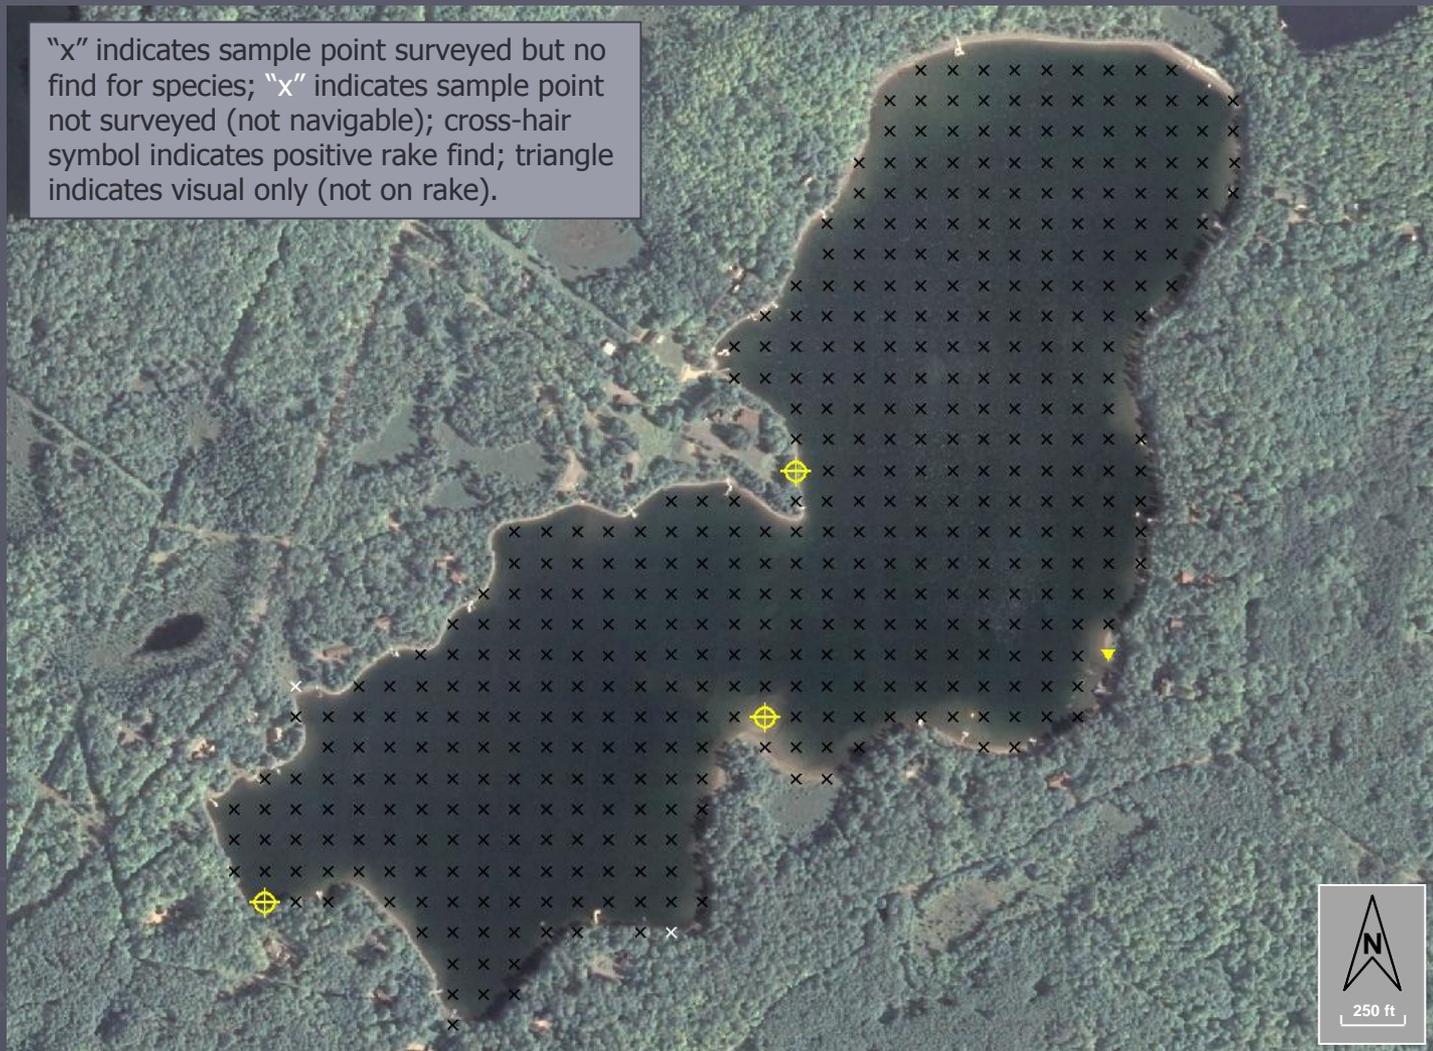
Figure 11. Distribution of plant species, Carlin Lake (2010)

*Juncus pelocarpus f. submersus* (Brown-fruited rush)

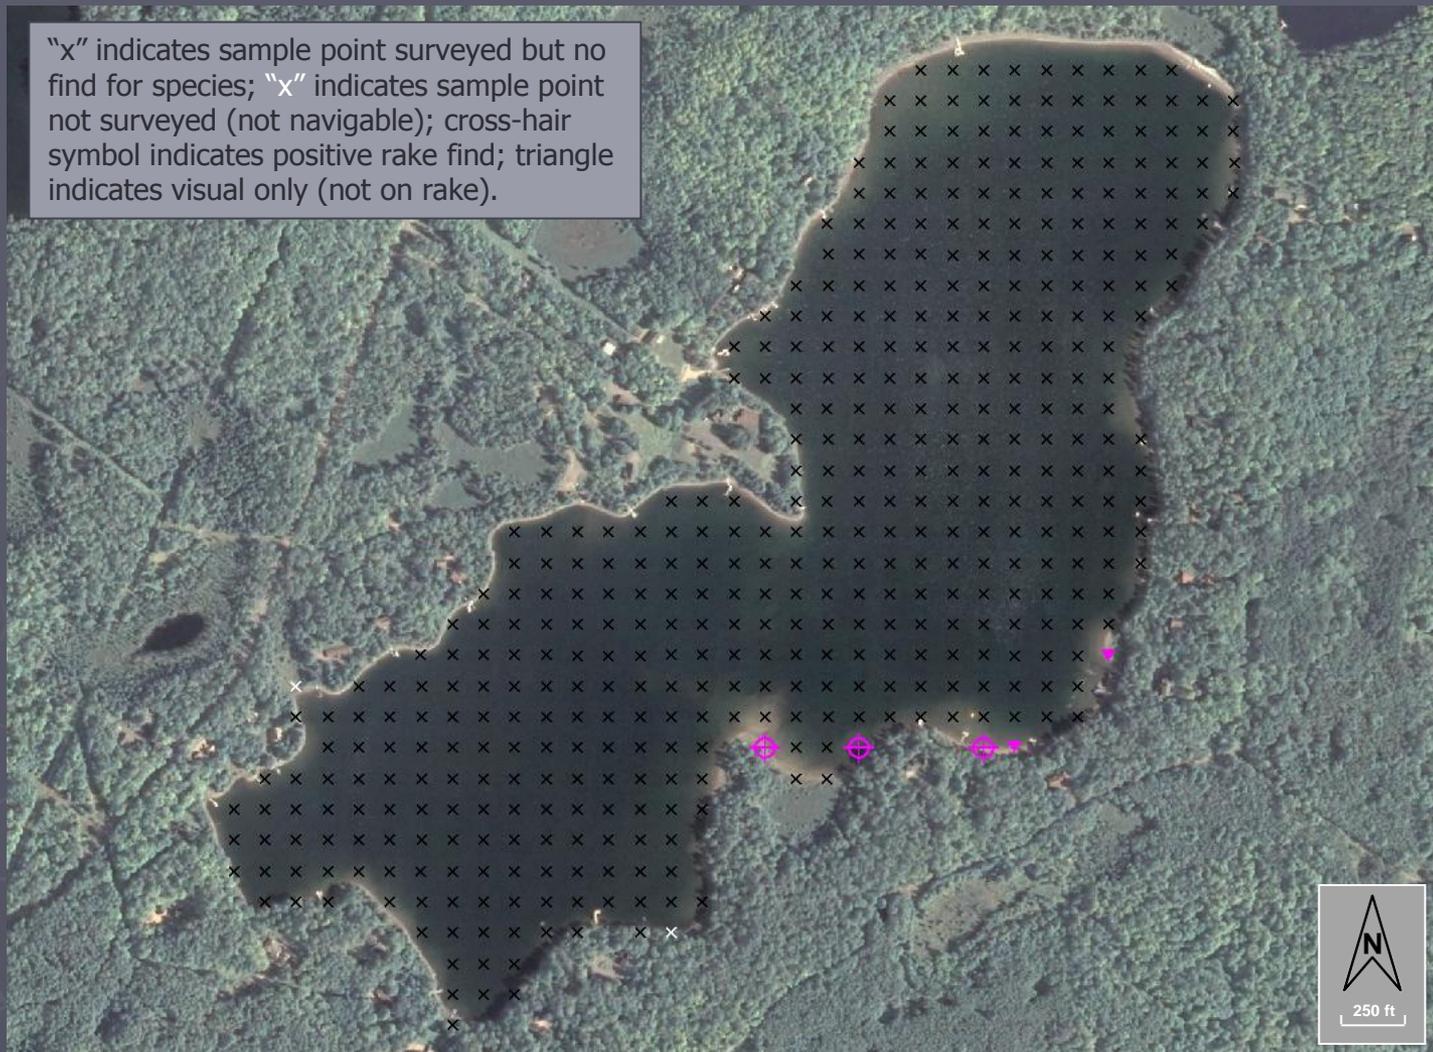
Figure 12. Distribution of plant species, Carlin Lake (2010)

*Lobelia dortmanna* (Water lobelia)

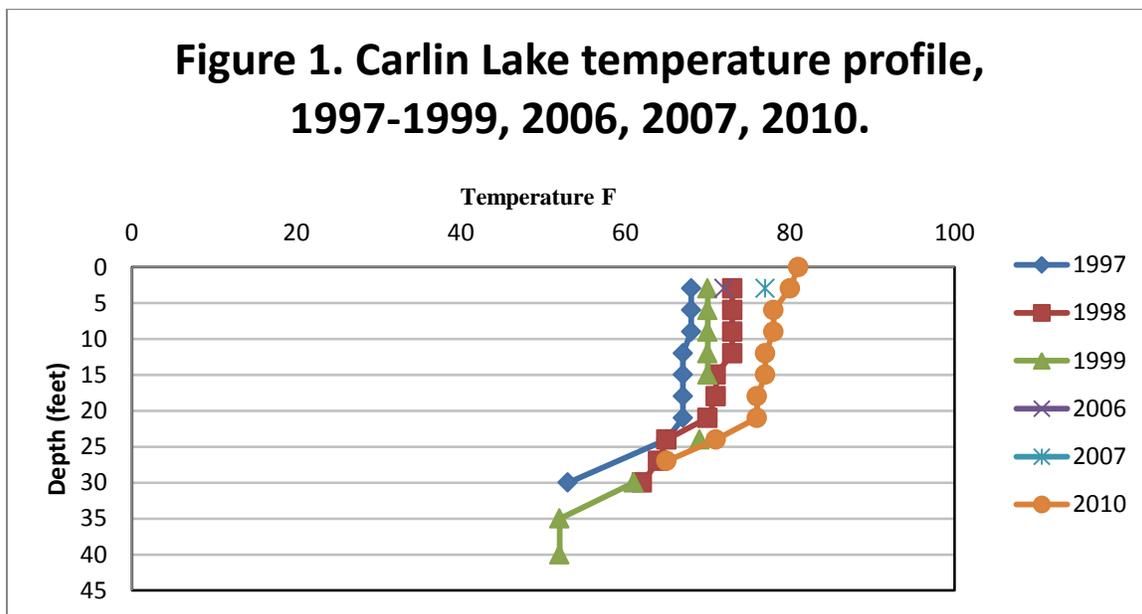
Measuring the temperature of a lake at different depths will determine the influence it has on the physical, biological, and chemical aspects of the lake. Lake water temperature influences the rate of decomposition, nutrient recycling, lake stratification, and dissolved oxygen (D.O.) concentration. Temperature can also affect the distribution of fish species throughout a lake. Carlin Lake had six temperature profiles completed since 1997 (Figure 1). In most sampled years the lake stratified around 20 feet deep.

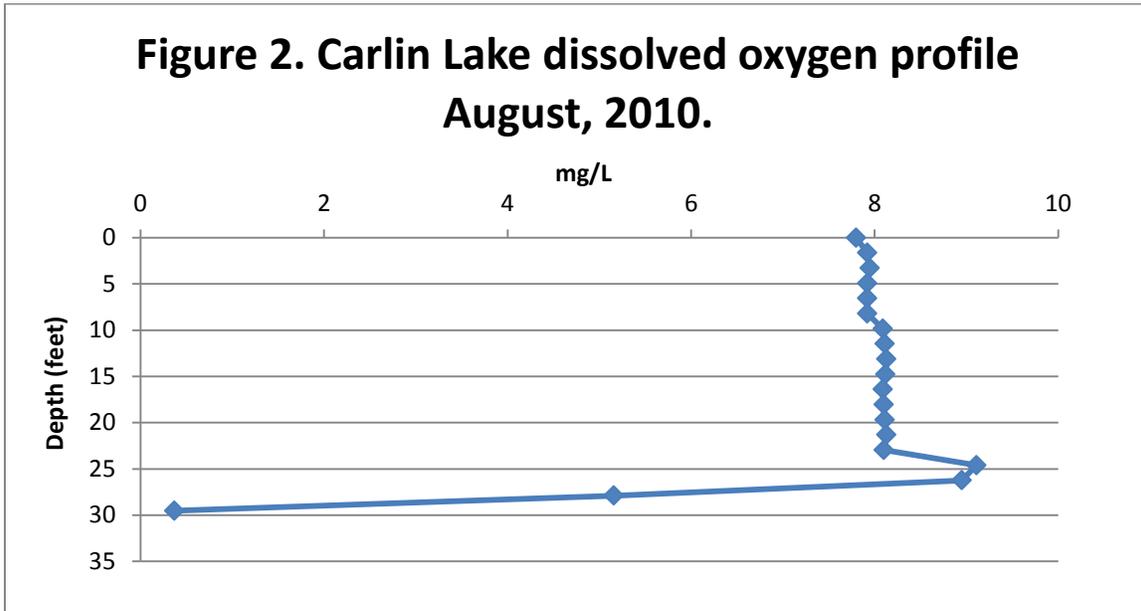
of a lake. The amount of dissolved oxygen is dependent on the water temperature, atmospheric pressure, and biological activity. Oxygen levels are increased by aquatic plant photosynthesis, but reduced by respiration of plants, decomposer organisms, fish, and invertebrates. The amount of dissolved oxygen available in a lake, particularly in the deeper parts of a lake, is critical to overall health. In Figure 2, we see the average dissolved oxygen in the first 23 feet is around 8.14 mg/L. At 27.88 feet, the dissolved oxygen drops to 5.16 mg/L, and at 29.52 feet, the level is lowest at 0.37 mg/L.

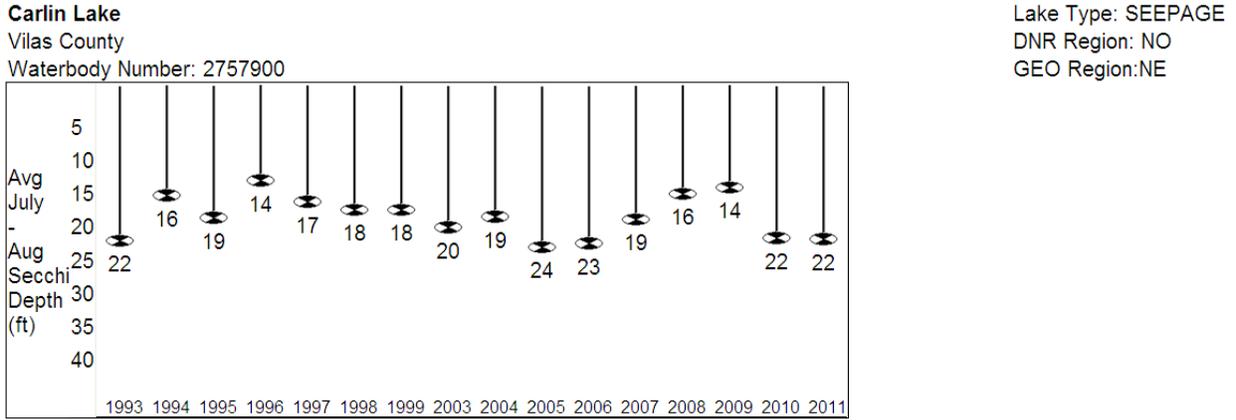
**Figure 3. Secchi depth averages for Carlin Lake (July and August only).**

Past secchi averages in feet (July and August only).

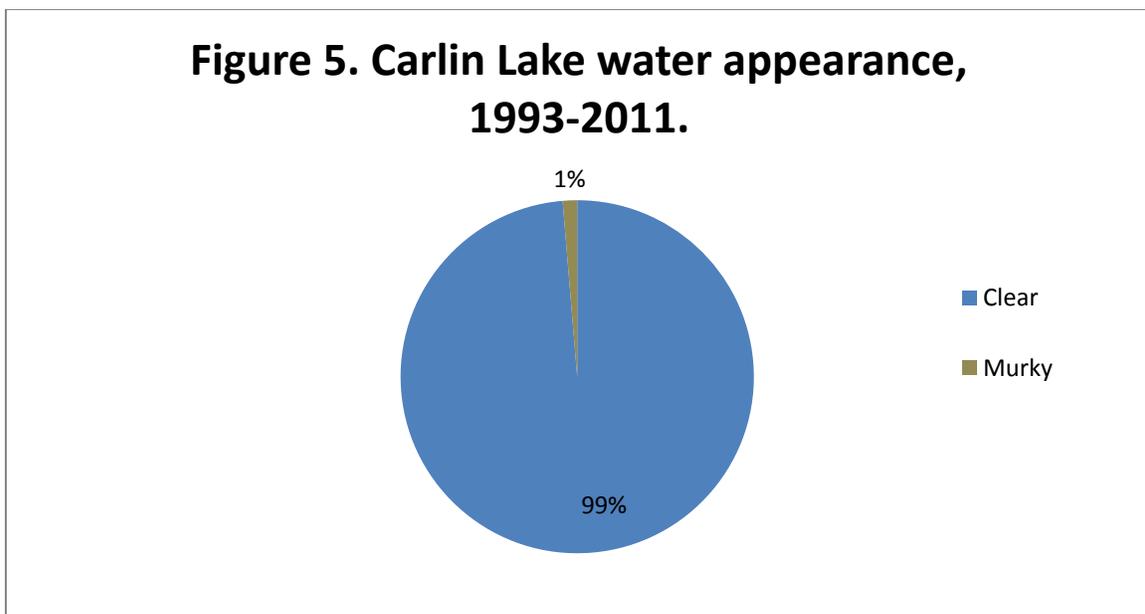
Turbidity is another measure of water clarity, but is caused by suspended particulate matter rather than dissolved organic compounds (Shaw et al., 2004). Particles suspended in the water dissipate light and reduce the depth at which the light can penetrate. This affects the depth at which plants can grow. Turbidity also affects the aesthetic quality of water. Water that runs off the watershed into a lake can increase turbidity by introducing suspended materials. Turbidity caused by algae is the most common reason for low Secchi readings (Shaw et al., 2004). In terms of biological health of a lake ecosystem, measurements less than 10 Nephelometric Turbidity Units (NTU) represent healthy conditions for fish and other organisms. Turbidity has not been sampled in Carlin Lake in the past, but Citizen Lake Monitoring Network looked at the water column appearance in Carlin Lake, and throughout the sampled years 99% of volunteers viewed it as “clear,” and 1% called it “murky” (Figure 5).

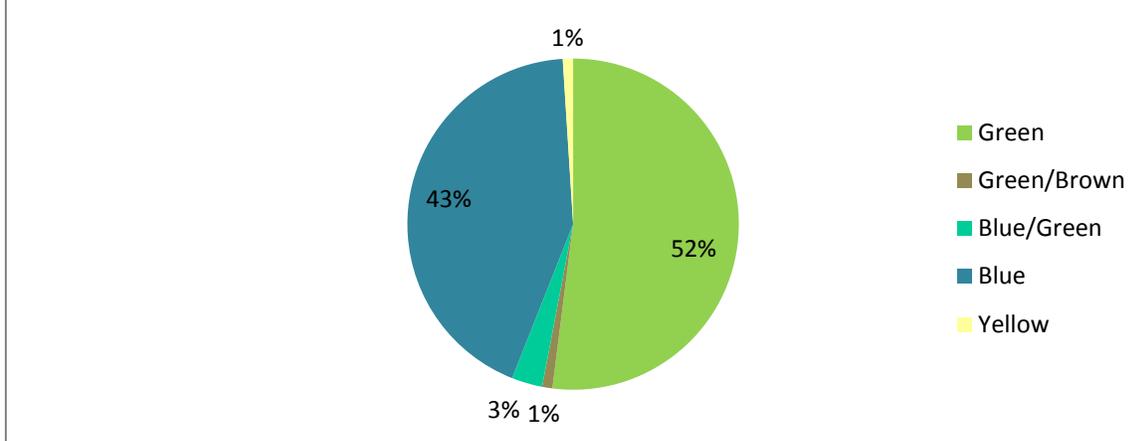
**Figure 6. Carlin Lake visual water color, 1993-2011**

Color of lake water is related to the type and amount of dissolved organic chemicals. Its main significance is aesthetics, although it may also influence light penetration and in turn affect aquatic plant and algal growth. Many lakes have naturally occurring color compounds from decomposition of plant material in the watershed (Shaw et al., 2004). Units of color are determined from the platinum-cobalt scale and are therefore recorded as Pt-Co units. Shaw states that a water color between 0 and 40 Pt-Co units is low. Carlin Lake had a color sample completed on September 22, 1995, and the value was 10 Pt-Co. Citizen Lake Monitoring Network as recorded their view of the water color. Throughout the sampled years, 52% of volunteers viewed the lake to be “green,” and 43% called it “blue” (Figure 6).

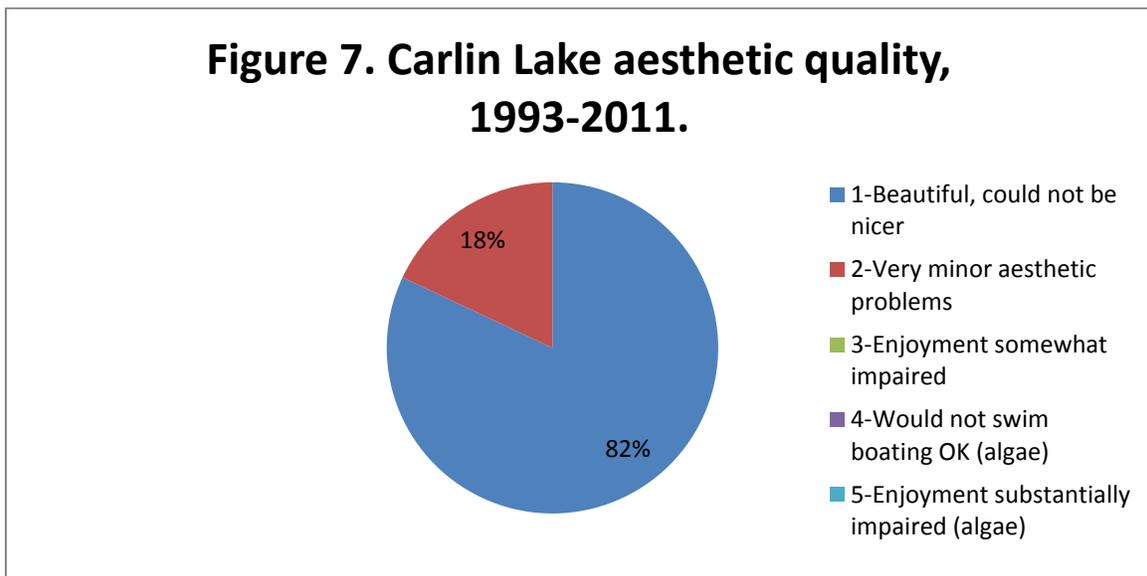
**Figure 7. Carlin Lake aesthetic quality, 1993-2011.**

When Secchi depth readings are collected, the CLMN record their perceptions of the water, based on the physical appearance and the recreational suitability. These perceptions can be compared to water quality parameters to see how the lake user would experience the lake at that time. When interpreting the transparency data, we see that when the Secchi depth decreases, the rating of the lake’s physical appearance also decreases. Throughout sampled years, 82% of CLMN volunteers viewed the lake as “beautiful, could not be nicer” (Figure 7).

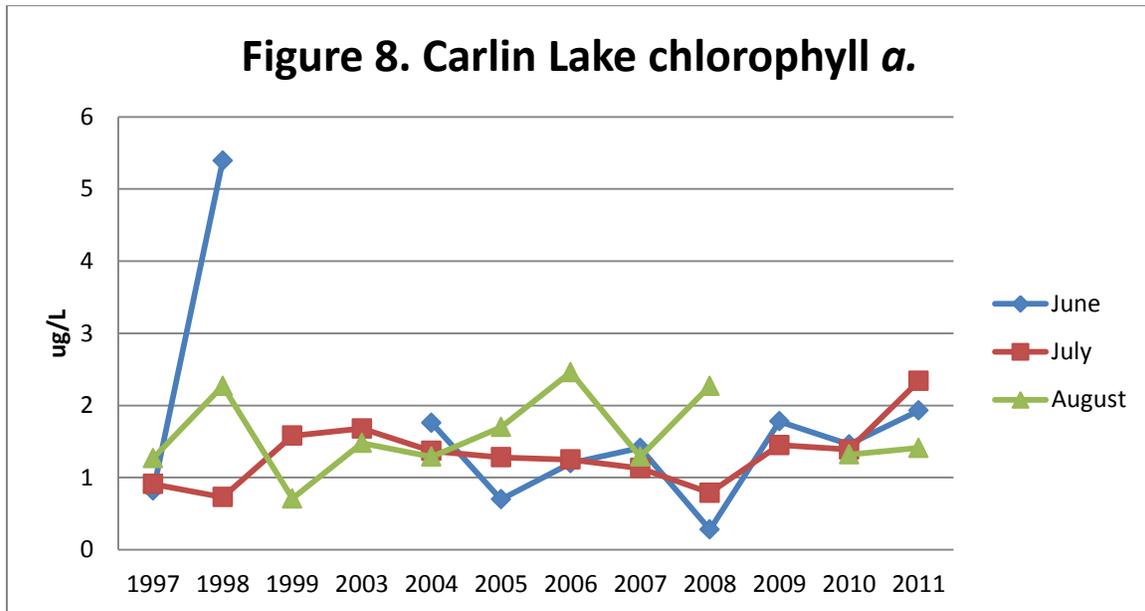
Chlorophyll *a* is the photosynthetic pigment that makes plants and algae green. Chlorophyll *a* in lake water is therefore an indicator of the amount of algae. Chlorophyll *a* concentrations greater than 10 µg/L are perceived as a mild algae bloom, while concentrations greater than 20 µg/L are perceived as a nuisance. Chlorophyll *a* has been monitored in Carlin Lake extensively, and all sampled years have low levels (Figure 8).

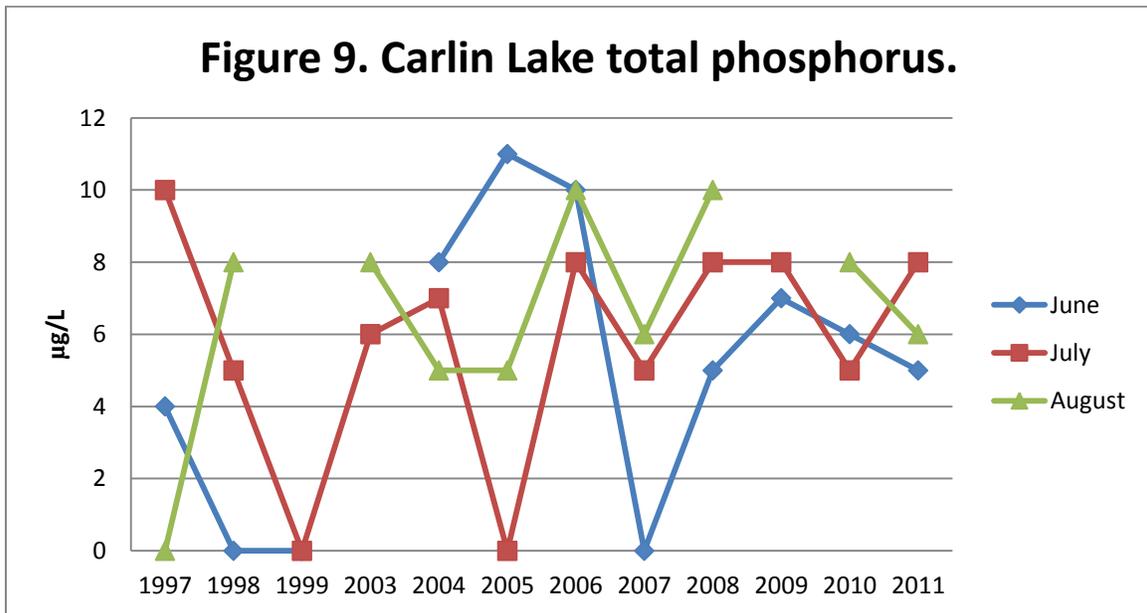
Phosphorus originates from a variety of sources, many of which are related to human activities. Major sources include human and animal wastes, soil erosion, detergents, septic systems and runoff from farmland or lawns (Shaw et al., 2004). Phosphorus provokes complex reactions in lakes. An analysis of phosphorus often includes both soluble reactive phosphorus and total phosphorus. Soluble reactive phosphorus dissolves in the water and directly influences plant growth (Shaw et al., 2004). Its concentration varies in most lakes over short periods of time as plants take it up and release it. Total phosphorus is considered a better indicator of a lake's nutrient status than soluble reactive phosphorus because its levels remain more stable (Shaw et al., 2004). Total phosphorus includes soluble phosphorus and the phosphorus in plant and animal fragments suspended in lake water. Ideally, soluble reactive phosphorus concentrations should be 10 µg/L or less at spring turnover to prevent summer algae blooms (Shaw et al., 2004). A concentration of total phosphorus below 20 µg/L for lakes should be maintained to prevent nuisance algal blooms (Shaw et al., 2004). Figure 9 shows the June, July, and August total phosphorus concentration data for Carlin Lake and indicates that total phosphorus levels are less than nuisance levels. Figure 10 indicates the water quality index, under a range of phosphorus concentrations, and shows that Carlin Lake ranges from "excellent" to "very good" with respect to total phosphorus concentrations.

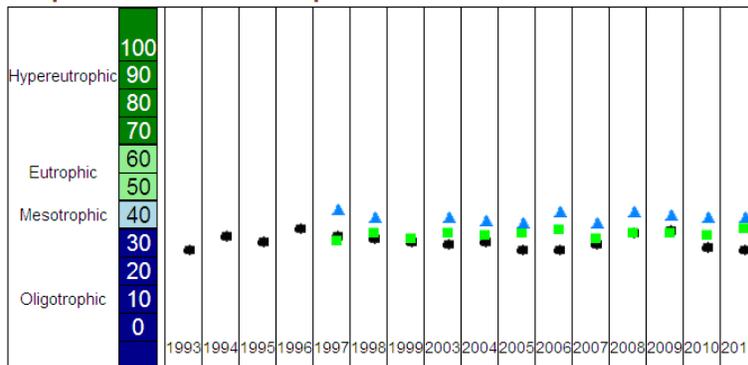
**Figure 11. Carlin Lake Trophic State Index (1993-2011).**

**Monitoring Station: Carlin Lake - Deep Hole, Vilas County**  
 Past Summer (July-August) Trophic State Index (TSI) averages.

◆ = Secchi	■ = Chlorophyll	▲ = Total Phosphorus
TSI(Chl) = TSI(TP) = TSI(Sec)	It is likely that algae dominate light attenuation.	
TSI(Chl) > TSI(Sec)	Large particulates, such as Aphanizomenon flakes dominate	
TSI(TP) = TSI(Sec) > TSI(Chl)	Non-algal particulate or color dominate light attenuation	
TSI(Sec) = TSI(Chl) >= TSI(TP)	The algae biomass in your lake is limited by phosphorus	
TSI(TP) > TSI(Chl) = TSI(Sec)	Zooplankton grazing, nitrogen, or some factor other than phosphorus is limiting algae biomass
