Presque Isle Wilderness Waters Program

Aquatic Plant Management Plan – Katinka Lake

Date: March 2014

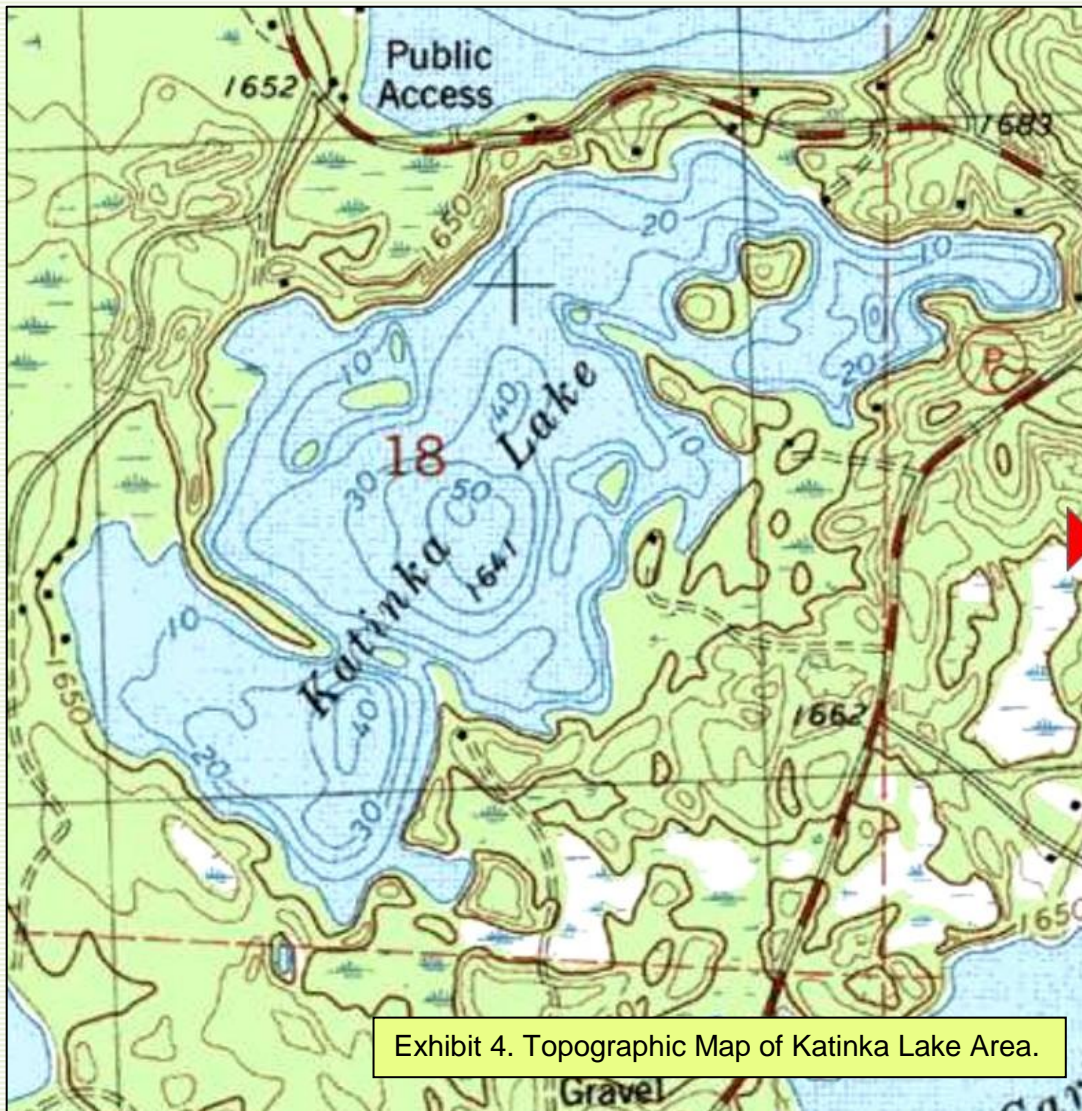
Exhibit 4. Topographic Map of Katinka Lake Area.

Katinka Lake has no public access site. We observe a total of 45 piers on the shoreline of Katinka Lake from a 2011 aerial photograph or about 8.5 piers per mile of shoreline. The riparian area consists of both upland and wetland areas (Exhibit 4).

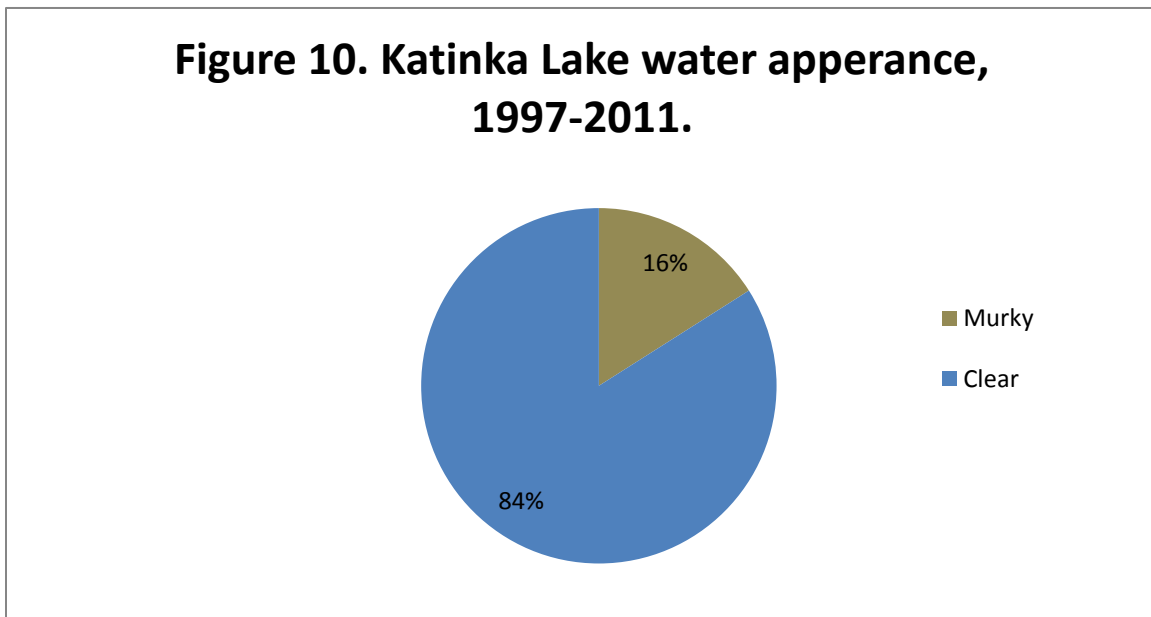
Turbidity is another measure of water clarity, but is caused by suspended particulate matter rather than dissolved organic compounds (Shaw et al., 2004). Particles suspended in the water dissipate light and reduce the depth at which the light can penetrate. This affects the depth at which plants can grow. Turbidity also affects the aesthetic quality of water. Water that runs off the watershed into a lake can increase turbidity by introducing suspended materials. Turbidity caused by algae is the most common reason for low Secchi readings (Shaw et al., 2004). In terms of biological health of a lake ecosystem, measurements less than 10 Nephelometric Turbidity Units (NTU) represent healthy conditions for fish and other organisms. Turbidity has not been analyzed for Katinka Lake, but water column appearance has been. Water column appearance was looked at by the Citizen Lake Monitoring Network (CLMN) and 84% of volunteers said the water appeared “clear” (Figure 10).
