Note: Methodology, explanation of analysis and scientific background on Virgin Lake studies are contained within the Three Lakes Chain-wide Management Plan document.

8.1 Virgin Lake

An Introduction to Virgin Lake

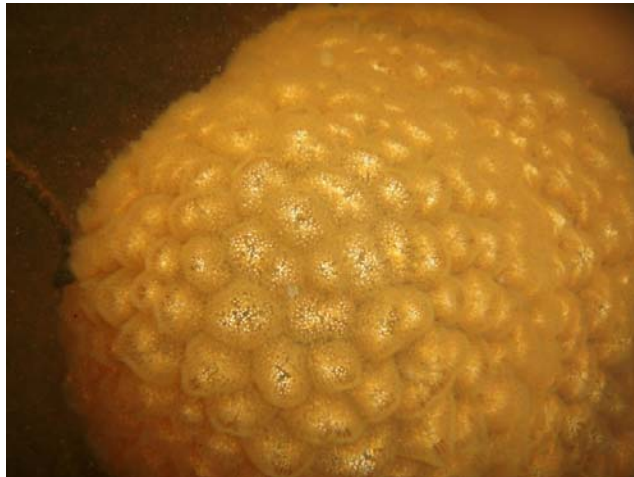
Many species observed during aquatic plant surveys. Several bryozoans (aquatic invertebrates consisting of colonies of microscopic organisms called “zooids” – pictured to the right), some relatively large in size, spotted as well.

Photo 8.1 Bryozoan from Virgin Lake, Oneida County

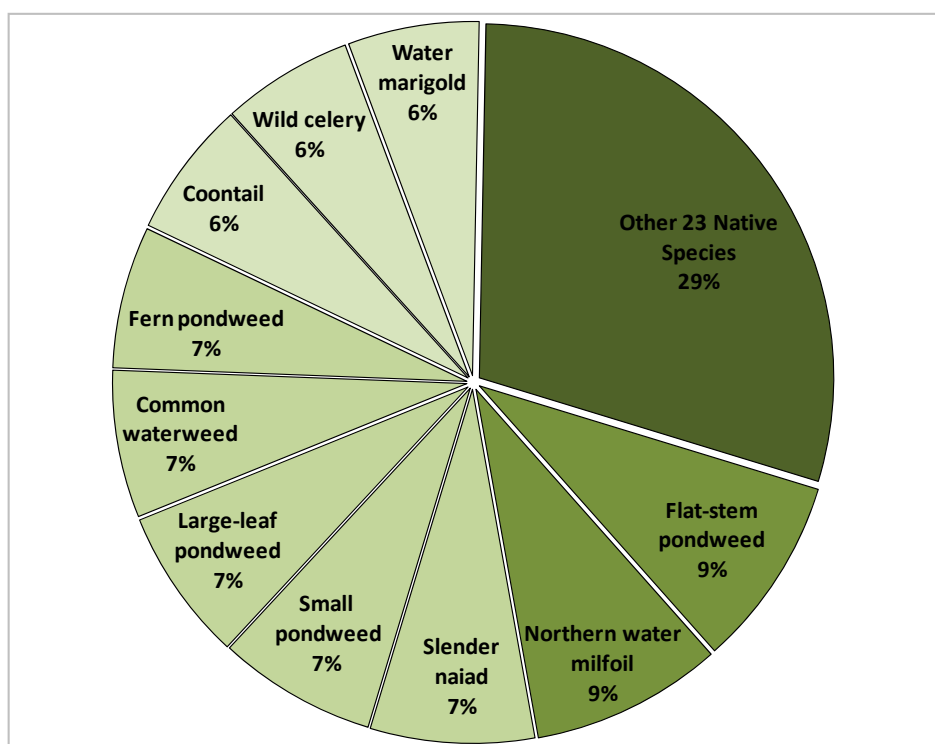
Figure 8.1.4-2 Virgin Lake aquatic plant relative frequency of occurrence analysis.
Created using data from 2010 point-intercept survey.

As explained earlier in the Primer on Data Analysis and Data Interpretation Section, the littoral frequency of occurrence analysis allows for an understanding of how often each of the plants is located during the point-intercept survey. Because each sampling location may contain numerous plant species, relative frequency of occurrence is one tool to evaluate how often each plant species is found in relation to all other species found (composition of population). For instance, while northern water milfoil was found at 19% of the sampling locations, its relative frequency of occurrence is 9%. Explained another way, if 100 plants were randomly sampled from Virgin Lake, 9 of them would be northern water milfoil. This distribution can be observed in Figure 8.1.4-2, where together 10 species account for 71% of the population of plants within Virgin Lake, while the other 23 species account for the remaining 29%. Fifteen additional species were located from the lake but not from of the point-intercept survey, and are indicated in Table 8.1.4-1 as incidentals.

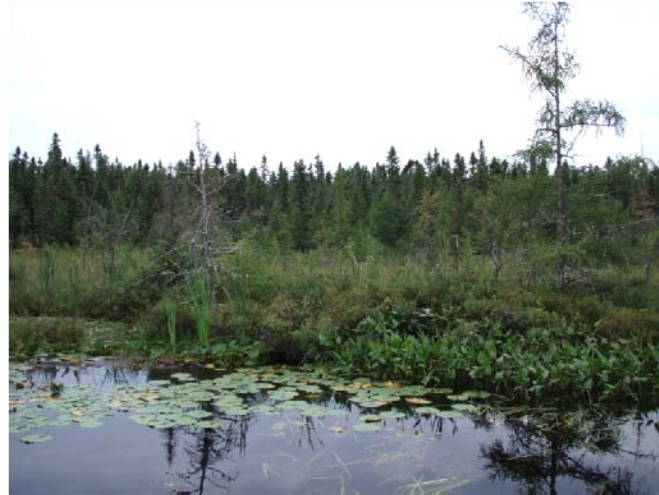
Photo 8.2.1 Whitefish Lake, Oneida County

Many (49) aquatic plant species encountered during poin-intercept survey. Very large muskellunge spotted in shallow waters of isolated eastern bay.

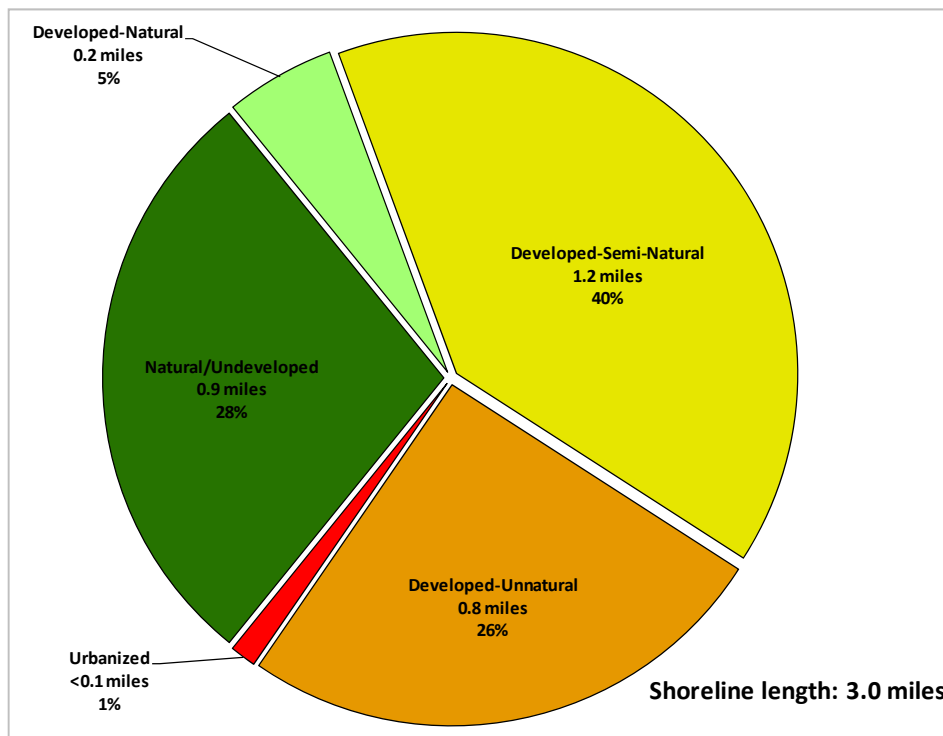
Figure 8.2.3-1. Whitefish Lake shoreland categories and total lengths. Based upon a late summer 2010 survey. Locations of these categorized shorelands can be found on Whitefish Lake Map 1.

As mentioned previously in the Chain-wide Shoreland Condition Section, one of the most sensitive areas of the watershed is the immediate shoreland area. This area of land is the last source of protection for a lake against surface water runoff, and is also a critical area for wildlife habitat. In late summer of 2010, Whitefish Lake's immediate shoreline was assessed in terms of its development. Whitefish Lake has stretches of shoreland that fit all of the five shoreland assessment categories. In all, 1.1 miles of natural/undeveloped and developed-natural shoreline (33% of the entire shoreline) were observed during the survey (Figure 8.2.3-1). These shoreland types provide the most benefit to the lake and should be left in their natural state if at all possible. During the survey, about 0.9 miles of urbanized and developed-unnatural shoreline (27% of the total shoreline) was observed. If restoration of the Whitefish Lake shoreline is to occur, primary focus should be placed on these shoreland areas as they currently provide little benefit to, and actually may harm, the lake ecosystem. Whitefish Lake Map 1 displays the location of these shoreline lengths around the entire lake.

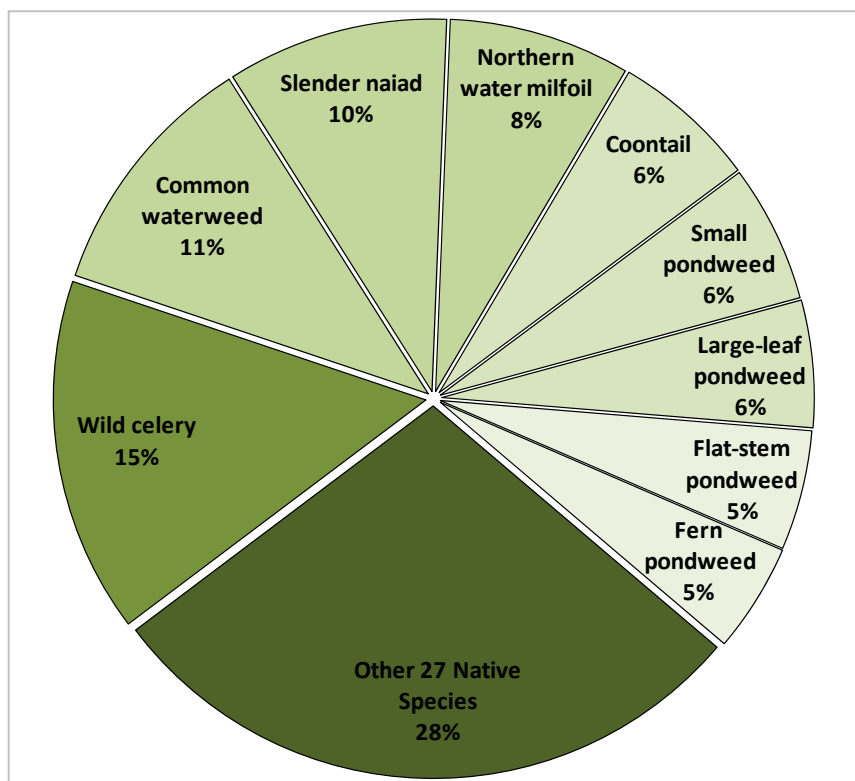
Figure 8.2.4-2 Whitefish Lake aquatic plant relative frequency of occurrence analysis.
Created using data from 2010 point-intercept survey.

As explained earlier in the Primer on Data Analysis and Data Interpretation Section, the littoral frequency of occurrence analysis allows for an understanding of how often each of the plants is located during the point-intercept survey. Because each sampling location may contain numerous plant species, relative frequency of occurrence is one tool to evaluate how often each plant species is found in relation to all other species found (composition of population). For instance, while wild celery was found at 56% of the sampling locations, its relative frequency of occurrence is 15%. Explained another way, if 100 plants were randomly sampled from Whitefish Lake, 15 of them would be wild celery. This distribution can be observed in Figure 8.2.4-2, where together nine species account for 72% of the population of plants within Whitefish Lake, and the other 27 species account for the remaining 28%. Thirteen additional species were found incidentally within the lake (not from of the point-intercept survey), and are indicated in Table 8.2.4-1 as incidentals.

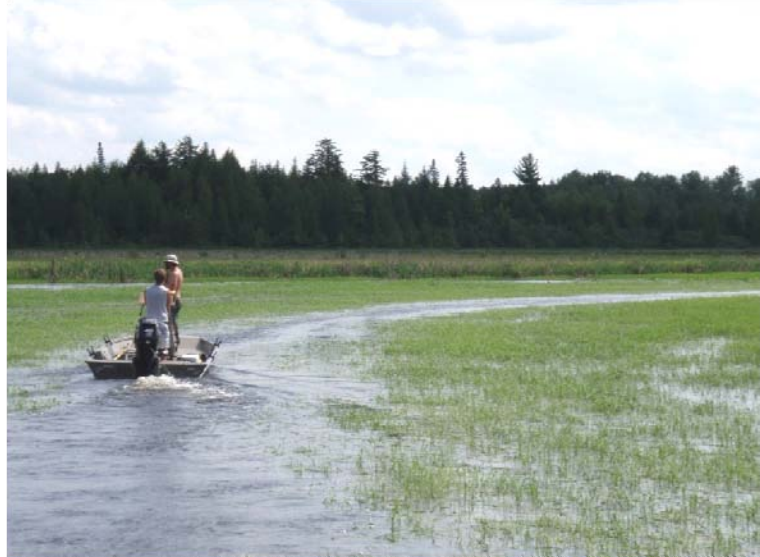
Photo 8.3.1 The Thoroughfare, Oneida County

Numerous emergent and floating-leaf aquatic plants observed during point-intercept survey, including wild rice, sedge species, cattails, white water lilies, spatterdock and watershield.

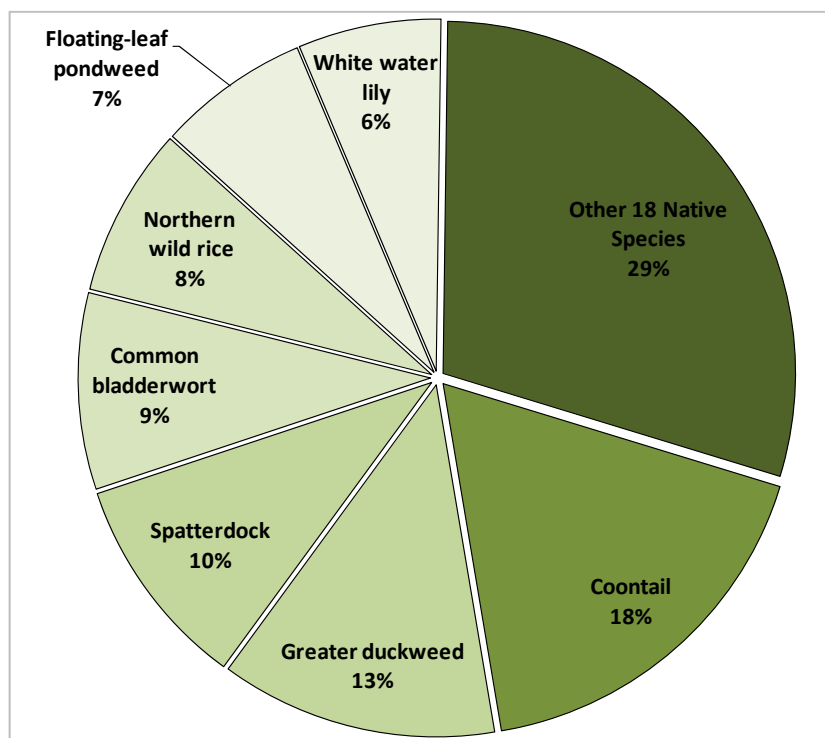
Figure 8.3.4-2 The Thoroughfare aquatic plant relative frequency of occurrence analysis. Created using data from 2010 point-intercept survey.

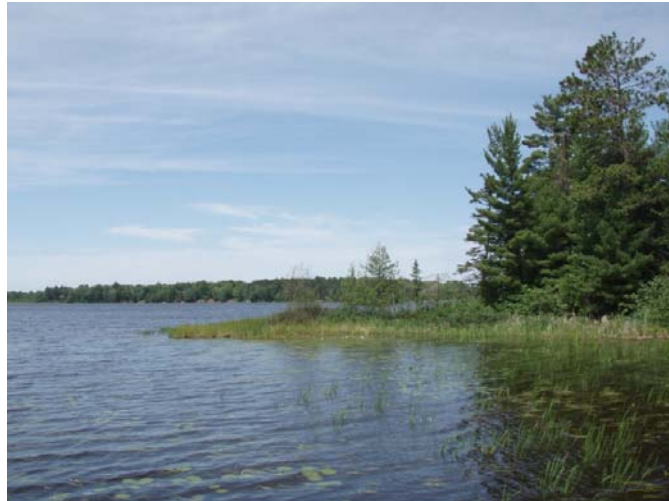
Photo 8.4.1 Big Lake, Oneida County

Purple loosestrife plant located along shoreline. Plant was hand-pulled entirely, location marked with GPS coordinates.

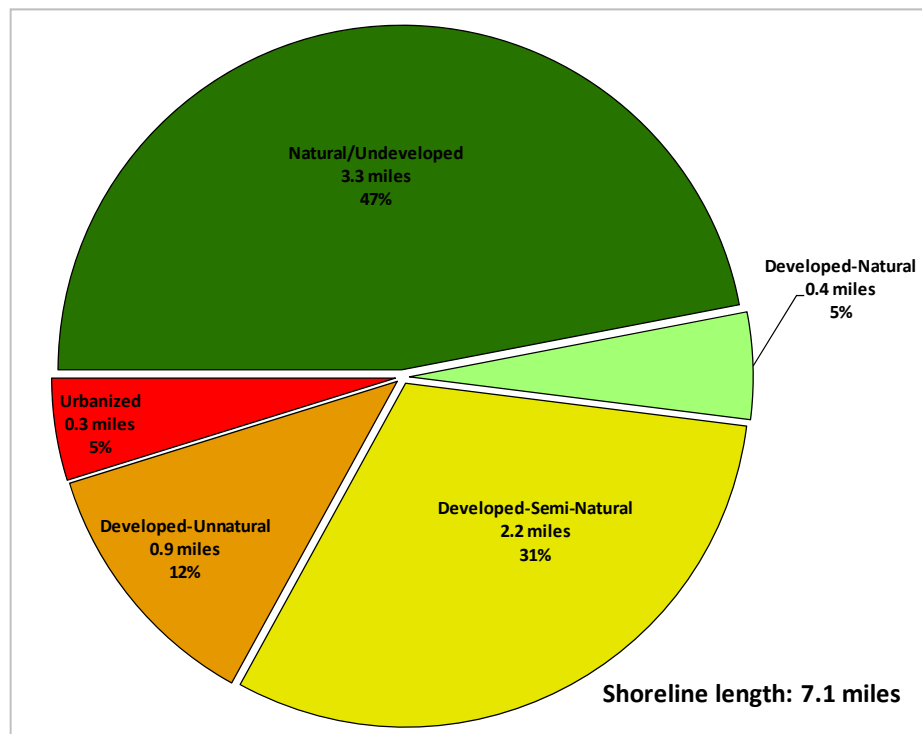
Figure 8.4.3-1. Big Lake shoreland categories and total lengths. Based upon a late summer 2010 survey. Locations of these categorized shorelands can be found on Big Lake Map 1.

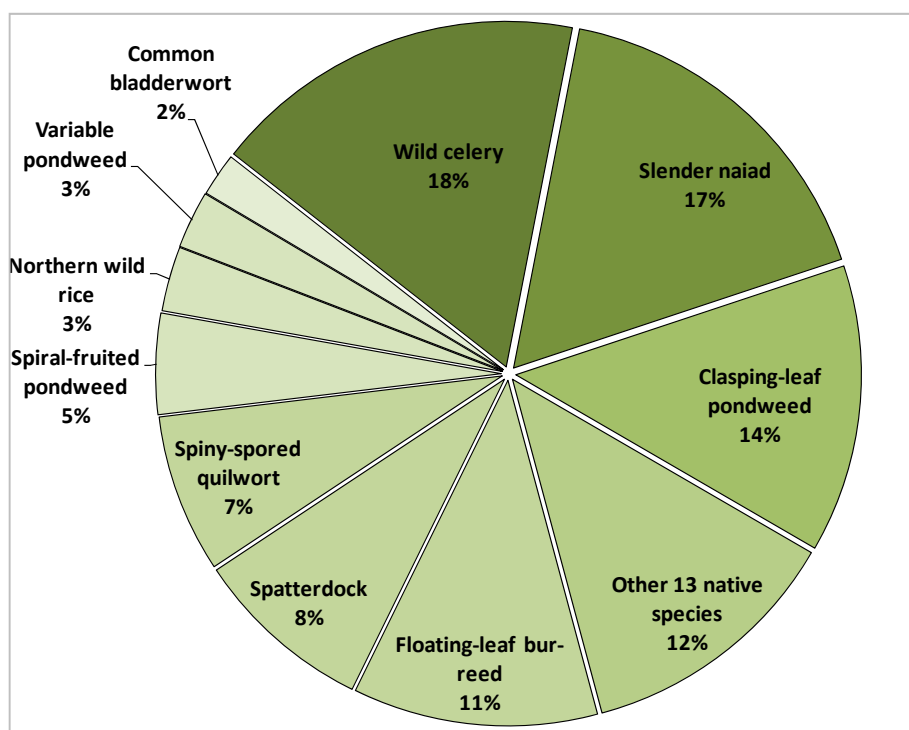
Figure 8.4.4-2 Big Lake aquatic plant relative frequency of occurrence analysis.
Created using data from 2010 point-intercept survey.

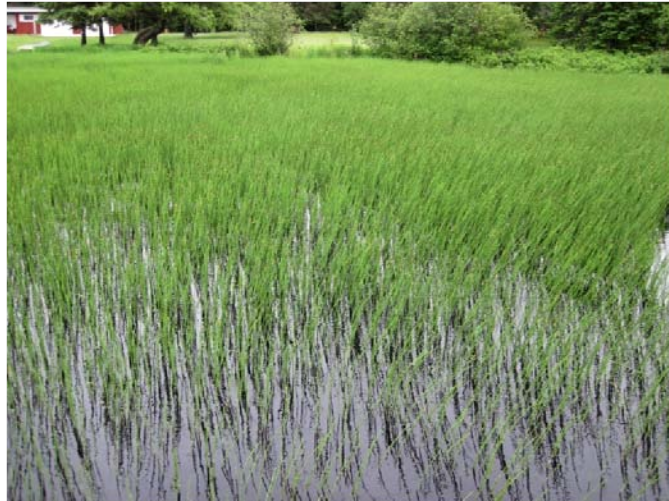
Photo 8.5.1 Dog Lake, Oneida County

Unusually large community of water horsetail (Equisetum fluviatile) encountered during aquatic plant surveys (pictured at right).

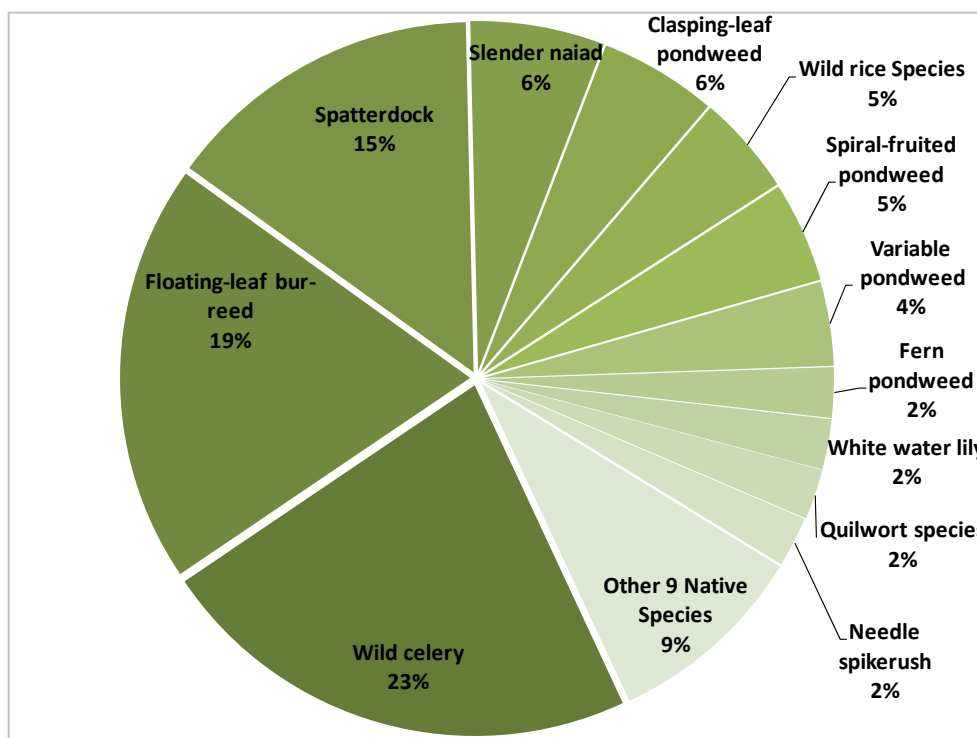
Figure 8.5.4-2 Dog Lake aquatic plant relative frequency of occurrence analysis.
Created using data from 2011 point-intercept survey.

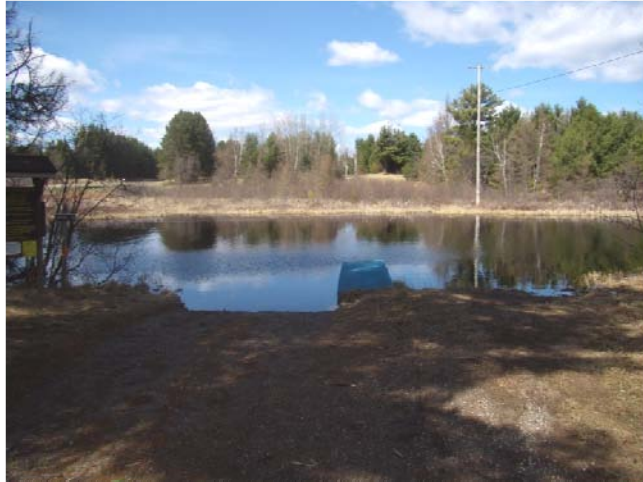
Photo 8.6.1 Crystal (Mud) Lake, Oneida County

A shallow, dark lake consisting primarily of mucky substrate. Few sampling locations held aquatic plants. No exotic aquatic plant species observed during 2011 field work.

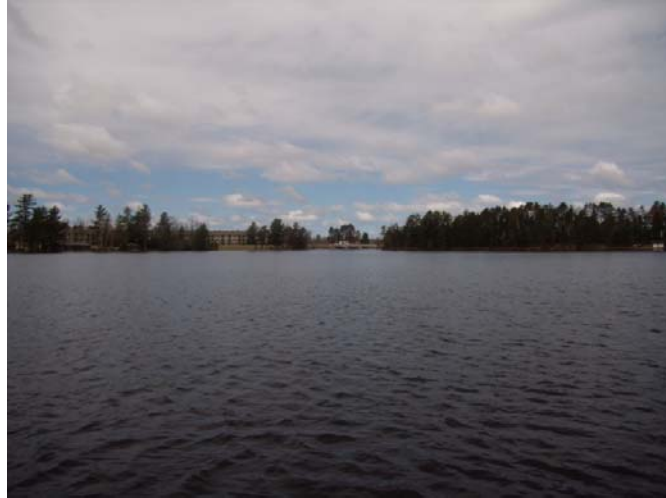
Photo 8.7.1 Deer Lake, Oneida County

Navigation tricky on west side of lake, where shallow water and thick floating-leaf aquatic plants were commonly encountered. Dark, stained water observed during surveys.

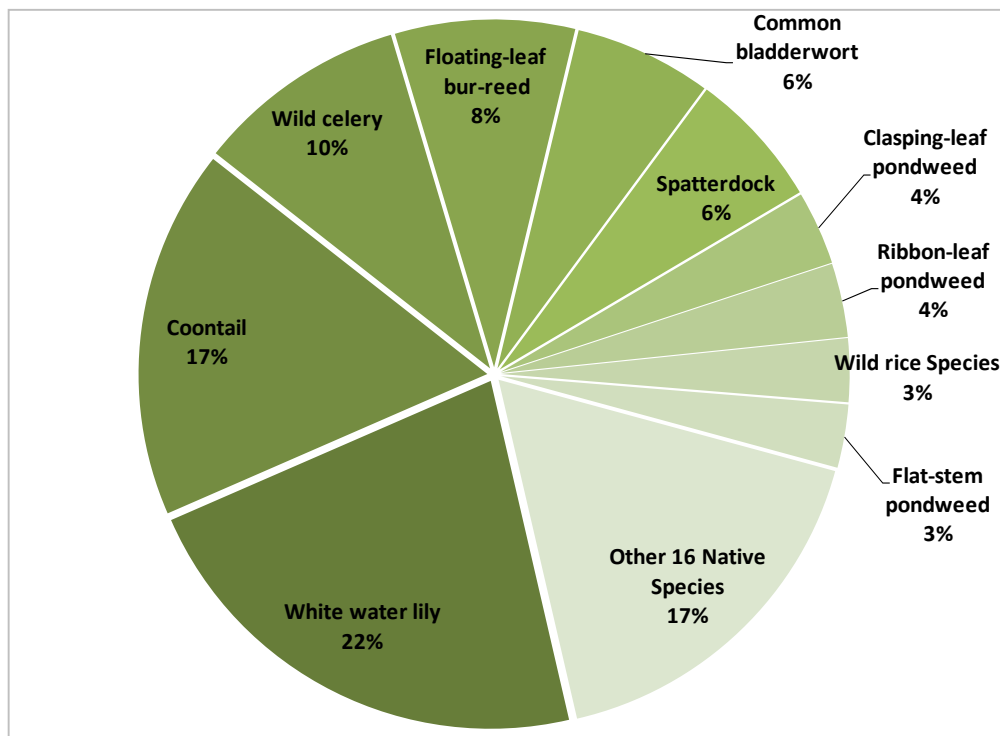
Figure 8.7.4-2 Deer Lake aquatic plant relative frequency of occurrence analysis.

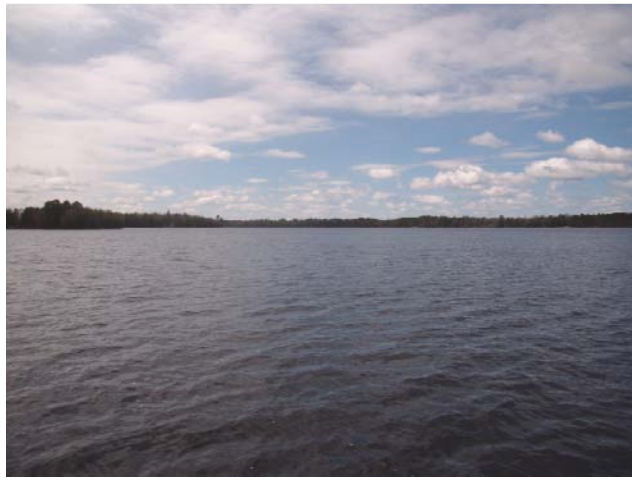
Photo 8.8.1 Big Stone Lake, Oneida County

Lake is quite deep. The littoral region is dominated by a sandy substrate. Primary plant species appears to be wild celery. Much unnatural shoreline observed during surveys.

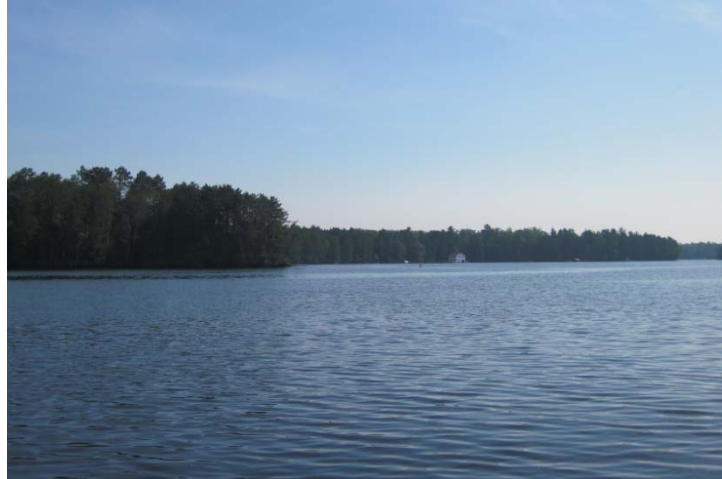
Photo 8.9.1 Laurel Lake, Oneida County

Many emergent and floating-leaf plants as well as islands located in north-eastern section of lake – very diverse habitat, great for wildlife!

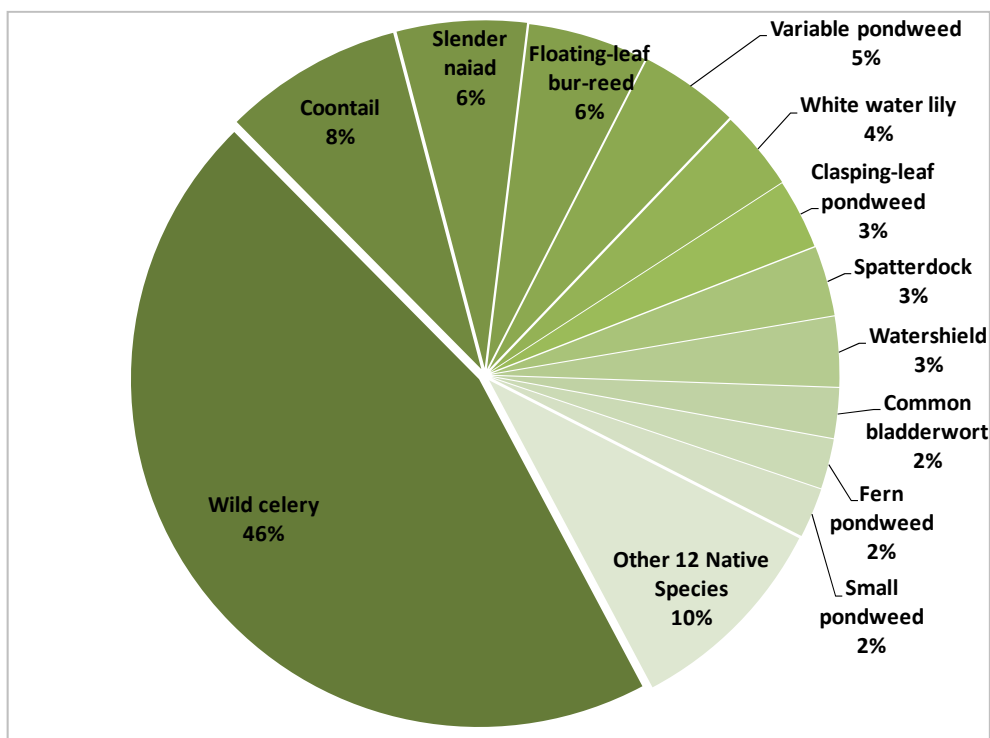
Figure 8.9.4-2 Laurel Lake aquatic plant relative frequency of occurrence analysis.
Created using data from 2011 point-intercept survey.

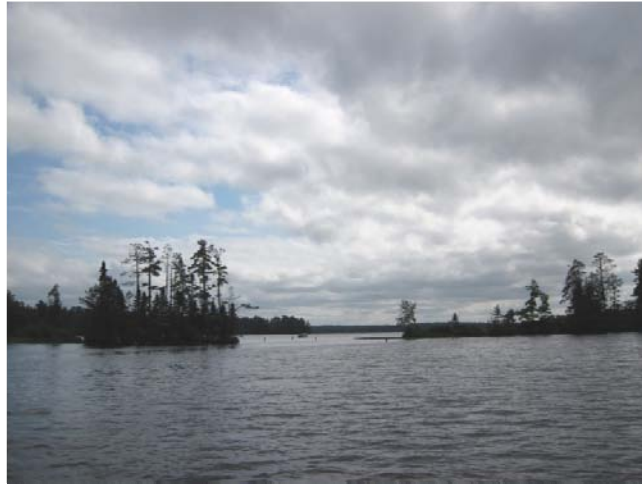
Photo 8.10.1-1 Fourmile Lake, Oneida County

Abundant wild rice observed during aquatic plant surveys. Lake has much natural shoreline surrounding it – great wildlife habitat! Pale yellow iris spotted several times during the early season AIS survey.

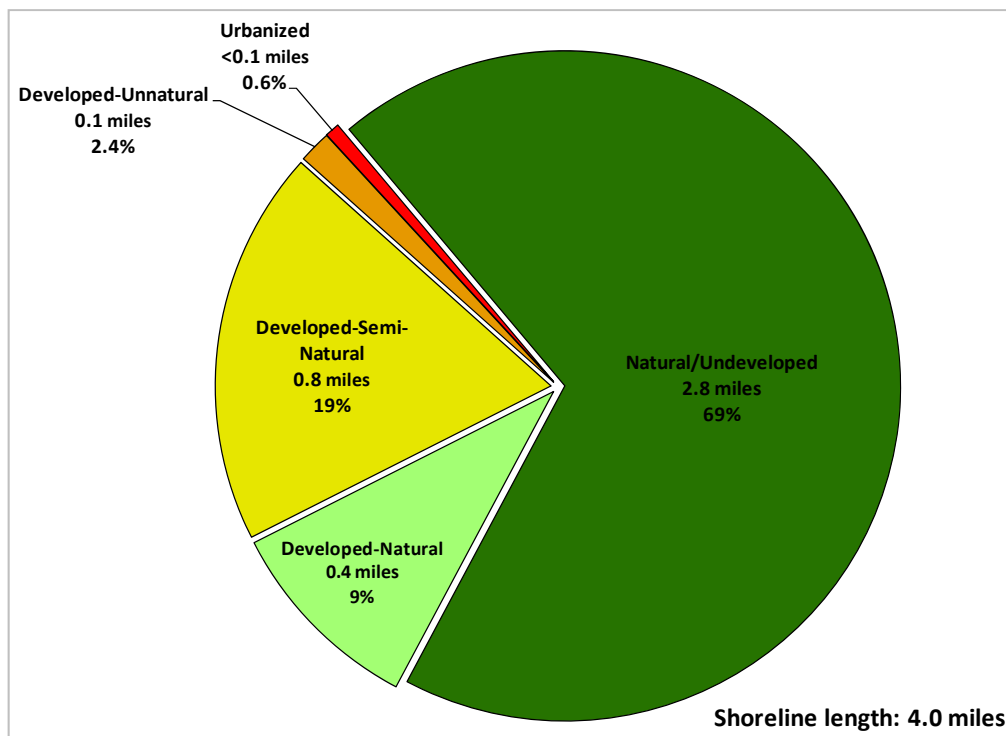
Figure 8.10.2-1. Fourmile Lake shoreland categories and total lengths. Based upon a late summer 2012 survey. Locations of these categorized shorelands can be found on the Fourmile Lake Shoreline Condition Map.

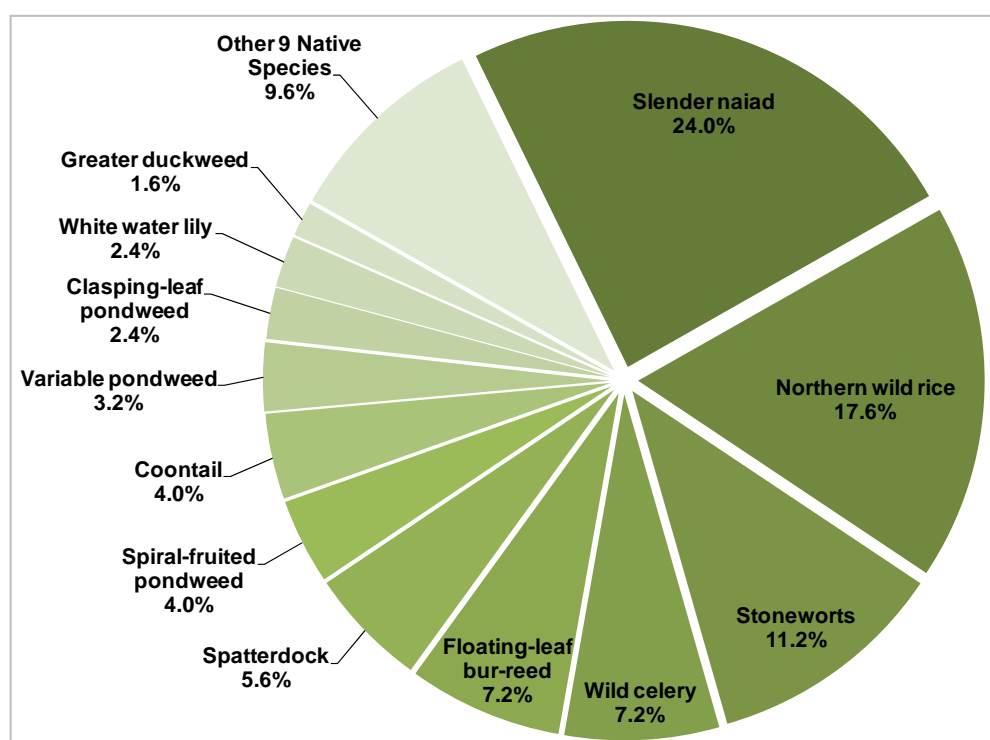
Figure 8.10.4-2 Fourmile Lake aquatic plant relative frequency of occurrence analysis.
Created using data from 2012 point-intercept survey.

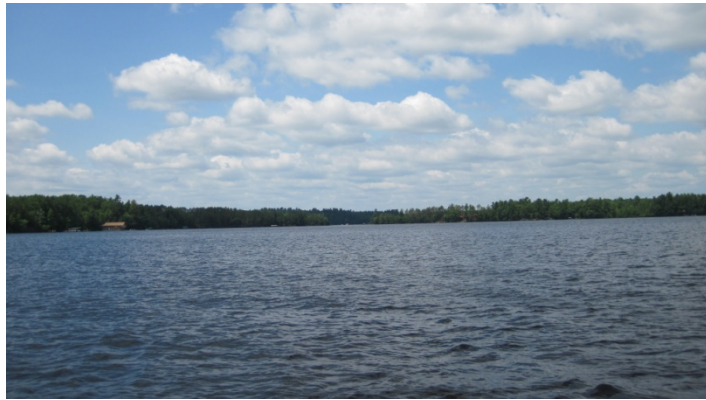
Photo 8.11.1-1 Big Fork Lake, Oneida County

A fair amount of development observed on the lake. Vasey's pondweed found in two point-intercept locations. Shoreline was dotted with much pale yellow iris during early-season AIS survey.

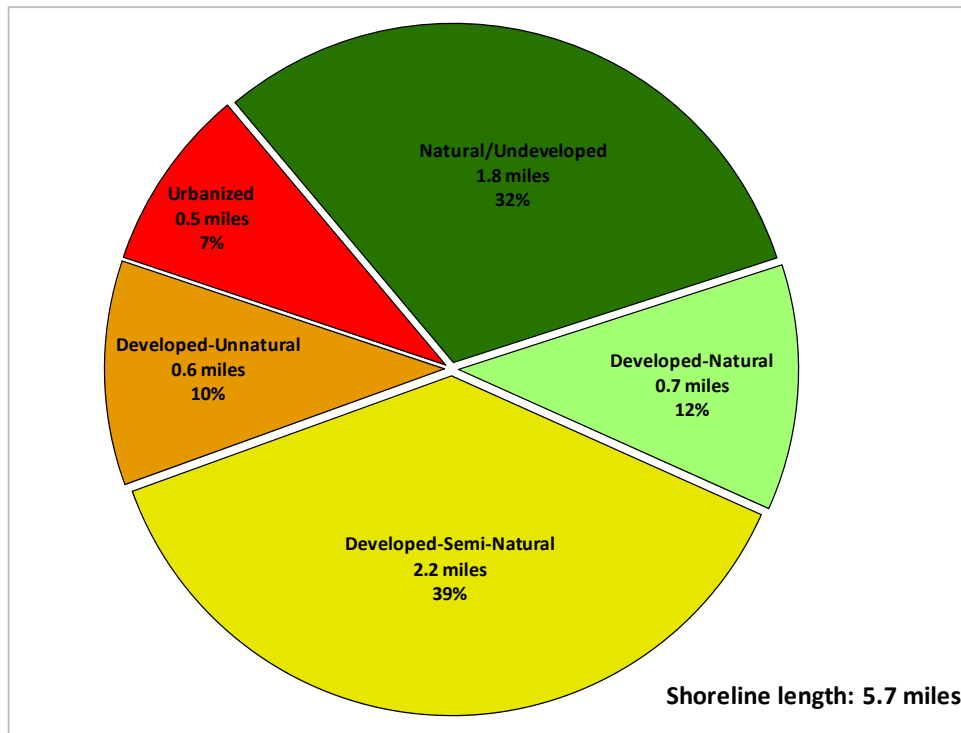
Figure 8.11.2-1. Big Fork Lake shoreland categories and total lengths. Based upon a late summer 2012 survey. Locations of these categorized shorelands can be found on the Big Fork Lake Shoreline Condition Map.

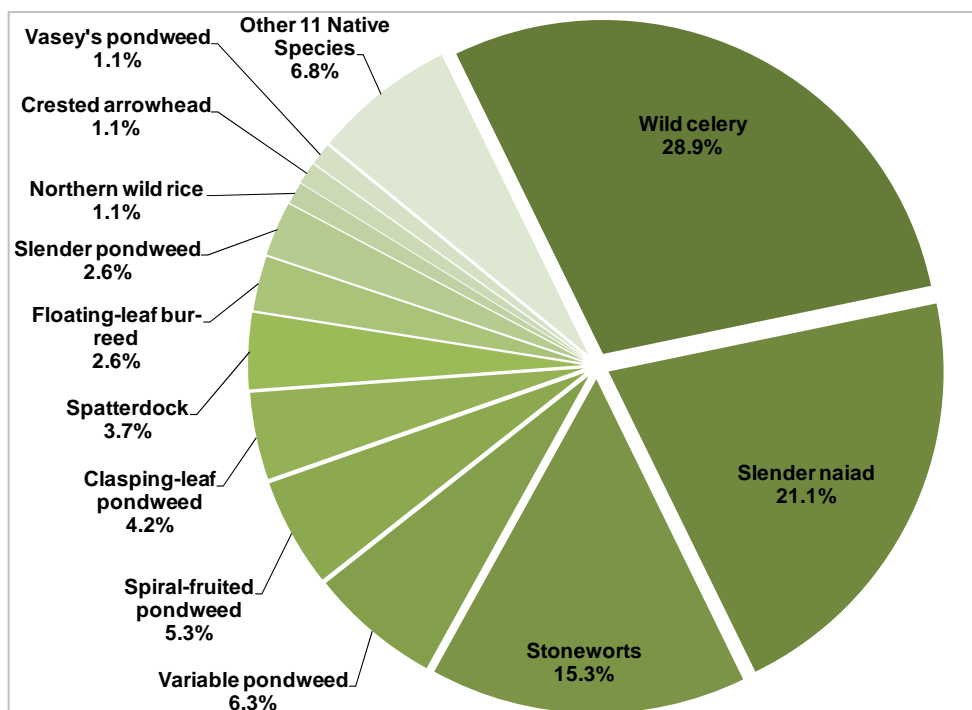
Figure 8.11.4-2 Big Fork Lake aquatic plant relative frequency of occurrence analysis.
Created using data from 2012 point-intercept survey.
