Lake Management Plan for the Pike Lake Chain of Lakes Price and Vilas Counties, Wisconsin

[Pike Lake Chain includes Pike Lake, Round Lake,
Amik Lake, and Turner Lake]

2012

Prepared by Steve McComas, Blue Water Science
with significant contributions from the Pike Lake Chain of Lakes
Association, and Wisconsin Department of Natural Resources

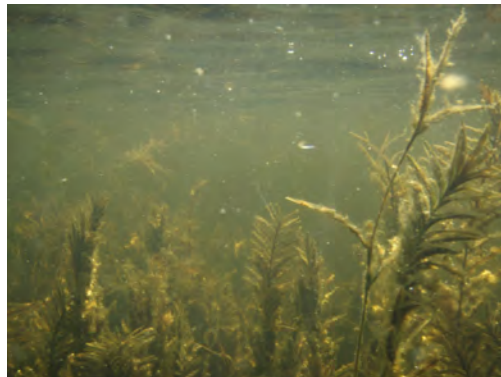
Fern Pondweed (dominant in Amik)

Plant assemblages (groups of plant species) were similar for Pike and Round Lakes and water celery was the most common plant. Amik and Turner Lakes had different dominant plants which likely reflects different bottom conditions and shallower depths. The dominant plant in Amik was fern pondweed and the dominant plant in Turner was elodea.

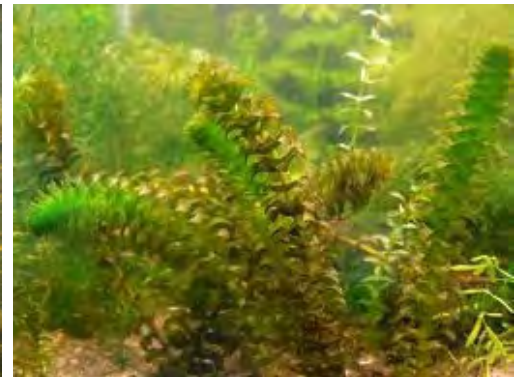
Elodea (dominant in Turner)

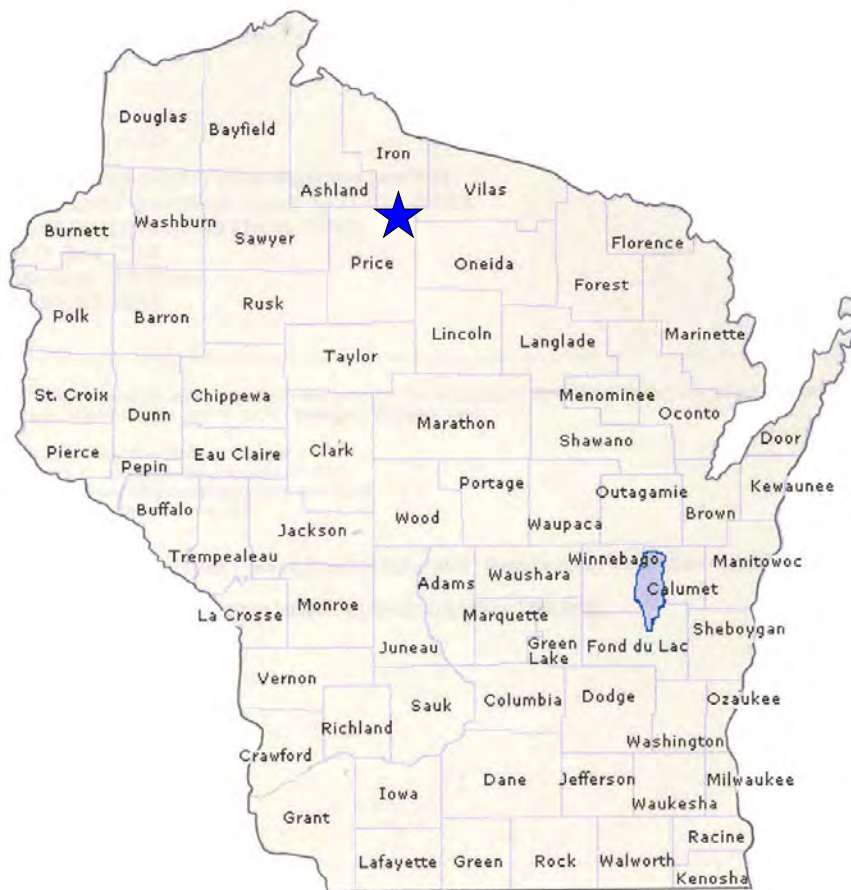
Figure 1. Pike, Round, and Amik and Turner Lakes are located in Price and Vilas Counties, Wisconsin.

The Pike Lake Chain of Lakes is located in Price and Vilas Counties, Wisconsin (Figure 1). Lake sizes and depths are shown in Table 1.

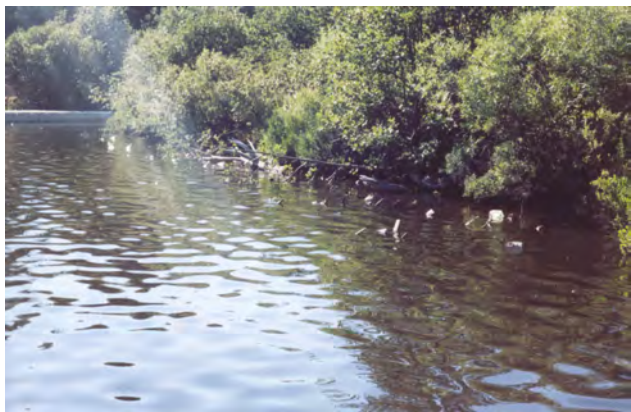
Figure 2a. Discarded wooded slabs from the sawmill operation are still found in a southern bay of Pike Lake.

1921-28: Steam-powered sawmill processes all types of timber. Located in bay on the southwest shore of Pike Lake.

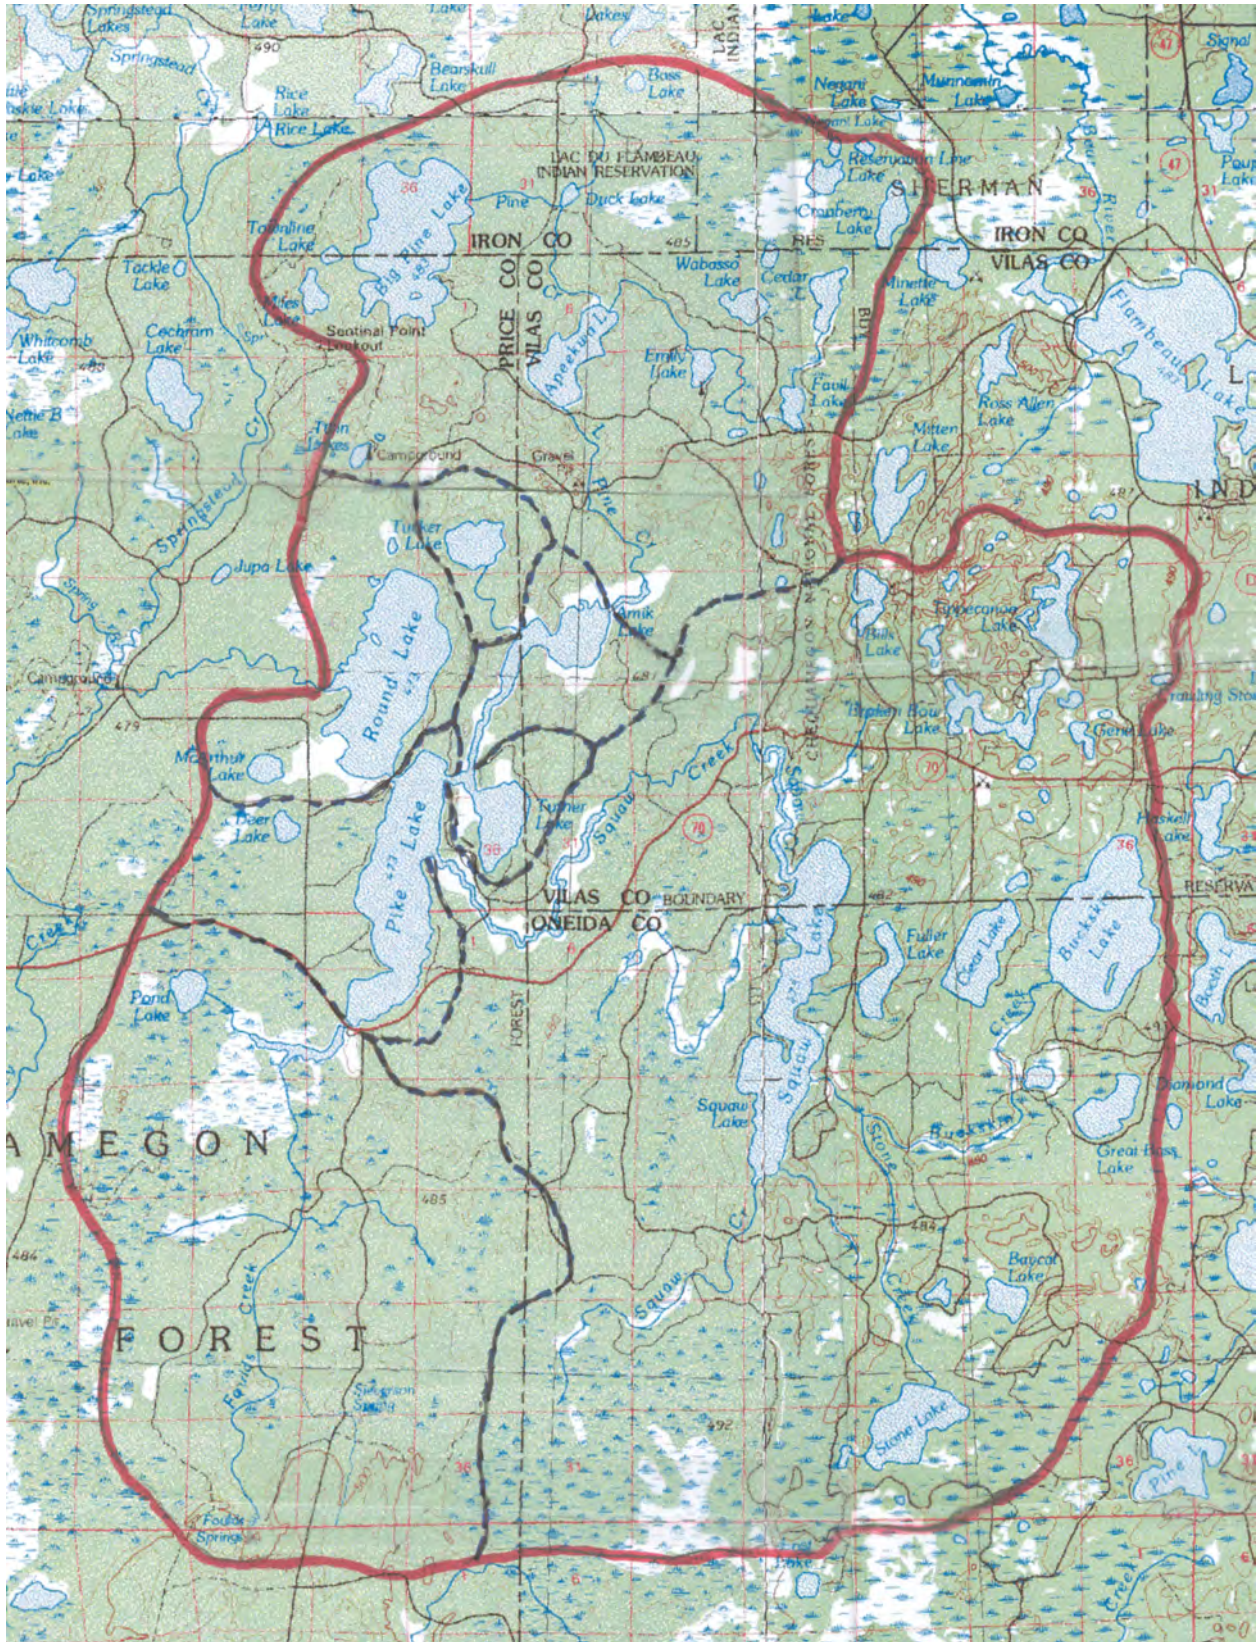
Figure 3. Watershed delineation for Pike, Round, Amik, and Turner Lakes.

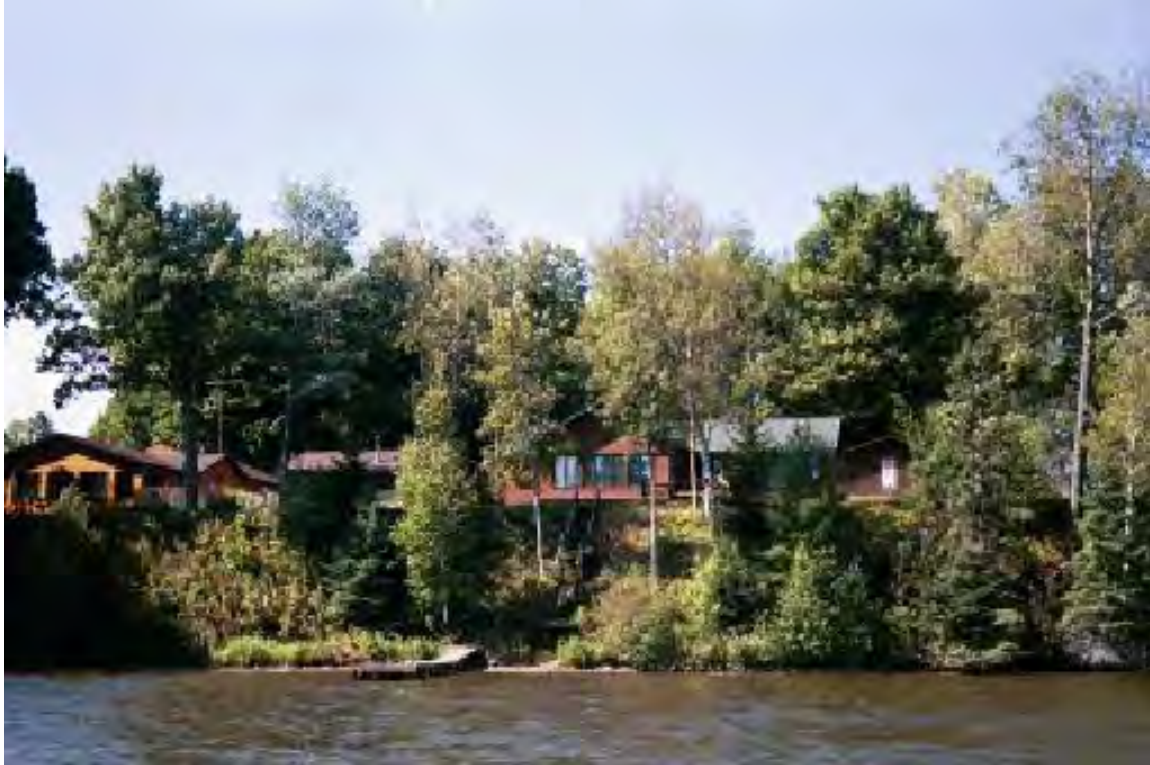
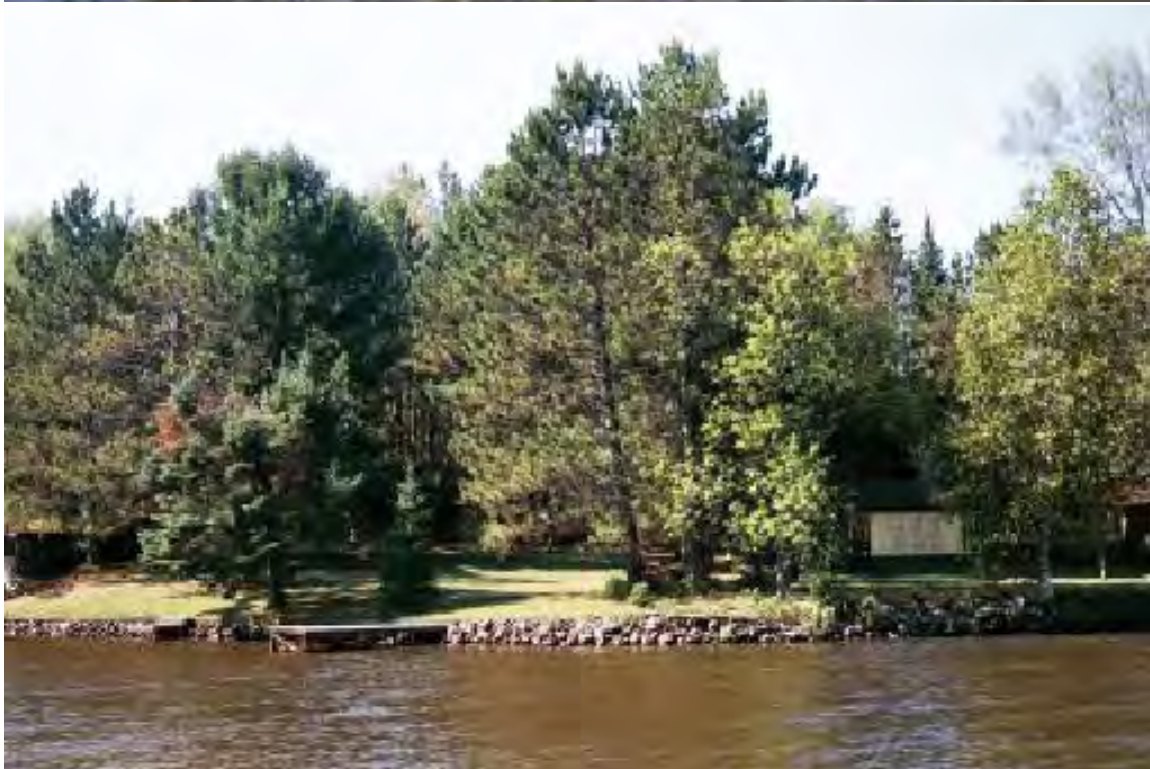
Figure 5. [top] This parcel would rate as having a shoreline with a buffer greater than 50% of the lot width and an understory with greater than 50% natural cover. [bottom] This parcel would not qualify as having a natural shoreline buffer greater than 50% of the lot width. Also, understory in the upland area would be rated as having less than 50% natural cover.

For each photograph, the shoreline and the upland condition were evaluated. Examples of shoreland conditions are shown in Figure 5. The criteria for natural conditions were the presence of 50% native vegetation in the understory and at least 50% natural vegetation along the shoreline in a strip at least 15 feet deep. Although buffer strips 25 feet deep have been recommended since 2000, when the first shoreline surveys were conducted by Blue Water Science in the 1990's, a 15-foot buffer strip was acceptable and offered some nutrient reduction benefits. The 15-foot buffer strip was used in the Pike Chain inventory so results could be compared to other inventories. Shorelands were evaluated at the 75% natural level as well.

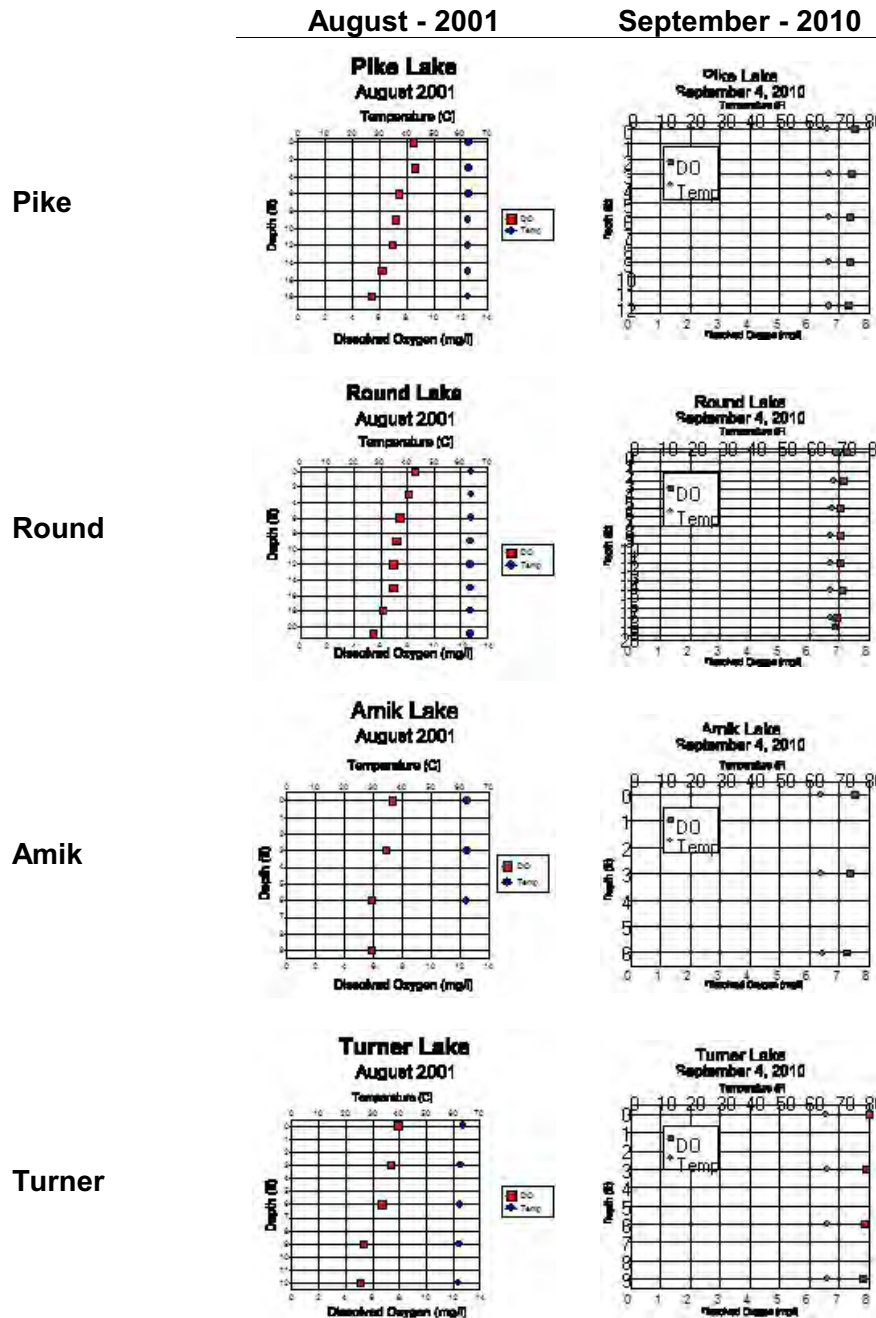
Figure 9. Dissolved oxygen/temperature profiles for Pike, Round, and Amik and Turner Lakes.

Winter oxygen levels can be low in the bottom water of all four lakes. However oxygen is present in the upper water column. In summer, the lakes are well mixed and oxygen is present throughout the summer.

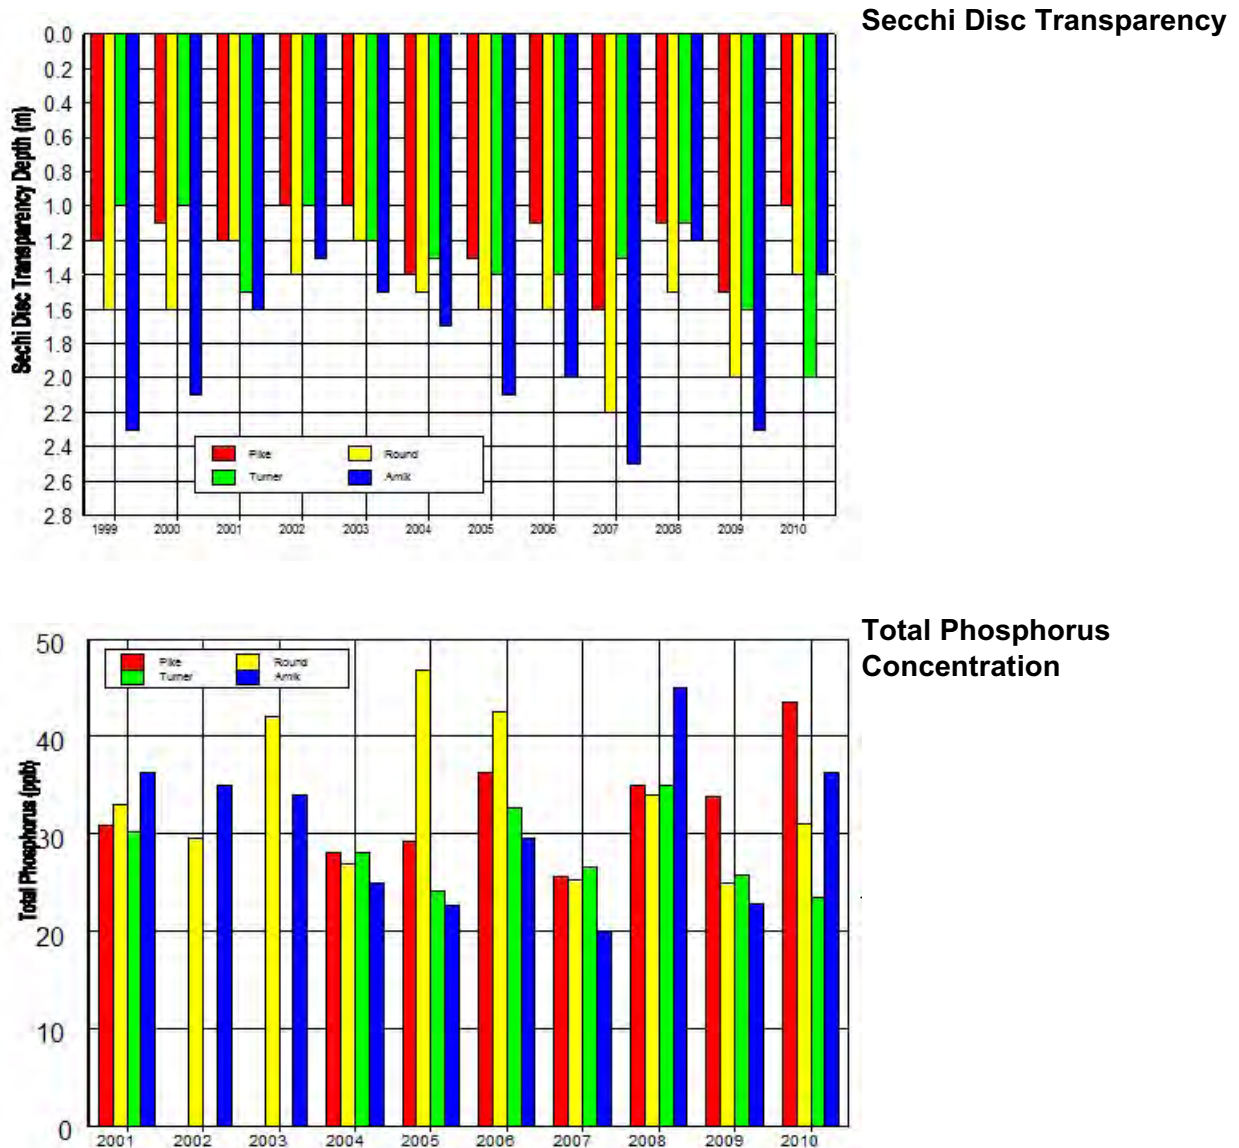
Figure 10. Secchi disc transparency (meters) and total phosphorus (ppb) from 1999 through 2010.

A summary of Secchi disc transparencies and total phosphorus concentrations collected from 1999 through 2010 are shown in Figure 10.

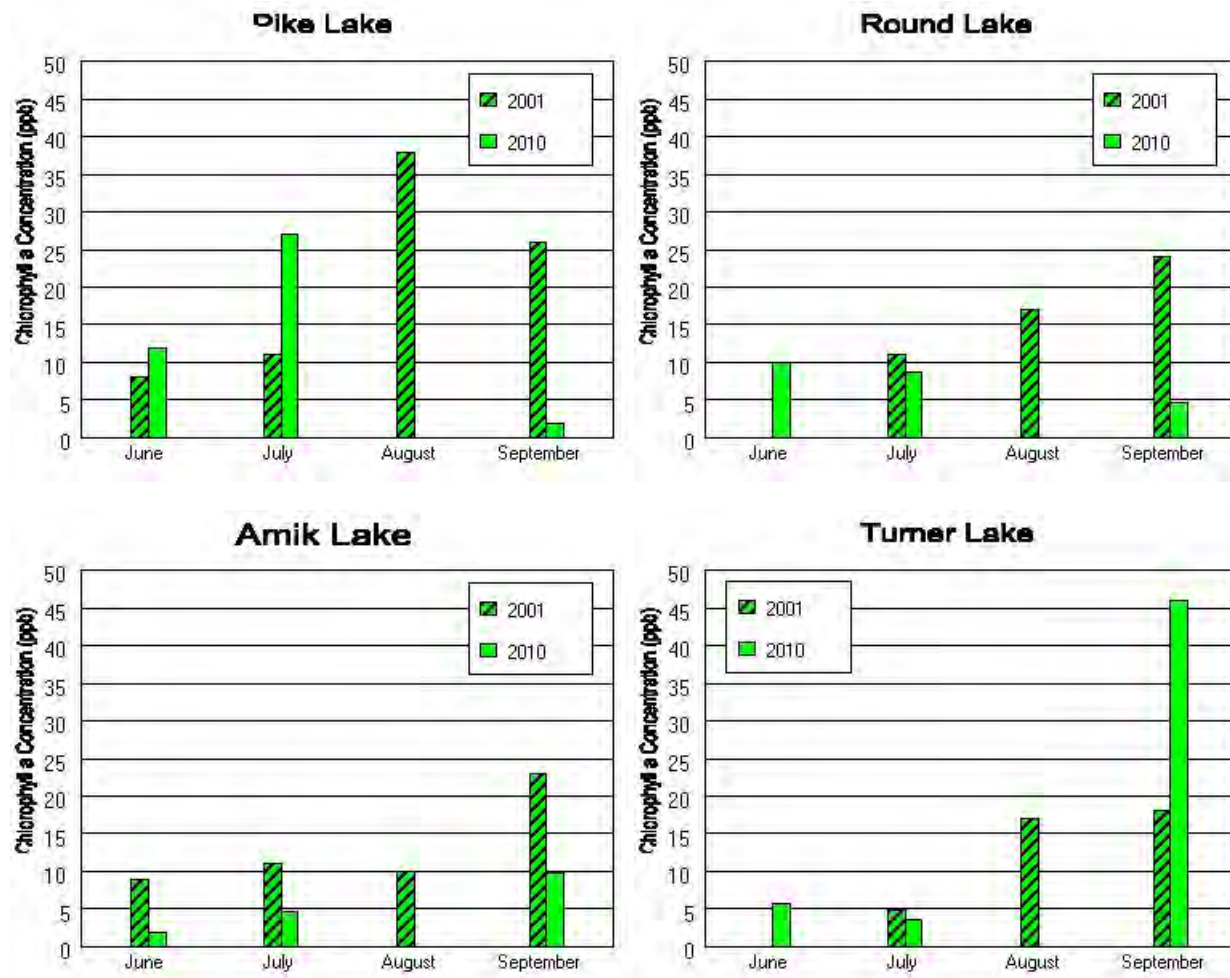
Figure 13. Chlorophyll concentrations for June, July, August, and September 2001 and 2010.

Results of chlorophyll testing for the summer of 2001 and 2010 are shown in Figure 13 and Table 18. There is a fair amount of variability from 2001 to 2010 and from lake to lake.

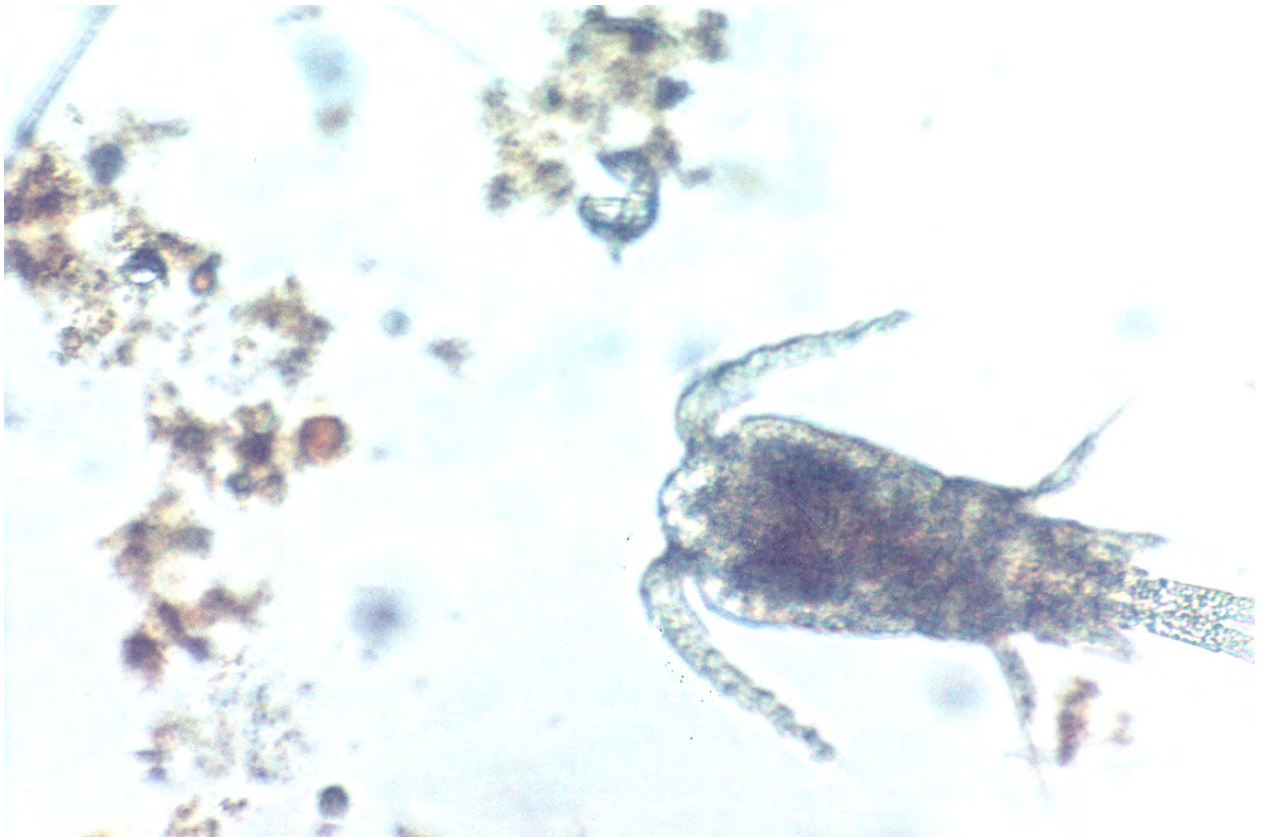
Figure 15. Example of a zooplankton species from Turner Lake, July 2001.

Zooplankton are important in lakes. They graze on algae. If the algae population is composed of small algae cells, these are edible by zooplankton, and this grazing action can actually keep the lake relatively clear. The zooplankton community is composed of species of daphnia and copepods in the four lakes (Figure 15). The zooplankton communities are typical of lakes in this region.

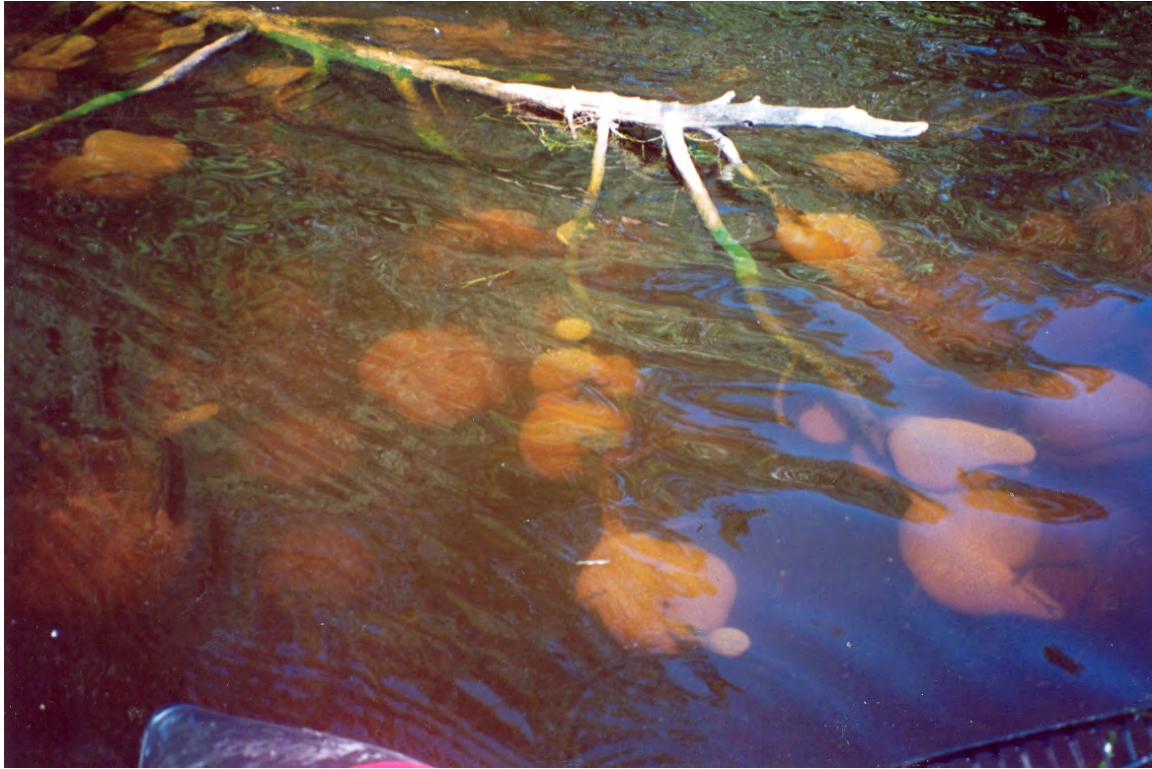
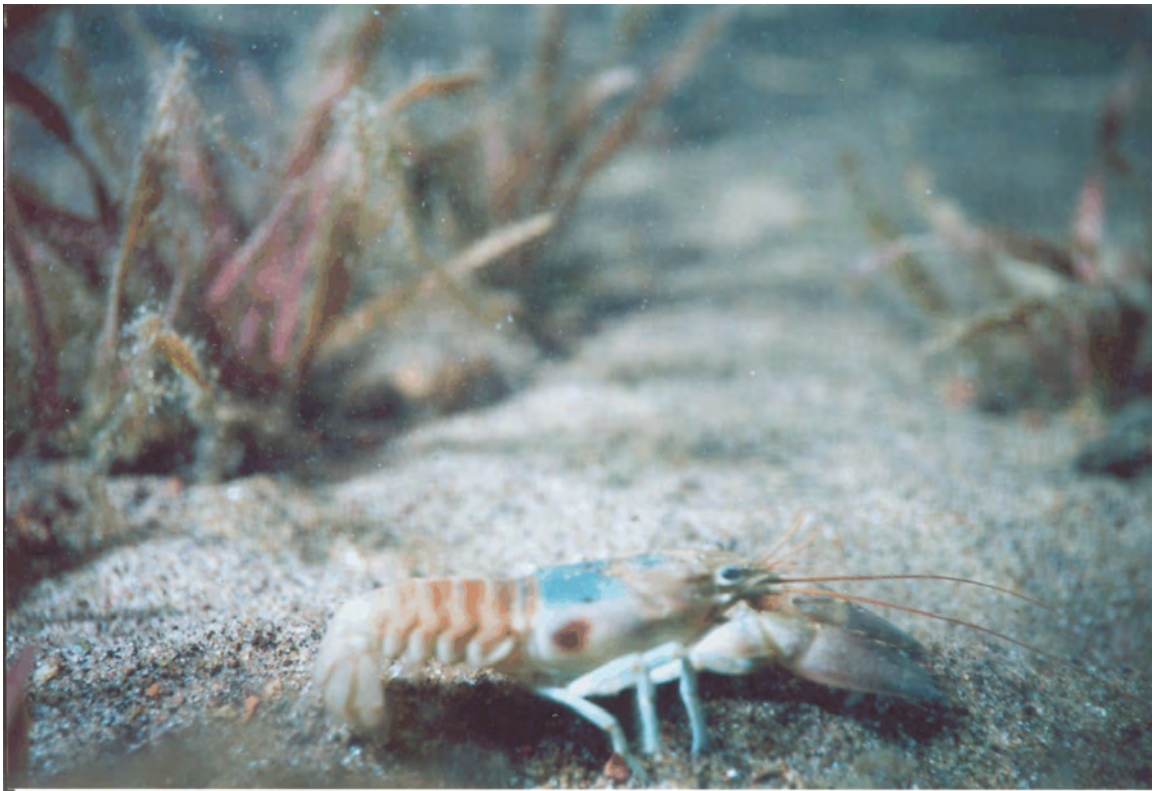
Figure 16. [top] Bryozoan colonies found in Amik Lake, August 4, 2001. [bottom] Rusty crayfish like the one shown above have been found in Pike Lake.

However, there are a couple of invertebrates surprises. In Amik Lake, a colony of bryozoans is present. They are attached to tree branches and can grow to the size of a basketball, but a cantaloupe size is more common in Amik (Figure 16).

There is also a report of rusty crayfish in Pike Lake. They are regional exotics and not desirable for a lake. They can decimate plant beds. They will be monitored in the future as one of the lake management recommendations.

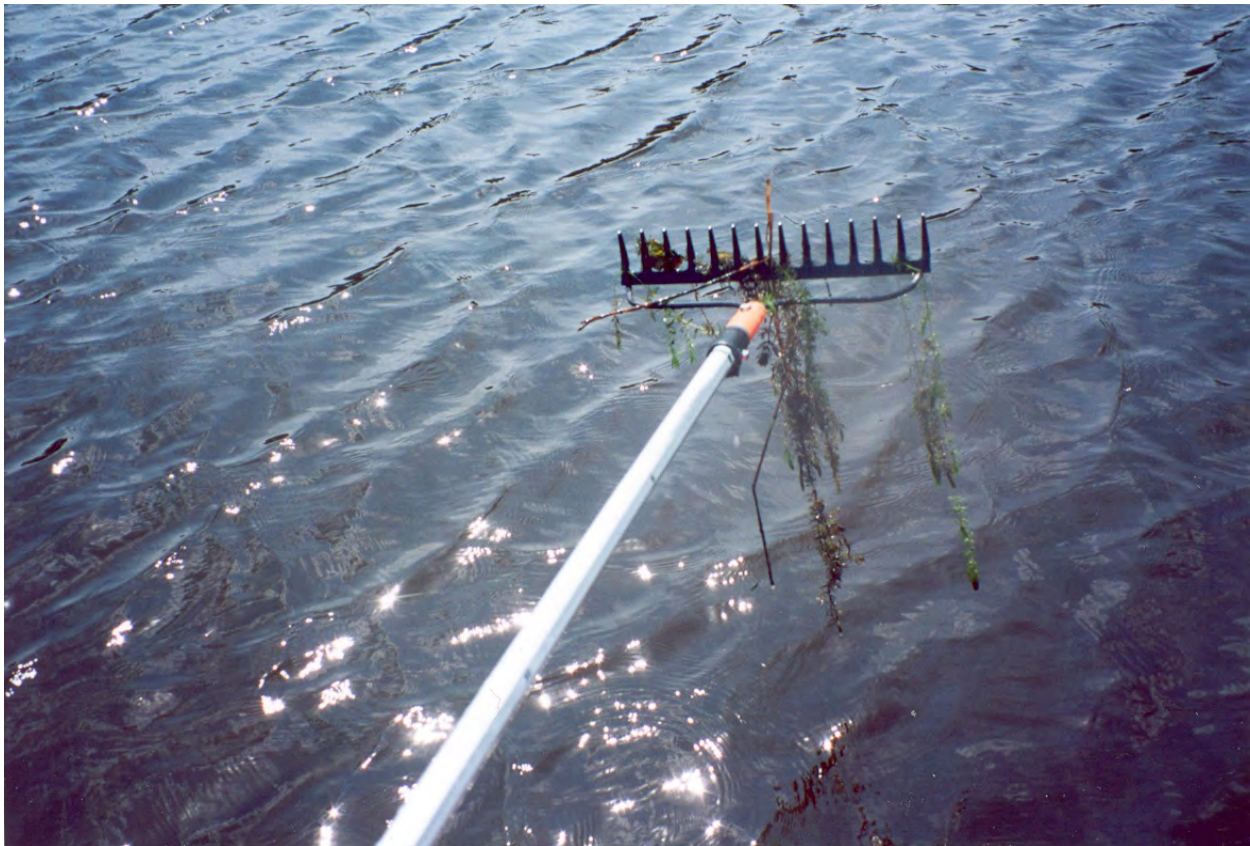
Figure 17. Coontail, a native, non-rooted plant was found in low densities in Pike Lake, June 2001, but found in high densities in Amik Lake.

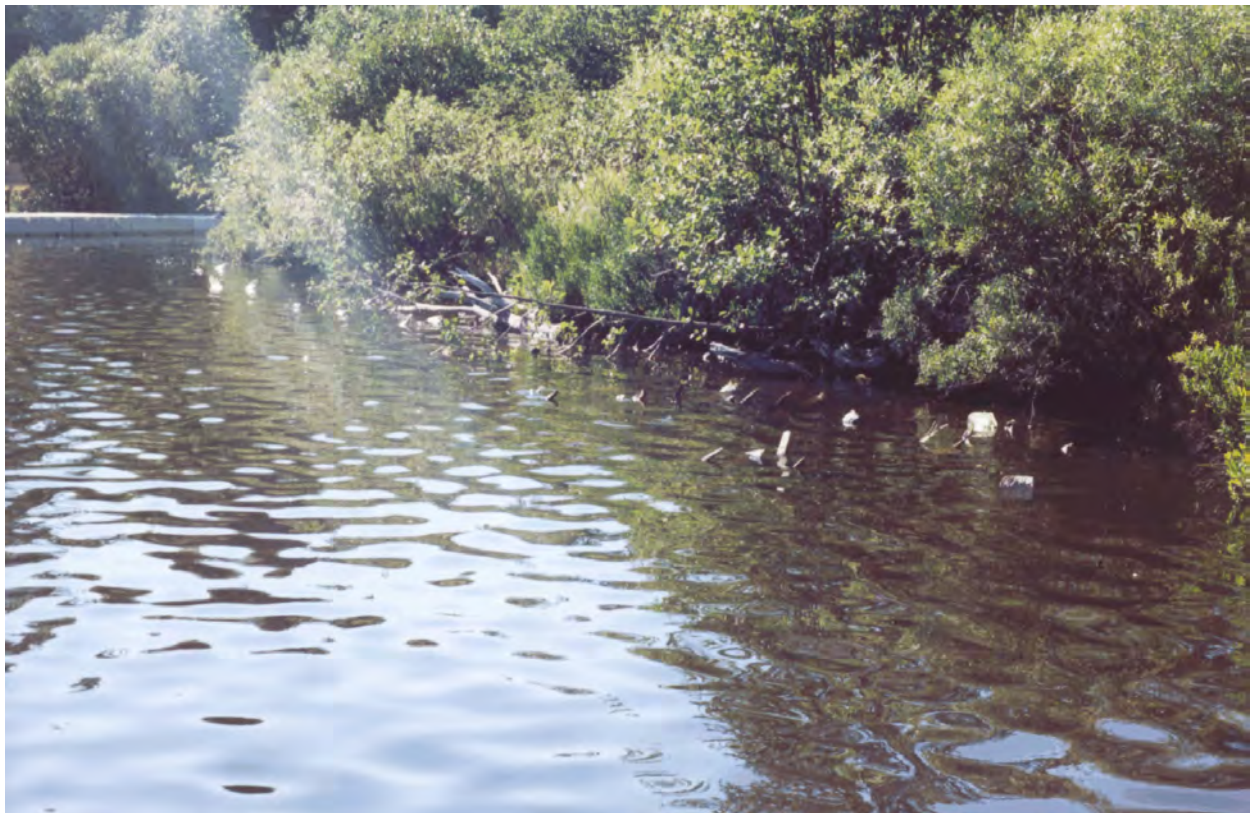
Figure 18. Discarded wooded slabs from the sawmill operation are still found in a southern bay of Pike Lake.

A unique feature of Pike Lake is the bottom covering of wooden slabs in the north shore of the southern bay. They were discarded into the bay during the sawmill operation. No aquatic plants were found in this area (Figure 20), but they offer some habitat for fish and invertebrates.

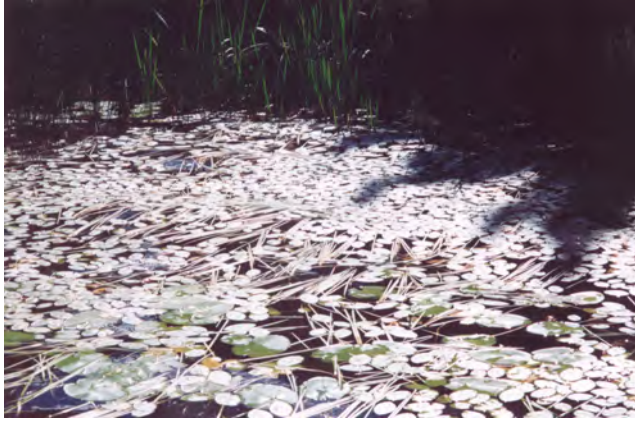
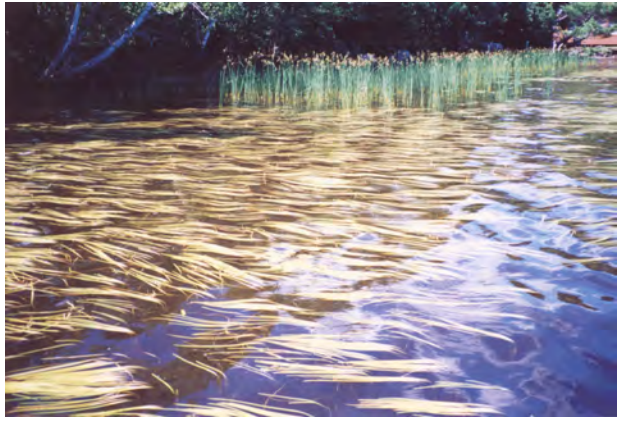
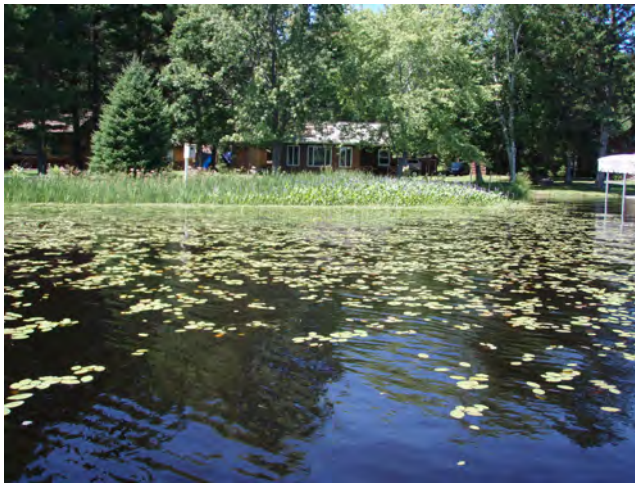
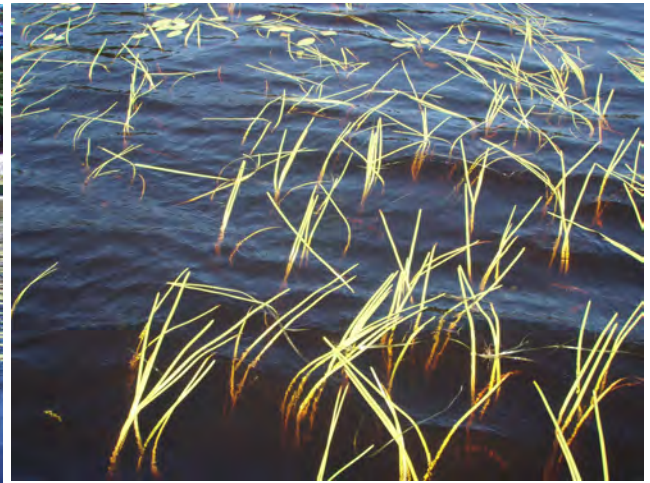
Figure 19. [top photos] Examples of floatingleaf plants in Pike Lake consisting of watershield and Sparganium on July 26, 2001. [bottom photos] Aquatic plants on July 15, 2010.

Pike Lake Aquatic Plants: Pike Lake has a lot of different aquatic plant species; it's just that they only grow in shallow water (in water less than 6 feet deep). Water celery and naiads were the most common species (summarized in Table 21). Floatingleaf species were present and very pretty in the areas that they colonized (Figure 19).

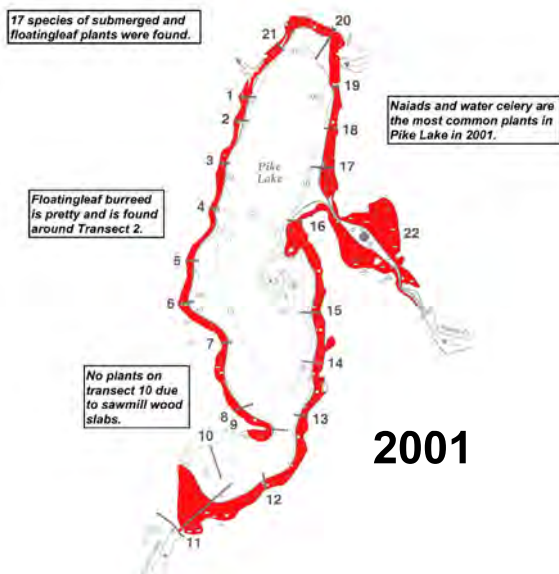
Figure 20. Pike Lake aquatic plant maps based on surveys conducted by Blue Water Science. [top] Aquatic plant distribution in 2010 is shown with green circles. [bottom] Aquatic plant distribution in 2001 is shown with red shading.

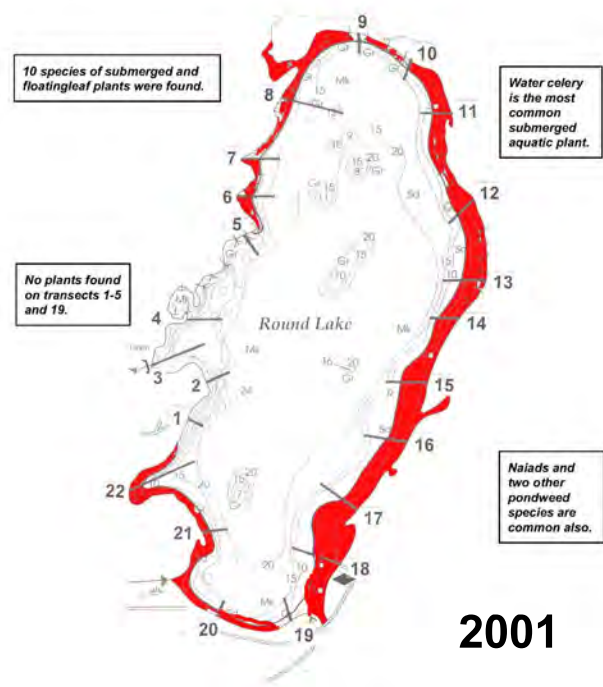
Figure 22. Round Lake aquatic plant map based on surveys conducted by Blue Water Science. [top] Aquatic plant distribution in 2010 is shown with green circles. [bottom] Aquatic plant distribution in 2001 is shown with red shading.

Plants only grew out to a depth of six feet. Plant coverage is shown in Figure 22.

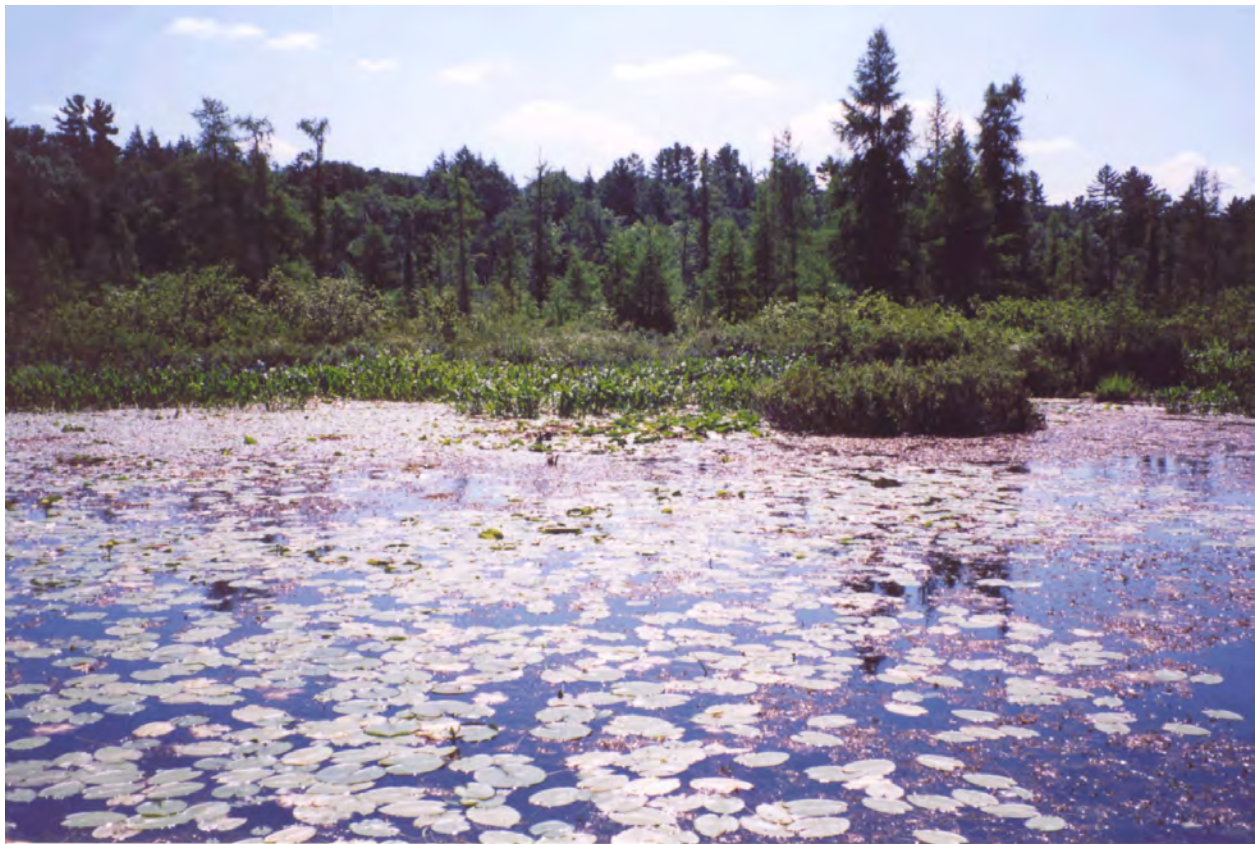
Figure 23. Nearshore growth of aquatic vegetation in Amik Lake, July 2001.

Amik Lake Aquatic Plants: Amik Lake has a diverse plant community with 14 species of floatingleaf and submerged plants. In 2010, fern pondweed was the most common species followed by a half dozen other species. Amik Lake is shallow and plant growth was found throughout most of the lake in 2010, but generally scattered. Plant growth is robust along the nearshore areas (Figure 23).

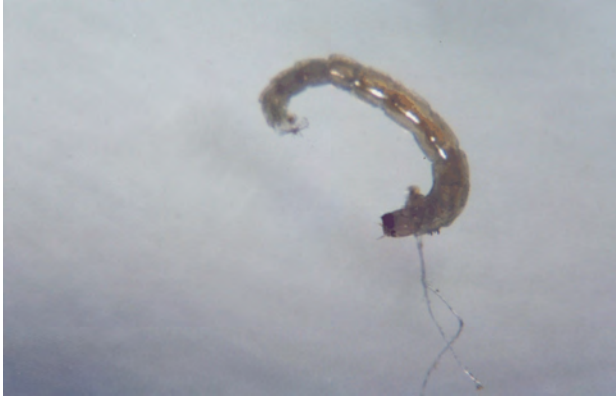
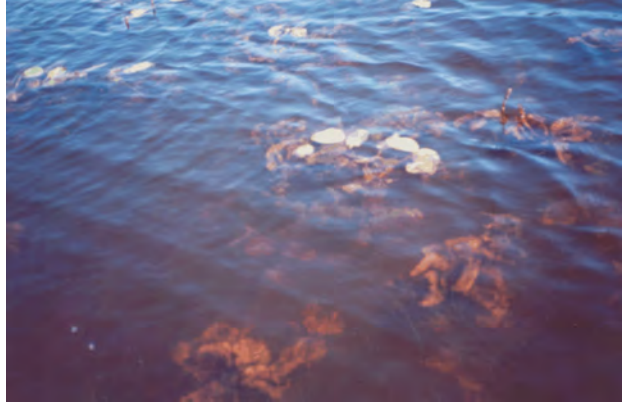
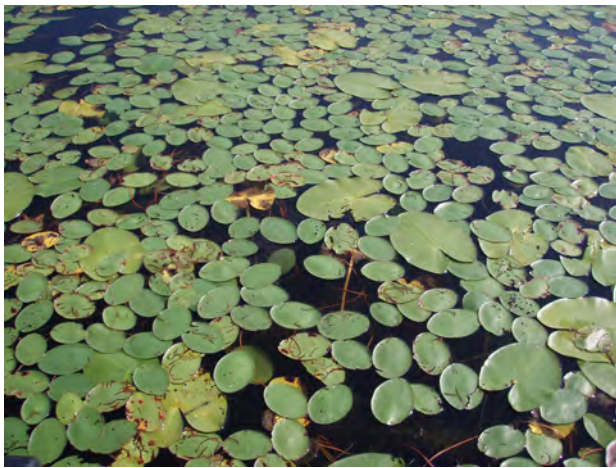
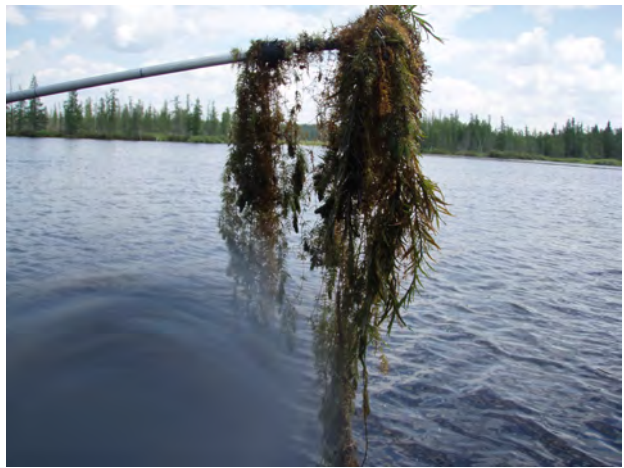
Figure 24. [top-left] This chironomid species was found on the underside of cabbage leaves in Amik Lake in 2001.

[top-left] At the time of the plant survey on July 26, 2001, much of the cabbage community was found scattered and not at nuisance densities.

An interesting plant species in Amik Lake is cabbage (*Potamogeton amplifolius*). In 2000 it was reported to cover almost the entire lake basin. However, in 2001, cabbage was present, but scattered. It had the appearance of a “die-back”. Upon inspection of leaves and stems, we found that aquatic insect larvae were apparently feeding on the leaves and stems of the cabbage probably causing the “die-back”. Its possible this insect could be responsible for controlling the excessive growth of cabbage (Figure 24).

In 2010, cabbage was common, but the dominant plant was fern pondweed (Figure 24).

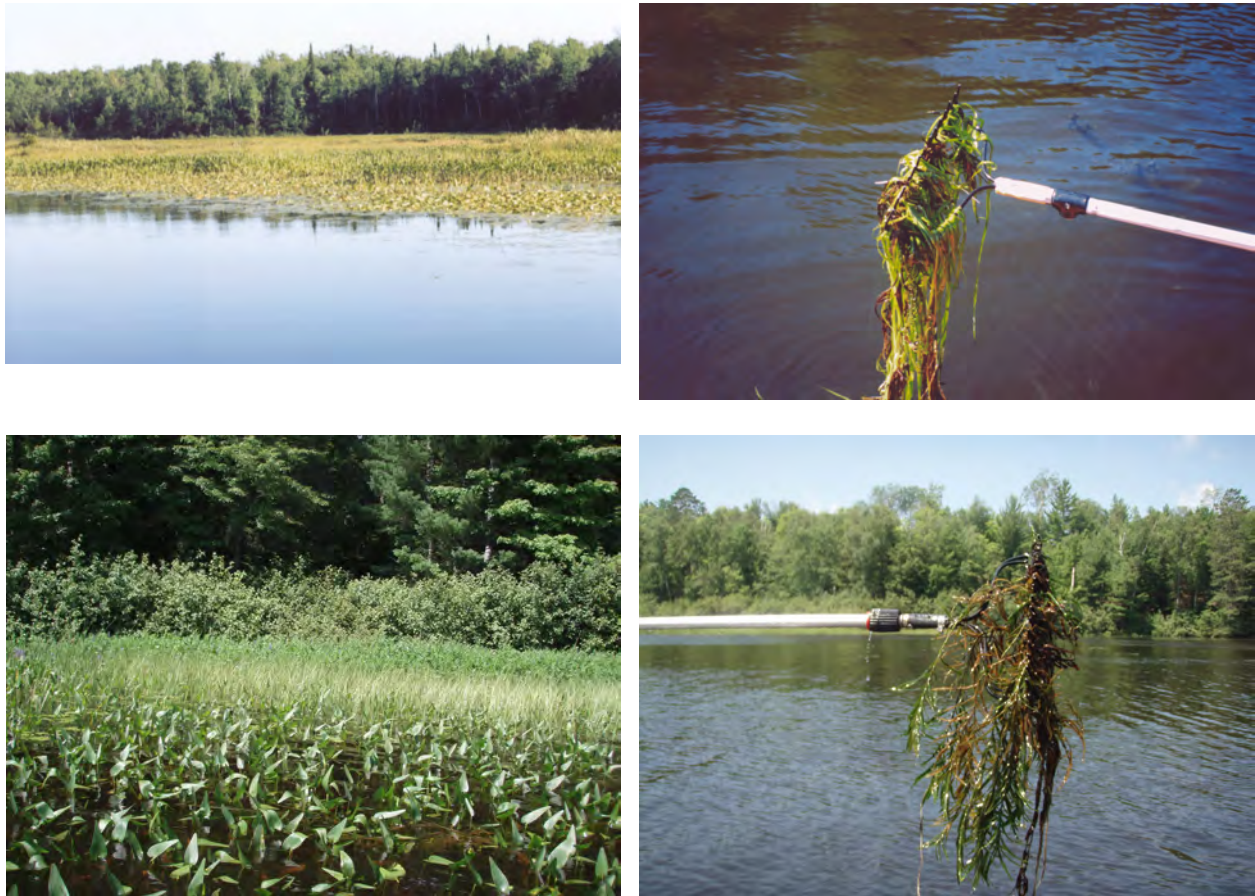
Figure 26. [top-left] Nearshore vegetation in Turner, on August 4, 2001. [top-right] Water celery and elodea collected during the plant survey on Turner Lake in 2001. [bottom-left] Arrowhead plants in Turner Lake on July 16, 2010. [bottom-right] Fern pondweed found in Turner Lake on July 16, 2010.

Turner Lake Aquatic Plants: Turner Lake has a diverse aquatic plant community dominated by elodea in 2010 followed by fern pondweed (Table 21 and Figure 26). Plant growth may have expanded in 2010 compared to 2001 survey (Figure 27).

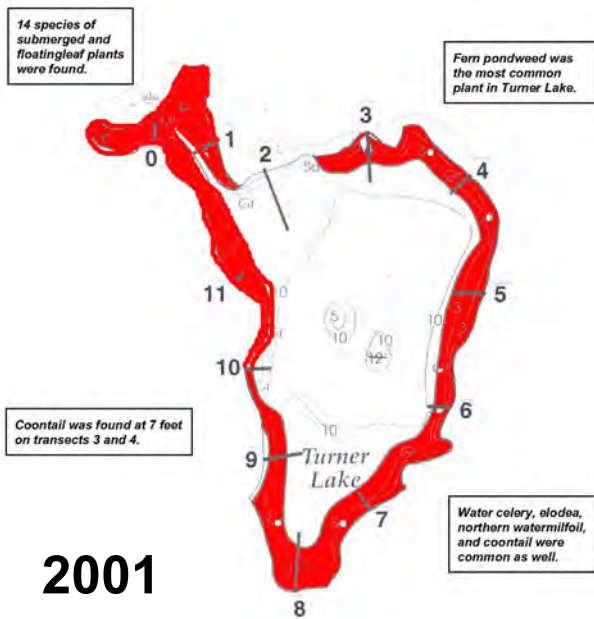
Figure 27. Turner Lake aquatic plant map based on surveys conducted by Blue Water Science. [top] Aquatic plant distribution in 2010 is shown with green circles. [bottom] Aquatic plant distribution is shown with red shading.

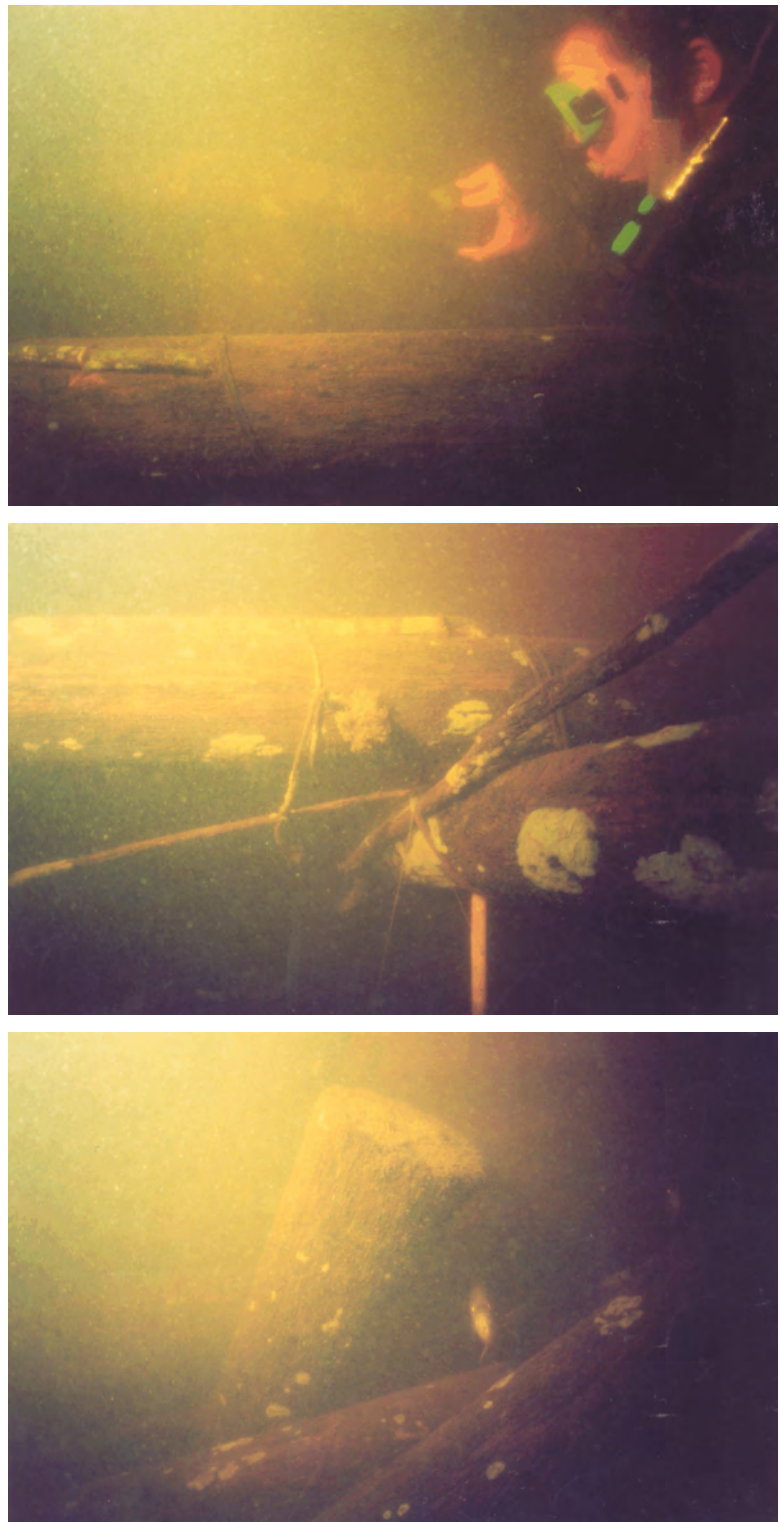
Figure 31. Underwater views of a fish crib in Round Lake in July, 2001.

In 2001, fish cribs were observed by scuba diving. The two cribs observed in Round Lake were mostly intact (Figure 31) and in fact, a bluegill was observed using the crib (Figure 31, bottom).

Because of the brownish water color due to the wetland or “bog” stain, cribs are hard to see, although fish will find them and use them for protection.
