Lake Management Plan for the Pike Lake Chain of Lakes Price and Vilas Counties, Wisconsin

[Pike Lake Chain includes Pike Lake, Round Lake,
Amik Lake, and Turner Lake]

2012

Prepared by Steve McComas, Blue Water Science
with significant contributions from the Pike Lake Chain of Lakes
Association, and Wisconsin Department of Natural Resources

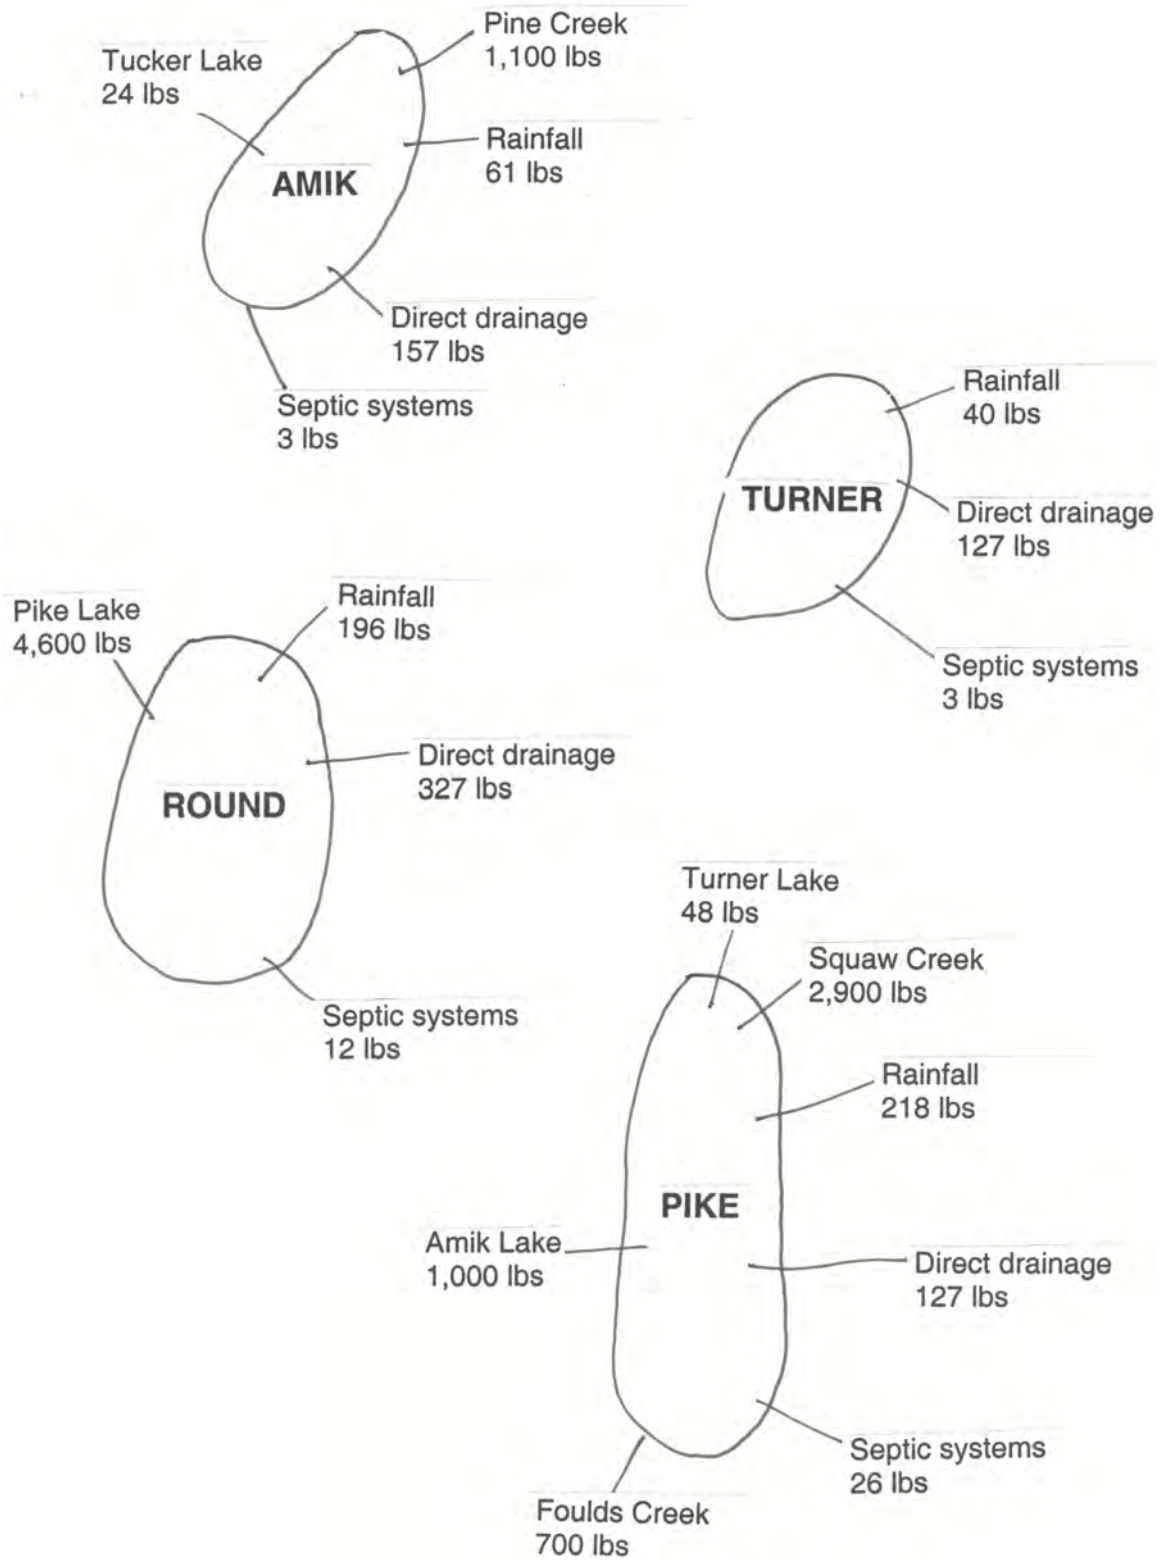
Figure 32. Summary of phosphorus sources to the Pike Chain of Lakes.

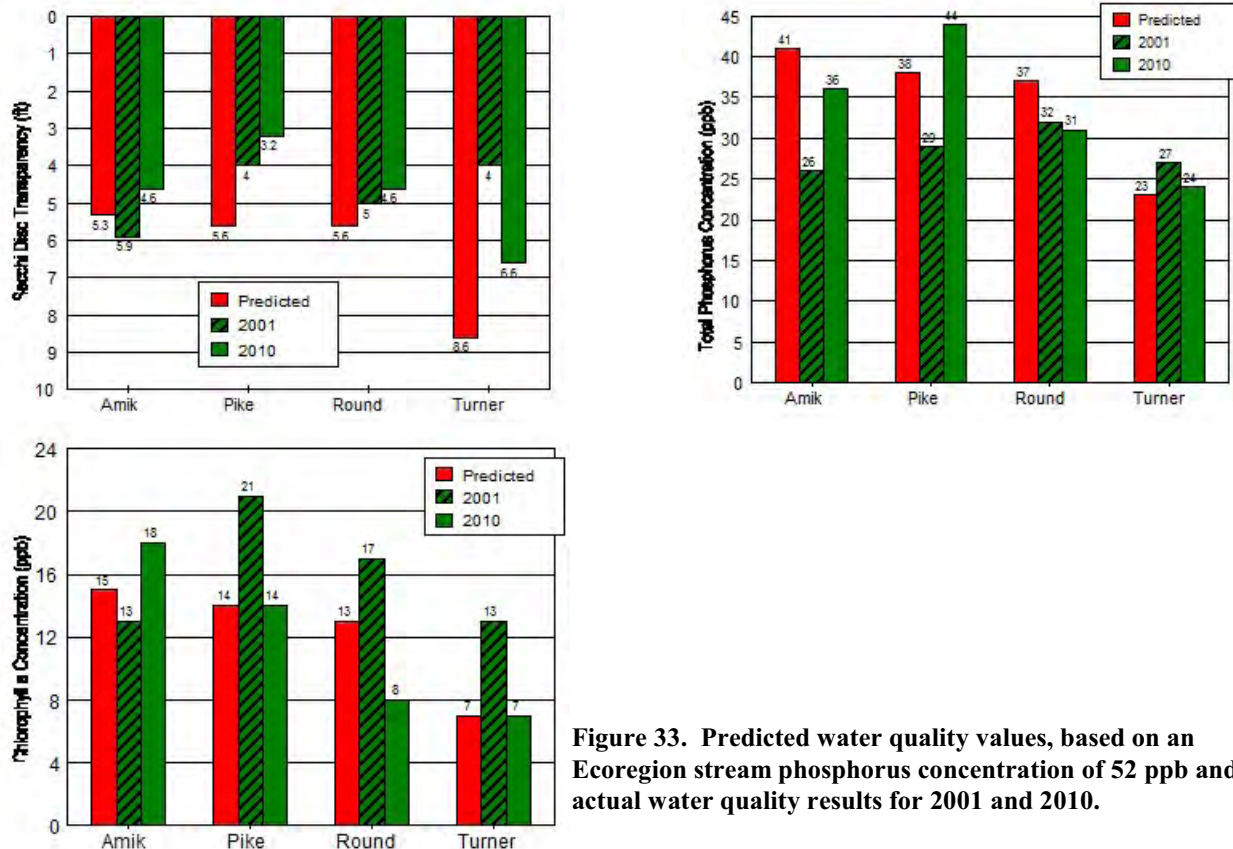
Figure 33. Predicted water quality values, based on an Ecoregion stream phosphorus concentration of 52 ppb and actual water quality results for 2001 and 2010.

One way to check the status of the Pike Lake Chain lakes was to insert existing data into equations to see if the answers matched what the observed water quality conditions are. These equations are referred to as lake models.

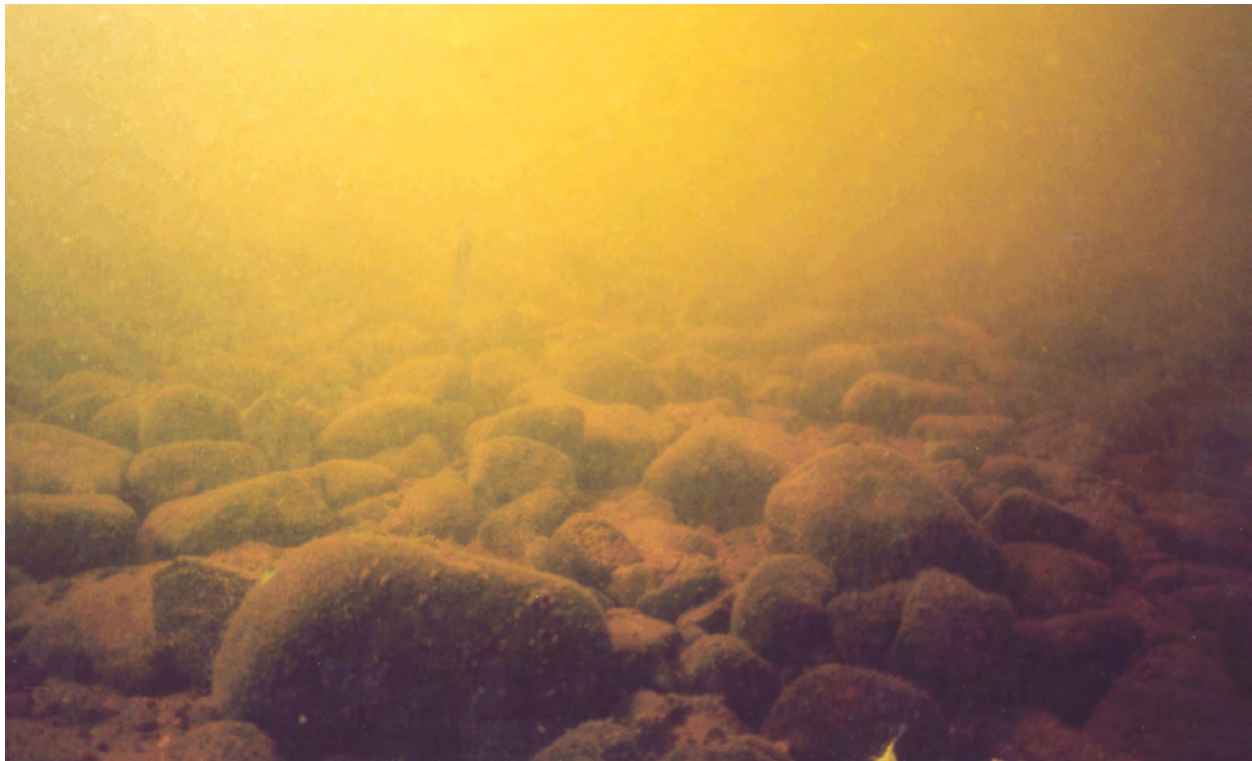
Figure 34. Underwater view of Round Lake, July 2001. These rocks would provide suitable habitat for zebra mussel attachment, but low calcium concentrations would likely limit zebra mussel growth.

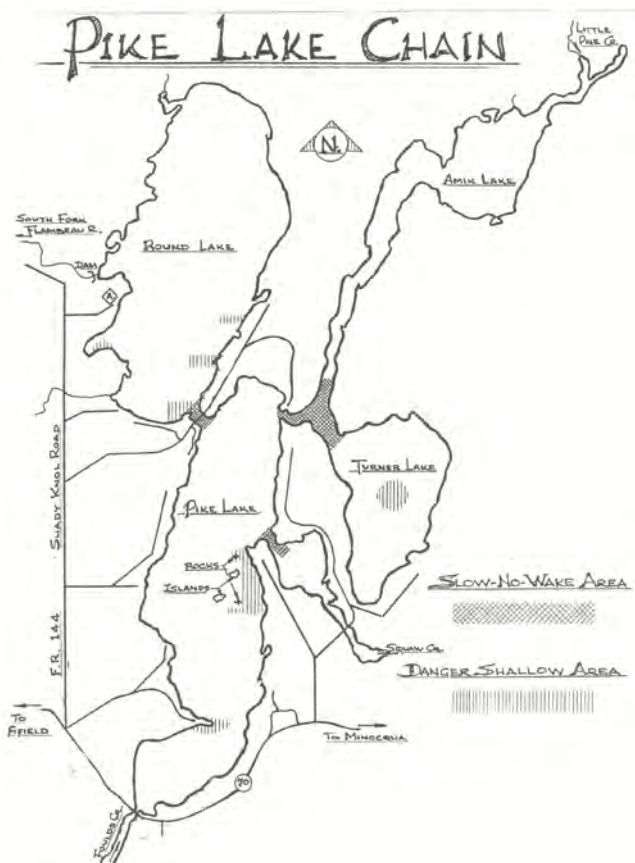
Figure 37. Map produced by a Lake Association board member showing no-wake and shallow areas.

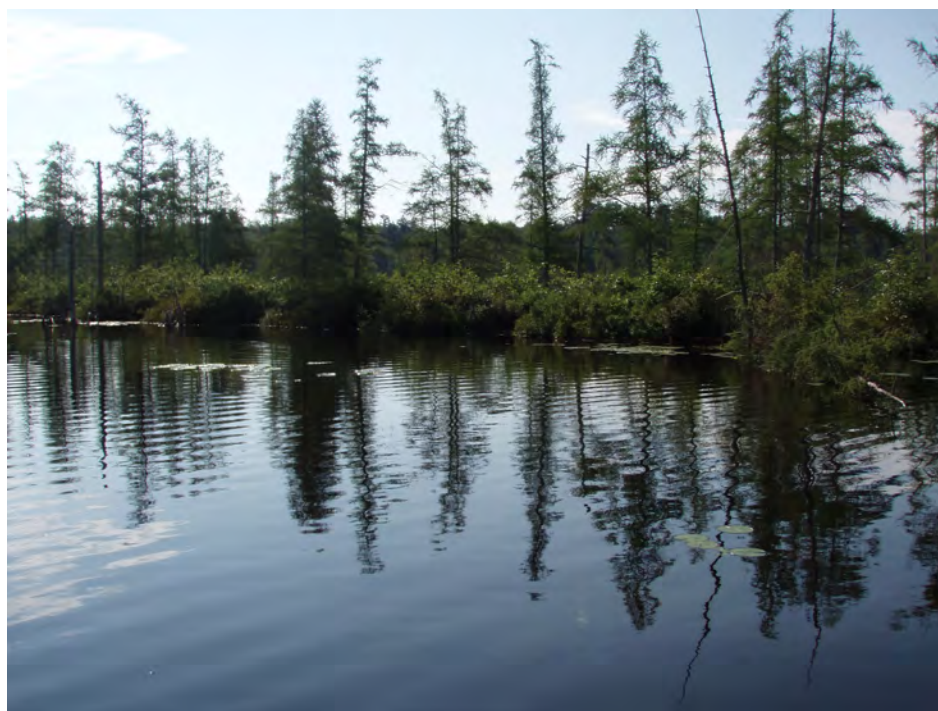
Figure 38. Extensive wetland acreage is present in the watershed. In a wet year coming off a dry year, extra nutrients will be flushed out of the wetlands.

The wetland acreage in the Pike Chain of Lakes watershed is significant. The exact acreage was not determined in this study but wetland and forest acreage is the dominant land use category. Agricultural and residential development are minor land use components. The wetlands in the watershed are relatively unimpacted and in a natural condition. However, in some years they may contribute an above average phosphorus load to the lakes. The condition where extra nutrients are exported from wetlands occurs in a “wet” year (above average precipitation) following a “dry” year (below average precipitation). Extra phosphorus is flushed out of the wetlands and into the streams and eventually into the lakes. This is what occurred in 2010 and lake phosphorus levels were above average. This is basically a natural occurrence. No special wetland nutrient management projects are recommended at this time.

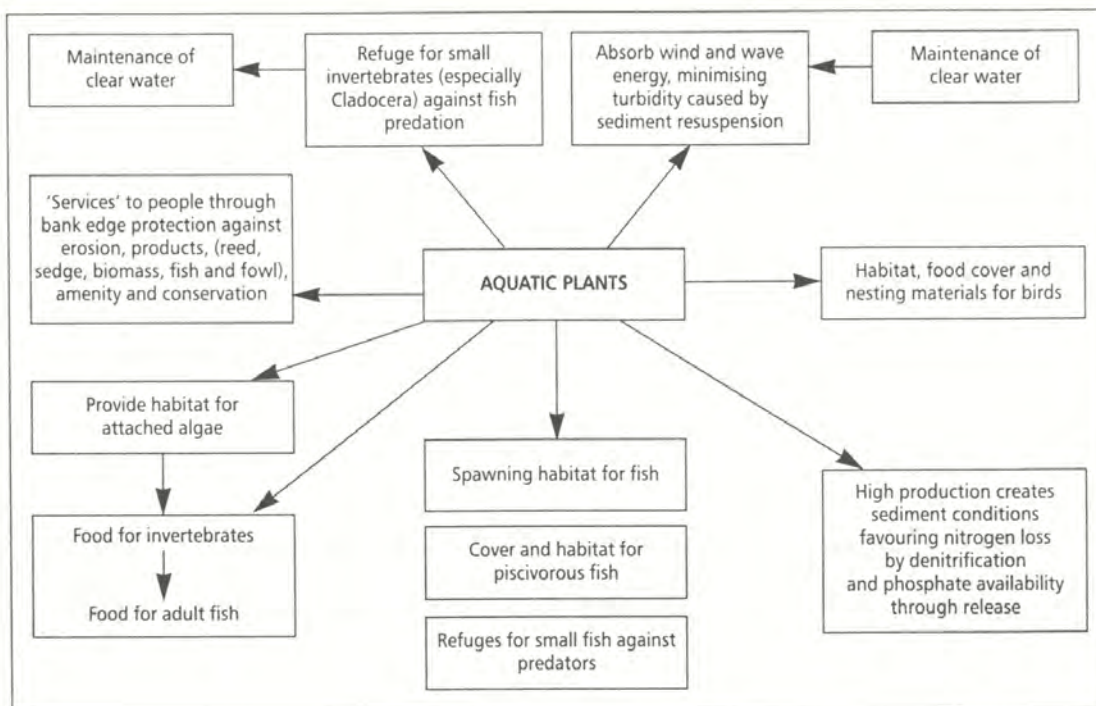
Figure 40. Links between aquatic plants and other organisms, including ourselves (source: Moss and others. 1996. A guide to the restoration of nutrient-enriched shallow lakes. Broads Authority Norwich, England).

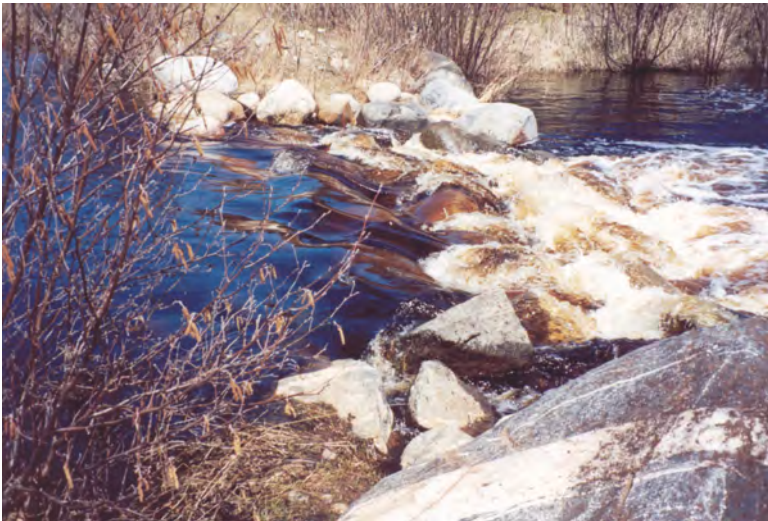
Figure A-3. Foulds Creek - April 2001. The creek flows north into Pike Lake with a relatively high flow in spring.

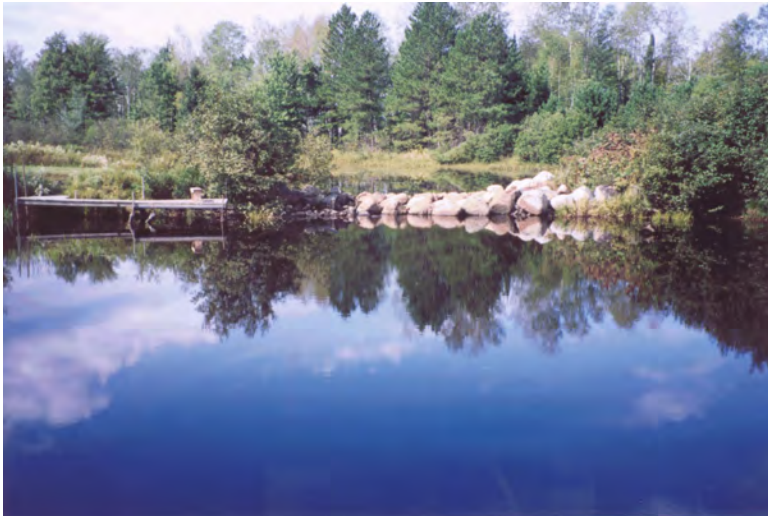
Figure A-4. Fould's Creek - September 2001. In the fall, the flow in Foulds Creek is low. The average flow annual flow is estimated at 14 cubic feet per second.

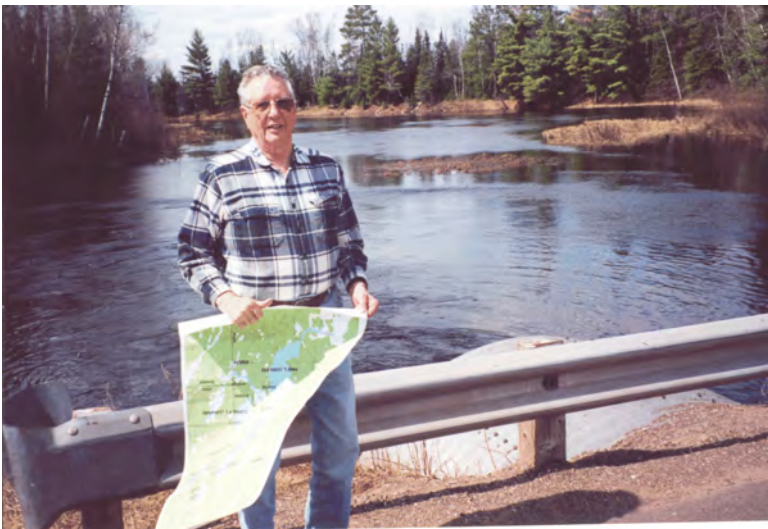
Figure A-5. Squaw Creek is a major inflow to Pike Lake.
