2011 Aquatic Plant Management Plan End of Year Summary

Rice Lake Aquatic Plant Management Plan Implementation

Rice Lake, Barron County

DNR No. ACEI-095-11
SEH No. RICLI 120323

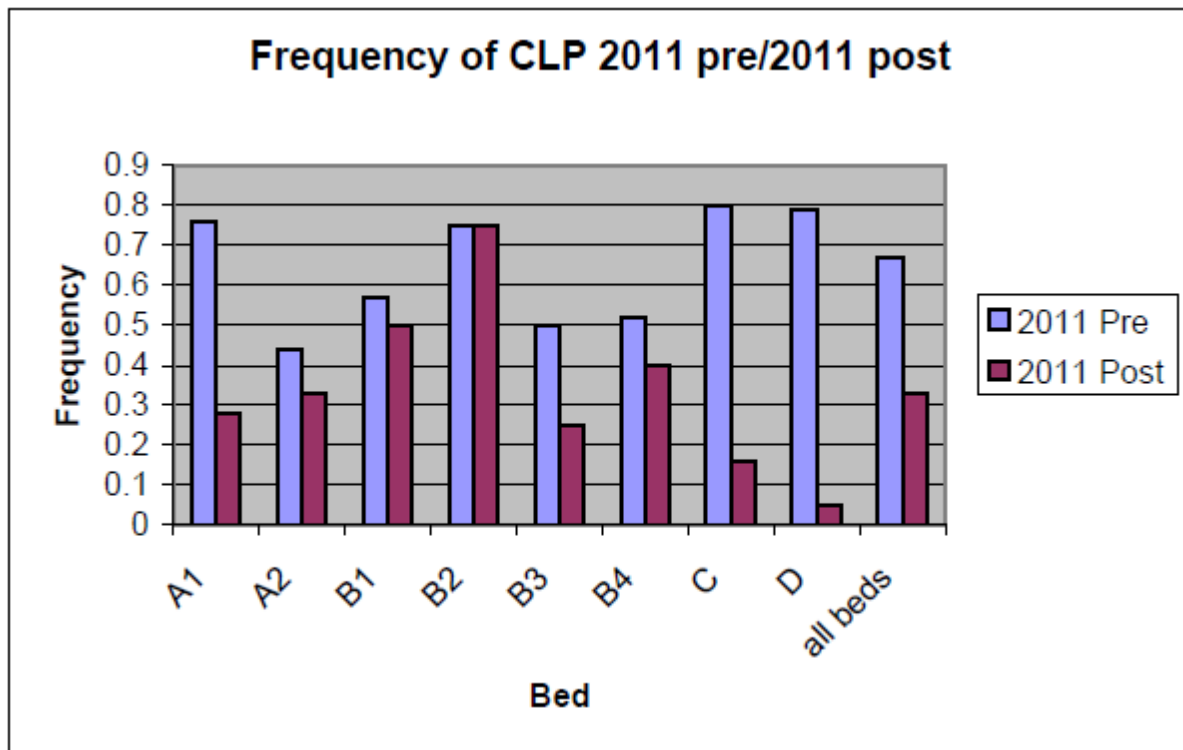
Figure 1 – Pre Post CLP Reduction in the 2011 Chemical Treatment (EIS)

Post treatment survey work was completed by EIS approximately 4 wks later in late June. Survey results indicated a statistically significant reduction in CLP from pre treatment levels when all treatment areas are considered. However, only a couple of the beds had statistically significant changes when considered individually (Figure 1). Overall, the treatments were less effective in 2011 than in 2010 in several areas near Lakeshore Drive and additional CLP growth was documented outside of the 2011 treatment areas, in essence having been missed by the application.

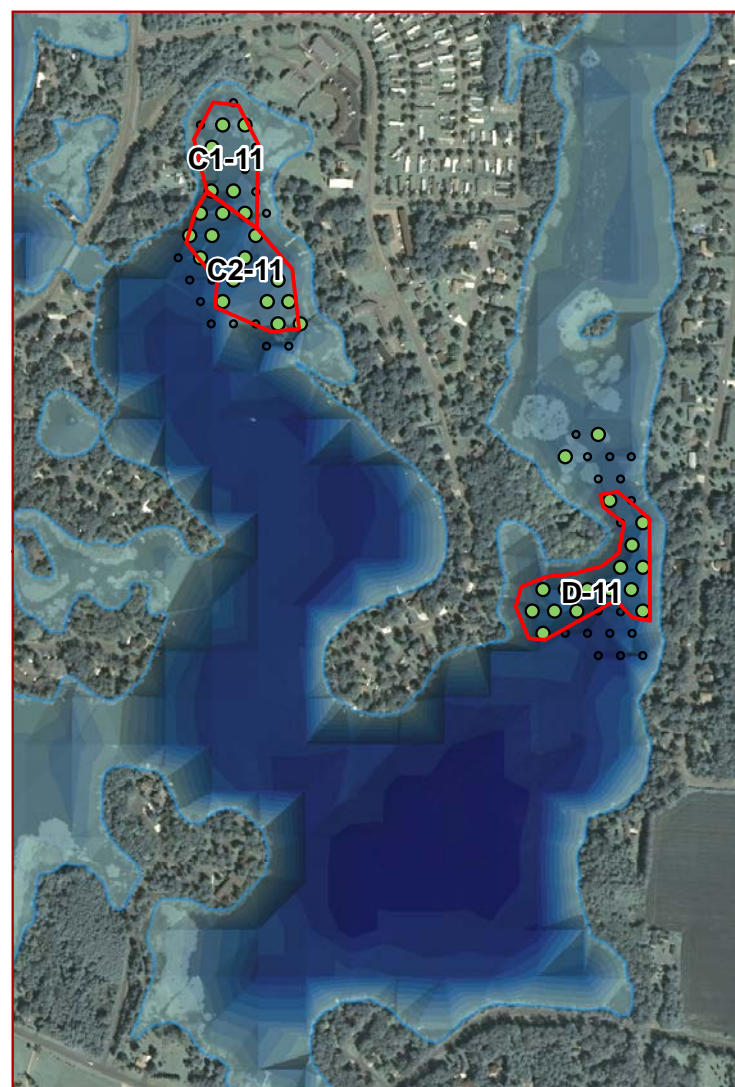
Rice Lake
2011 Curly-Leaf Pondweed
Treatment Areas
Barron County, Wisconsin

Bed	Mean		Substrate	Treatment	
	Acreage	Depth (ft)		Rate ^a (lbs/acre)	Density
A1-11	7.52	5.2	Rock, sand	17	High
A2-11	1.59	4.4	Sand	15	High
B1-11	10.08	4.5	Rock and muck	15	Moderate
B2-11	3.47	4.8	Muck, rock	16	High
B3-11 ^a	1.60	9.0	Muck, rock	40	Moderate
B4-11	6.49	5.4	Muck, rock	18	High
C1-11	2.56	3.7	Muck	12	High
C2-11	4.18	7.1	Muck	23	High
D-11 ^a	4.07	8.1	Muck	36	High
TOTAL	41.56

^a Treated at 1.0 parts per million (ppm), all others at 0.75 ppm

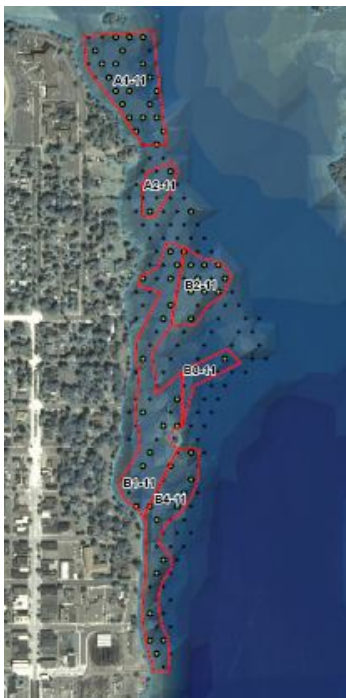
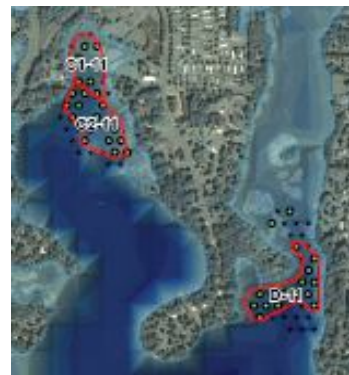
Figure 1: Treatment beds on Rice Lake for 2011 (created by Jake Macholl, SEH, Inc)

On May 17, 2011 eight beds of *Potamogeton crispus*-curly leaf pondweed (CLP) totaling 41.56 acres were treated with herbicide (endothall) (see figure 1). Prior to treatment, a pre-treatment survey was conducted at 252 predetermined sample points. The presence of CLP was recorded at each sample point, along with depth.

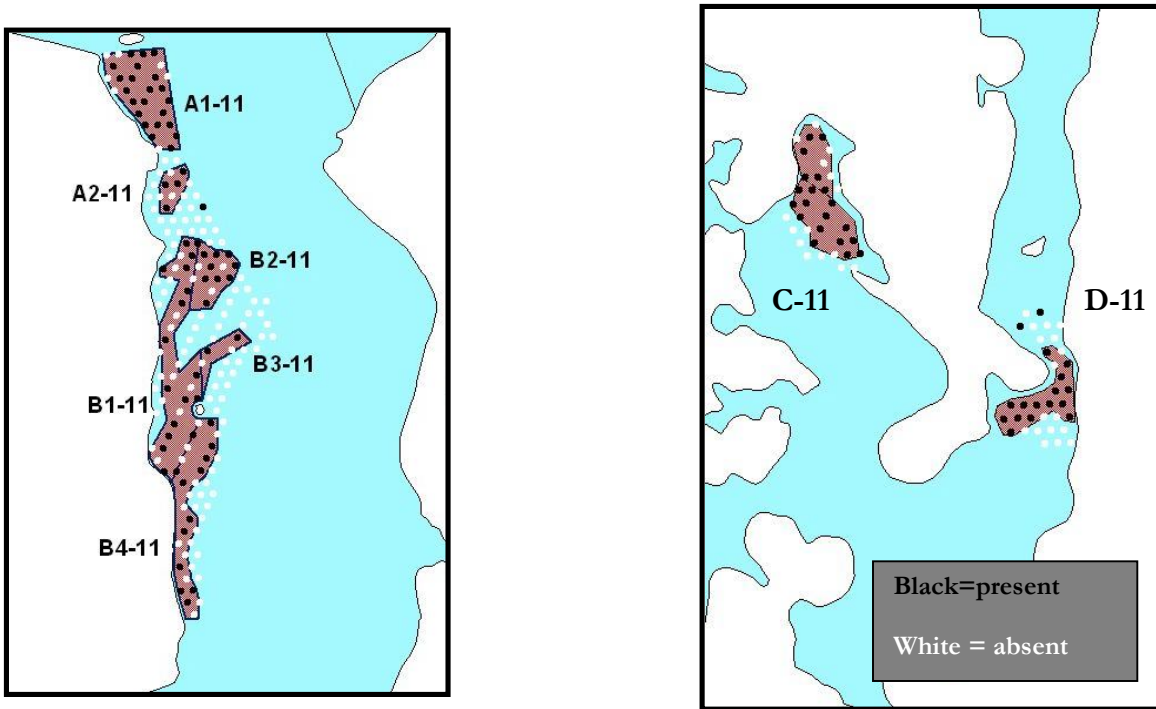
Figure 3: Maps with adjusted treatment beds based upon pre-treatment survey data.

Figure 3 shows the adjusted treatment areas with the pretreatment survey results included. This map shows the justification of the treatment adjustments.

Due to the adjustments, many sample points were now out of the treatment areas. The points inside of the treatment areas were the only ones used for the CLP treatment analysis. The points outside of the treatment areas can be used to help determine treatment areas in 2012, especially since many ended up having CLP growth in them.

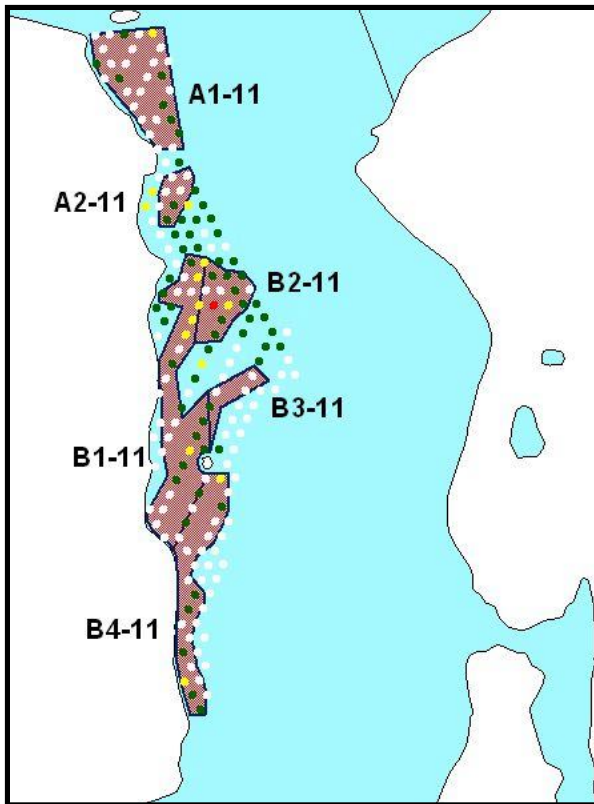
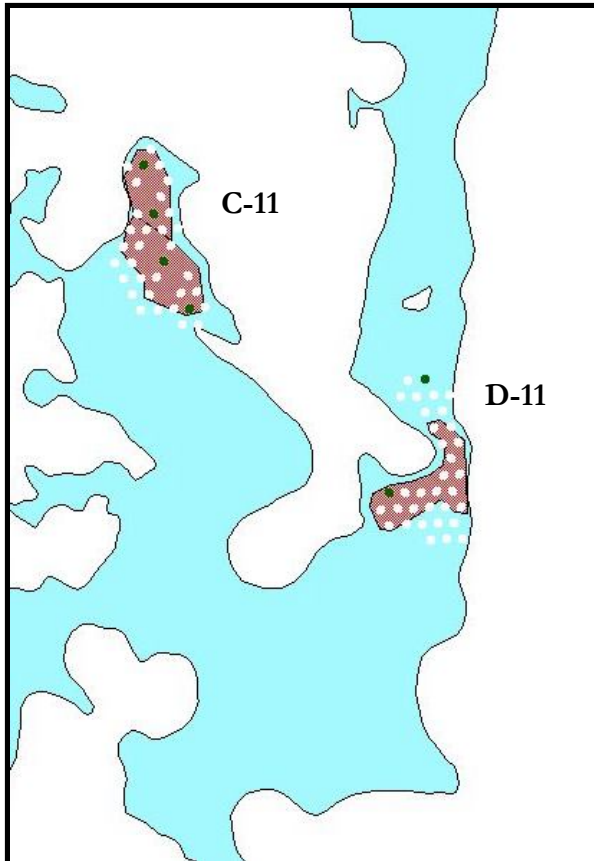
Figure 4: Map of post treatment survey with CLP density at each sample point.

The post treatment survey shows an increase in CLP growth in beds A1, A2 and B1 thru B4 as compared to 2010. Beds C and D showed minor increases compared to 2010. However, there was frequency decreases in all beds when comparing the presence of CLP in the pre-treatment survey of 2011 to the post treatment survey of 2011.

An interesting observation is that there are a number of sample points outside of the adjusted treatment beds that had growth of CLP in the post treatment survey, that had no CLP present in the pre-treatment survey. There was a concern that the CLP may be missed in the pre-treatment survey, resulting in not treating areas that should be treated. However, based upon the water temperature of 52.7 to 53.7 degrees F as well as the size of the CLP sampled, the CLP that was going to grow should have been out of dormancy. However, it is obvious that the CLP appeared later even though it wasn't sampled. It is possible that the rake sample missed possible CLP. To reduce this chance an underwater camera is used in the pretreatment survey, but apparently this method missed the CLP also. Suggestions for avoiding this in the future are addressed in the discussion section.

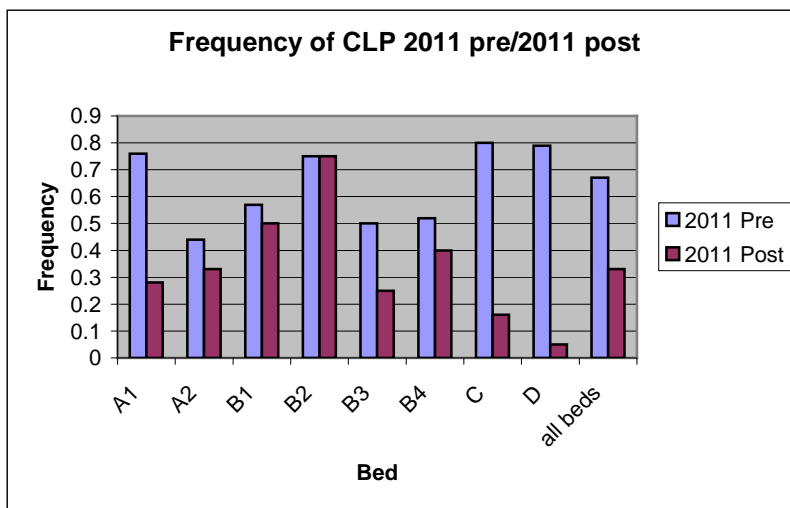
Figure 5: Graph showing frequency data comparison of pre and post treatment surveys 2011.

Table 2 shows that there was a reduction in frequency between the before treatment survey (pre) and the post treatment survey in 2011. Only Beds A1, C and D had statistically significant reductions. However, all beds together showed a statistically significant reduction, showing some effectiveness of the treatment. Figure 5 shows the difference graphically.

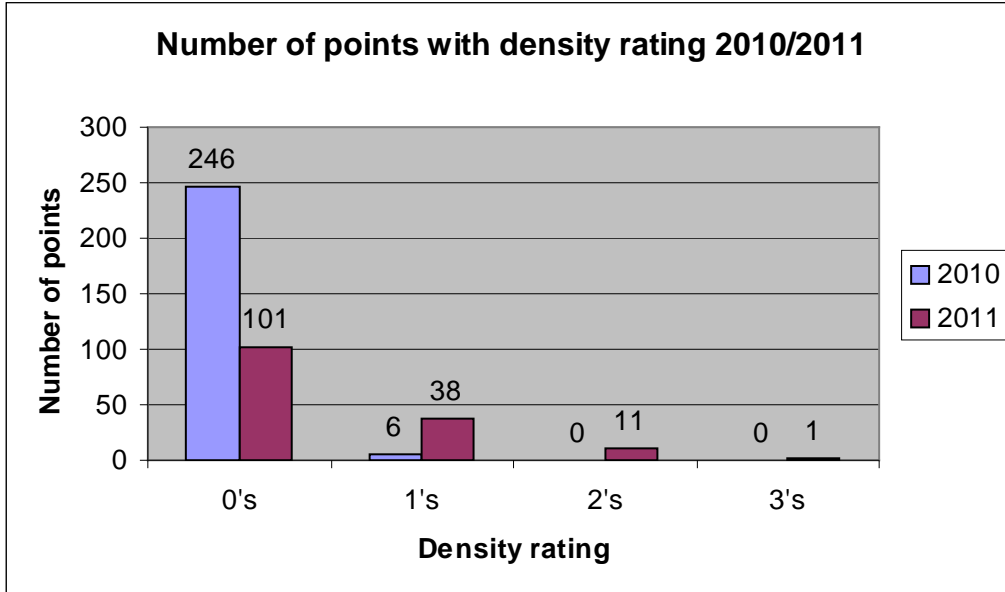
Figure 6: Graph showing the number of points with particular density rating 2010 and 2011.

It is safe to assume that the density was higher in 2011 than in 2010, since the frequency was higher. Figure 6 shows this difference. The density is not recorded in the pre-treatment survey since the plants are so small and is not a valid comparison to when the CLP is at peak growth, thus potentially indicating invalid changes.
