MARL LAKE

WAUSHARA COUNTY, WISCONSIN

COMPREHENSIVE LAKE MANAGEMENT PLAN

June 2003

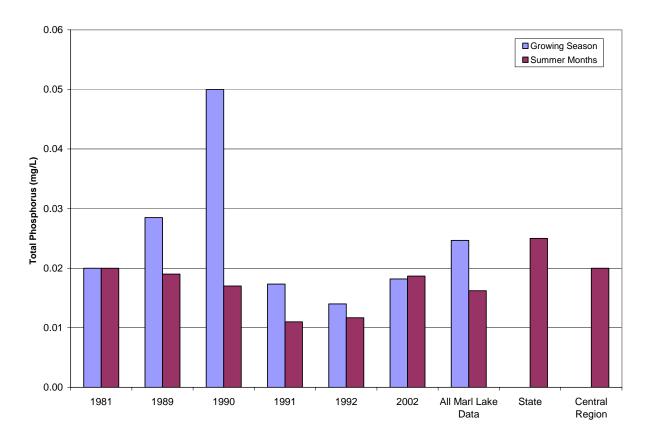
Figure 2. Mean total phosphorus concentrations from Marl Lake, state and central region. All means were calculated from surface samples. Growing season includes April-October measurements

Overall, when compared to the WQI values in Table 1, the data found in Figures 2-4 indicate that the water quality of Marl Lake is quite good and that there is no clear evidence of changes in water quality over the past 2 or so decades. This is good news because there was concern over rising phosphorus levels in the late 1980's and early 1990's (Wisconsin Department of Natural Resources 1990). However, the data contained in Figure 2 indicate that the levels have decreased or remained the same. One of the data points that concerned the author was the phosphorous concentration recorded during April 1990 (mentioned above) of 0.010 mg/l, the highest level recorded for the surface waters of Marl Lake. Within the document, he mentions that further data analysis would determine if the reading is an anomaly; apparently it was.

The data displayed in Figures 2-4 also indicate that, in general, the phosphorus and chlorophyll-*a* concentrations within Marl Lake are below those found in the state and the central region. Comparisons of water transparency show the water of Marl Lake has been consistently much clearer than that found in other lakes within the region and state.

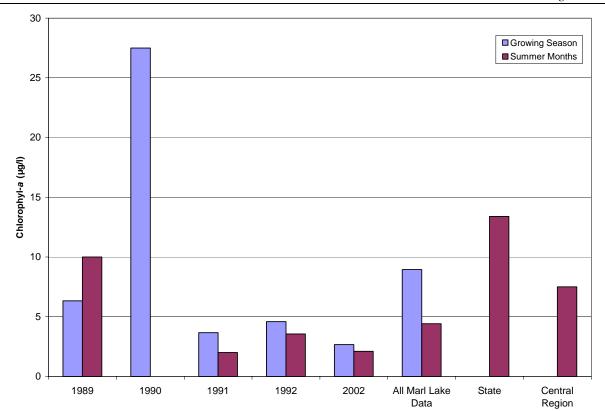
Figure 3. Mean chlorophyll-a concentrations from Marl Lake, state and central region. All means were calculated from surface samples. Growing season includes April-October measurements

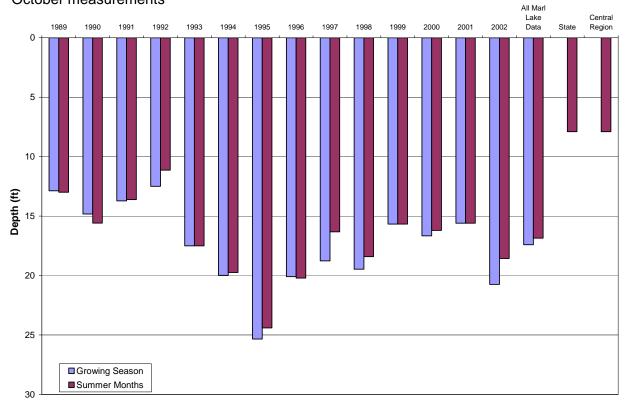
Figure 4. Mean Secchi disk transparencies from Marl Lake, state and central region. Growing season includes April-October measurements

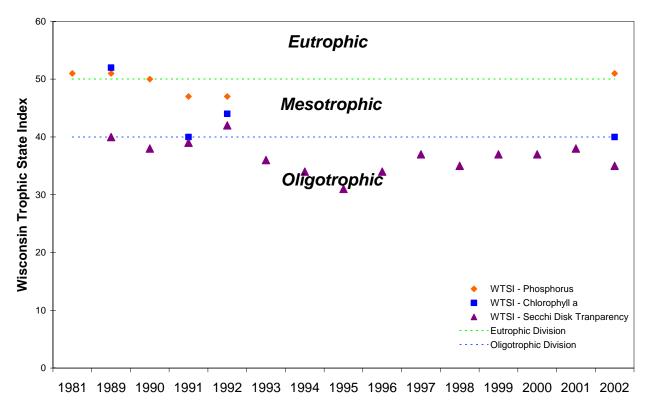
Figure 5. Wisconsin Trophic State Index results for Marl Lake.

lakes. The WTSI is used extensively by the WDNR and is reported along with lake data collected by Self-Help Volunteers. The phosphorus data indicate that for the most part, Marl Lake fluctuates within a mesotrophic/eutrophic state. Yet, the chlorophyll-a and water clarity values indicate the lake is much closer to an oligotrophic state. Based on the relationship between these parameters described above, we would expect to find similar trophic values for all three parameters. One explanation may be that the *limiting nutrient* within Marl Lake is not phosphorus. However, this is not likely because the summer *nitrogen to phosphorus ratios* are normally well over 60:1; indicating a very strong phosphorus limitation for algal production. It is likely that the phosphorus is unusable by the algae because it is bound to marl that is precipitating within the lake. In fact, dissolved phosphorus, the form algae use, were below detectable levels during the spring and midsummer samples. So, the same compound that gives Marl Lake its incredible bluish-green color also functions to precipitate phosphorus out of the water column where it can be utilized by algae.

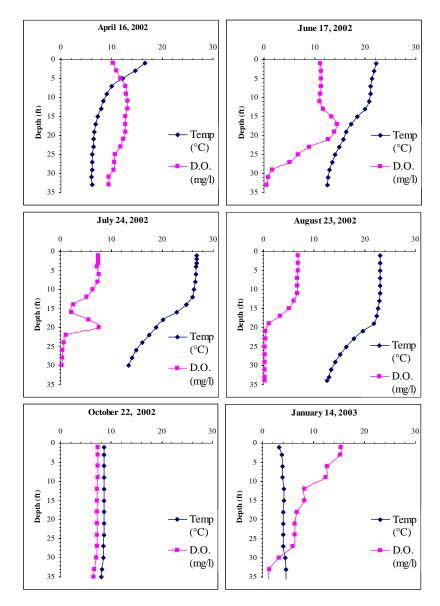
Figure 6. Results of temperature and dissolved oxygen profiles for Marl Lake.

The temperature and dissolved oxygen profiles (Figure 6) completed during this study at Marl Lake, indicate the lake does stratify during the summer and winter months and that oxygen levels within the *hypolimnion* can be depleted producing *anoxic* conditions. In many lakes, this is a concern because these anoxic conditions can lead to fishkills. However, this is likely not a concern for Marl Lake because even during these stratified periods, well over half of the lake's volume is well-oxygenated.

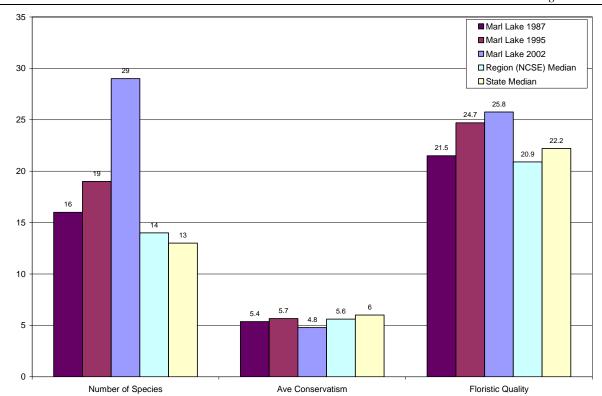
Figure 8. Floristic Quality Assessment (FQA) results for current and historic datasets of Marl Lake, the ecoregion and state. The ecoregion results shown are a combination of results from the North Central Hardwood Forest and Southeastern Wisconsin Till Plains ecoregions (Nichols 1999).

The Floristic Quality Assessment (FQA) (see Methods Section) indicates that Marl Lake has a relatively high quality plant community that is made up of many species that are normally found in disturbed systems. Essentially, the FQA uses species conservatism, or its likelihood of occurring in an undisturbed system, along with the number of native species found in the lake to calculate the system's Floristic Quality Index (FQI). average species conservatism (Figure 8) for the survey data from this study is slightly lower than those found during the other surveys on Marl Lake and those calculated for the ecoregion and the state. This means that the species that were located in the lake are likely to be found in more disturbed systems – systems with development and other forms anthropogenic influences. However, the great variety of species found during the 2002 survey resulted in a high FQI for the lake, indicating that although the lake is moderately disturbed, it still supports an

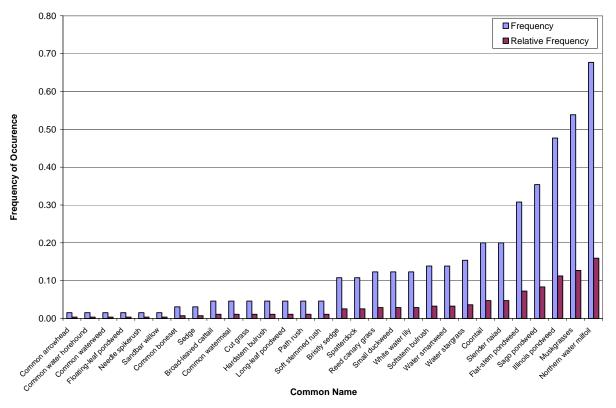
Figure 9. Frequency results for current survey results at Marl Lake.

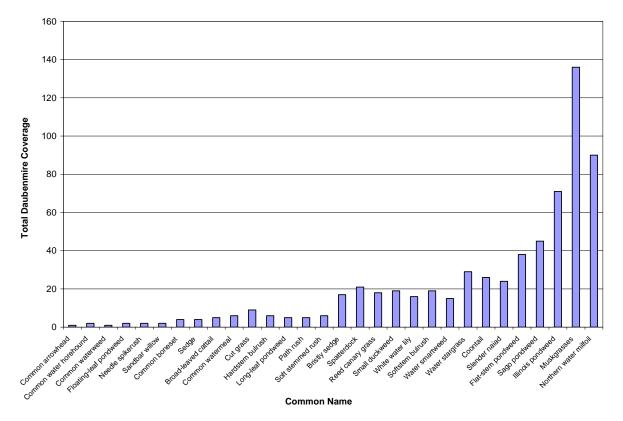
Figure 10. Total Daubenmire coverage results for current survey results at Marl Lake

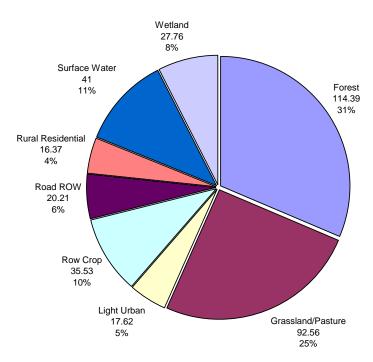
Figure 13. Land use types and associated acreages within the Marl Lake watershed. Percentages indicate percent of total watershed acreage.

Field-verified land use data for the Marl Lake watershed are displayed in Figures 12 and 13. Currently, the majority of land within the Marl Lake watershed is either forested or in grassland/pasture. As mentioned above, fully vegetated areas produce very little surface runoff; in fact, these areas allow 60-80% or greater of the precipitation that falls on them to infiltrate the ground. Having a large proportion of the watershed in these land use types does a great deal to prevent excessive phosphorus loading to the lake.

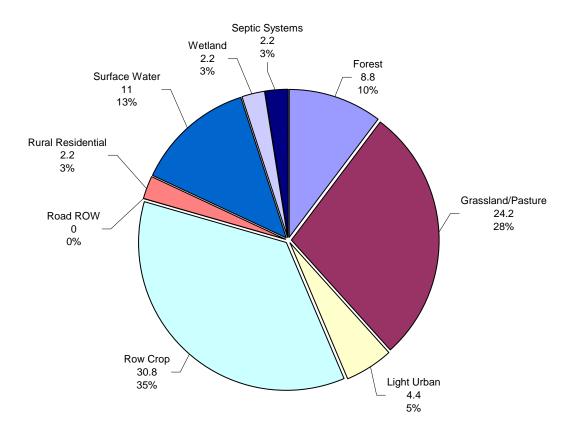
Figure 14. Estimated phosphorus loading values for the Marl Lake watershed. Loads are listed in lbs/yr of phosphorus. Percentages indicate percent of total external phosphorus load.

Modeling results of the land use types listed are shown in Figure 14. The most noticeable source is row crops. Although this land use category only accounts for roughly 10% of the total watershed acreage, it loads the greatest amount of phosphorus to the lake. Fortunately, there are many ways of controlling this type of loading (see Recommendations Section).

Although it only accounts for approximately 2% of the total estimated load entering the lake, septic tank inputs are always a concern around lakes, especially in the soils around Marl Lake. These soils, called Plainfield sand (USDA 1989), are excellent for conveying effluent away from conventional septic system drainfields, but do very little for the filtering of contaminants, including phosphorus. This unfiltered phosphorus can easily enter the groundwater and move into the lake.

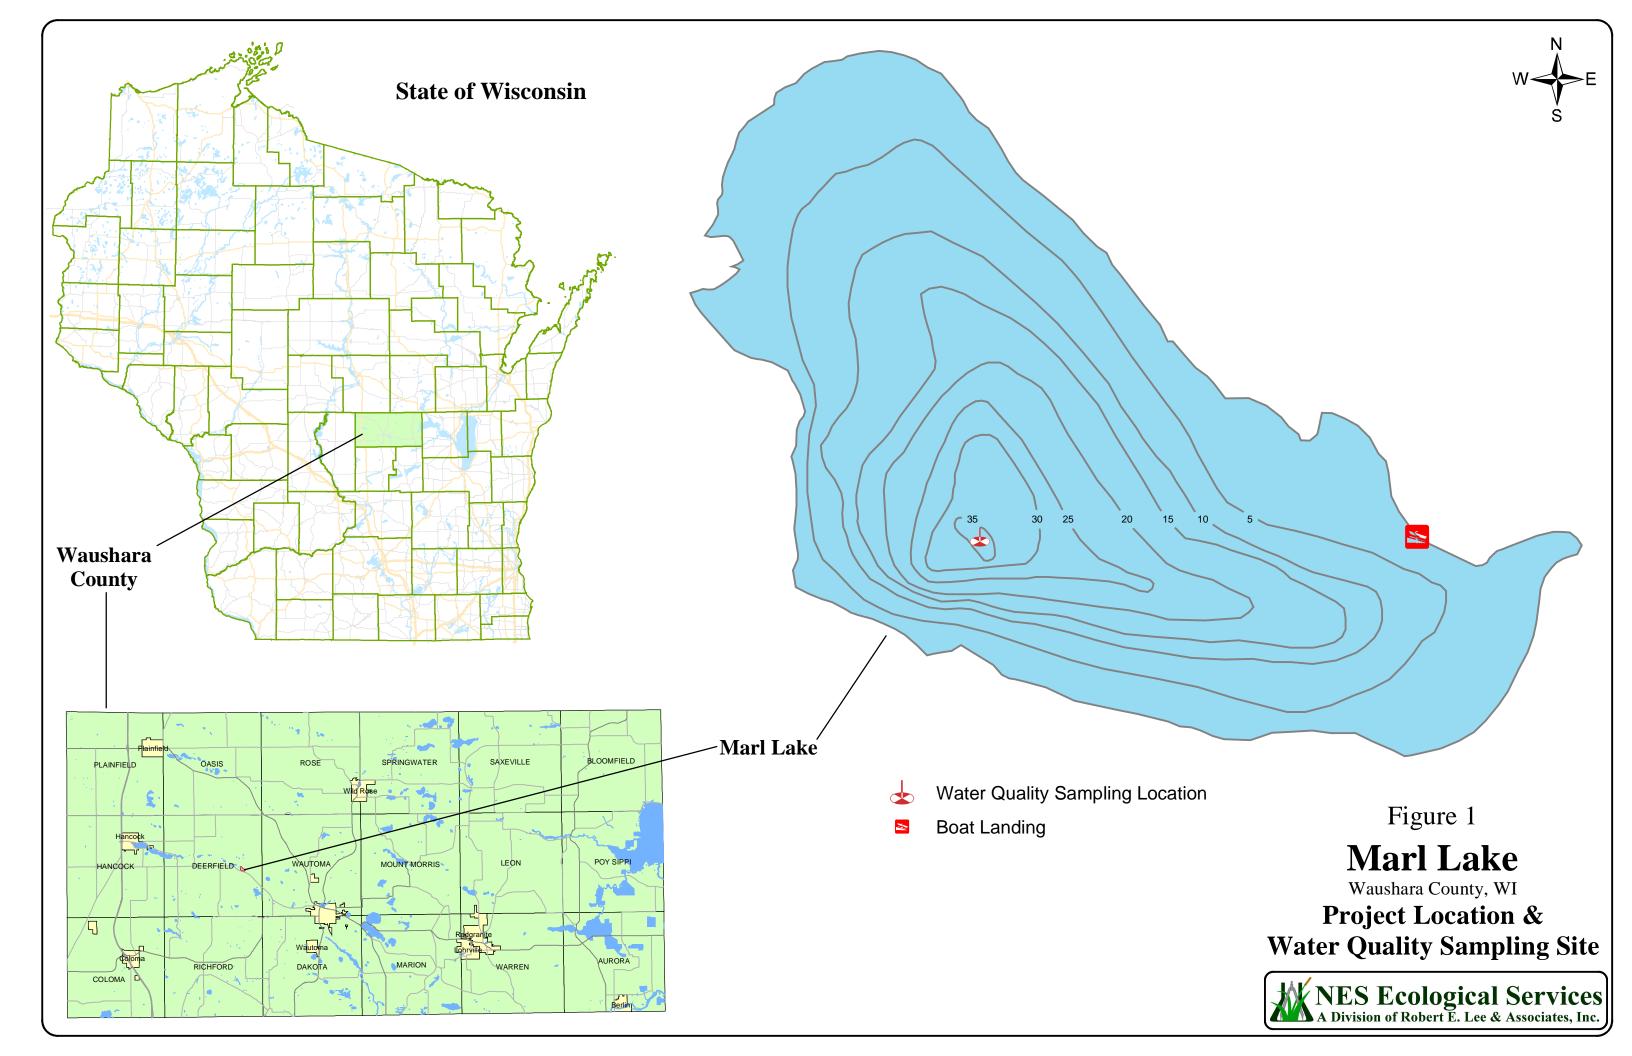
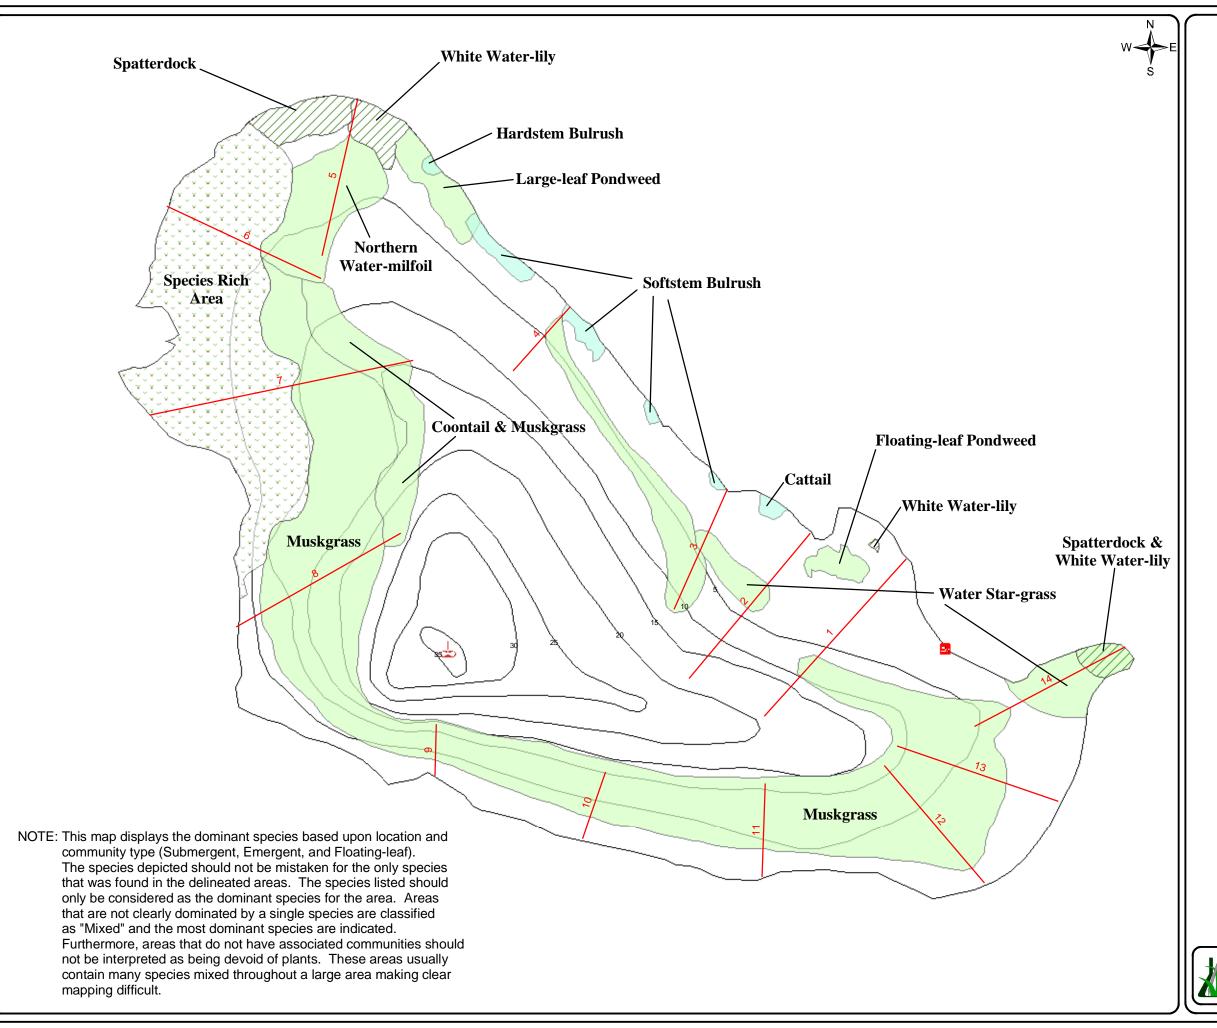
- * This area contained the most abundant and diverse plant assemblage in the lake. It contained nearly every species of submergent, floating-leaf, and emergent vegetation found throughout the rest of the lake. Please see Table 2 for a list of these plant species.
- ** Emergent species occurred frequently around the edge of the lake. The areas indicated on the map are larger areas clearly dominated by a single species.

Two areas of the lake support excellent aquatic plant communities that are likely used a great deal by the Marl Lake fishery for spawning, nursery, cover, and feeding requirements. The largest of these areas is located on the northwest end of the lake and is indicated on Figure 11 as the "Species Rich Area", while the other, smaller area, is located in the small bay east of the boat landing (Transect 14). The larger area contained nearly every species found throughout the rest of the lake from all three plant community types (submergent, emergent, and floating-leaved). Although the other area was clearly dominated by water star-grass (*Zosterella dubia*), and water-lilies (*Nuphar variegata* and *Nymphaea odorata*), it still contains many other species of emergent and submergent plants that indicate it is a high-quality area.

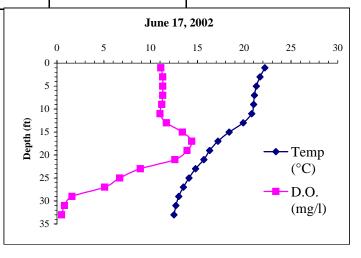
Depth	Temp	D.O.		Sp. Cond
(ft)	(°C)	(mg/l)	pН	(µS/cm)
1.0	26.7	7.4	7.9	252
2.0	26.7	7.4	8.0	252
3.0	26.7	7.4	8.1	252
4.0	26.6	7.2	8.2	251
6.0	26.6	7.6	8.2	251
8.0	26.5	7.3	8.3	251
10.0	26.2	6.4	8.3	257
12.0	26.0	5.1	8.2	281
14.0	24.7	2.5	8.0	314
16.0	22.9	2.2	7.8	341
18.0	20.1	5.6	7.5	334
20.0	18.8	7.5	7.4	330
22.0	17.4	1.1	7.5	345
24.0	16.1	0.7	7.6	353
26.0	14.8	0.4	7.6	352
28.0	14.1	0.4	7.8	357
30.0	13.4	0.3	7.8	370

MARLS	MARLB
Total P (mg/l)	0.020	0.042
Dissolved P (mg/l)	0.000	
Chl \underline{a} ($\mu g/l$)	0.67	
TKN (mg/l)	0.640	1.180
NO ₄ +NO ₃ -N (mg/l)	0.147	0.019
NH ₃ -N (mg/l)	0.064	0.340
Total N (mg/l)	0.787	1.199
Lab Cond. (µS/cm)		
Lab pH	9.04	7.83
Alkal (mg/l CaCO ₃)	125	180
otal Susp Sol (mg/l)	0	6
Calcium (mg/l)	18.9

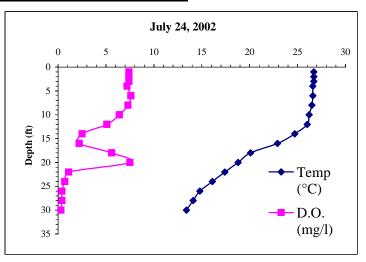
Depth	Temp	D.O.		Sp. Cond
(ft)	(° C)	(mg/l)	pН	(µS/cm)
1.0	23.1	6.8	8.8	300
3.0	23.1	6.8	9.0	300
5.0	23.1	6.8	9.0	300
7.0	23.1	6.7	9.0	300
9.0	23.1	6.7	8.9	300
11.0	23.1	6.7	8.8	300
13.0	22.9	6.0	8.6	306
15.0	22.7	5.1	8.4	321
17.0	22.3	3.3	8.1	339
19.0	21.8	1.1	7.8	356
21.0	19.7	0.4	7.8	376
23.0	17.9	0.4	7.5	384
25.0	16.4	0.3	7.4	378
27.0	15.1	0.3	7.5	379
29.0	14.2	0.3	7.5	394
31.0	13.4	0.3	7.3	421
33.0	13.0	0.3	7.2	450
34.0	12.6	0.3	7.1	468
	_	_

Parameter	MARLS	MARLB
Total P (mg/l)	0.017	0.037
Dissolved P (mg/l)		
Chl \underline{a} ($\mu g/l$)	5.13	
TKN (mg/l)		
NO ₄ +NO ₃ -N (mg/l)		
NH ₃ -N (mg/l)		
Total N (mg/l)		
Lab Cond. (µS/cm)		
Lab pH		
Alkal (mg/l CaCO ₃₎		
otal Susp Sol (mg/l)	3	5
Calcium (mg/l)

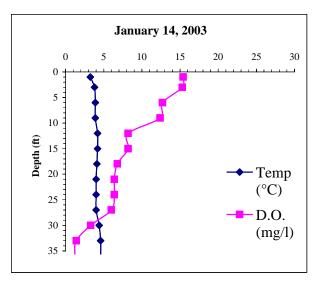
Depth	Temp	D.O.		Sp. Cond
(ft)	(°C)	(mg/l)	pН	(µS/cm)
1.0	3.3	15.4	8.6	392
3.0	3.8	15.3	8.6	393
6.0	3.9	12.7	8.7	393
9.0	3.9	12.4	8.7	393
12.0	4.2	8.2	8.3	403
15.0	4.2	8.2	8.0	416
18.0	4.1	6.8	7.8	436
21.0	4.0	6.4	7.7	452
24.0	4.0	6.4	7.6	461
27.0	4.0	6.0	7.6	472
30.0	4.4	3.3	7.5	481
33.0	4.6	1.4	7.4	484
36.0	4.6	1.2	7.4	484

Parameter	MARLS	MARLB
Total P (mg/l)	0.019	0.019
Dissolved P (mg/l)		
Chl \underline{a} ($\mu g/l$)		
TKN (mg/l)	0.940	0.630
NO ₄ +NO ₃ -N (mg/l)	0.744	1.800
NH ₃ -N (mg/l)	0.202	0.257
Total N (mg/l)	1.684	2.430
Lab Cond. (µS/cm)		
Lab pH		
Alkal (mg/l CaCO ₃₎		
Total Susp Sol (mg/l)		
Calcium (mg/l)

Notes: Ice thickness = 0.9'
