Wild Goose Lake Comprehensive Planning Report 2003

Prepared for the Wild Goose Lake Association

Brook Waalen
Polk County Land and Water Resources Department
215 Main Street
PO Box 460
Balsam Lake, WI 54810

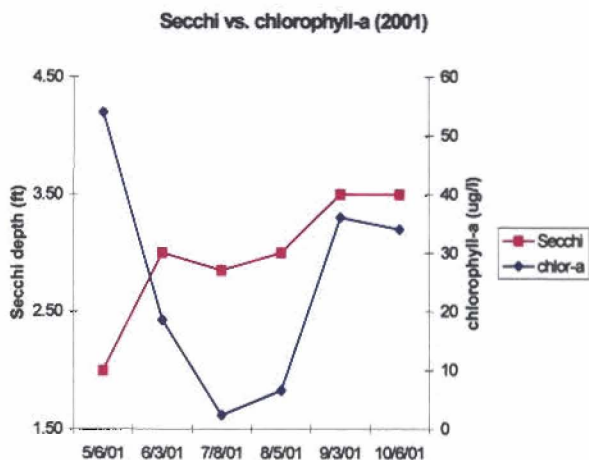
In 2001 the chlorophyll-a levels in Wild Goose varied considerably throughout the summer but averaged 25.1 mg/l (median = 24.4) between May and October. This is high and has the potential to cause problems. Some types of algae, specifically blue-green algae, can be offensive (and at times overpowering) when they 'bloom' or die in great quantities and are then blown to shore. Dense algae growth in the water column also decreases water clarity and this is already occurring on Wild Goose to some extent. However, the chlorophyll-a levels fluxed considerably over 2001 yet the Secchi depth remained quite stable varying by only 1.5ft.

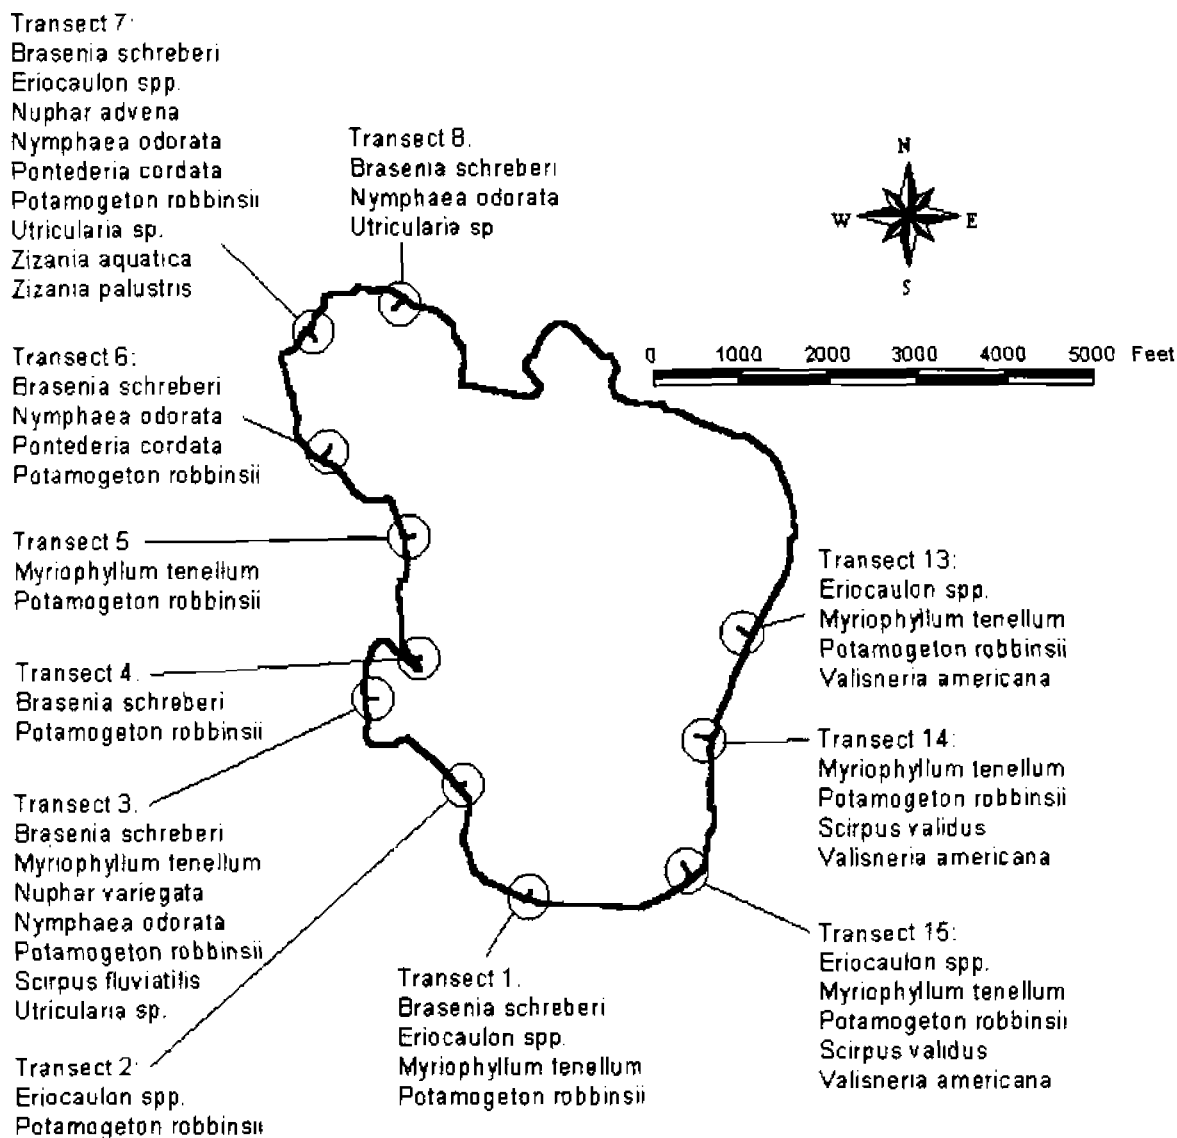
Aquatic Plant Survey and Litoral Zone

The area in green is referred to as the 'litoral zone.' The litoral zone is the most important area for aquatic wildlife. This is where sunlight is able to reach the lake bottom, young fish find refuge, and the dynamics play out between the land and the water. As many as 90% of the living things in lakes and rivers are found along their shallow margins and shores. (Source: Rideau Canal, Parks Canada)
