Herbicide Treatment Analysis for *Potamogeton crispus* (CLP)

Big Lake
Polk County, WI

June, 2014

*Prepared by: Ecological Integrity Service, LLC
Amery, WI*

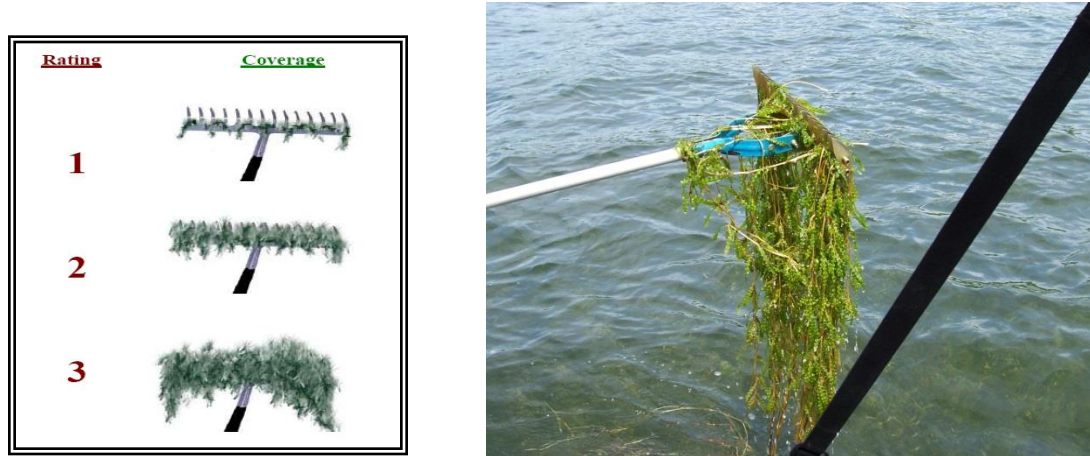
Figure 2: Density rating system and example CLP rake sample.

The second survey is referred to as the post treatment survey. This survey involves going to the same GPS coordinates as the pre-treatment survey and doing a rake sample at the point. If any CLP is on the rake, the density of the CLP is recorded (see fig 2 for reference). All other species are also recorded from the rake sample in order to verify no damage to the native plants.

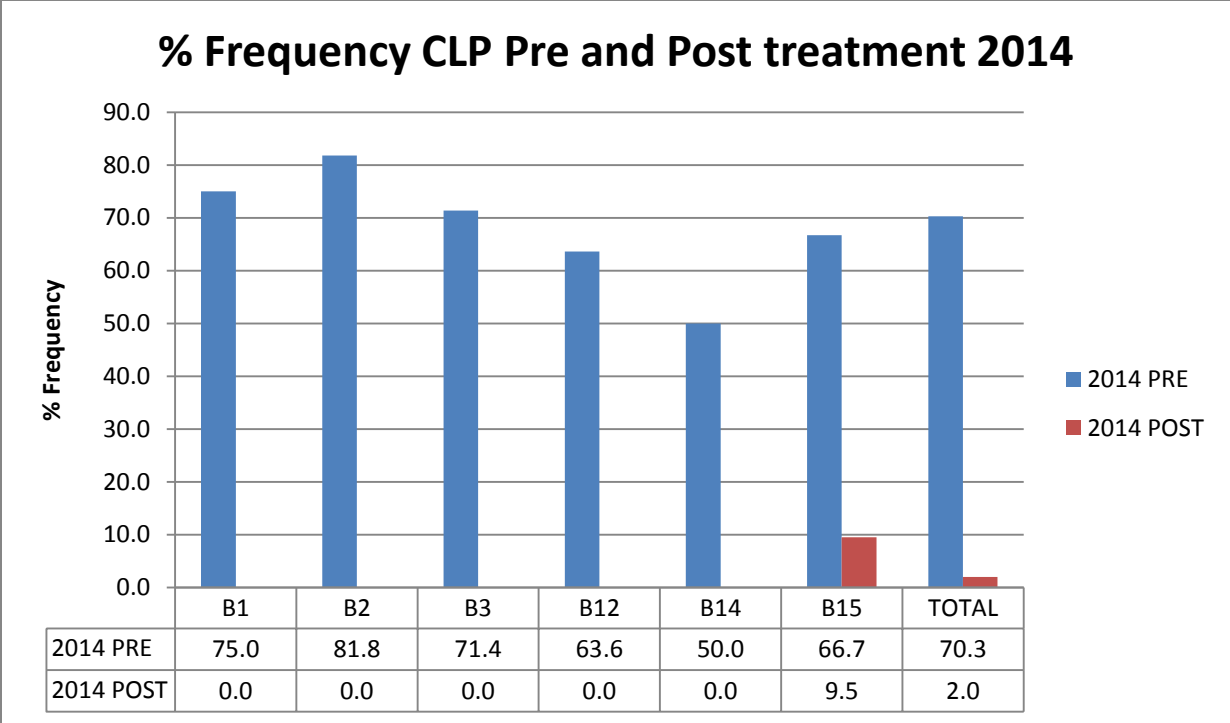
Figure 7: Graph depicting the reduction in CLP growth from pre to post treatment 2014.

The frequency reduction from the 2014 pretreatment CLP growth to the 2014 post treatment growth was significant ($p=1.2 \times 10^{-24}$). All beds showed a reduction, most of which were quite substantial. The overall reduction (all beds considered) was from a frequency of 70.3% to a frequency of 2.0%. This demonstrates an effective reduction of CLP growth from herbicide treatment.

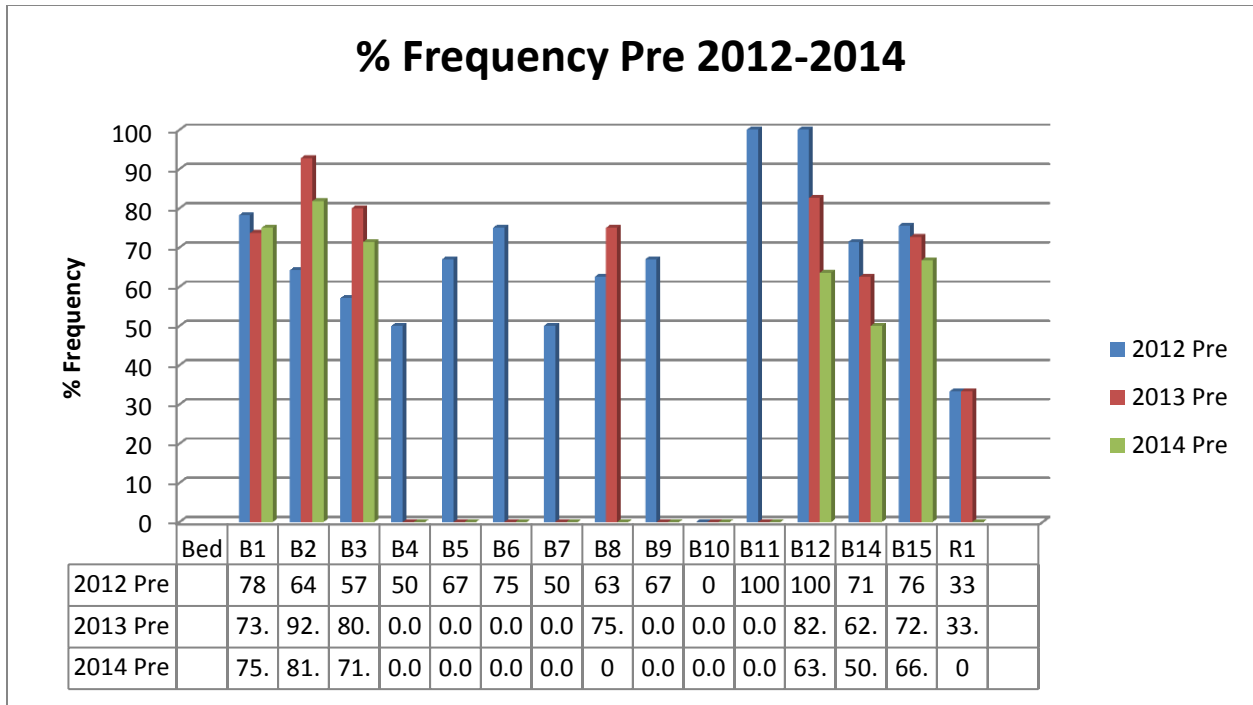
Figure 9: Graph showing the pretreatment CLP frequency in each bed, 2012-2014. Note the lack of frequency of beds in 2013 and 2014. This shows the CLP has been significantly reduced in those beds.

In addition, a frequency reduction occurred from the pretreatment survey in 2013, to the pretreatment survey in 2014. This reduction was quite small, but the chi-square analysis

indicates it was statistically significant ($p=0.04$). This is a good indication of long-term CLP reduction.
