Curly-leaf Pondweed (*Potamogeton crispus*) Pre/Post Herbicide and Bed Mapping Surveys Balsam Lake - WBIC: 2620600 Polk County, Wisconsin

Endangered Resource Services, LLC
Matthew S. Berg, Research Biologist
St. Croix Falls, Wisconsin

May 19, June 16, and June 20, 2013

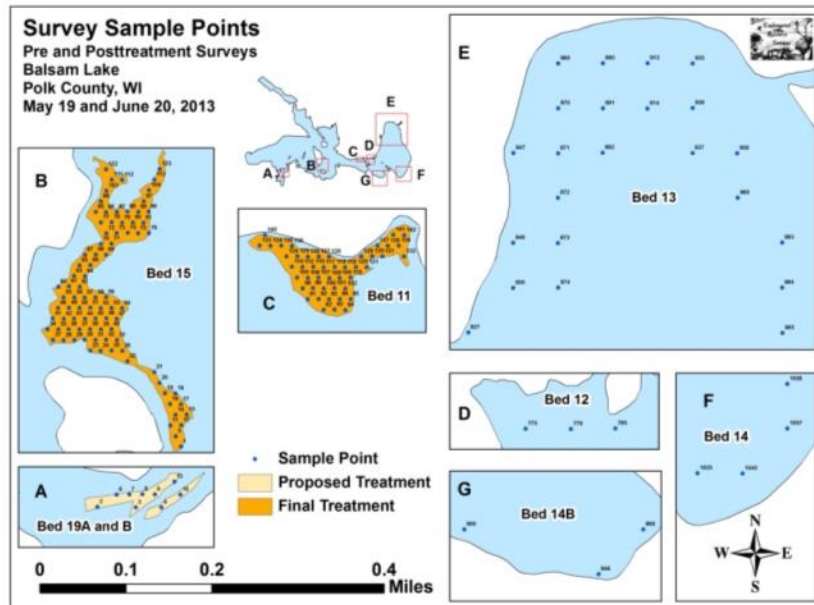
Figure 3: 2013 Pre/Post Survey Points and CLP Treatment Areas

The proposed treatment areas covered 14.38 acres or approximately 0.70% of the lake's 2,054 total acres. However, after surveying these areas on May 19th, we found CLP was rare to absent in Beds 19A and 19B. Because of this, they were eliminated from the treatment plan bringing the final total to down 13.41 acres or 0.65% of the lake's surface area (Table 1) (Figure 3) (Appendix I).

Treatment occurred on June 3rd, 2013 with Lake Restoration, Inc. (Rogers, MN) applying Aquathol K (Endothall) at a rate of 1.5 ppm (64.16 total gallons). The reported water temperature at the time of treatment was 65.4°F. Unfortunately, this value is higher than the recommended treatment temperature range of 50 - 60°F. Wind speeds were reported to be 3-5mph.
