AQUATIC PLANT SURVEY  
AND  
AQUATIC PLANT MANAGEMENT PLAN

CAMP AND CENTER LAKE  
KENOSHA COUNTY, WISCONSIN

Camp and Center Lake Rehabilitation District

October, 1995

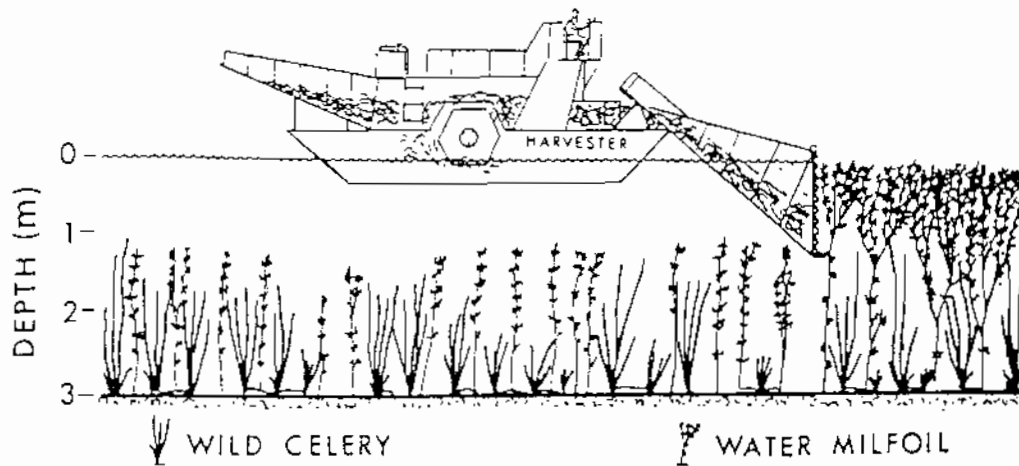
Figure Two - Selective harvesting by varying the cutting depth can promote the growth of desirable species (Engel, 1987).

Limiting disruption of native aquatic plant beds meets long-term lake management goals by maintaining plant materials for recolonization of areas of the lakes which now may be dominated by nuisance species. The cyclic nature of Eurasian milfoil, improvements in watershed protection and general effectiveness of the harvesting program may promote improved conditions for the increased densities of desirable native species whose growth forms and biomass production tendencies may be more compatible with lake uses (Engel, 1987, Nichols et al, 1988). For example, most pondweeds, wild celery, and water stargrass are desirable native species that generally do not become nuisance species. These species most often grow in lower densities than the nuisance plants and provide excellent wildlife and fish resources. Through the limited or reduced harvesting of these and similar species, their populations may flourish and compete with the "weedy" species that are being continually harvested. The protection of the desirable species will provide natural "seedbanks" or "plantbanks" for re-establishment into other areas of the lakes. Figure Two shows the implementation of this type of management strategy. Appendix H provides a flow chart to assist with the development of harvesting strategies based on the aquatic plant density and composition of that cutting period.

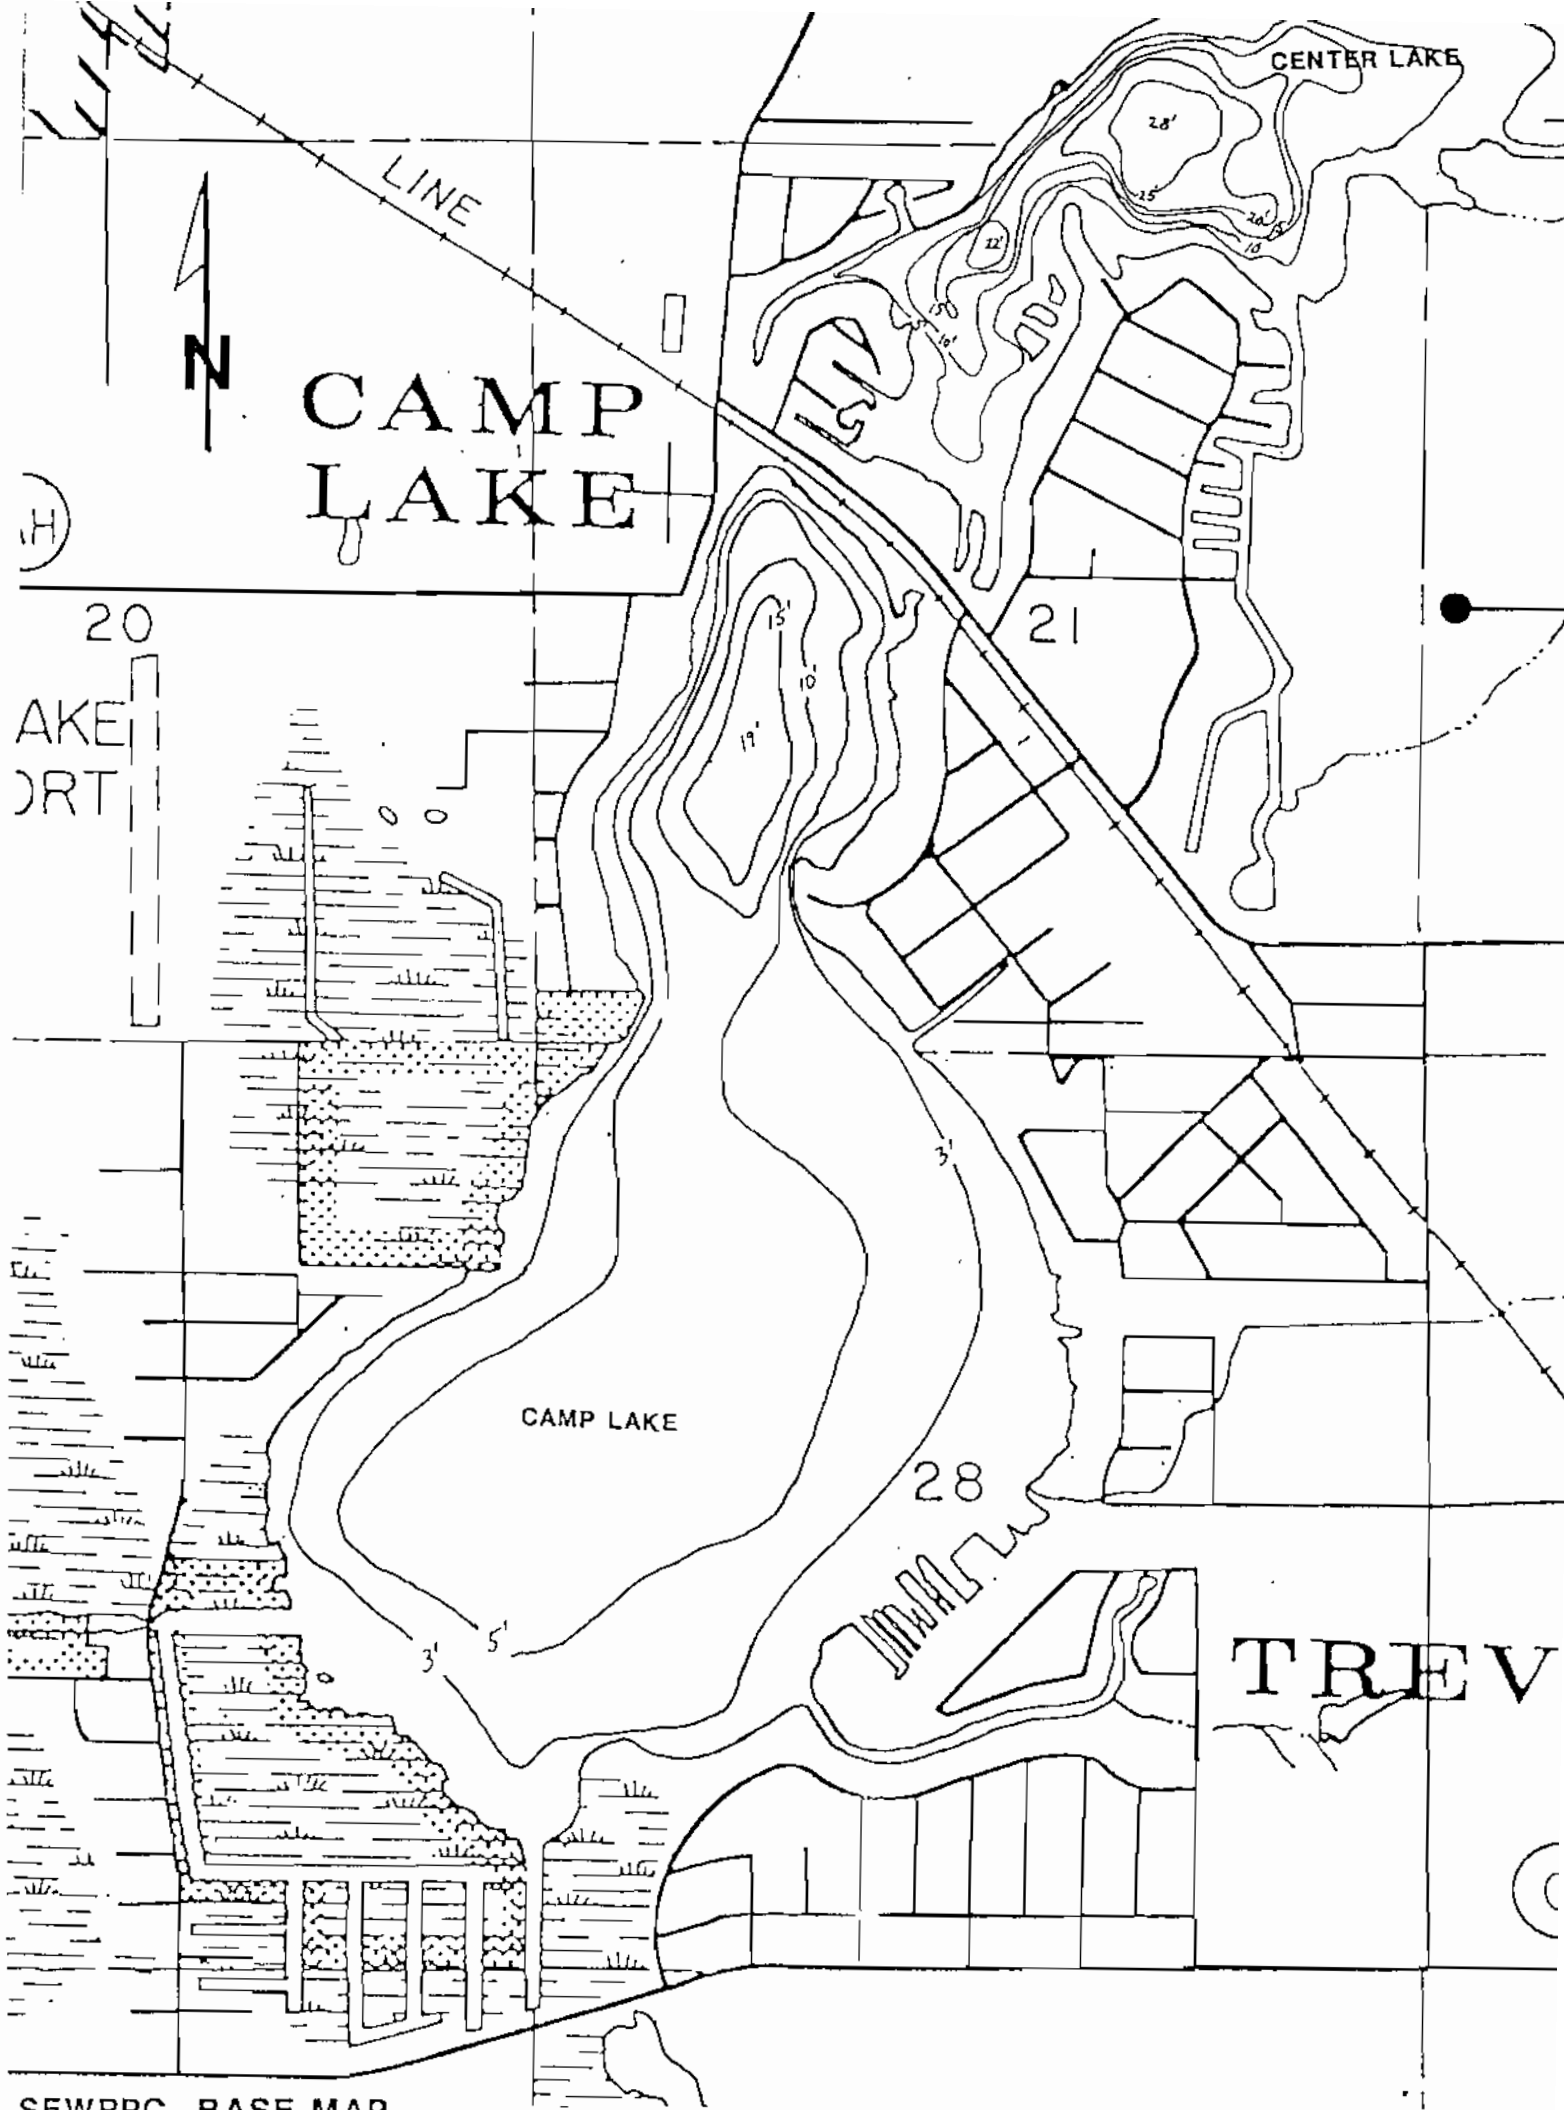
Camp Lake is susceptible to winterkill, with a maximum depth of 19 feet. Center Lake's maximum depth is 28 feet. The bathymetric map for both lakes is provided as Exhibit 3

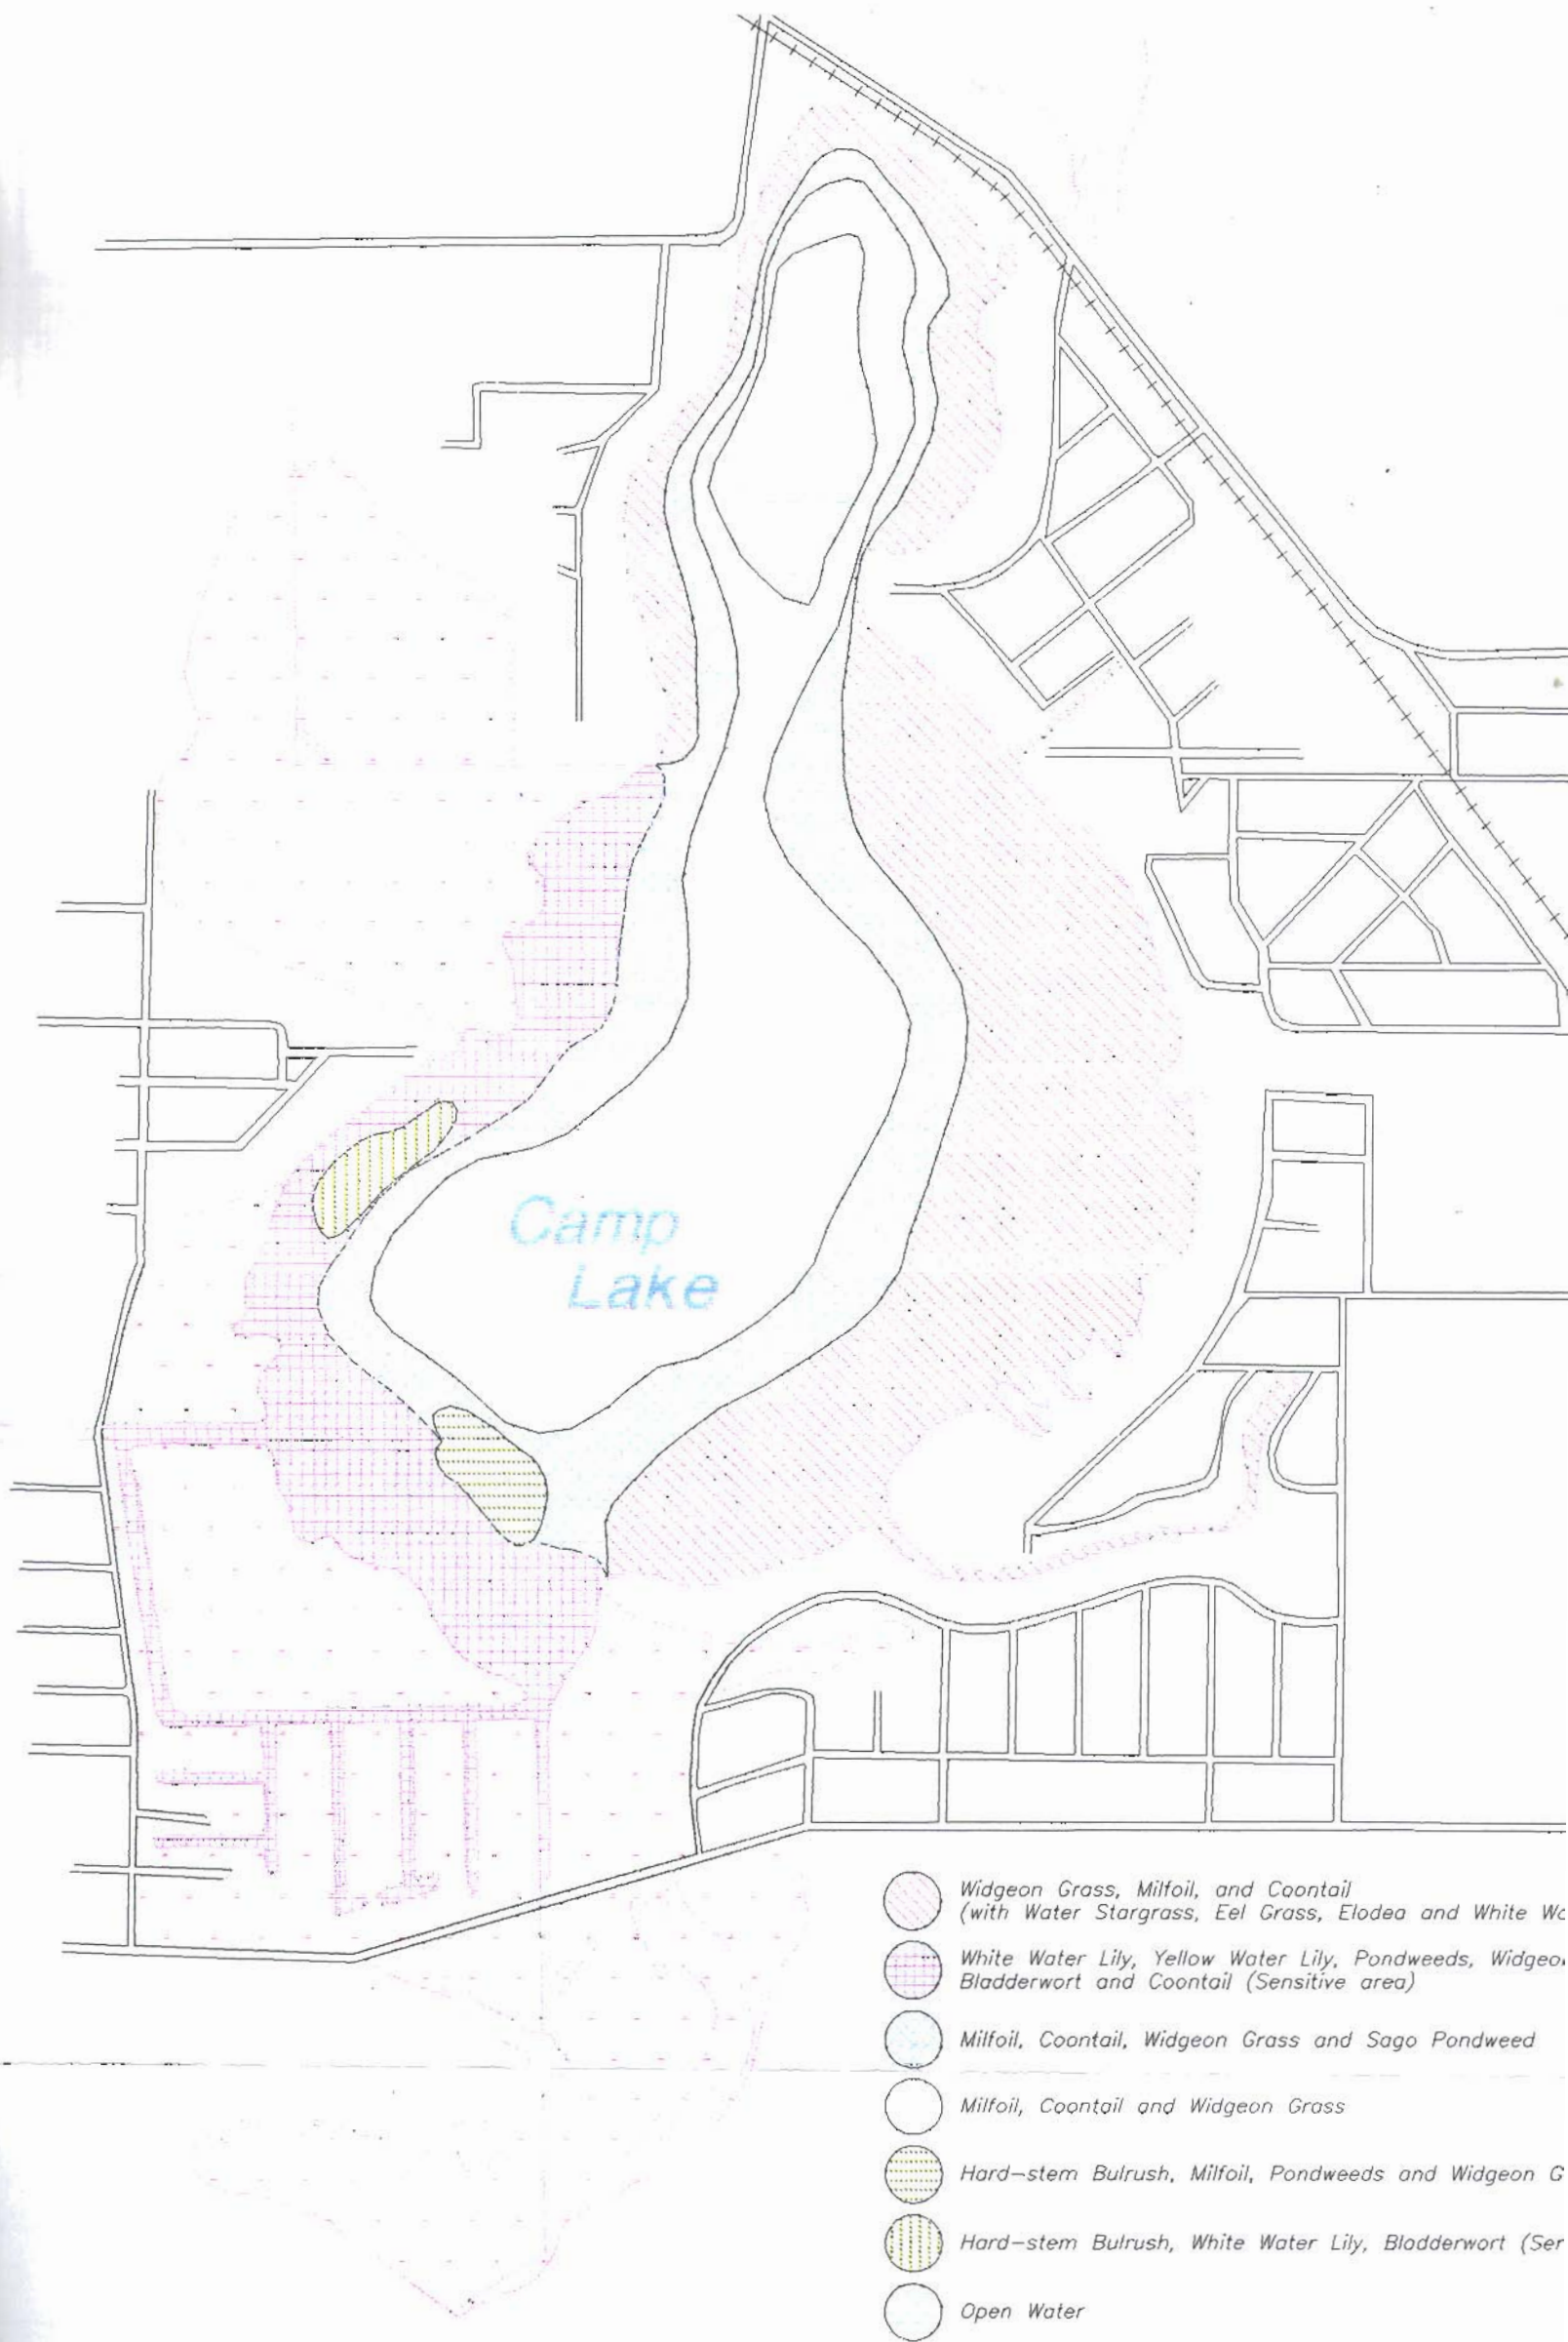
**Vegetation Communities  
Camp Lake**

- Widgeon Grass, Milfoil, and Coontail  
(with Water Stargrass, Eel Grass, Elodea and White Water Lily)*
- White Water Lily, Yellow Water Lily, Pondweeds, Widgeon Grass, Bladderwort and Coontail (Sensitive area)*
- Milfoil, Coontail, Widgeon Grass and Sago Pondweed*
- Milfoil, Coontail and Widgeon Grass*
- Hard-stem Bulrush, Milfoil, Pondweeds and Widgeon Grass*
- Hard-stem Bulrush, White Water Lily, Bladderwort (Sensitive area)*
- Open Water*

A total of 15 transects were surveyed during late-July, 1993 to categorize the vegetation communities and distribution within Camp Lake (Exhibit 4). Exhibit 5 is an aquatic vegetation map representing the dominant species within major depth categories. Average Secchi depth was 4 feet during the sampling period. Maximum rooting depth was 15 feet, with vegetation found consistently to that depth. The littoral zone occupies 96% of the lake area, with only 16 acres devoid of submerged or emergent vegetation. A total of 32 species were encountered during the transects surveys (Table 3). Species occurring along shorelines in very shallow water or in riparian wetlands were not included in the species list. Appendix A provides the summary data tables of the results of the rake surveys along the designated transects. Appendix B provides transects summary data. Appendix C are the summary statistics of the depth categories.
