AN AQUATIC
PLANT
MANAGEMENT
PLAN FOR
LAKE
BEULAH

Prepared for
The Lake Beulah
Management District
and
The Lake Beulah Protective
and Improvement Association
June, 1996
by
Lynn Carlson, Glenn Kreinbrink
and Phil Davis

FOR
LAKE BEULAH
WALWORTH COUNTY, WISCONSIN
1996

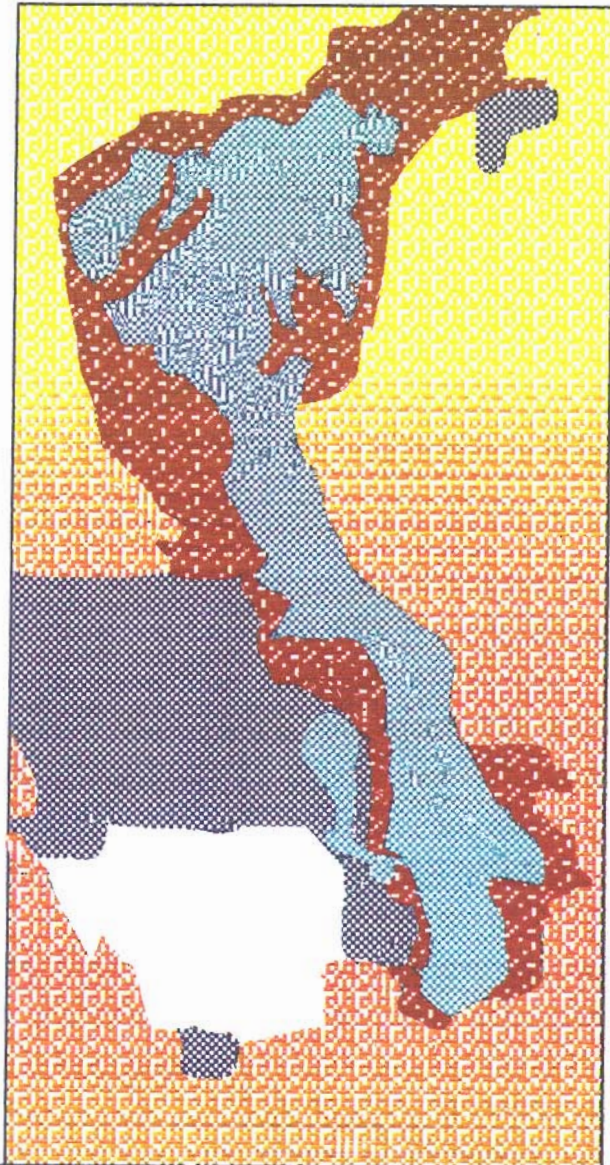
Map Number6 Land Use Plan

Land immediately adjacent to the lake is primarily all residential as shown in Map# 6. The one major exception is the large strip of shoreline that stretches between Camp Edwards, on the North and the Seminary on the South, which is zoned rural-agricultural. However, a large part of that area is either steeply sloped or is part of one of the sensitive areas (Sensitive Area #6, defined earlier) that is made up of wetlands and marsh and is not suitable for either agricultural or residential use. Opportunities for any new development around the lake are very few.

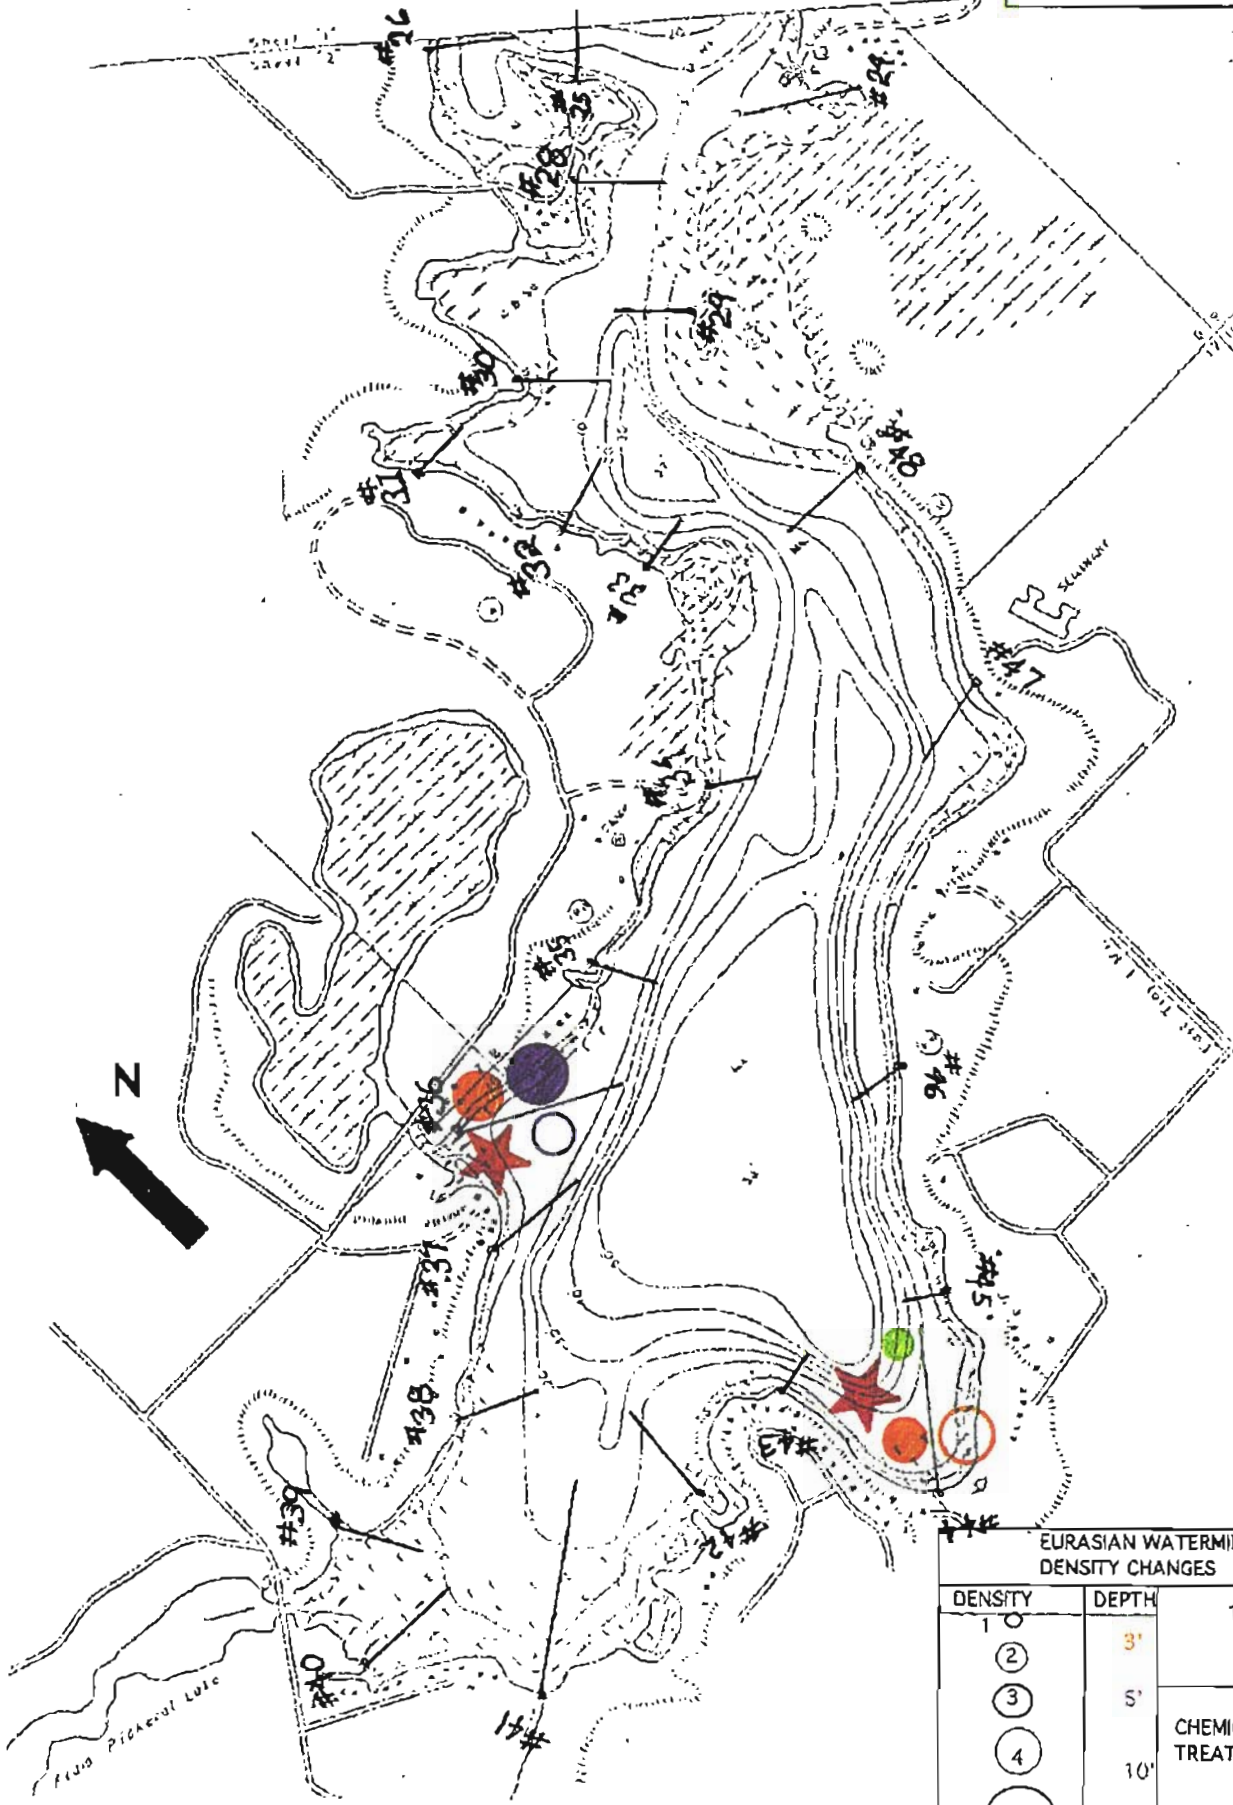
EURASIAN WATERMILFOIL DENSITY CHANGES

DENSITY	DEPTH	1995	1999
1		○	●
2	3'	○	●
3	5'		
4	10'		
5	15'		
		CHEMICALLY TREATED 1999 ★
