HORSESHOE LAKE, BARRON AND POLK COUNTIES

2014 AQUATIC PLANT MANAGEMENT SUMMARY REPORT WDNR WBIC: 2630100

Prepared by: Dave Blumer, Lake Educator

April 1, 2015

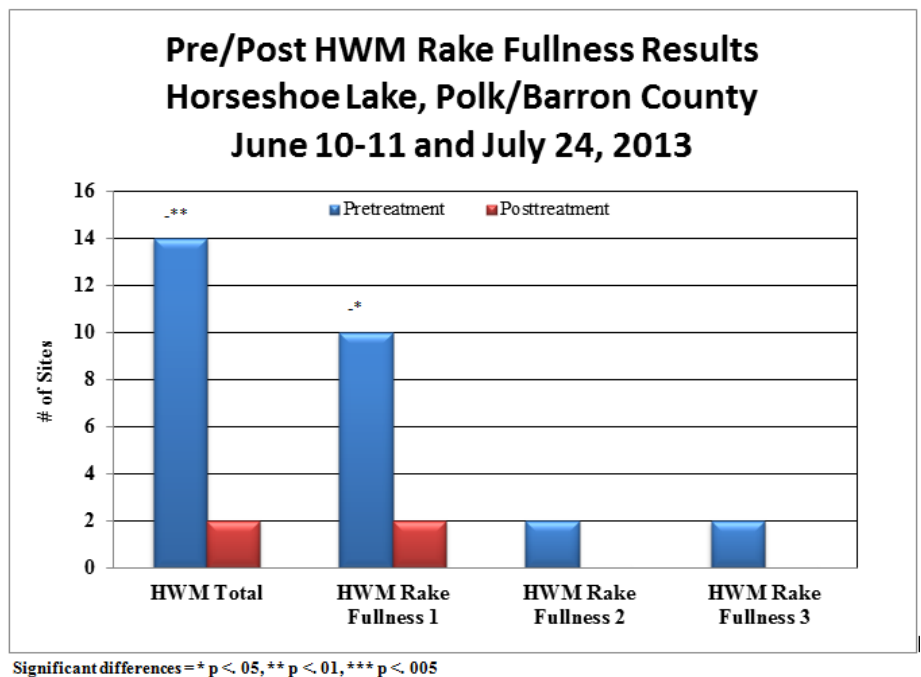
Figure 3: Pre/Post Changes in HWM Rake Fullness (ERS, 2013)

During the post-treatment survey, no HWM was found in any of the treatment areas. This decrease in total HWM was moderately significant (Figure 3).

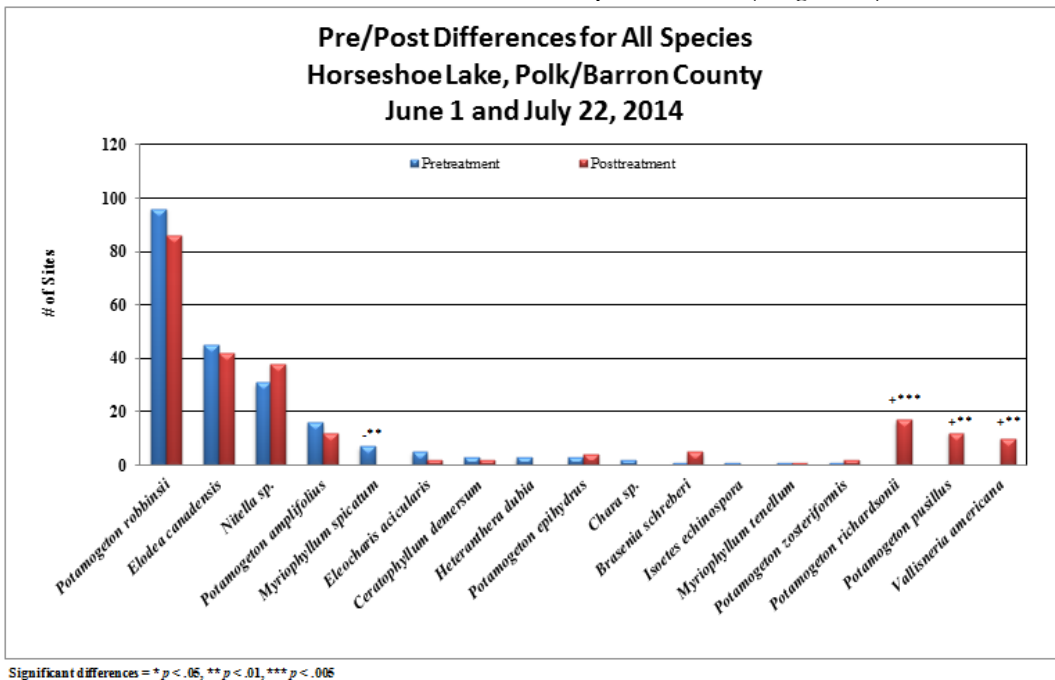
Figure 4: 2014 Pre/post changes in aquatic plants

Fern pondweed and common waterweed were the two most common native species in both the pre and post-treatment surveys and neither showed a significant change post-treatment. No species other than HWM showed a significant decline post-treatment (Figure 11). Conversely, clasping-leaf pondweed showed a highly significant increase post-treatment, and small pondweed and wild celery showed moderately significant increases. More information related to the pre and post-treatment survey including species maps is available in Hybrid Eurasian X Northern water milfoil (*Myriophyllum spicatum* X *Myriophyllum sibiricum*) Pre/Posttreatment and Fall Bed Mapping Surveys Horseshoe Lake - WBIC: 2630100 Polk/Barron County, Wisconsin (Berg, 2014).

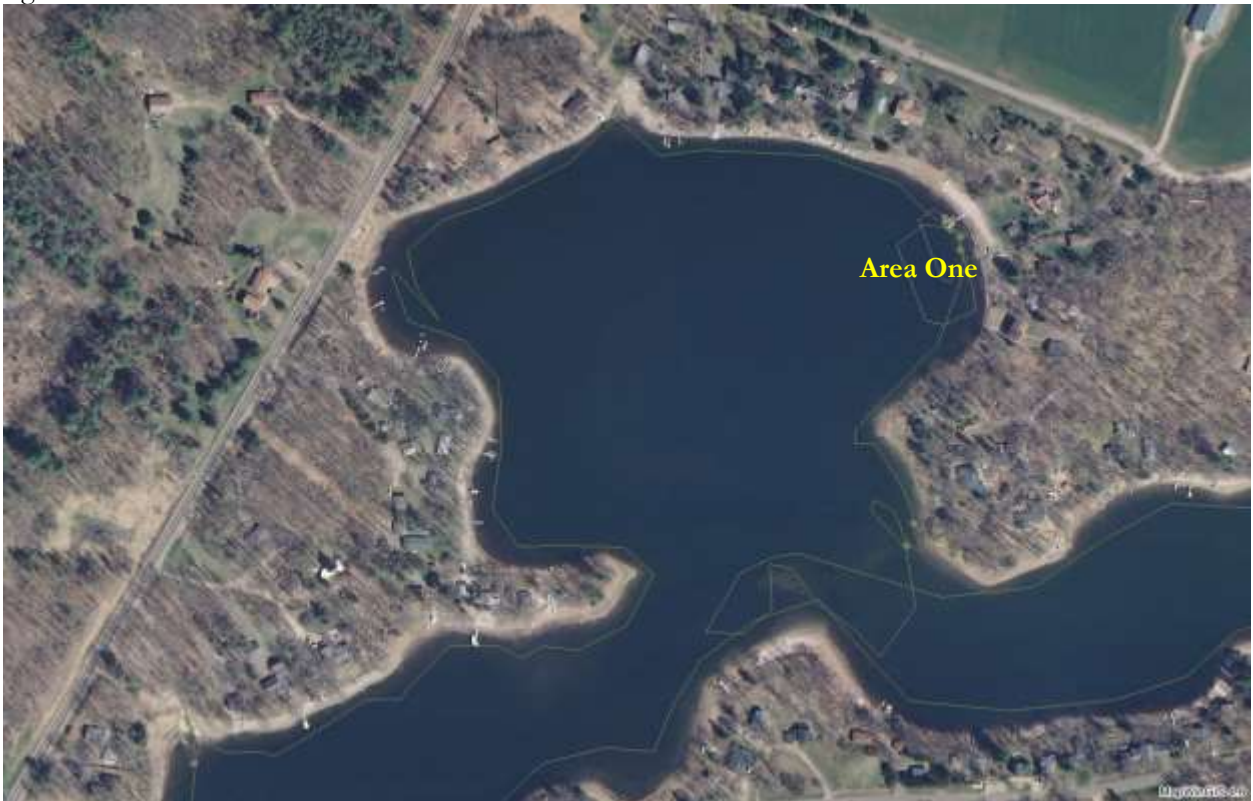
Figure 5: 2014 EWM weevil survey, Area One.

53 stems of hybrid EWM were collected by hand from Area One (Figure 5) in the northwestern-most bay on the northeast shore on July 30, 2014. Fragments were put in ziplock bags and stored in a cooler and refrigerator until inspection was completed. Stem density in the area was sparse, but shoreland was close by with both disturbed and natural shoreline. Stem length was from approximately 15-40 inches. All 53 stems were inspected on July 31. No stage of the EWM weevil was identified. No adults, eggs, larva, or pupa were found, and no blast holes or stem damage were noticed.

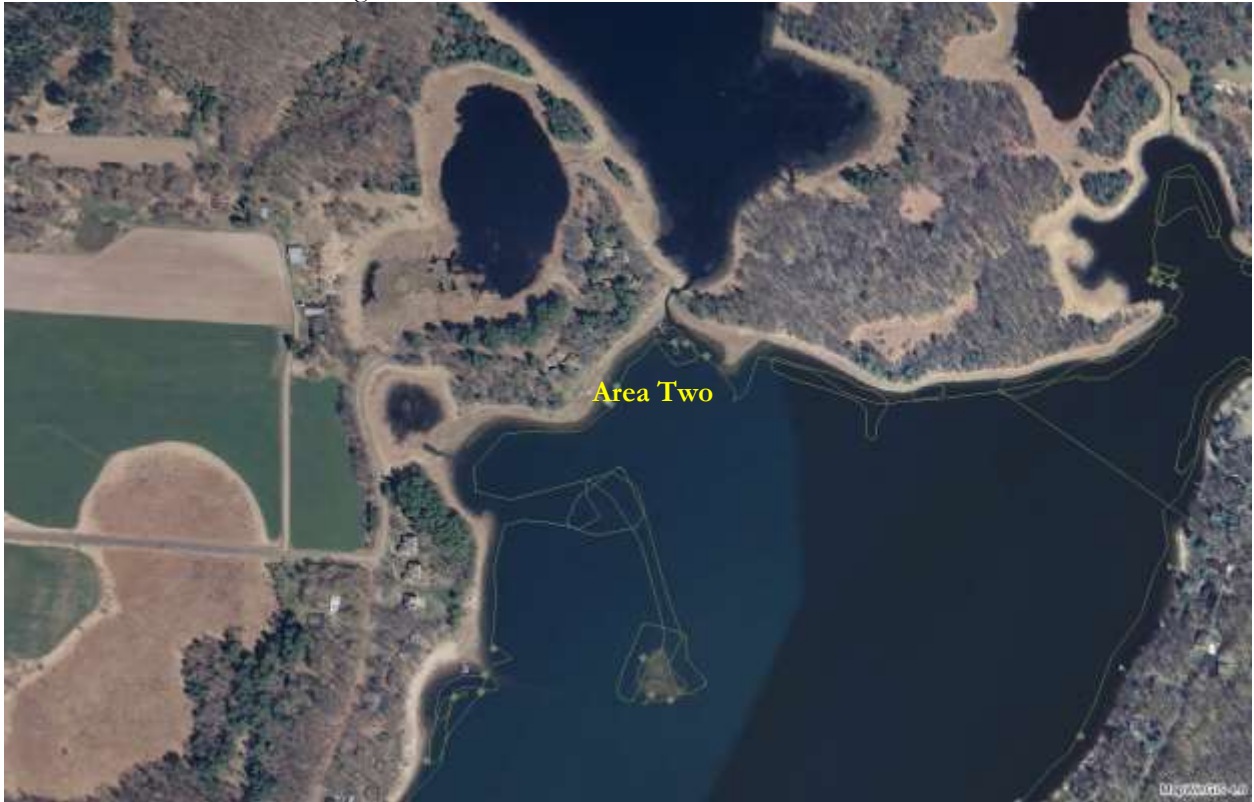
Figure 6: 2014 EWM weevil survey, Area Two

20 stems of hybrid EWM were collected by hand from Area Two (Figure 6) in the northeastern mid-section of the lake on July 30, 2014. Fragments were put in ziplock bags and stored in a cooler and refrigerator until inspection was completed. Stem density in this area was sparse with only a few stems or small clusters of stems. The shoreline in this area was completely natural, except there was a sand beach area of approximately 5-ft between the waters' edge and natural ground cover. Stem length was from approximately 15-40 inches. All 20 stems were inspected on July 31. No stage of the EWM weevil was identified. No adults, eggs, larva, or pupa were found. One blast hole was identified, but no other stem damage was noticed.

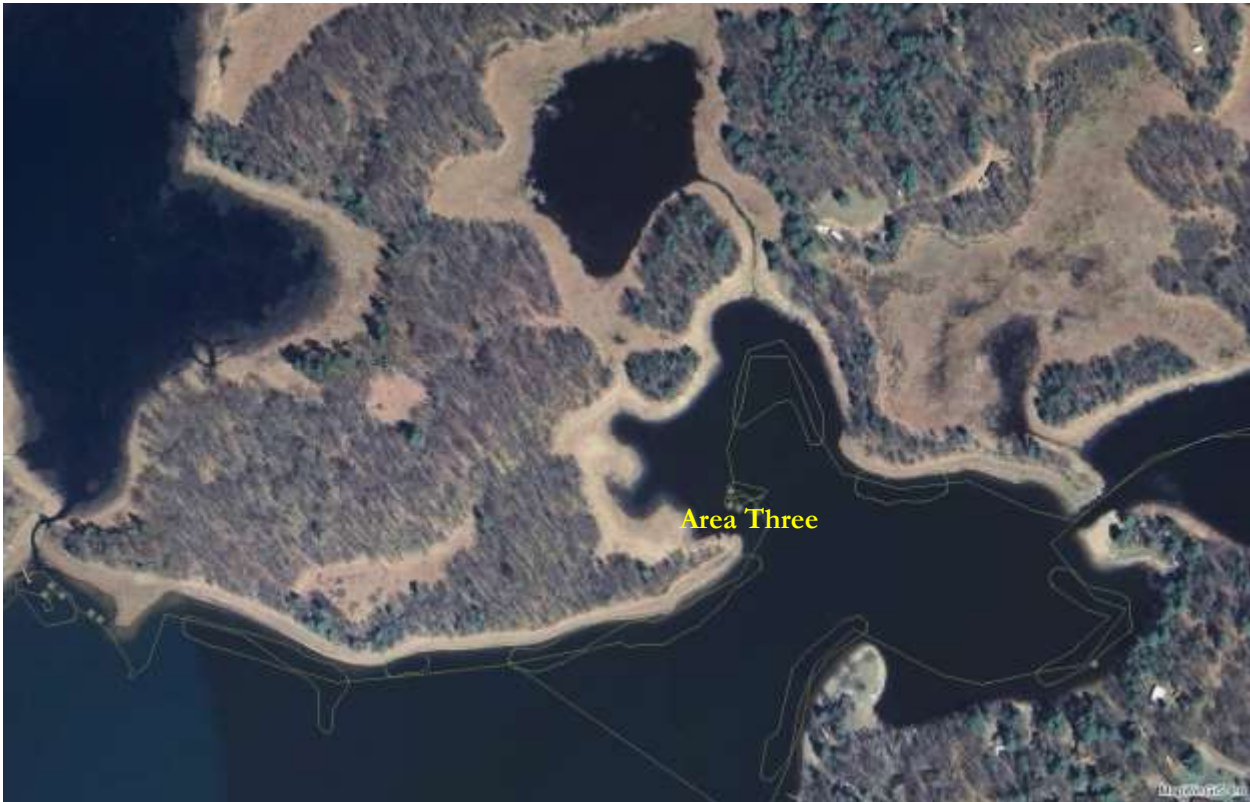
Figure 7: 2014 EWM weevil survey, Area Three

30 stems of hybrid EWM were collected by hand from Area Three (Figure 7) just inside the small bay on northeastern end of the lake on July 30, 2014. Fragments were put in ziplock bags and stored in a cooler and refrigerator until inspection was completed. Stem density in this area was moderate with dozens of individual plants and small clusters. This was the only area on the lake that even approached “bed status”. The shoreline in this area was completely natural. Stem length was from approximately 15-40 inches. All 30 stems were inspected on July 31. No stage of the EWM weevil was identified. No adults, eggs, larva, or pupa were found. No blast holes or any other stem damage was noticed.

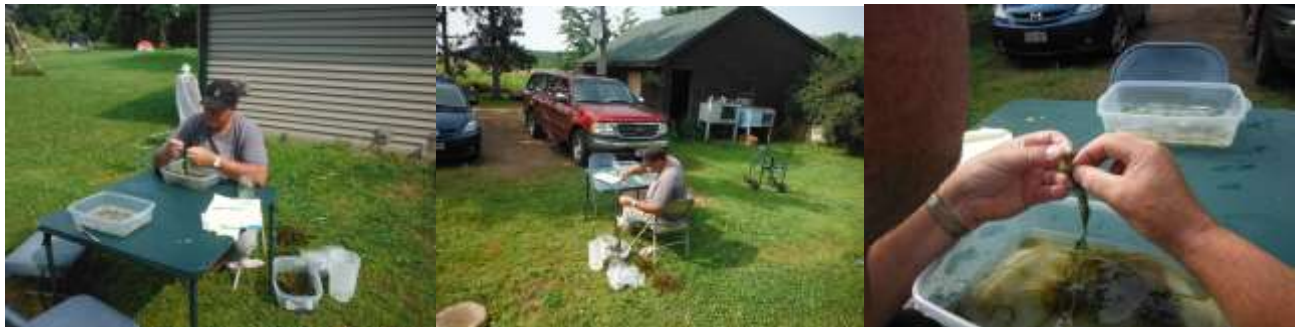
Figure 8: 2014 EWM weevil inspection completed by LEAPS

More than 100 stems were collected and inspected looking for the presence or indicators of the presence of EWM weevils (Figure 8). None were found.

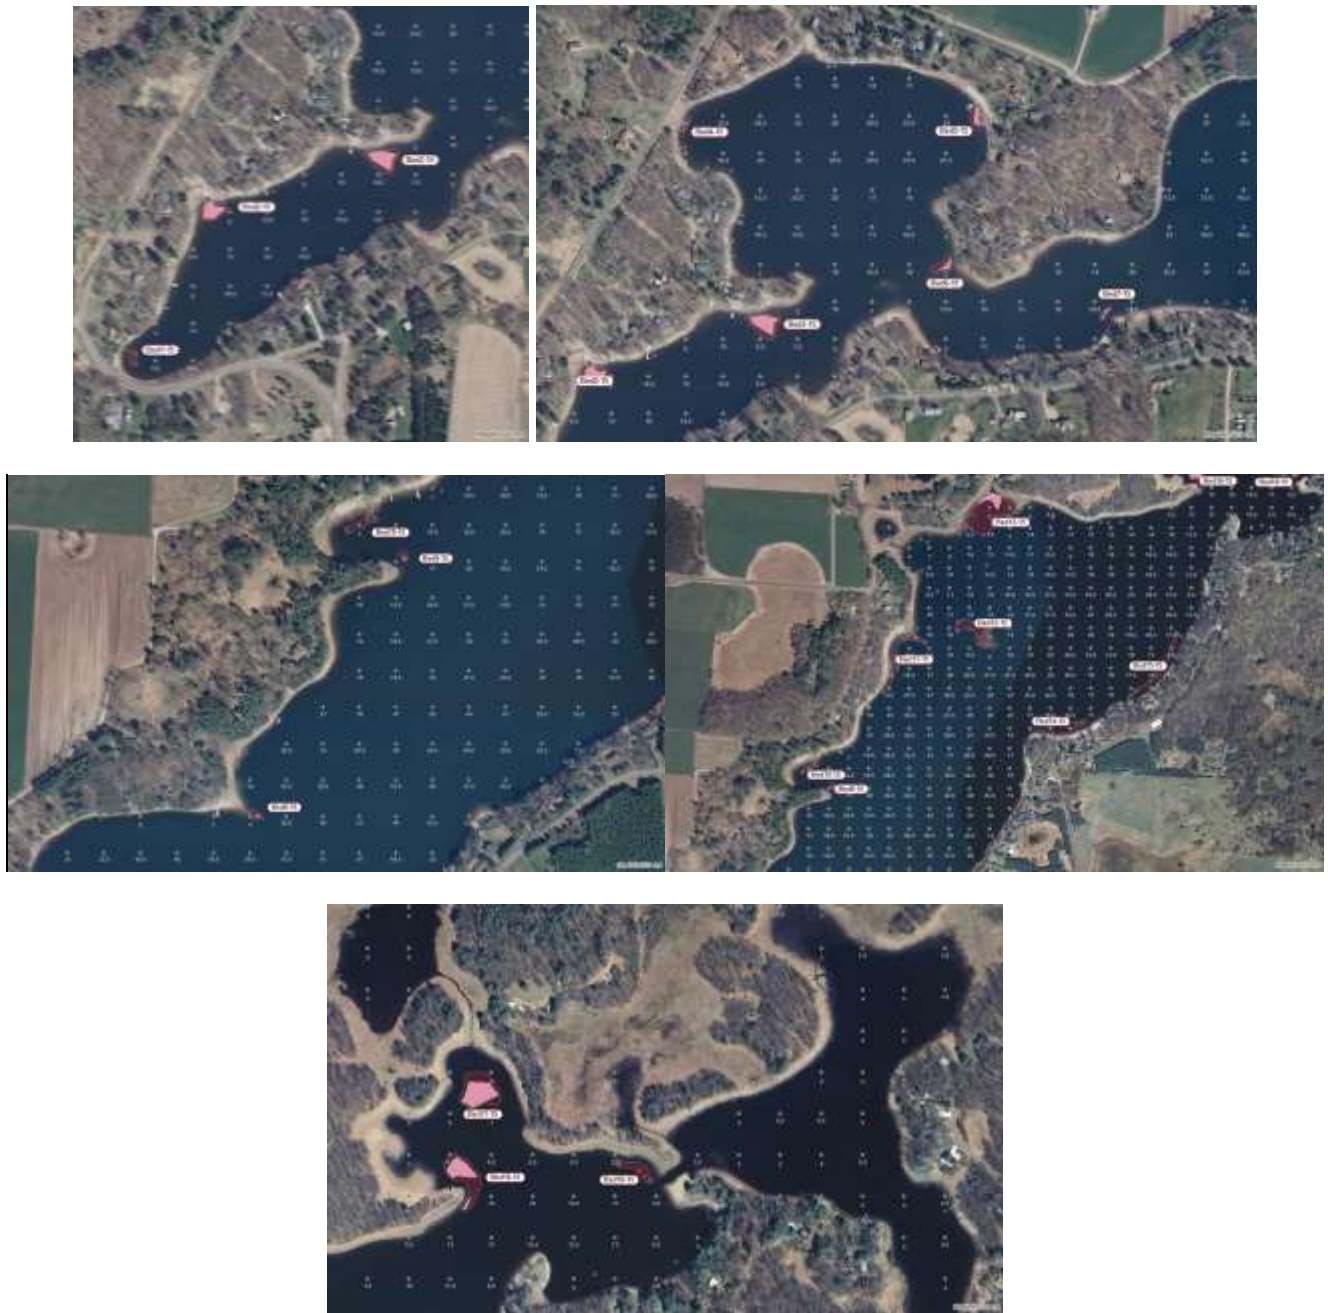
Figure 10: 2015 Proposed treatment areas

A HWM treatment proposal has been made for 2015 that includes 17 beds totaling 3.89 acres using Navigate granular herbicide at 3.5 - 4.0 ppm and 1 bed of 2.1 acres using DMA 4, a liquid herbicide with the same active ingredient (2,4-D), at 3.5 ppm. The concentration of herbicide used depends on bed size and average depth of the treatment area (Table 3, Figure 10). Larger treatment areas (>1.5 acres) may be treated with liquid 2,4-D herbicide rather than granular. The HWM treatment for 2015 was proposed prior to modifications in the management criteria necessary to consider the use of aquatic herbicides, but does generally follow the new guidelines being suggested in the new APM Plan. The new APM Plan has not been approved by the HLIA or the WDNR so management in 2015 still falls under the guise of the existing APM Plan written in 2010. Future HWM management proposals will follow guidelines ultimately approved in the new APM Plan. Aquatic plant survey work to support management will be similar to past survey work, although the post-treatment survey will likely be combined with a bed mapping survey and done later in the season. Fall HWM bed-mapping would then be discontinued.

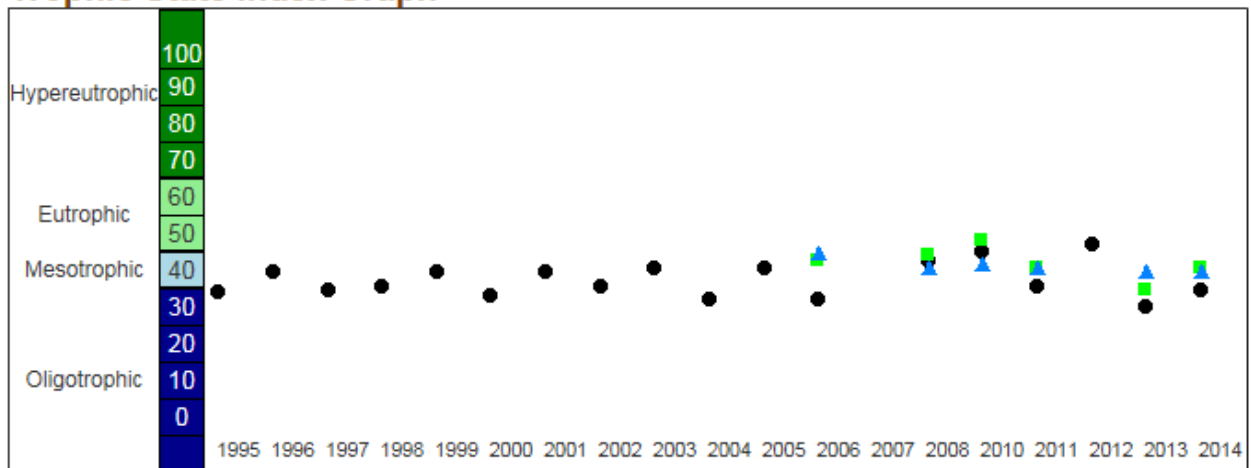
Figure 12: Summer (July and August) TSI values for total phosphorus and chlorophyll-a at the Deep Hole on Horseshoe Lake

Figure 12 shows the average summer Trophic State Index (TSI) value for total phosphorus, chlorophyll, and Secchi disk readings. The overall Trophic State Index in 2014 (based on chlorophyll) for the Deep Hole in Horseshoe Lake was 51. The TSI suggests that Horseshoe Lake at the Deep Hole in 2014 was eutrophic. This TSI usually suggests decreased clarity, fewer algal species, oxygen-depleted bottom waters during the summer, plant overgrowth evident, and a warm-water fishery (pike, perch, bass, etc.) only.

CLMN chemistry data collected in 2014 at the Deep Hole in Horseshoe Lake showed an average summer Chlorophyll level of 8.78µg/l (compared to a Northwest Georegion summer average of 16.6µg/l). The summer Total Phosphorus average for 2014 was 15.25µg/l. Lakes that have more than 20µg/l of total phosphorus may experience noticeable algae blooms.
