Curly-leaf pondweed (*Potamogeton crispus*)

Pre/Post Herbicide Turion Surveys

Big Chetac Lake – WBIC: 2113300

November 1-2, 2014

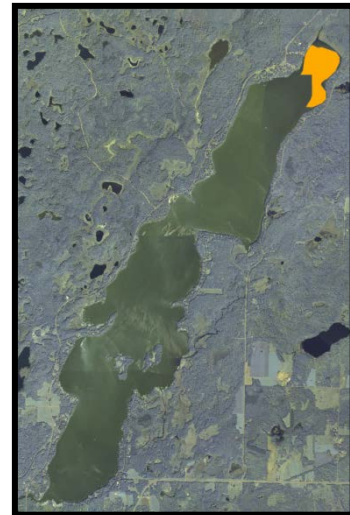
2014 - Posttreatment Turion Density

2014 Final CLP Treatment Area

Overall mean turion density in the treatment area decreased by 35.1% (46.29 turions/m²) when compared to fall 2013 (71.33 turions/m²), and by 70.8% when compared to the pretreatment baseline (158.59 turions/m²). Despite this positive outcome, we noted that it was less than the 50% decline we would have expected if the treatment had killed all turions that should have germinated. This may mean that some turions germinated after the treatment due to the late spring, or it could mean that conditions allowed for a “second crop” in late summer when additional CLP plants germinated, grow, and set turions. In the control areas, mean density increased 57.5% over fall 2013 levels to 138.68 turions/m². Densities in the treatment area were much less variable (± 74.52) compared to fall 2013 (± 142.93). The control areas’ standard deviation jumped sharply to ± 138.68 (up from ± 88.07 in fall 2013).

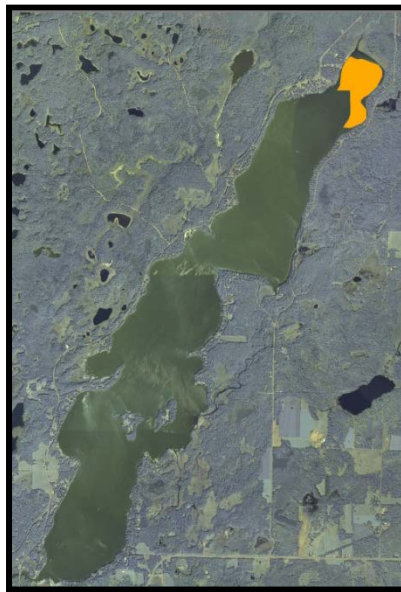
Figure 1: 2014 Spring CLP Treatment Area

In 2013, after years of study and discussion among board members, residents, local businesses, and the WDNR, the Big Chetac Chain Lake Association applied for and received a 3 year WDNR exotic species control grant to begin actively managing CLP chemically and manually. After evaluating the 2008 maps, it was decided to treat 90 acres in the north bay in 2013 (Treatment was also initially proposed in the east side public boat landing bay, but, out of concern for the Northern wild rice (*Zizania palustris*) in the "Bull Pen" bay directly south of the landing, no treatment occurred here in either 2013 or 2014). Following the posttreatment and fall CLP turion surveys in 2013, it was decided to treat the same 90 acre area in 2014 (Figure 1).

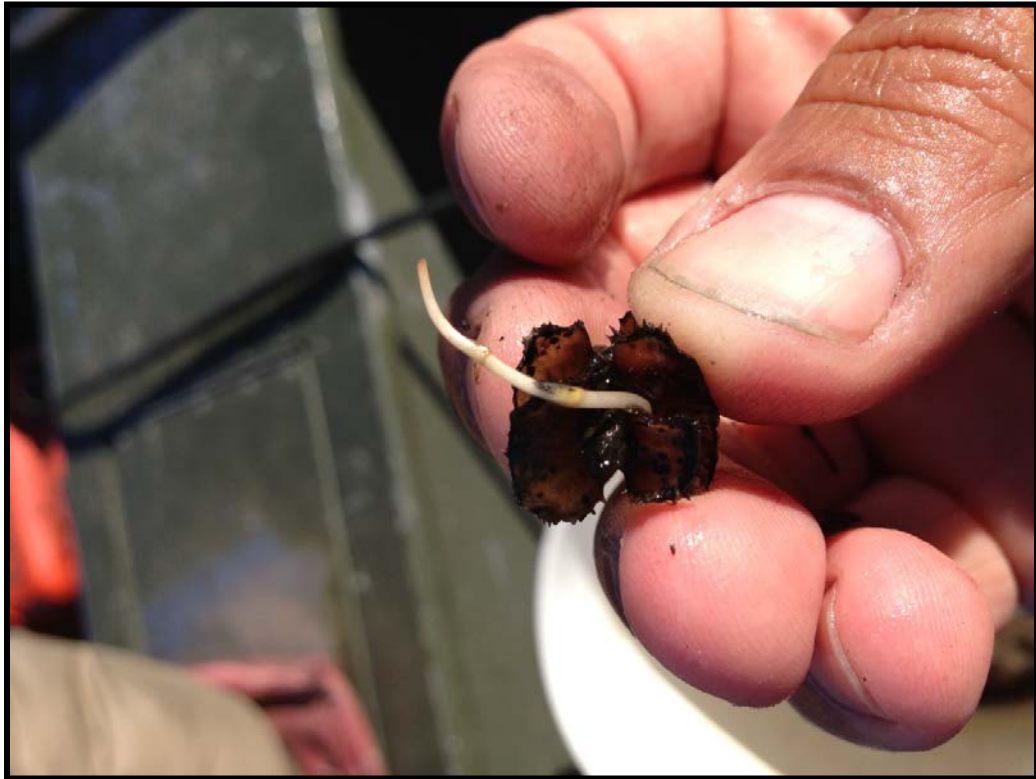
Figure 2: Germinating CLP Turion – North Bay of Big Chetac

Although Curly-leaf pondweed occasionally reproduces by seed, the vast majority of plants resprout from stiff overwintering buds called turions that are normally produced in number by the plants prior to their late June/early July senescence (Figure 2). After the pinecone-like turions germinate in late fall or early winter, plants continue to grow slowly under the ice. Following ice out, growth accelerates, and plants rapidly canopy allowing them a competitive advantage over slower growing native species (Capers 2005).

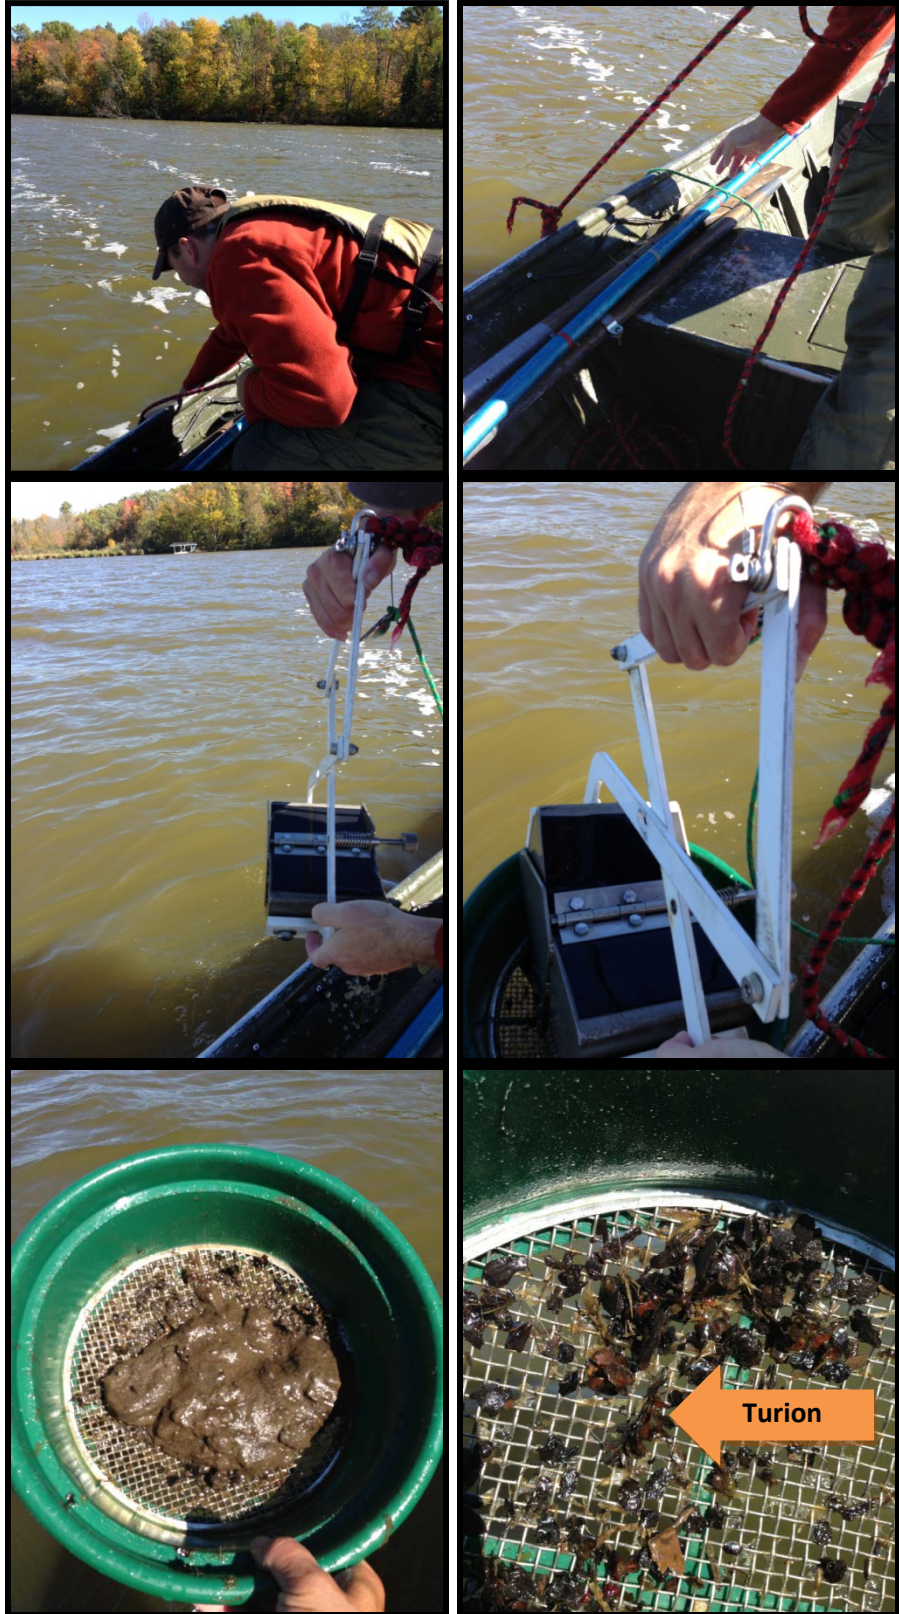
Figure 4: Ponar Grab and Turion Sieving

During the surveys, we located each point with a handheld mapping GPS unit (Garmin 76CSx) and used a Petite Ponar dredge with a 0.0232m² (36in²) sample area to take a bottom sediment grab from each side of the boat at each location. These samples were then rinsed in a fine sieve to separate out the sediment and detritus (Figure 4). We discarded all rotten turions, tallied all live turions, and multiplied the combined total live turions from the two samples by 21.5 to get an estimate in turions/m² at each location. This value gives an idea of how many CLP plants will germinate in an area in 2015.

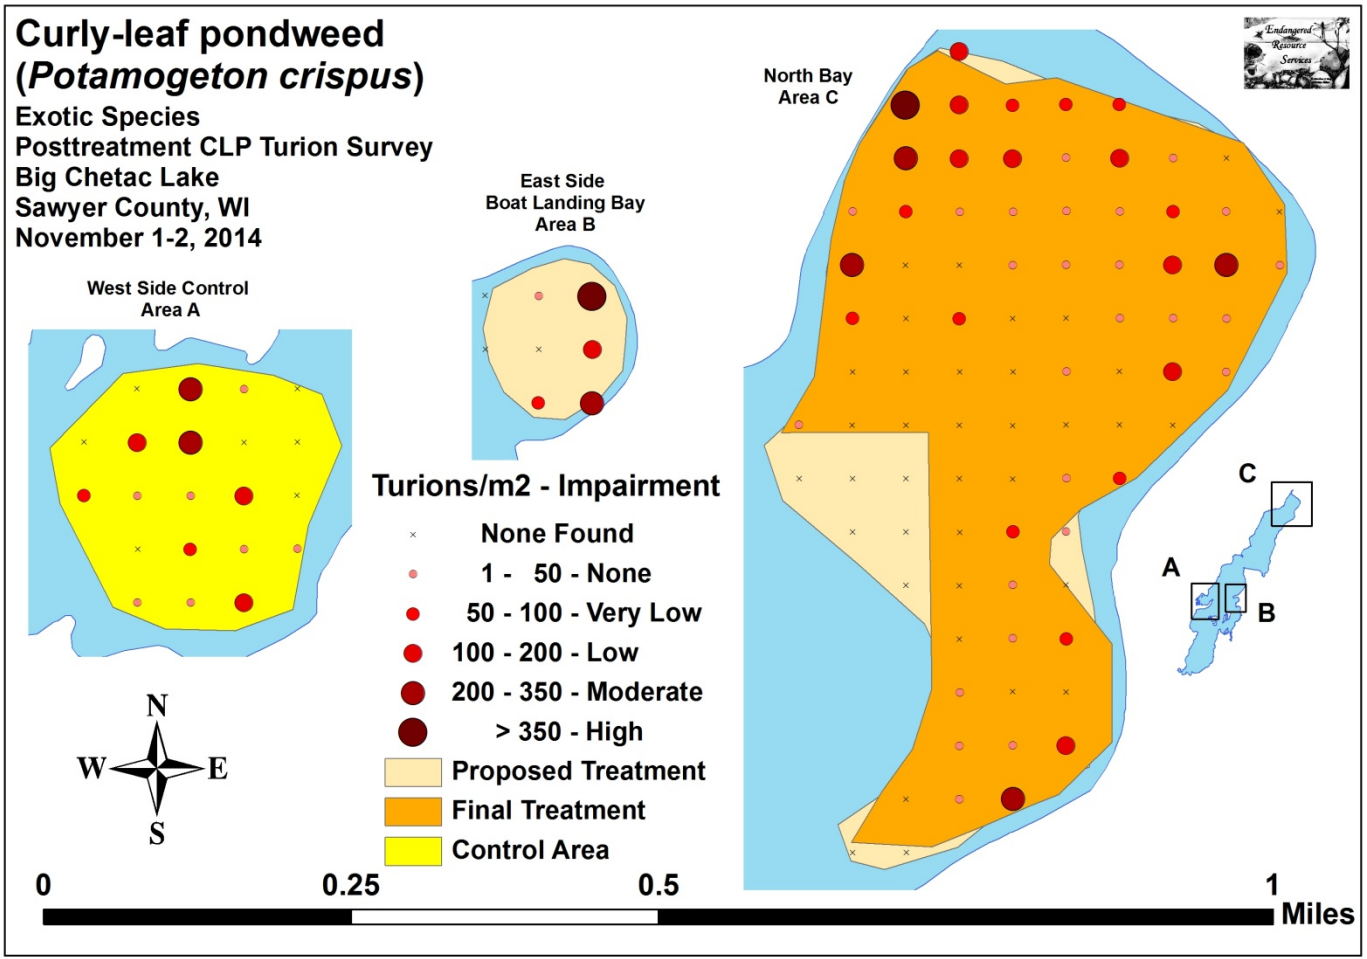
- × None Found
- 1 - 50 - None
- 50 - 100 - Very Low
- 100 - 200 - Low
- 200 - 350 - Moderate
- > 350 - High
- Proposed Treatment
- Final Treatment
- Control Area

When compared to September 2013, the November 2014 survey demonstrated a 12.5% reduction in overall turion coverage in the north treatment area with 49 of 85 points having live turions present (57.65%) (Figure 8) (Appendix II). This was also a nearly 33% reduction from the 73 points turions were found at during the original 2013 baseline pretreatment survey. In the control bays where coverage fell 8.7% in 2013, we found turions at 19 points suggesting a further 9.5% decline (17.5% overall when compared to the original survey). As in fall 2013, we found that the majority of points in the treatment area still had viable turions. However, only five points (5.88%) were predicted to be at the nuisance level with densities >200 turions/m². This was a reduction of over 80% when compared to the 26 nuisance points (30.59%) in the original pretreatment survey. The control bays, which had experienced a 75% reduction in predicted nuisance coverage in 2013, jumped back to their baseline total of four points (13.79%).
