2013 Aquatic Plant Management Summary Report

2013 Aquatic Plant Management Plan Implementation
Barron County, Wisconsin

SEH No. RECLA 124338

Spring Treatment with Endothall to Control Curlyleaf Pondweed

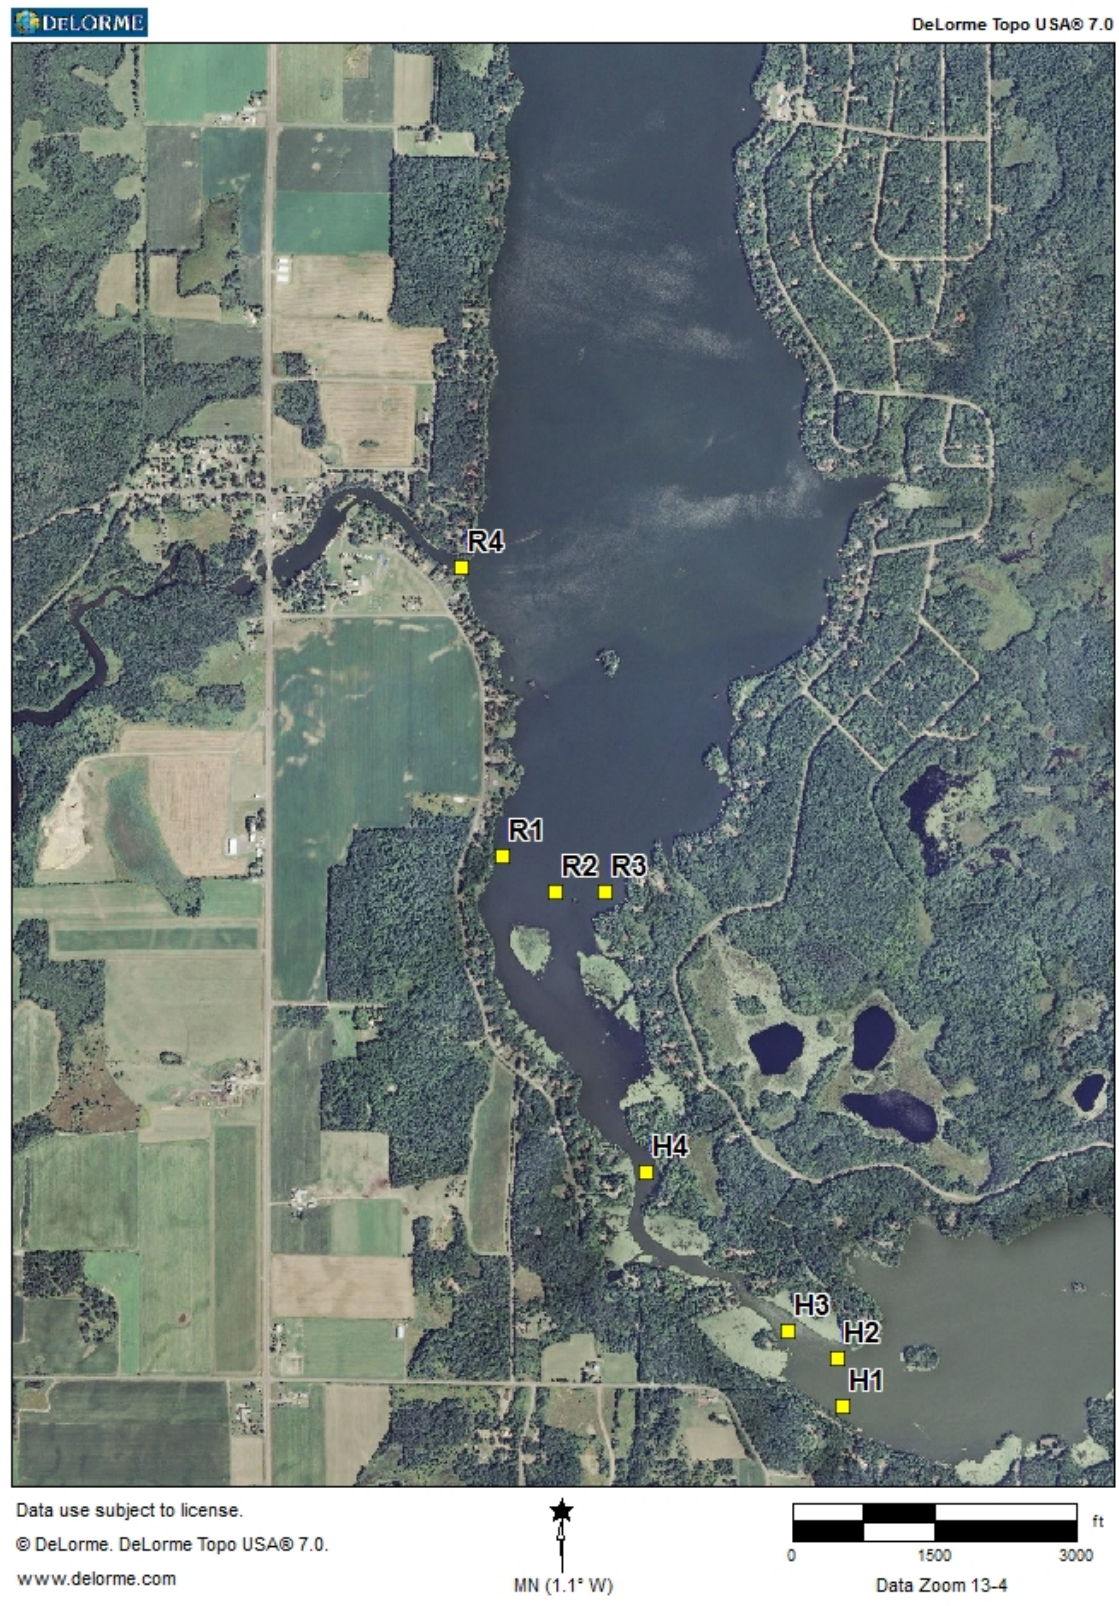
Figure 2. 2013 Red Cedar and Hemlock Lake Endothall Water Sample Sites

Three water sample locations were located in the Red Cedar Lake treatment area, and three water sample locations were located in the Hemlock Lake treated area (Figure 2). Additional sample sites were located in untreated areas near the outflow from Red Cedar Lake and in between the two treated areas. Water samples were collected from each sample site using an integrated water sampler which collects water from the entire water column. Water samples were collected at intervals of approximately 1, 3, 9, 12, 24, 48, and 72 hours after treatment (HAT) Samples were taken to shore after completion of each sample interval, and 3 drops of muriatic acid were added to each sample bottle to fix the endothall and prevent degradation. Samples were then stored in a refrigerator, until shipped to the US Army Engineer Research and Development Center (ERDC) laboratory in Gainesville, FL for analysis of endothall.

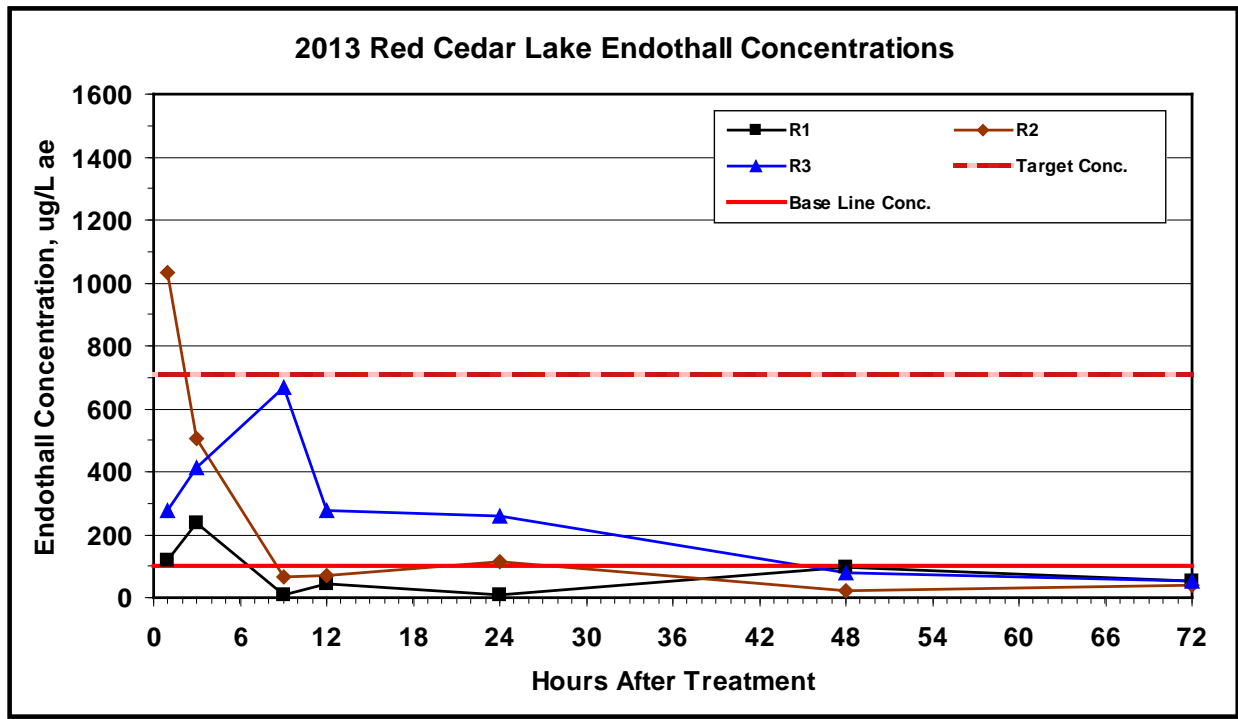
Figure 3

Endothall concentrations in samples collected from the Red Cedar Lake treatment area ranged from 10 to 1032 ug/L, 1 to 12 HAT (Figure 3). The mean endothall concentration at 1 HAT was 475 ug/L ae compared to the target concentration of 710 ug/L ae. All concentrations were less than a base line concentration of 100 ug/L ae by 48 HAT.

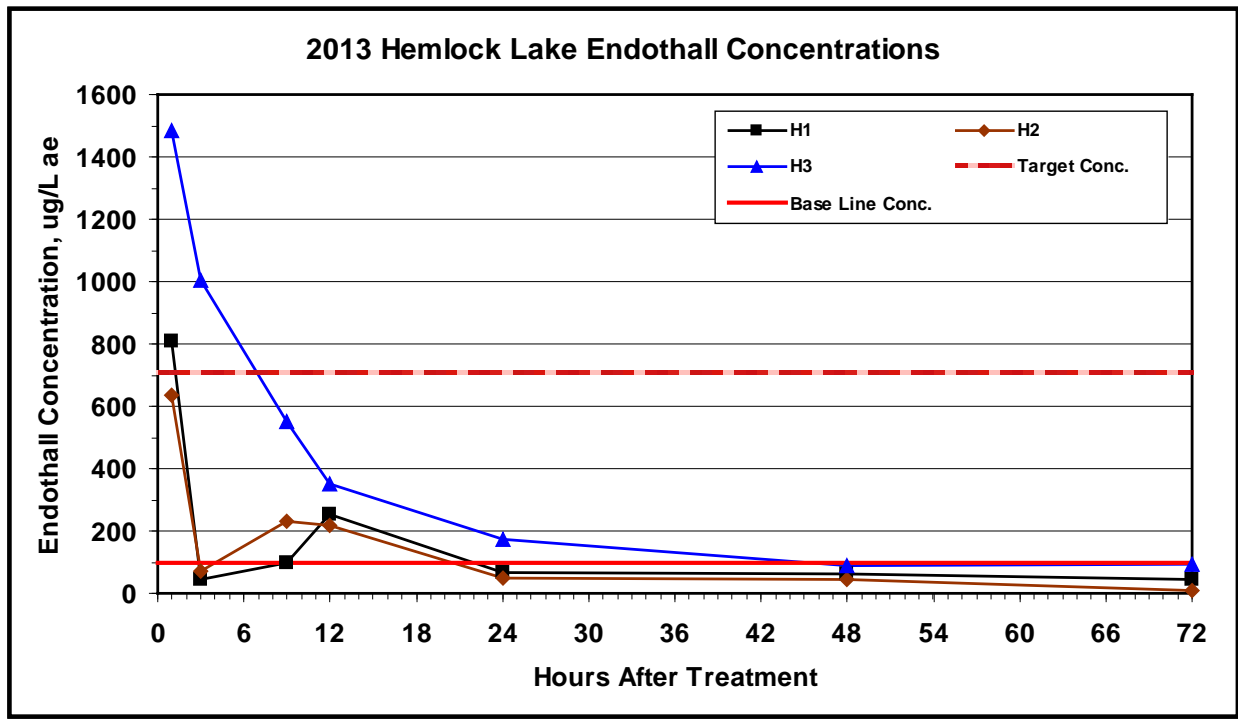
Figure 4

Endothall concentrations in samples collected from the Hemlock Lake treatment area ranged from 43 to 1482 ug/L, 1 to 12 HAT (Figure 4). The mean endothall concentration at 1 HAT was 976 ug/L ae compared to the target concentration of 710 ug/L ae. All concentrations were less than a base line concentration of 100 ug/L ae by 24 HAT.

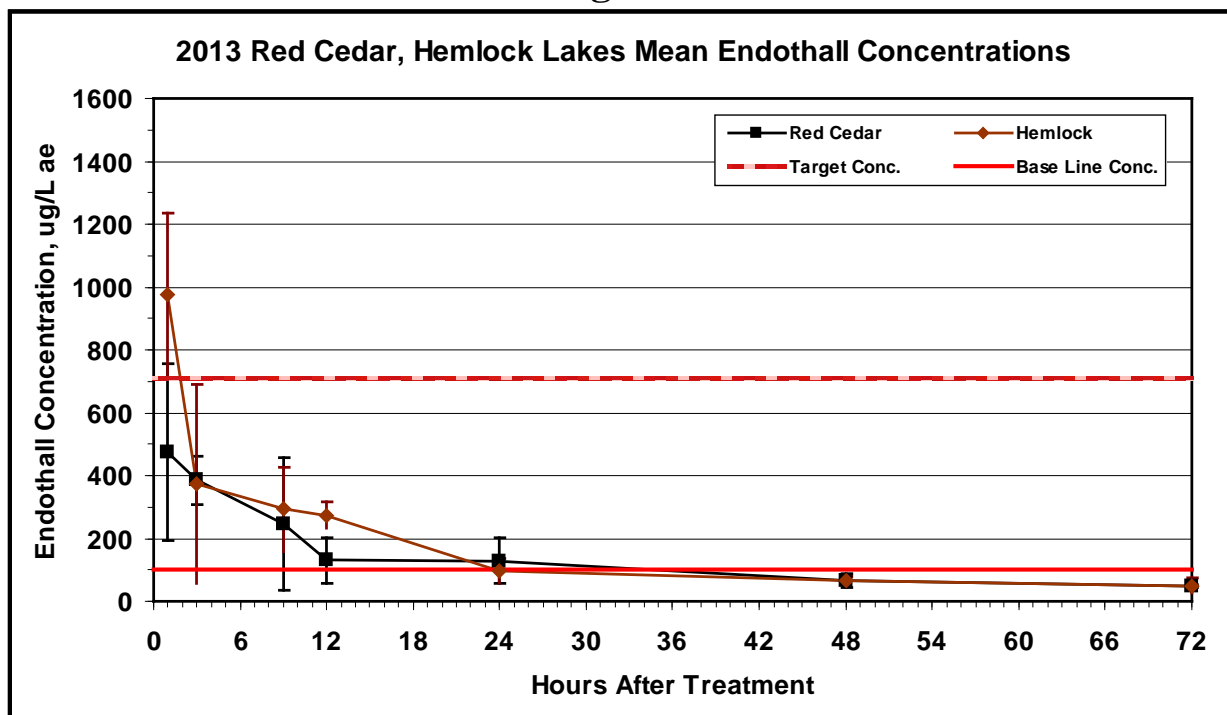
Figure 5

The mean peak endothall concentration from Red Cedar Lake was 475 ug/L ae at 1 HAT and 976 ug/L ae from Hemlock Lake at 1 HAT. Concentrations of endothall at 3 HAT were 385 ug/L ae in samples from Red Cedar Lake and 373 ug/L ae from Hemlock Lake. Mean endothall concentration data showed similar dissipation rates through 24 HAT (Figure 5) and were near or

less than the base line concentration of 100 ug/L ae by 24 HAT. Concentrations in all samples were less than 100 ug/L ae by 48 HAT.

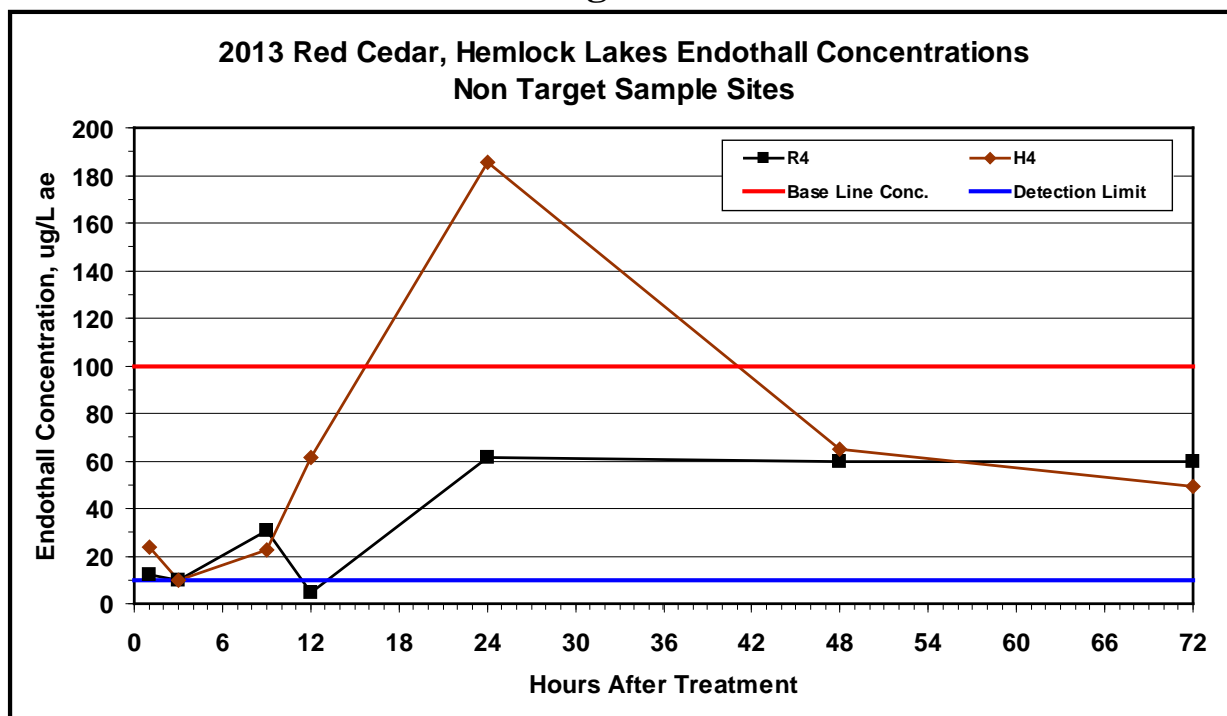
Figure 6

Concentrations of endothall in samples from non treated sample sites (R4 and H4) were mostly near or less than the detection limit of 10 ug/L ae (Figure 6). The endothall concentration in one sample collected from site H4 was greater than the base line concentration of 100 ug/L ae.
