# Eurasian water milfoil (*Myriophyllum spicatum*) Pre/Post Herbicide and Fall Bed Mapping Surveys Lower Vermillion Lake – WBIC: 2098200 Barron County, Wisconsin

Vermillion Lakes Association, Short Elliott Hendrickson Inc., and the Wisconsin Department of Natural Resources (Grant AIRR-108-12)

Endangered Resource Services, LLC

June 10, July 20, and October 13, 2013

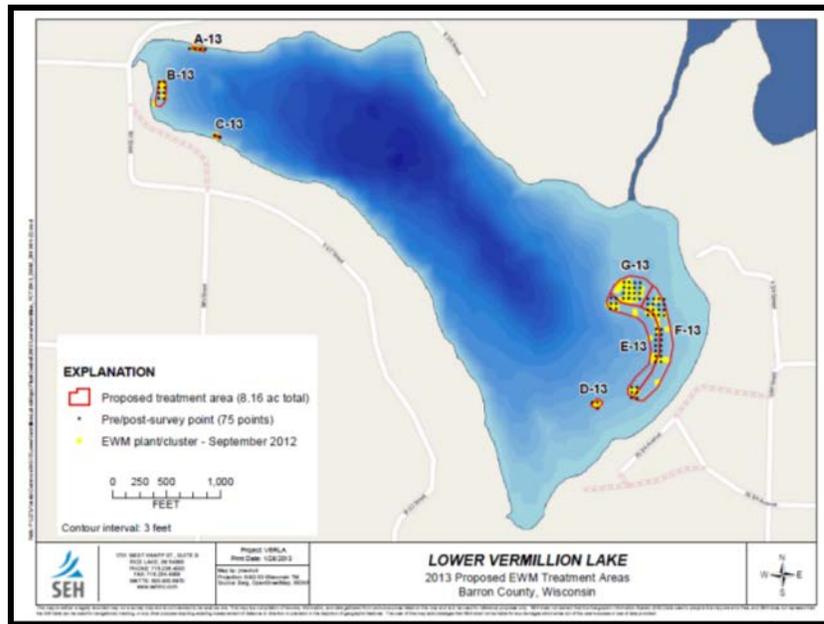
**Figure 1: 2013 EWM Treatment Areas**

In 2008, the Wisconsin Department of Natural Resources (WDNR) confirmed the presence of Eurasian water milfoil (EWM) (*Myriophyllum spicatum*) in Lower Vermillion Lake, and the Vermillion Lakes Association (VLA) has been actively working to control this invasive exotic species ever since. Following the 2012 fall EWM bed mapping survey that found EWM in scattered patches throughout the northwest bay near the boat landing and newly established in the broad eastern flat, the VLA, under the direction of Short Elliott Hendrickson Inc. (SEH) and in accordance with the WDNR approved Vermillion Lakes Aquatic Plant Management Plan, decided to chemically treat seven areas in 2013. Combined, they totaled 8.16 acres or 3.8% of the lake's total surface area (Figure 1).

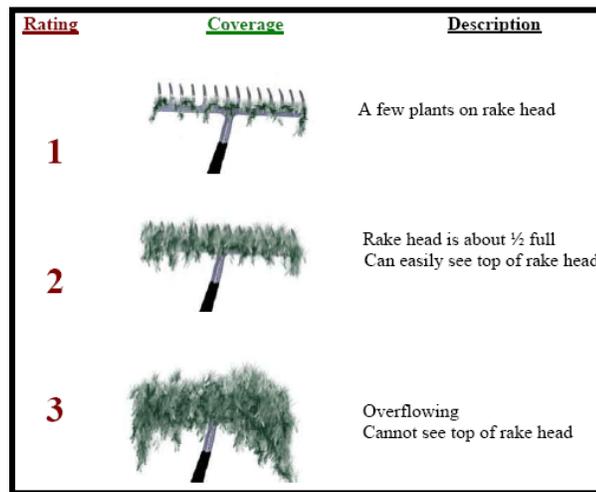
**Figure 2: Rake Fullness Ratings**

During the surveys, we located each of these points using a handheld mapping GPS unit (Garmin 76CSx) and used a rake to sample an approximately 2.5ft section of the bottom. All plants on the rake were assigned a rake fullness value of 1-3 as an estimation of abundance, and a total rake fullness for all species was also recorded (Figure 2). Visual sightings of EWM and Curly-leaf pondweed (*Potamogeton crispus*), another exotic invasive species, were noted if they occurred within 6ft of the point. In addition to plant data, we recorded the lake depth using a hand held sonar (Vexilar LPS-1) and the bottom substrate (bottom type) when we could see it or reliably determine it with the rake.

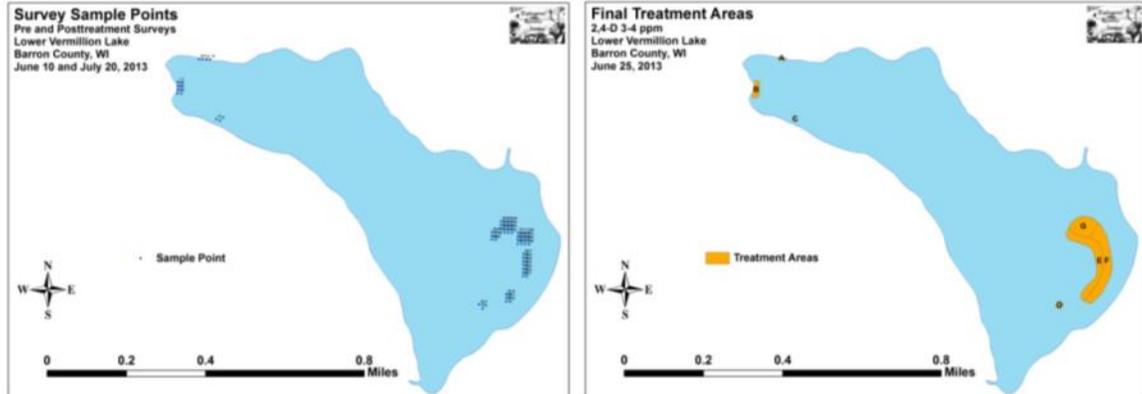
**Figure 3: 2013 Survey Sample Points and Final Treatment Areas**

Initial expectations were to treat seven beds totaling 8.16 acres with granular or liquid 2, 4-D (Navigate) at a concentration of 3-4 ppm (Table 1). Following the pretreatment survey, it was determined to maintain all seven of these areas as planned. The final treatment was conducted by Northern Aquatic Services on June 25<sup>th</sup> (Figure 3) (Appendix I).

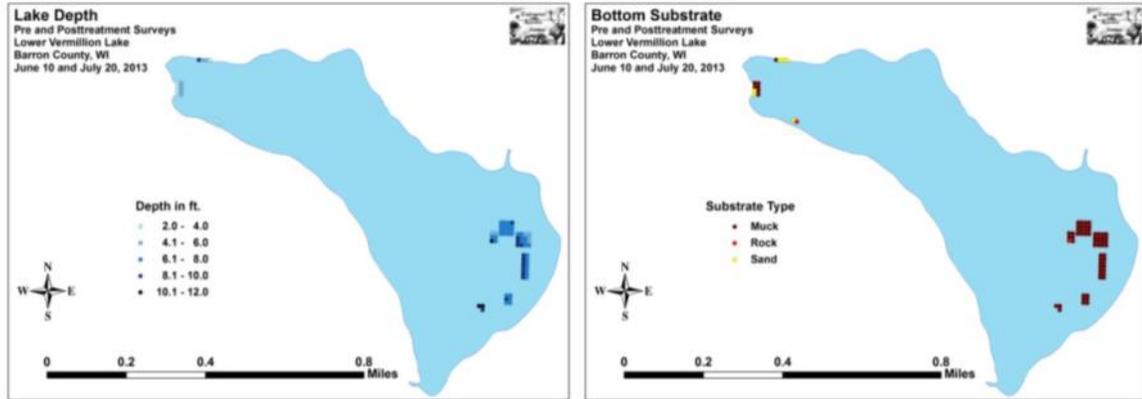
**Figure 4: Treatment Area Depths and Bottom Substrate**

The treatment area littoral zone extended to a maximum of 12.0ft during the pretreatment survey and 10.0ft during the posttreatment survey. Mean and median depths for all plants were 7.2ft and 7.0ft respectively during the pretreatment and a similar 7.5ft and 7.0ft during the posttreatment survey (Table 2). Most EWM was established over organic muck with a few low density patches occurring on sandy bottoms near the shoreline (Figure 4) (Appendix III).

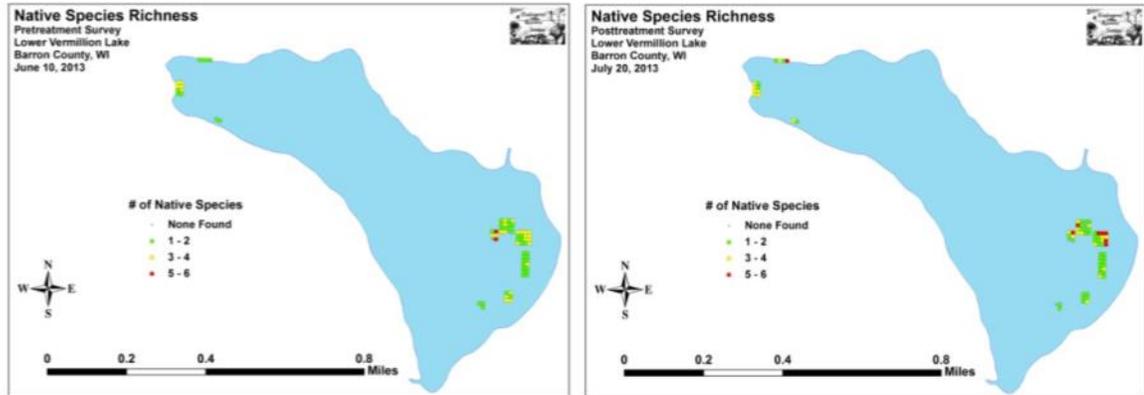
**Figure 5: Pre/Post Native Species Richness**

Initial diversity within the beds was moderate with a Simpson Diversity Index of 0.79. This value was essentially unchanged at 0.77 posttreatment. However, the Floristic Quality Index, a measure of only native species, showed a slight increase from 18.0 pretreatment to 21.6 posttreatment. Mean native species richness at sites with vegetation was 2.32/site pretreatment and also increased slightly to 2.65/site posttreatment (Figure 5). Total rake fullness declined from a moderately dense average of 2.40 pretreatment to 2.29 posttreatment (Figure 6) (Appendix IV).

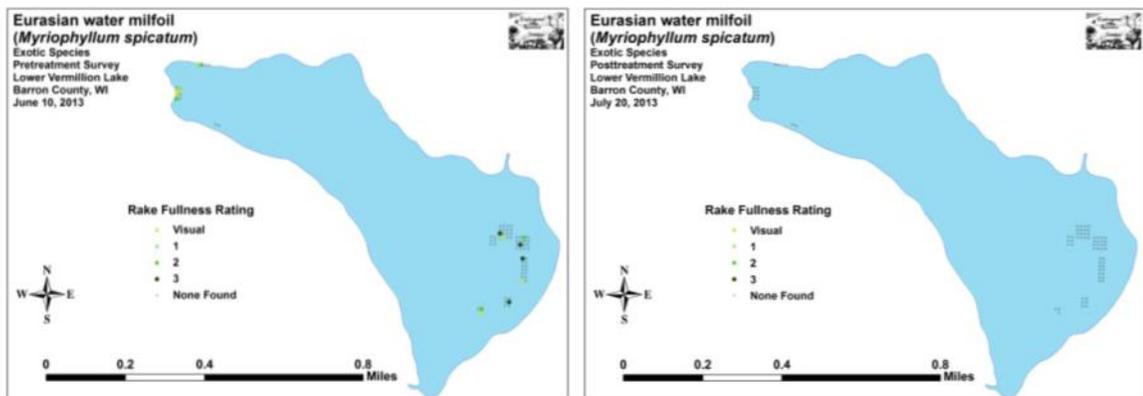
**Figure 7: Pre/Post EWM Density and Distribution**

We found EWM at 11 points during the pretreatment survey. Of these, three had a rake fullness of 1, and four had a rake fullness of 2 and 3 each. We also noted EWM as a visual at six additional points. During the posttreatment survey, we did not find EWM at any point in the survey. We also did not see any EWM plants inter-point or anywhere else in the lake (Figure 7) (Appendix V). Our findings suggested a highly significant reduction in overall EWM as well as significant reductions in rake fullness 1 and 2 (Figure 8).

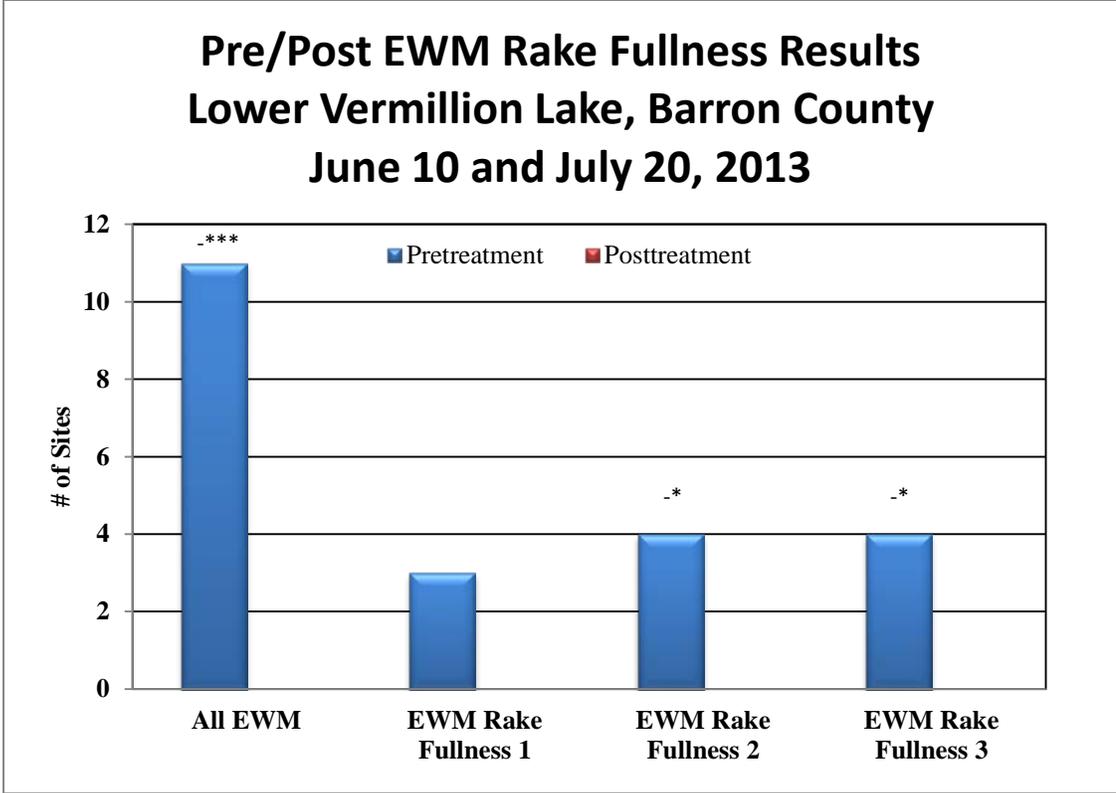
**Figure 8: Pre/Post Changes in EWM Rake Fullness**

Significant differences = \* p < .05, \*\* p < .01, \*\*\* p < .005

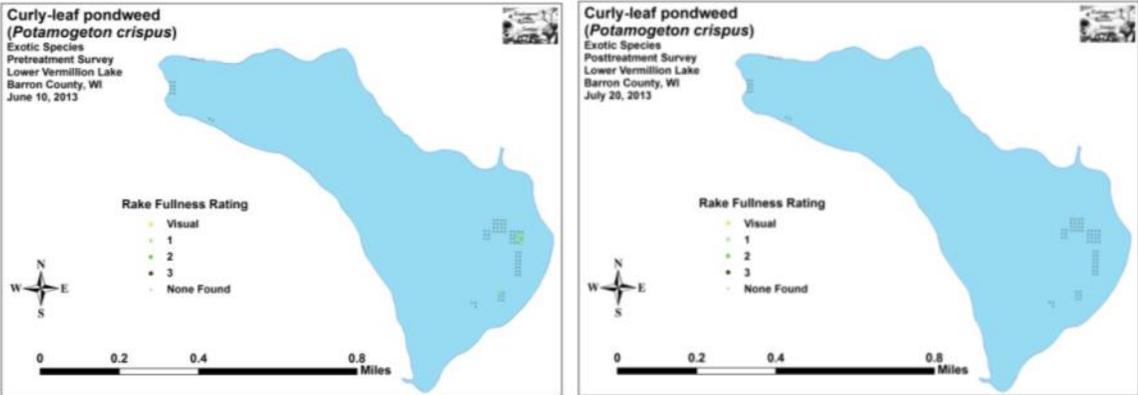
**Figure 9: Pre/Post CLP Density and Distribution**

Curly-leaf pondweed (*Potamogeton crispus*), another invasive exotic species, was found at five points in the pretreatment survey, but none in the posttreatment survey (Figure 9). This significant reduction was likely primarily due to the normal late June senescence for this species rather than the herbicide (Appendix V).

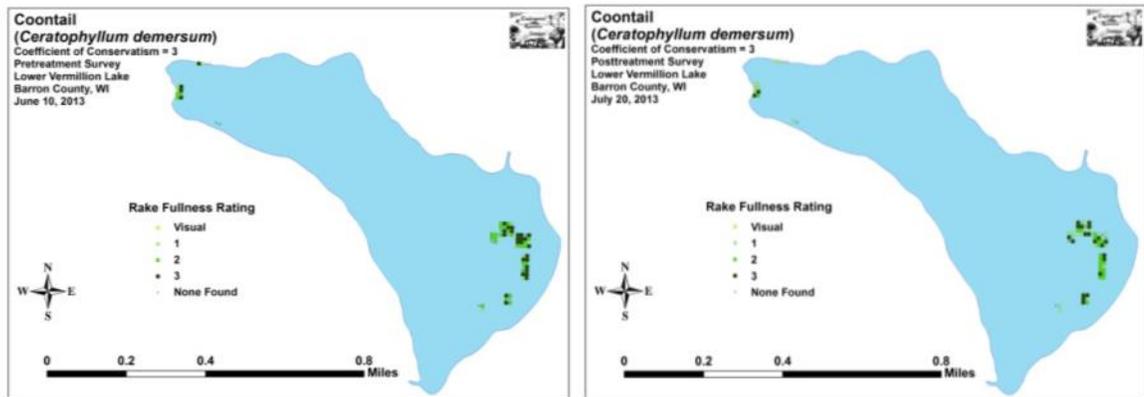
**Figure 10: Pre/Post Coontail Density and Distribution**

Coontail (*Ceratophyllum demersum*) and Flat-stem pondweed (*Potamogeton zosteriformis*), the two most common native species in both the pre and posttreatment surveys (Tables 3 and 4), showed no significant change posttreatment (Figures 10 and 11). Northern water milfoil (*Myriophyllum sibiricum*) was the only native species that showed evidence of being impacted by the treatment. Along with EWM, it was completely eliminated from the treatment areas and this reduction was highly significant. Conversely, Small pondweed (*Potamogeton pusillus*) and Claspingleaf pondweed (*Potamogeton richardsonii*) both demonstrated moderately significant increases posttreatment (Figure 12). These increases are likely the product of normal growing season expansion. Maps for all native species from the pre and posttreatment surveys are available in Appendixes VI and VII.

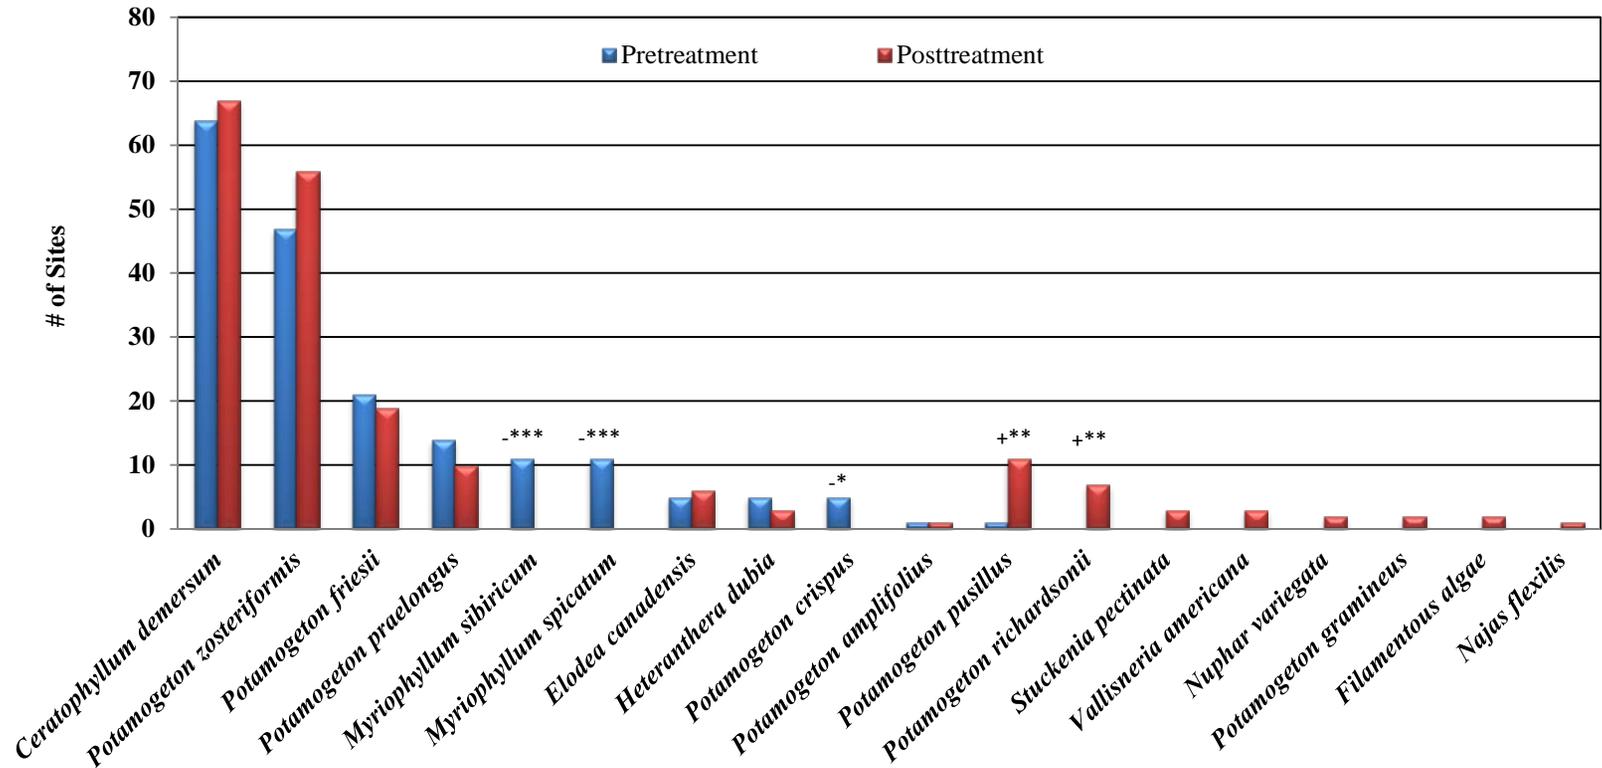
**Figure 12: Pre/Post Macrophyte Changes**

**Pre/Post Differences for All Species  
Lower Vermillion Lake, Barron County  
June 10 and July 20, 2013**

Significant differences = \* p < .05, \*\* p < .01, \*\*\* p < .005

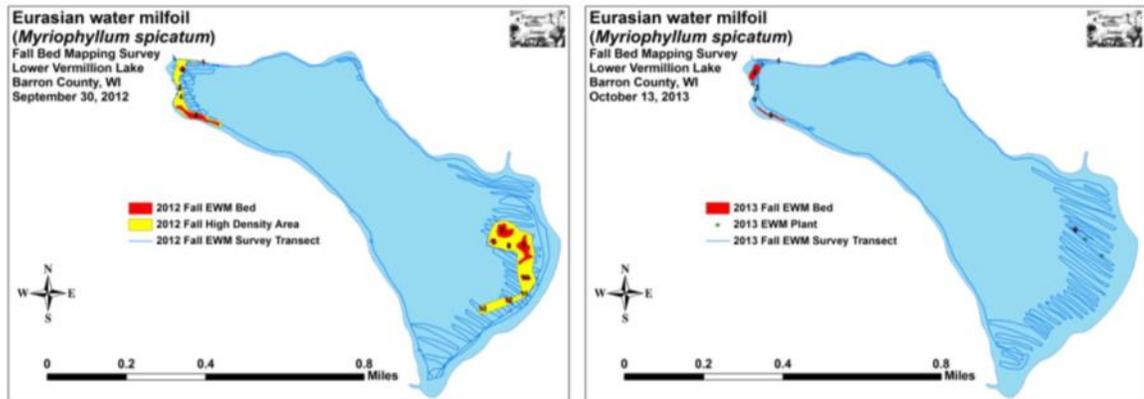
**Figure 13: 2012 and 2013 Fall EWM Bed Maps**

On October 13<sup>th</sup>, 2013, we located and mapped a total of 5 beds on the lake ranging in size from <0.01 acre (Bed 3) to 0.43 acres (Bed 2) (Figure 13) (Appendix VIII). In total, these beds covered 0.71 acres (Table 5). This represented a decrease of 1.99 acres over 2012 totals which equated to a nearly 74% decline in coverage. Despite this positive news, water clarity during the fall survey was poor making it hard to see down more than a few feet so there may be more plants in the eastern bay than we could detect. This may warrant adding “exploratory” points in former beds if a pretreatment survey is planned for 2014.

Beds 1 and 5 – Both areas were more high density areas than beds, but EWM plants were continuous, canopied and merging. They occurred in narrow strips along sharp drop-offs into 15ft+ of water which will likely again make treating these areas challenging.

Bed 2-3 – EWM plants were rapidly reestablishing throughout the treatment area, and many plants were prop-clipped as they were right in front of the channel away from the public boat landing.

Bed 4 – We noted only three individual plants near this former bed.

Bed 6 – Although EWM plants were greatly reduced from fall 2012, we found several canopied clusters in 5-7ft of water on the western end of the formerly expansive bed.

Beds 7-8 – These areas continue to be EWM free as we saw no evidence of plants anywhere during the posttreatment or fall bed mapping surveys.

Bed 9 – A single EWM plant was found and rake removed from this area during the fall survey.

Beds 10-13 – These areas were also EWM free during both the July and October surveys.
