Lake Magnor Comprehensive Planning Report 2003

Prepared for the Lake Magnor Lake Association

Brook Waalen
Polk County Land and Water Resources Department
215 Main Street
PO Box 460
Balsam Lake, WI 54853

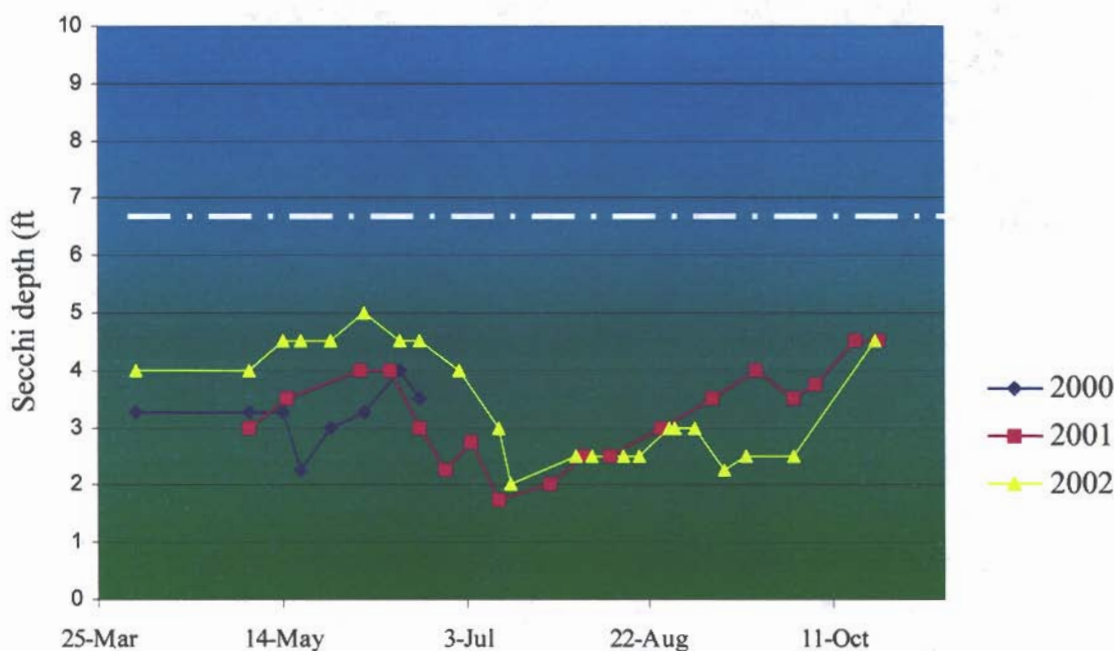
Secchi disk, 2000-2002

Lake Magnor's Secchi disk readings are low when compared to other lakes in the region. This lack of water clarity is caused by a combination of factors (true-color, chlorophyll-a, total suspended sediments, and suspended organic matter) that scatter or absorb light.

Volunteers on Lake Magnor took Secchi readings twice a week from May through October of 2001 and once in February and April of 2002 in two locations, the deep spot of the lake and at the bay by Barbo Lake. Using landmarks and a depth finder to pinpoint the locations, the pontoon ran in neutral while readings were taken. The individual taking the readings did not wear sunglasses.

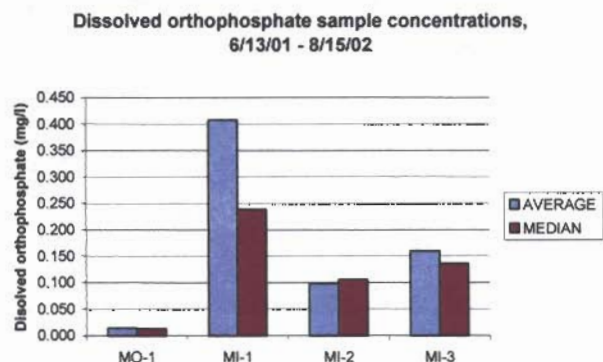
Total phosphorus is a measure of all forms of phosphorus, both organic and inorganic, and includes all of the aforementioned sources. This parameter was measured at least eight times (between 6/13/01 and 8/15/02) at all inlets and the outlet.

Dissolved orthophosphate is a measure of phosphorus that is immediately available for uptake by plants and algae. Large inputs of this parameter could trigger nuisance algal blooms as well as promote algal growth throughout the year. This parameter was measured on at least eight occasions at each inlet and the outlet.
