MILWAUKEE COUNTY POND & LAGOON MANAGEMENT PLAN

Prepared By: Milwaukee County Environmental Services June 2005

Milwaukee County Pond, Lagoon & Lake Management Plan

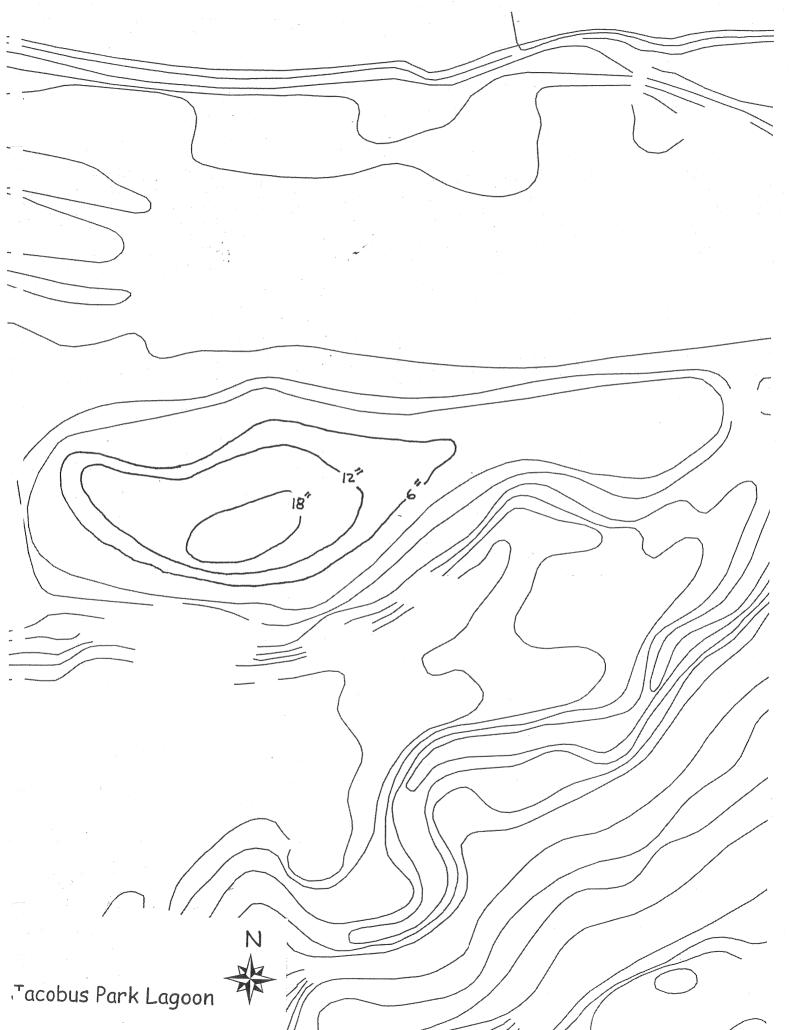
Appendix C Sediment Thickness Profiles

Sediment thickness testing indicated excessive siltation in a number of lagoons, including Whitnall Park, Dineen Park, and Kosciuszko. The siltation creates a poor habitat for fish, promotes growth of emergent plants, and degrades aesthetics. Sediment thickness profile maps are in Appendix C.

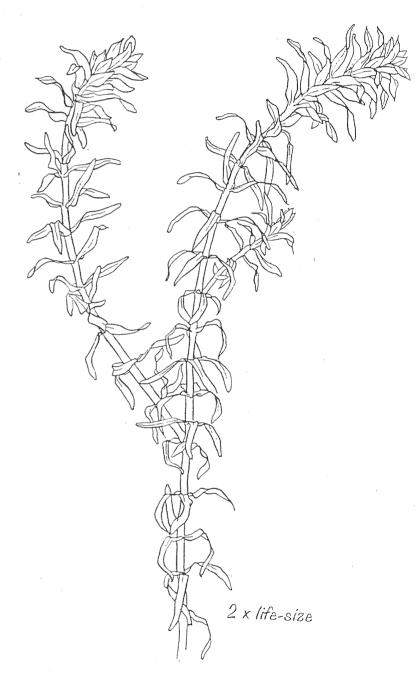
Elodea canadensis Common Waterweed, Elodea

Description: Elodea is a native, submersed plant with entire — opposite or whorled leaves. It has slender stems that emerge from a shallow rootstalk. The small, lance shaped leaves attach directly to the stem. Leaves are in whorls of three, or occasionally only two and tend to be more crowded toward the tip stems.

Habit: Elodea is found in water depths ranging from ankle deep to several meters deep. It is most abundant on fine sediments enriched with organic matter. The plants overwinter as an evergreen. In the spring, fresh green shoots develop on the ends of the stems. The plant spreads mainly by stem fragments. The branching stems often form a tangled may that can become a nuisance.

Value: The branching stems of elodea offer valuable shelter and grazing opportunities for fish, although very dense stands can obstruct fish movement. It also provides food for muskrats and waterfowl. They can eat the plant itself or feed on a wide variety of invertebrates that use the plant as habitat.

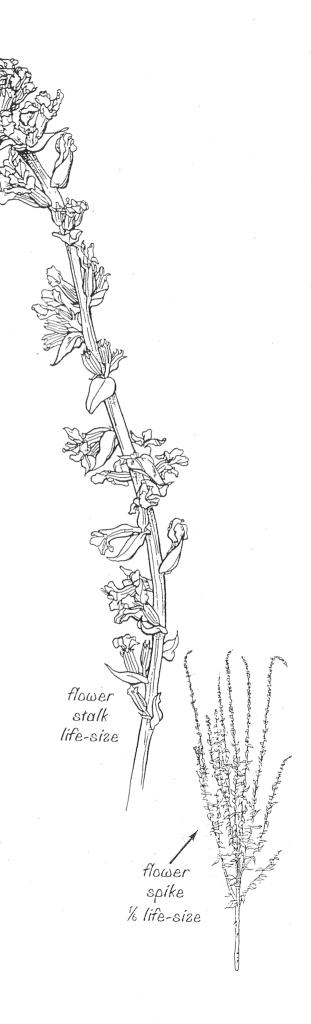
Lythrum salicaria Purple loosestrife

Description: Purple loosestrife has angled stems that emerge from a woody rootstalk. Leaves are lance-shaped, attach directly to the stem, and often have fine hairs on the surface. The leaves may be opposite, in whorls of three, or sometimes spiraled around the stem. Clusters of magenta flowers are produced in leaf axils of a terminal spike. Flowering usually starts in mid-July and continues through September. Purple loosestrife is a hardy perennial that survives the winter.

Habitat: Purple loosestrife can be found in a wide variety of sites from moist soil to shallow water. Disturbed sites create an opening for germination of seeds and expansion of new colonies.

Value: Purple loosestrife has little wildlife value. The seeds are low in nutrition, and the roots are too woody. The flowers are attractive to insects. They produce nectar and are regularly visited by honeybees.
