***Beaver Dam Lake Aquatic Plant Survey  
and Management Plan***

***Prepared for  
Beaver Dam Lake Management District***

***January 2006***

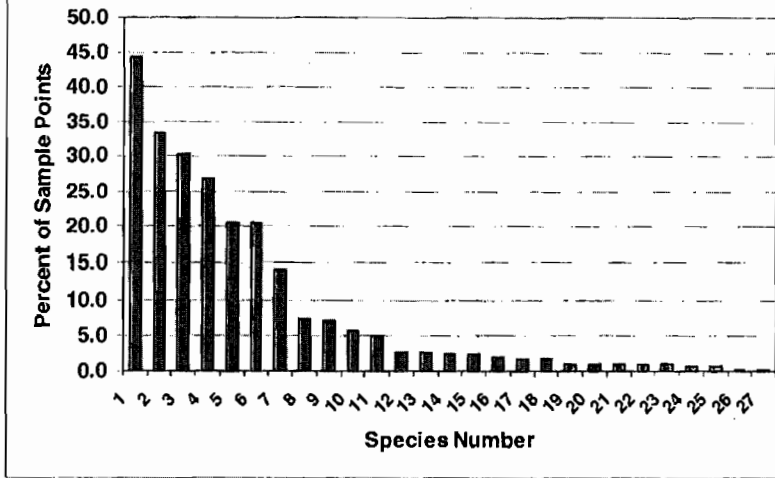
**Figure 13**  
**July 2005 West Beaver Dam Lake Aquatic Plant Survey**  
**Frequency of Occurrence (Percent of Sample Points)**

Species Number	Scientific Name	Common Name	Frequency (% of Sample Points)
1	<i>Chara spp.</i>	muskgrass	44.3
2	<i>Potamogeton illinoensis</i>	Illinois pondweed	33.3
3	<i>Potamogeton sp. (possibly epihydrus or robbinsii)</i>	pondweed (possibly ribbonleaf or Robbin's)	30.3
4	<i>Elodea Canadensis</i>	Canada waterweed	26.7
5	<i>Ceratophyllum demersum</i>	coontail	20.3
6	<i>Myriophyllum spicatum</i>	Eurasian watermilfoil	20.3
7	<i>Potamogeton zosteriformis</i>	flatstem pondweed	14.0
8	<i>Ceratophyllum sp.</i>	coontail	7.3
9	<i>Vallisneria americana</i>	Wild celery	7.0
10	<i>Potamogeton crispus</i>	curlyleaf pondweed	5.7
11	<i>Najas flexilis</i>	bushy naiad	5.0
12	<i>Brasenia schreberi</i>	watershield	2.7
13	<i>Nuphar advena</i>	yellow water lily	2.7
14	<i>Nymphaea tuberosa</i>	white waterlily	2.3
15	<i>Potamogeton natans</i>	floatingleaf pondweed	2.3
16	<i>Utricularia spp.</i>	bladderwort	2.0
17	<i>Potamogeton sp. (possibly diversifolius)</i>	pondweed (possibly waterthread)	1.7

Although a diverse aquatic plant community was observed, a few species were abundant. One measure of abundance is the frequency of occurrence of a species measured as the percentage of sample locations containing a species. As shown in Figure 13, the 6 most frequently occurring species in West Beaver Dam Lake during July of 2005 were:

- *Chara spp.* (muskgrass) was found in 44 percent of sample locations
- *Potamogeton illinoensis* (Illinois pondweed) was found in 33 percent of sample locations
- *Potamogeton sp. (possibly epihydrus or robbinsii)* (pondweed, possibly ribbonleaf or Robbin's) was found in 30 percent of sample locations.
- *Elodea canadensis* (Canada waterweed) was found in 27 percent of sample locations.
- *Ceratophyllum demersum* (coontail) was found in 20 percent of sample locations
- *Myriophyllum spicatum* (Eurasian watermilfoil) was found in 20 percent of sample locations.

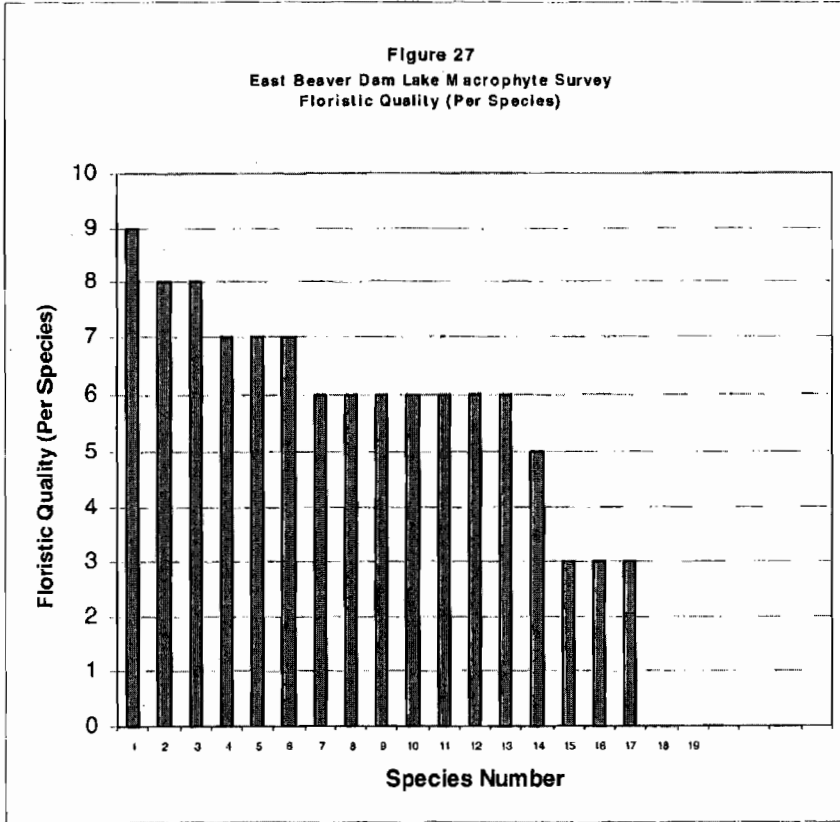
**Figure 27**  
**East Beaver Dam Lake Macrophyte Survey**  
**Floristic Quality (Per Species)**

Species Number	Scientific Name	Common Name	Floristic Quality
1	<i>Sagittaria graminea</i>	slender arrowhead	9
2	<i>Potamogeton</i> sp. (possibly <i>diversifolius</i> )	pondweed (possibly waterthread)	8
3	<i>Potamogeton</i> sp. (possibly <i>epihydus</i> or <i>robbinsii</i> )	pondweed (possibly ribbonleaf or Robbin's)	8
4	<i>Chara</i> spp.	Muskgrass	7
5	<i>Potamogeton amplifolius</i>	largeleaf pondweed	7
6	<i>Utricularia</i> spp.	Bladderwort	7
7	<i>Najas flexilis</i>	bushy naiad	6
8	<i>Nuphar variegata</i>	Spatterdock	6
9	<i>Nymphaea tuberosa</i>	white waterlily	6
10	<i>Potamogeton illinoensis</i>	Illinois pondweed	6
11	<i>Potamogeton zosteriformis</i>	flatstem pondweed	6
12	<i>Vallisneria americana</i>	wild celery	6
13	<i>Eleocharis</i> spp.	Spikerush	6
14	<i>Potamogeton natans</i>	floatingleaf pondweed	5
15	<i>Ceratophyllum demersum</i>	Coontail	3
16	<i>Ceratophyllum</i> sp.	Coontail	3
17	<i>Elodea canadensis</i>	Canada waterweed	3

In 2005, the mean C of West Beaver Dam Lake was 5 and the FQI was 26.7 (See Figure 26). The mean C of East Beaver Dam Lake was 5 and the FQI was 23.4. The Mean C of 5 indicates the lake's plant community is tolerant of moderate disturbance. The median FQI for Wisconsin is 22.2 (WDNR 2005). Beaver Dam Lake's FQI is higher than the median Wisconsin Lake, indicating the lake's plant community is of higher quality and less tolerant to disturbance than the plant community of the median Wisconsin lake. West Beaver Dam Lake noted a higher FQI than East Beaver Dam Lake. The plant community in West Beaver Dam Lake is of higher quality than the plant community of East Beaver Dam Lake.
