Map 1  
Anvil Lake  
Vilas County, Wisconsin  
**2014 Final EWM**  
**Manual Removal Strategy**

# Management of Eurasian Watermilfoil (*Myriophyllum spicatum*) using Diver Assisted Suction Harvesting

Anvil Lake, Vilas County, WI - 2014

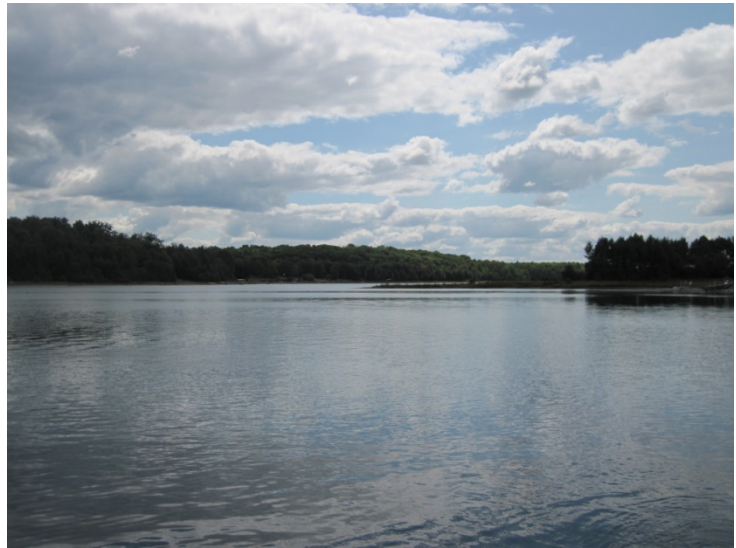
**Photo 1. Anvil Lake, Vilas County**

Anvil Lake, Vilas County, is an approximate 400-acre seepage lake with an average depth of 19 feet and a maximum depth of 32 feet (Photo 1). Eurasian water milfoil (*Myriophyllum spicatum*; EWM) was first discovered in Anvil Lake in July of 2012 by the Great Lakes Indian Fish & Wildlife Commission (GLIFWC). The WDNR was alerted of GLIFWC's findings and proceeded to do a point-intercept survey which confirmed more EWM in the northern bay. Onterra, LLC was then contacted by the Anvil Lake Association and a EWM peak-biomass survey was completed in August of 2012 with the assistance of the volunteer EWM locations provided by the Anvil Lake Association.

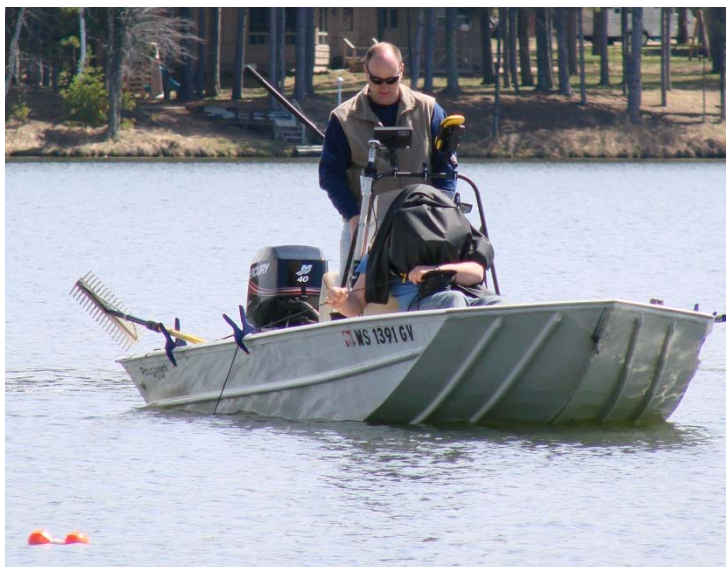
Onterra ecologists conducted a submersed camera focus area survey on July 21, 2014. This survey investigated the high biomass areas identified during the mid-June acoustic survey. A submersible camera was used to search the high biomass areas for EWM. With Onterra’s onboard GPS-driven computer system, surveyors were able to slowly drive transects across the identified focus areas with a customized mounted submersible camera (Map 2).

**Photo 2. Onterra crew conducting a submersible camera survey**

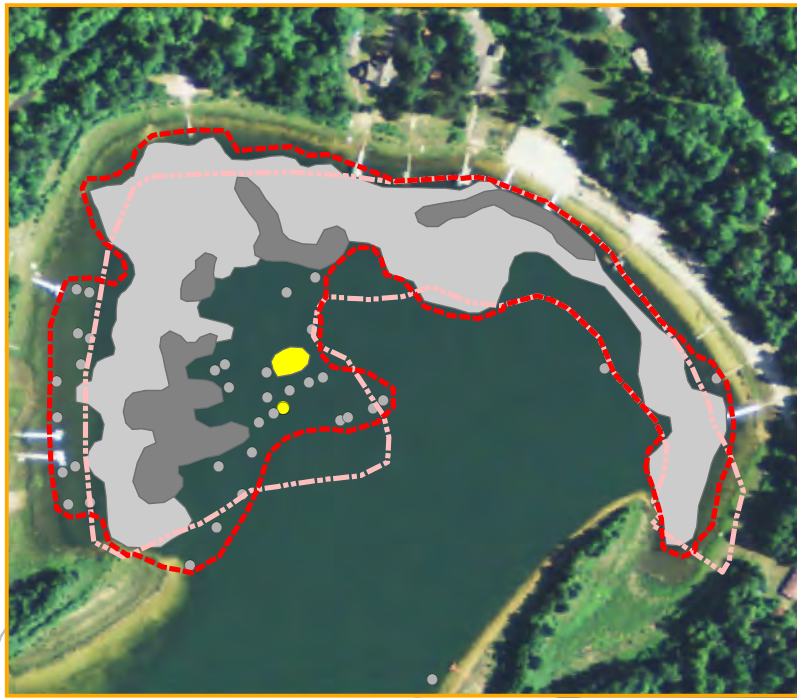
Map 2  
**Anvil Lake**  
 Vilas County, Wisconsin  
**July 2014**  
**EWM Focus Area**  
**Survey Results**

As a result of this survey, five single EWM plants were located (Map 2, red squares) but all were in areas where EWM had previously been found and no new areas of EWM were identified. Many notes were made about the native plants observed throughout the meandered areas (Map 2).

- EWM (July 2014)**
- Single or Few Plants
- Tracklog of Early-July Survey**
- Submersed Camera Insepection

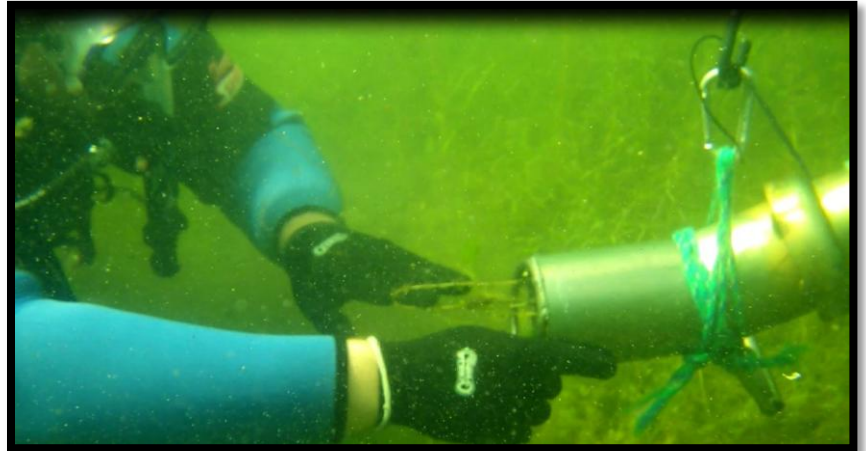
While using DASH, a diver typically will begin by locating a EWM plant from the surface, and then descend next to the plant while simultaneously lowering the nozzle. Divers works along the bottom by using fin pivots, kneeling on the bottom or hovering above the bottom at a distance where the root mass of the plant is within hands reach. The diver will either feed the top of the plant into the hose first and then uproot the plant or uproot the plant and feed it root wad first into the hose. It is very important that the diver shake as much sediment from the root

**Diver Feeding EWM Plant into Suction Hose**

wad before getting the root wad near the nozzle. Shaking the root wad away from the nozzle helps maintain visibility for the diver and minimizes debris and sediment in the holding bins. As plants are fed into the nozzle, the diver carefully observes for possible fragments. Fragments are caught by hand and fed into the nozzle.
