Long Lake

Manitowoc County, Wisconsin

Aquatic Plant Management Planning Project

Long Lake
Manitowoc County, Wisconsin
Aquatic Plant Management Planning Project
December 2010

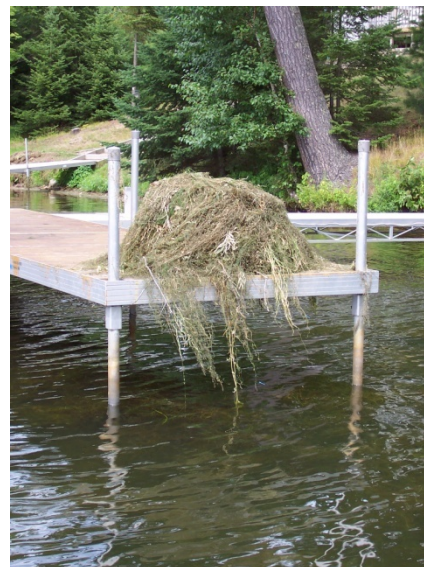
Manual removal methods include hand-pulling, raking, and hand-cutting. Hand-pulling involves the manual removal of whole plants, including roots, from the area of concern and disposing them out of the waterbody. Raking entails the removal of partial and whole plants from the lake by dragging a rake with a rope tied to it through plant beds. Specially designed rakes are available from commercial sources or an asphalt rake can be used. Hand-cutting differs from the other two manual methods because the entire plant is not removed, rather the plants are cut similar to mowing a lawn; however Wisconsin law states that all plant fragments must be removed. One manual cutting technique involves throwing a specialized “V” shaped cutter into the plant bed and retrieving it with a rope. The raking method entails the use of a two-sided straight blade on a telescoping pole that is swiped back and forth at the base of the undesired plants.

In addition to the hand-cutting methods described above, powered cutters are now available for mounting on boats. Some are mounted in a similar fashion to electric trolling motors and offer a 4-foot cutting width, while larger models require complicated mounting procedures, but offer an 8-foot cutting width. Please note that the use of powered cutters may require a mechanical harvesting permit to be issued by the WDNR.

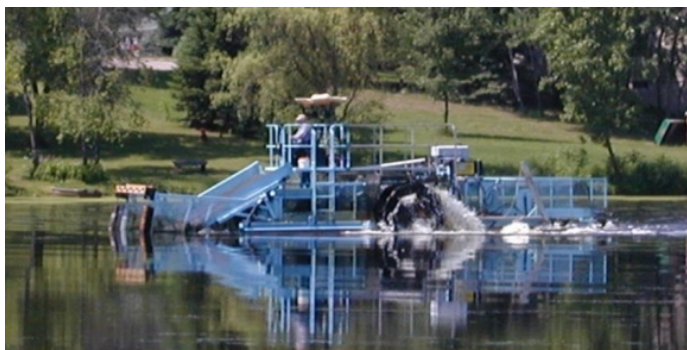
Aquatic plant harvesting is frequently used in Wisconsin and involves the cutting and removal of plants much like mowing and bagging a lawn. Harvesters are produced in many sizes that can cut to depths ranging from 3 to 6 feet with cutting widths of 4 to 10 feet. Plant harvesting speeds vary with the size of the harvester, density and types of plants, and the distance to the off-loading area. Equipment requirements do not end with the harvester. In addition to the harvester, a shore-conveyor would be required to transfer plant material from the harvester to a dump truck for transport to a landfill or compost site. Furthermore, if off-loading sites are limited and/or the lake is large, a transport barge may be needed to move the harvested plants from the harvester to the shore in order to cut back on the time that the harvester spends traveling to the shore conveyor. Some lake organizations contract to have nuisance plants harvested, while others choose to purchase their own equipment. If the latter route is chosen, it is especially important for the lake group to be very organized and realize that there is a great deal of work and expense involved with the purchase, operation, maintenance, and storage of an aquatic plant harvester. In either case, planning is very important to minimize environmental effects and maximize benefits.

Equipment costs vary with the size and features of the harvester, but in general, standard harvesters range between \$45,000 and \$100,000. Larger harvesters or stainless steel models may cost as much as \$200,000. Shore conveyors cost approximately \$20,000 and trailers range from \$7,000 to \$20,000. Storage, maintenance, insurance, and operator salaries vary greatly.

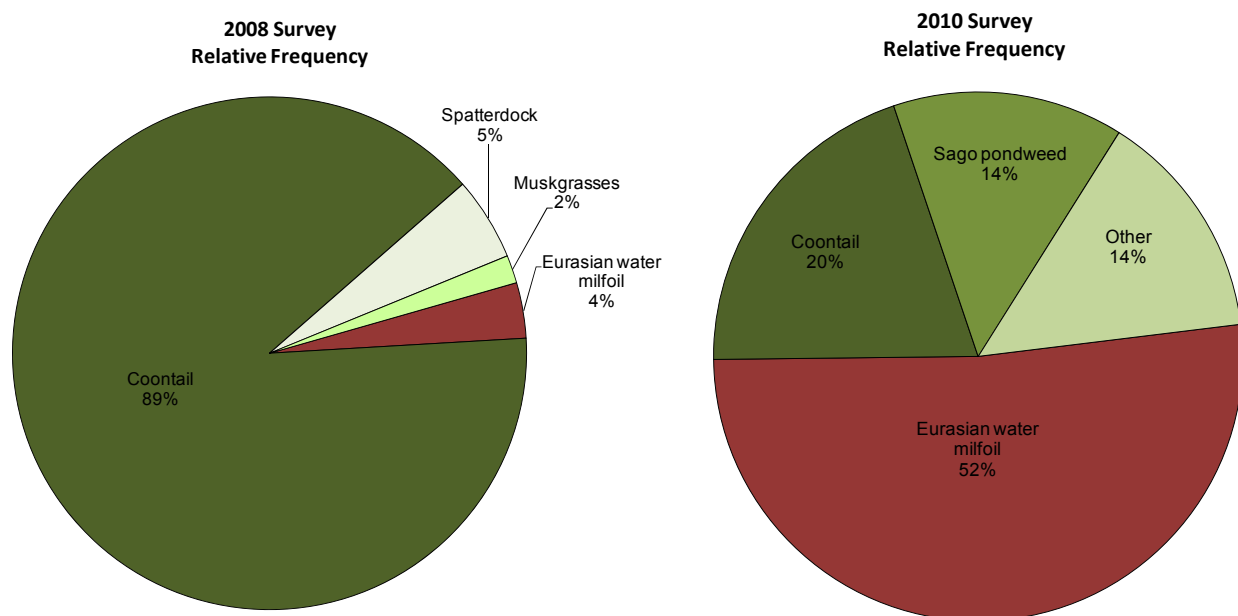
Figure 3.0-5 Long Lake aquatic plant relative frequency of occurrence in 2008 and 2010. Created using data from 2008 and 2010 aquatic plant point-intercept survey.

the lake had an extremely uneven distribution (relative frequency) of plant species throughout the lake. The left pie chart in Figure 3.0-4 shows that the aquatic plant community of Long Lake in 2010 was dominated by coontail. A slightly more even distributions was observed in 2010 (right pie chart in Figure 3.0-4) and the diversity of the lake was greater (0.67). However, both of these index values are quite low and show that the plant community of Long Lake is often dominated by one species, depending on environmental conditions at that time. Having a greater number of aquatic plant species and a more even distribution would likely insulate Long Lake from the extreme conditions observed in either survey years (2008 and 2010).

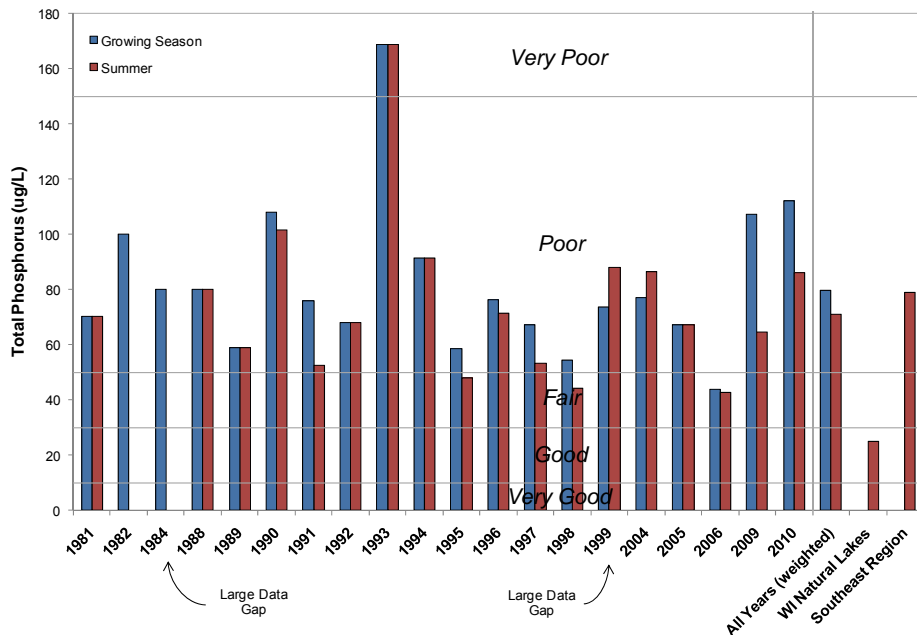
Figure 4.0-1 Long Lake, regional and state average total phosphorus values. Mean values calculated with summer month surface sample data. Water Quality Index values adapted from Lillie and Mason (1983).
