Figure 1-1
Aerial photograph of
Powell Marsh and Dead
Pike Lake from 2005

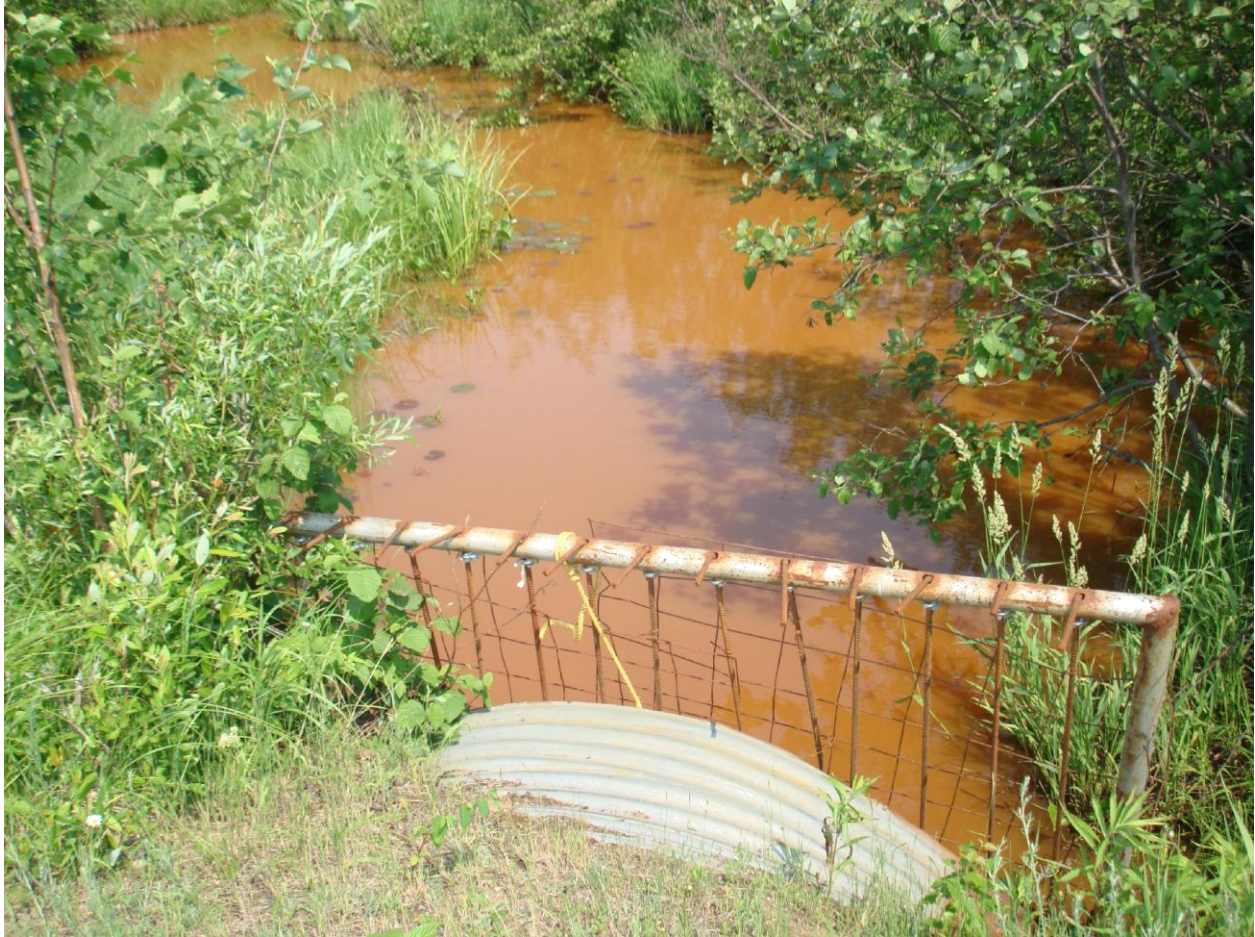
Figure 1-2. Iron stained water entering Dead Pike Lake from the Powell Marsh at the Main Inlet to Dead Pike Lake.

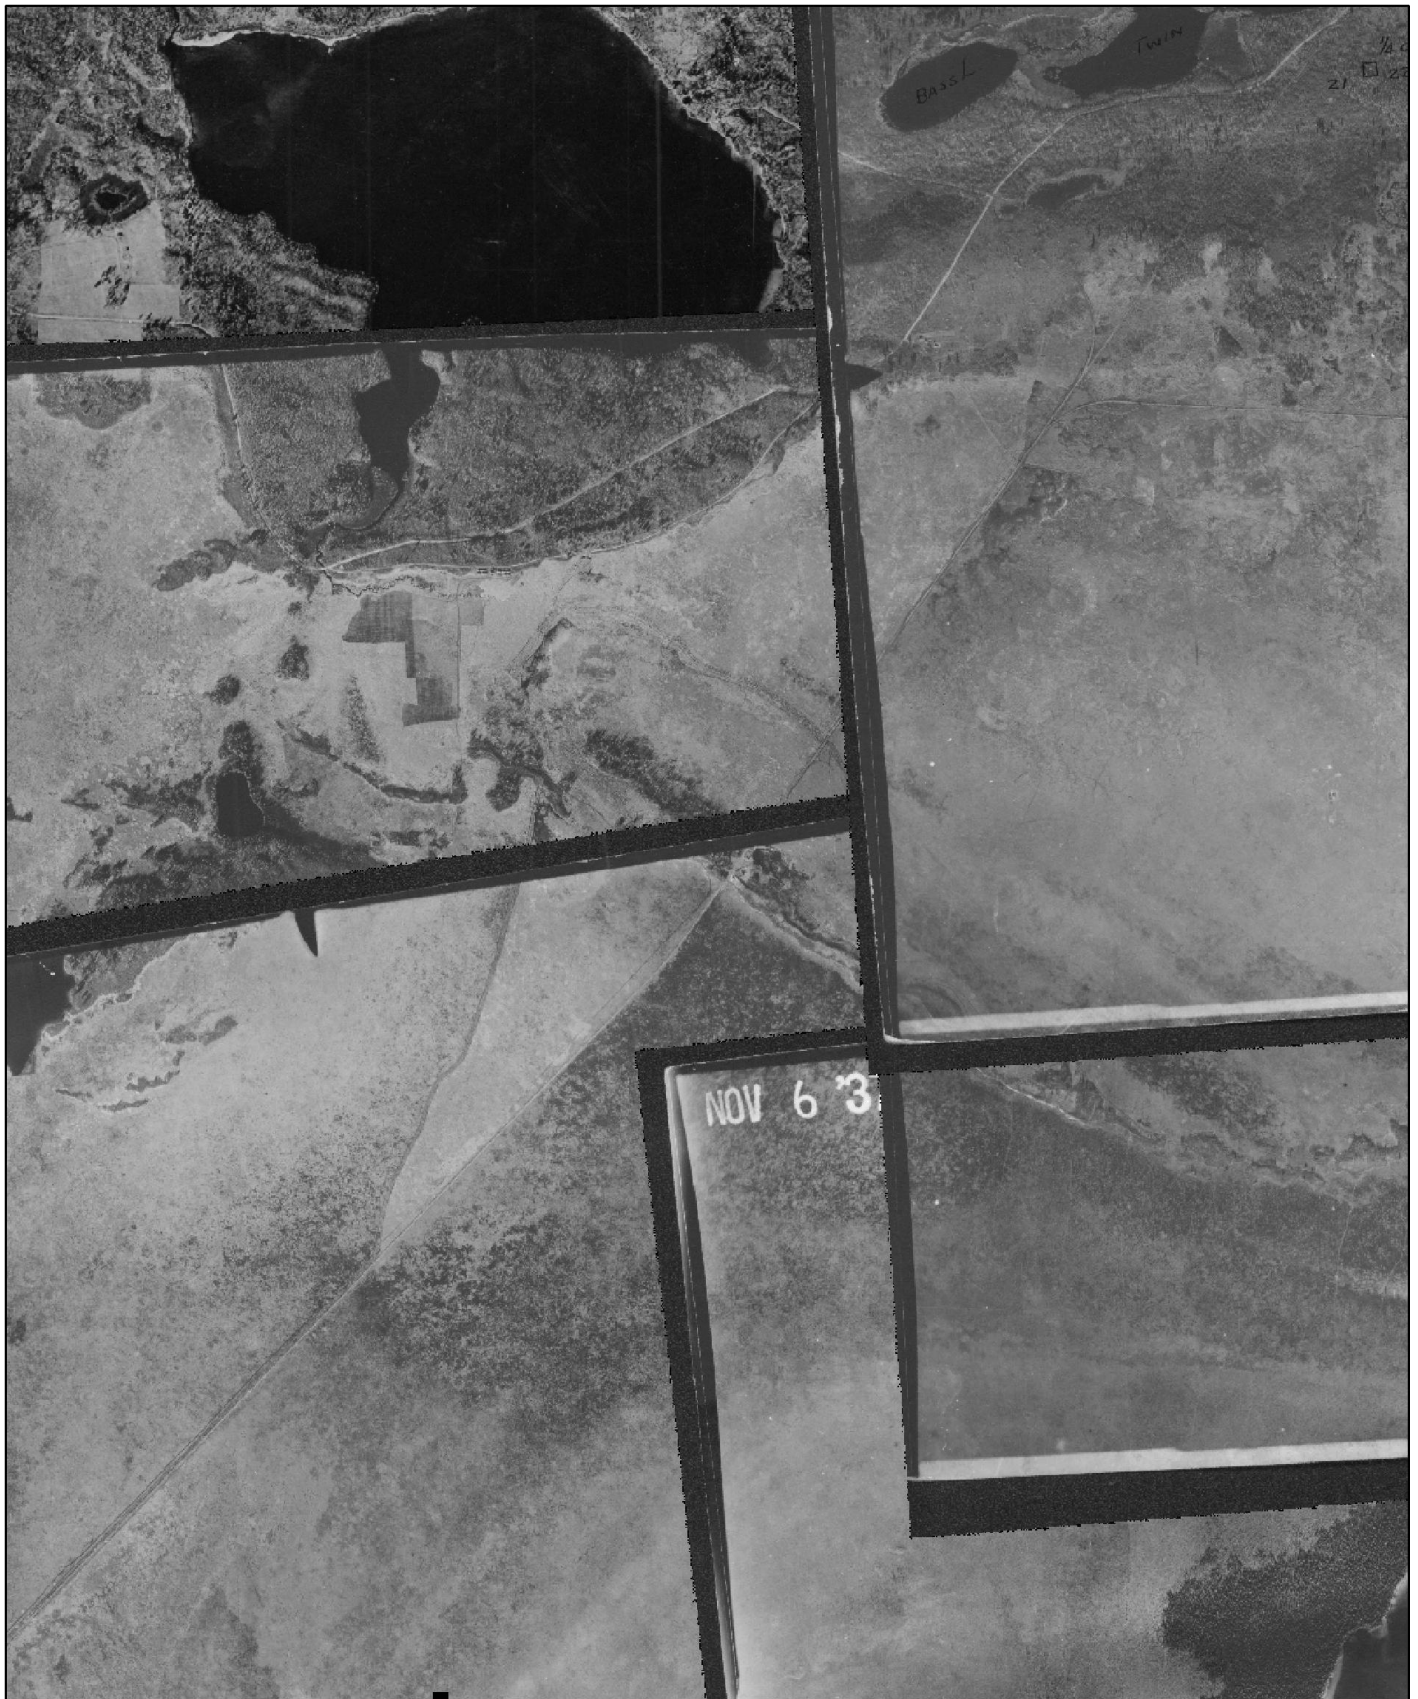
Figure 3-1
Aerial photograph of
Powell Marsh and Dead
Pike Lake from 1937

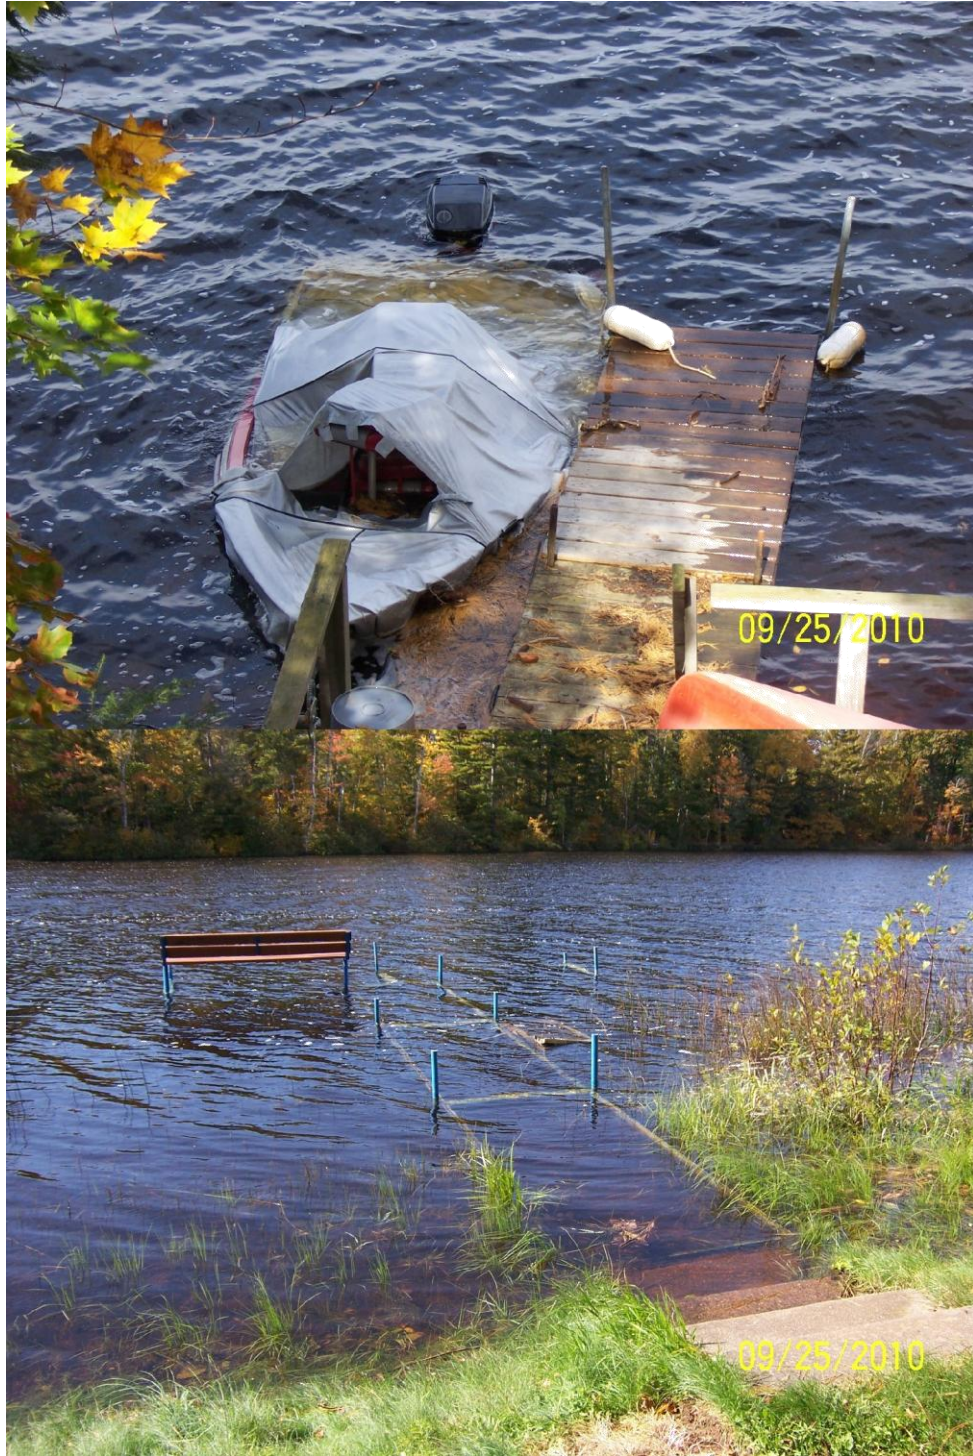
Figure 4-1. Pictures taken at Dead Pike Lake on September 25, 2010 following elevated discharges of water from the Powell Marsh control structures.

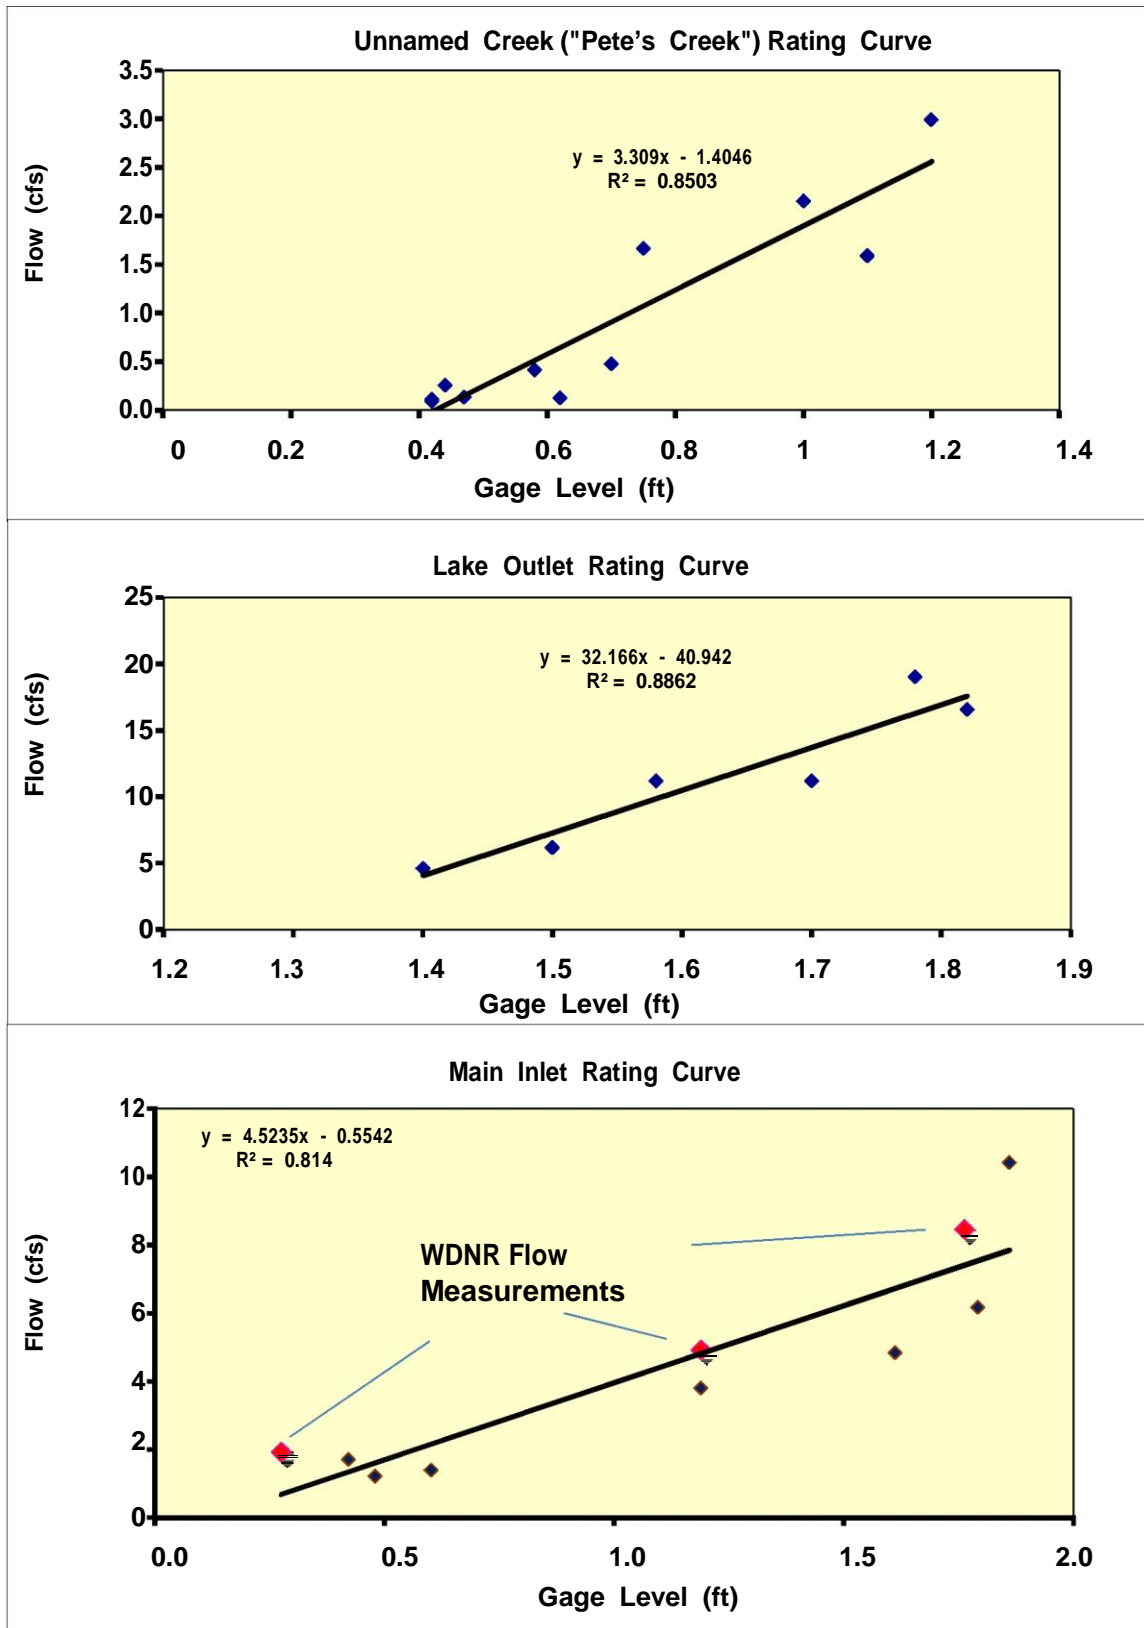
Figure 4-3. Rating curves for the main inlet, the unnamed creek inlet, and the outlet from Dead Pike Lake.

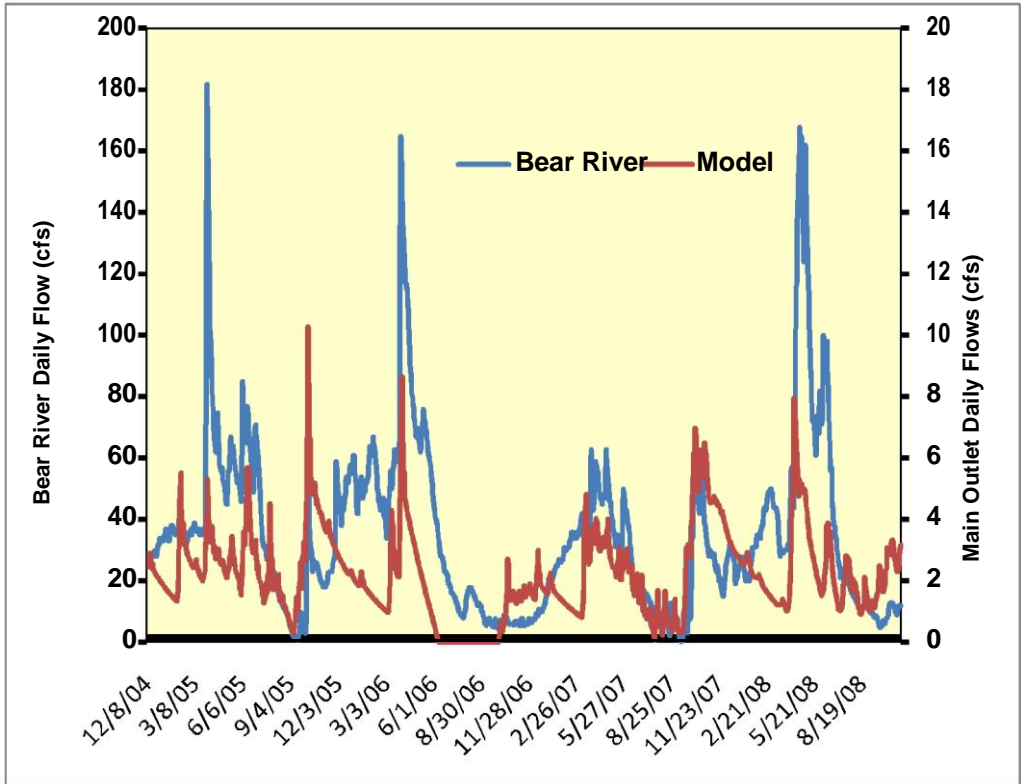
Figure 4-5. Comparison of modeled flows at the main outlet of the Powell Marsh at Powell Road with flow in the Bear River at USGS gauge 05357335.

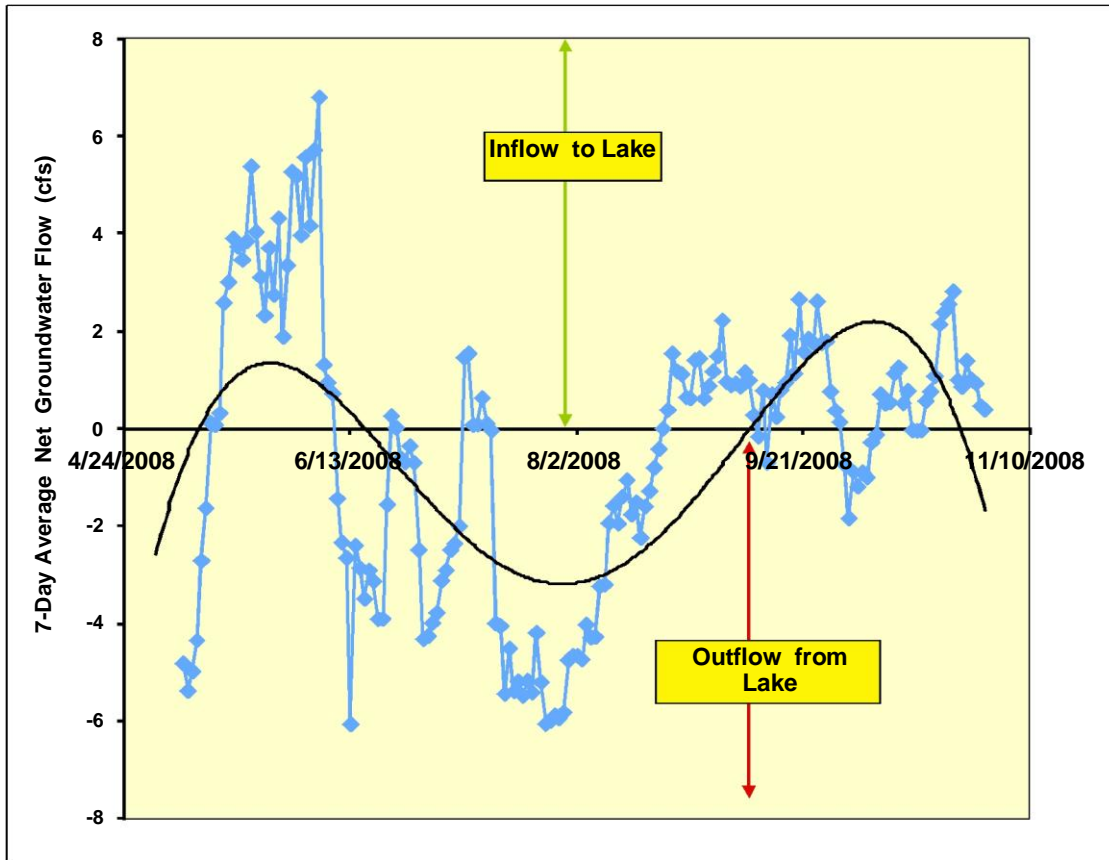
Figure 4-10. Calculated net groundwater inflows and outflows from Dead Pike Lake. Net groundwater inflow is equal to the difference between groundwater inflows minus outflows from the lake. Net groundwater inflow calculated as the difference of all water balance components that were measured for the Dead Pike Lake.

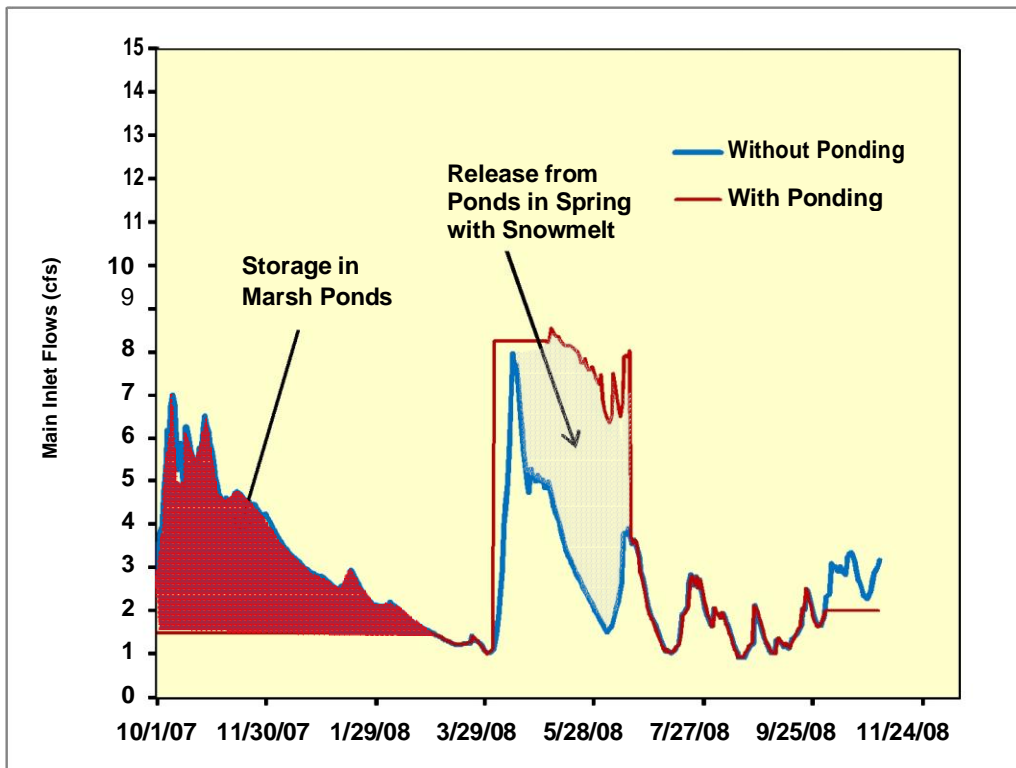
Figure 4-11. Modeled flows at the Main Inlet to Dead Pike Lake with and without the application of controls in the Powell Marsh to manage water levels in the Marsh ponds.

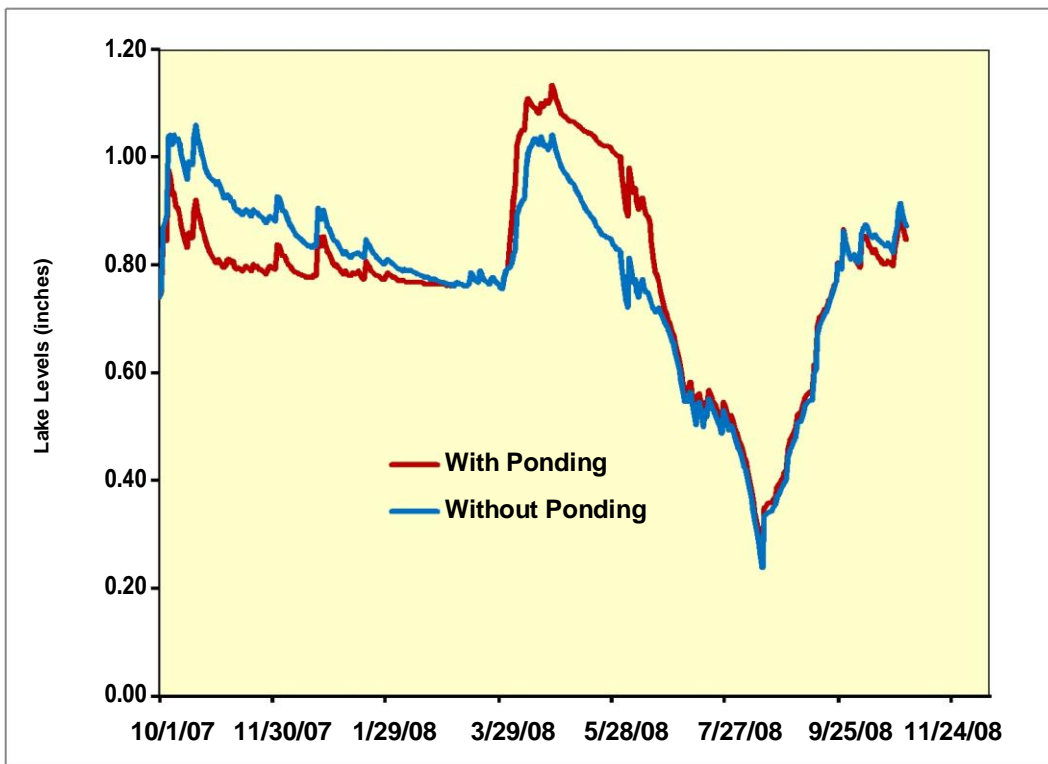
Figure 4-12. Estimated effect of controlled water releases from the Powell Marsh to Dead Pike Lake on water levels in Dead Pike Lake for the 2008 water year.

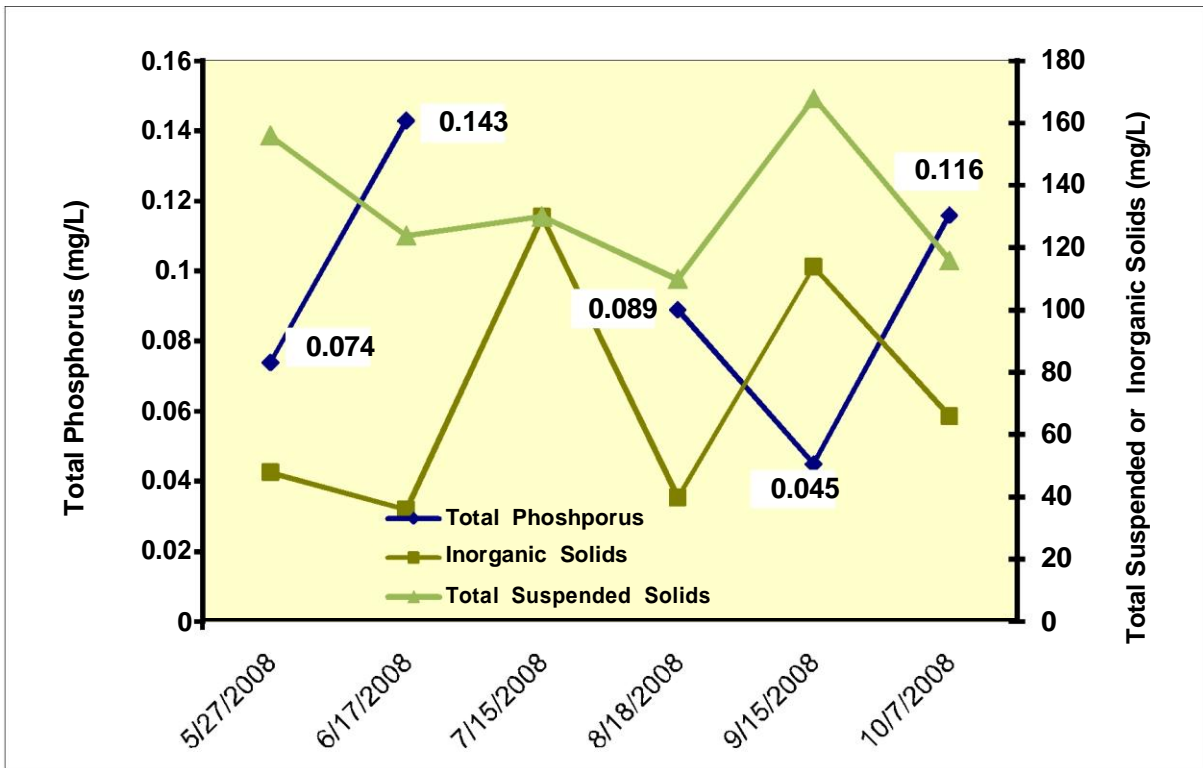
Figure 5-1. Total phosphorus, total suspended solids, and inorganic solids (estimated) monitored in 2008 at the Main Inlet to Dead Pike Lake.

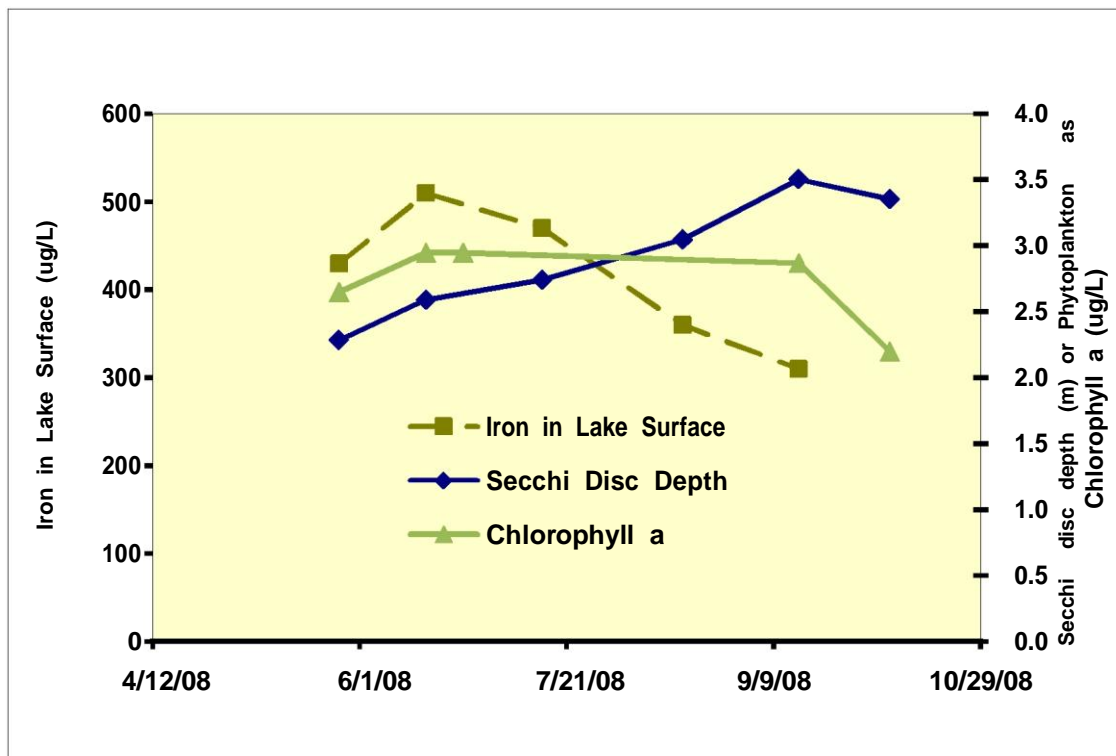
Figure 5-6. Comparison of iron concentration, lake clarity, and chlorophyll a concentrations in the surface of Dead Pike Lake. Sampling conducted at the deep hole of the lake.

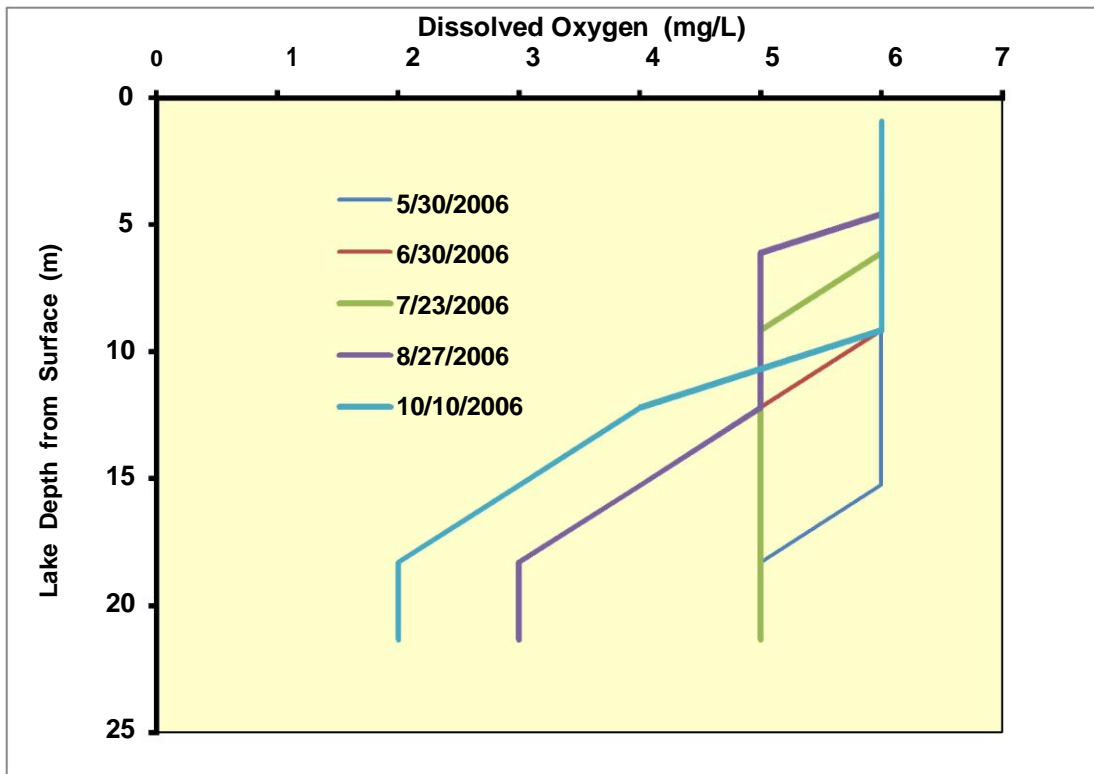
Figure 5-10. Lake dissolved oxygen profiles in Dead Pike Lake in 2008 and 2006.

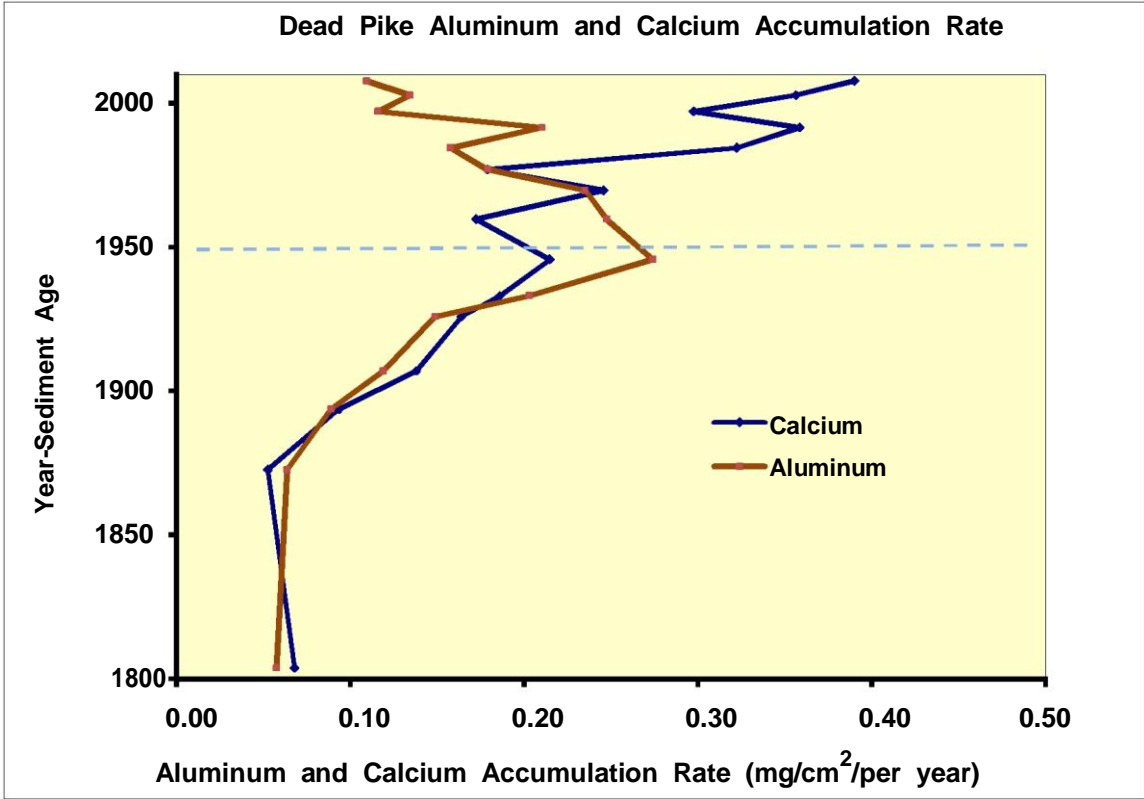
Figure 6-8. Rate of calcium and aluminum accumulation in the dated sediment core.

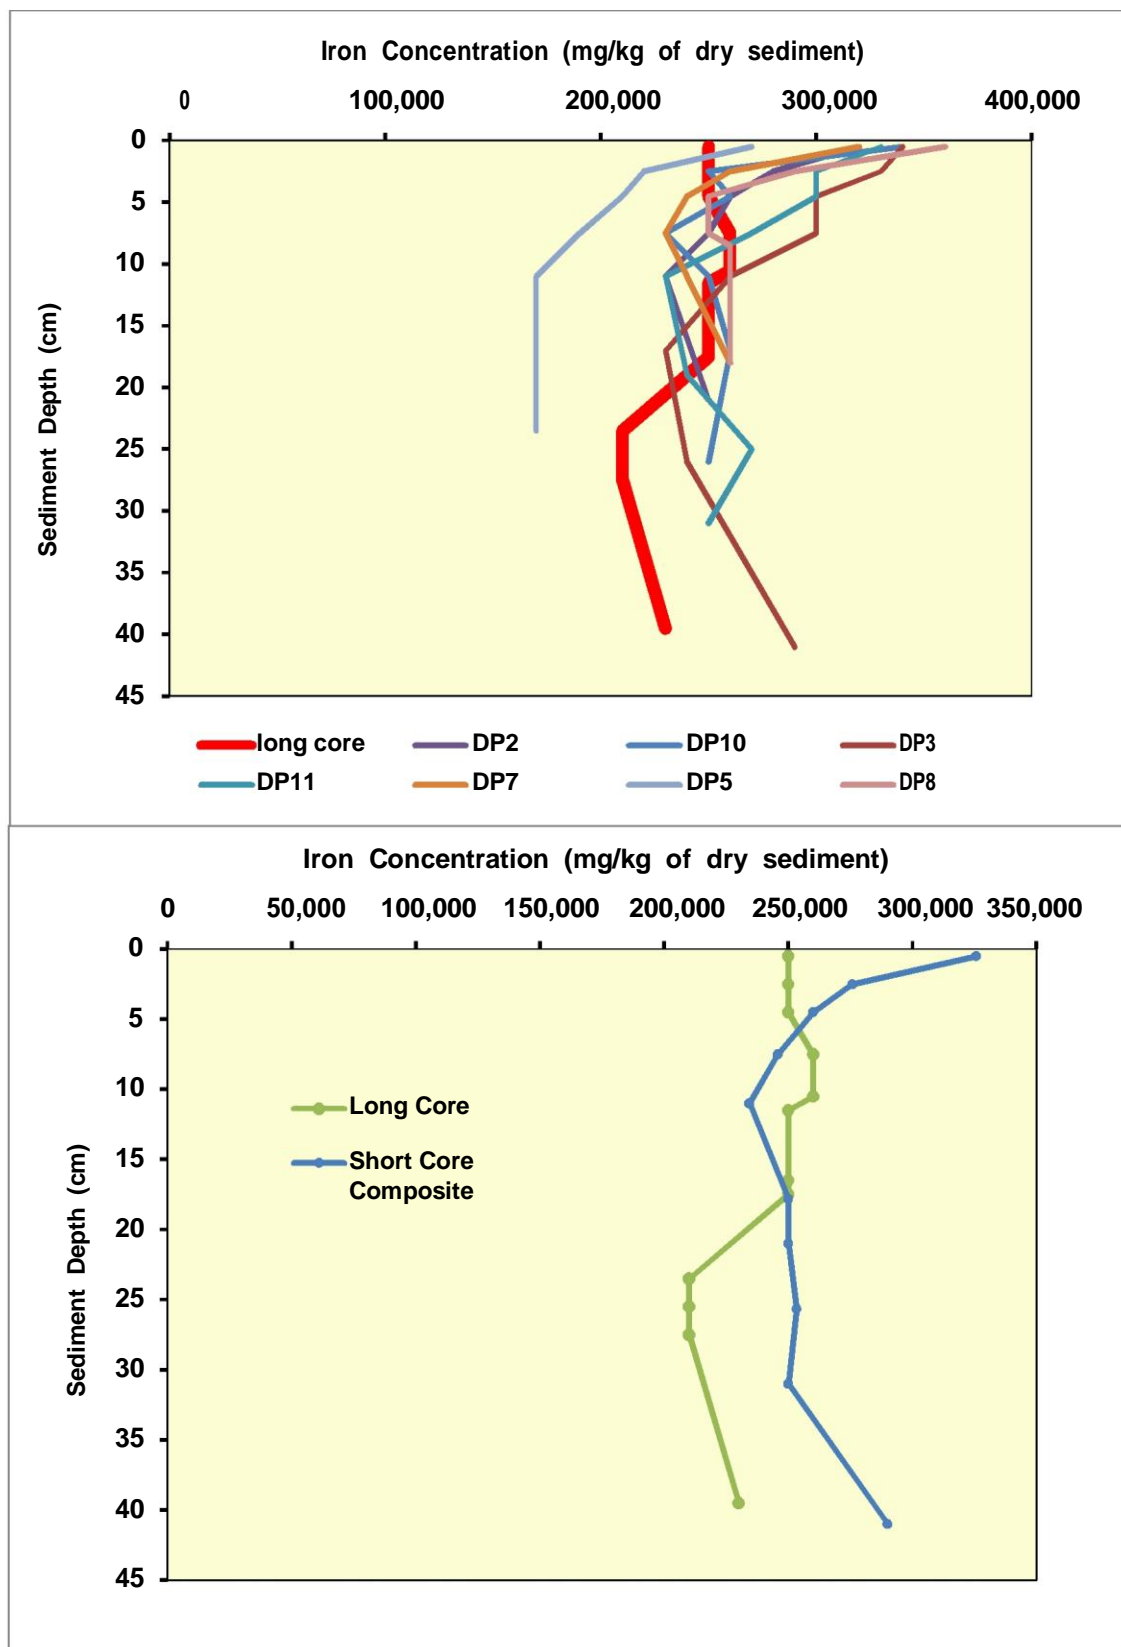
Figure 6-12. Comparison of iron in short cores and the dated long core.

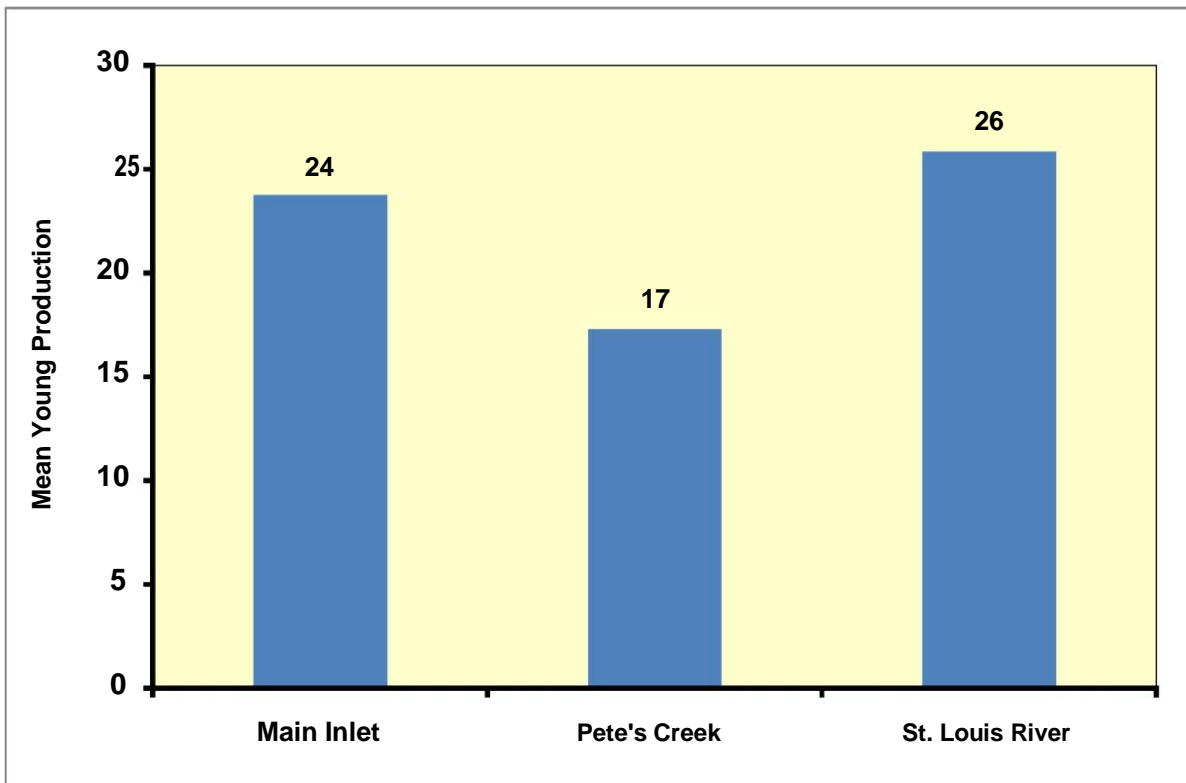
Figure 7-1. Mean young production for a 7-day toxicity test using the test species *Ceriodaphnia dubia* and water collected at two inlets to Dead Pike Lake and a reference water from northern Minnesota.

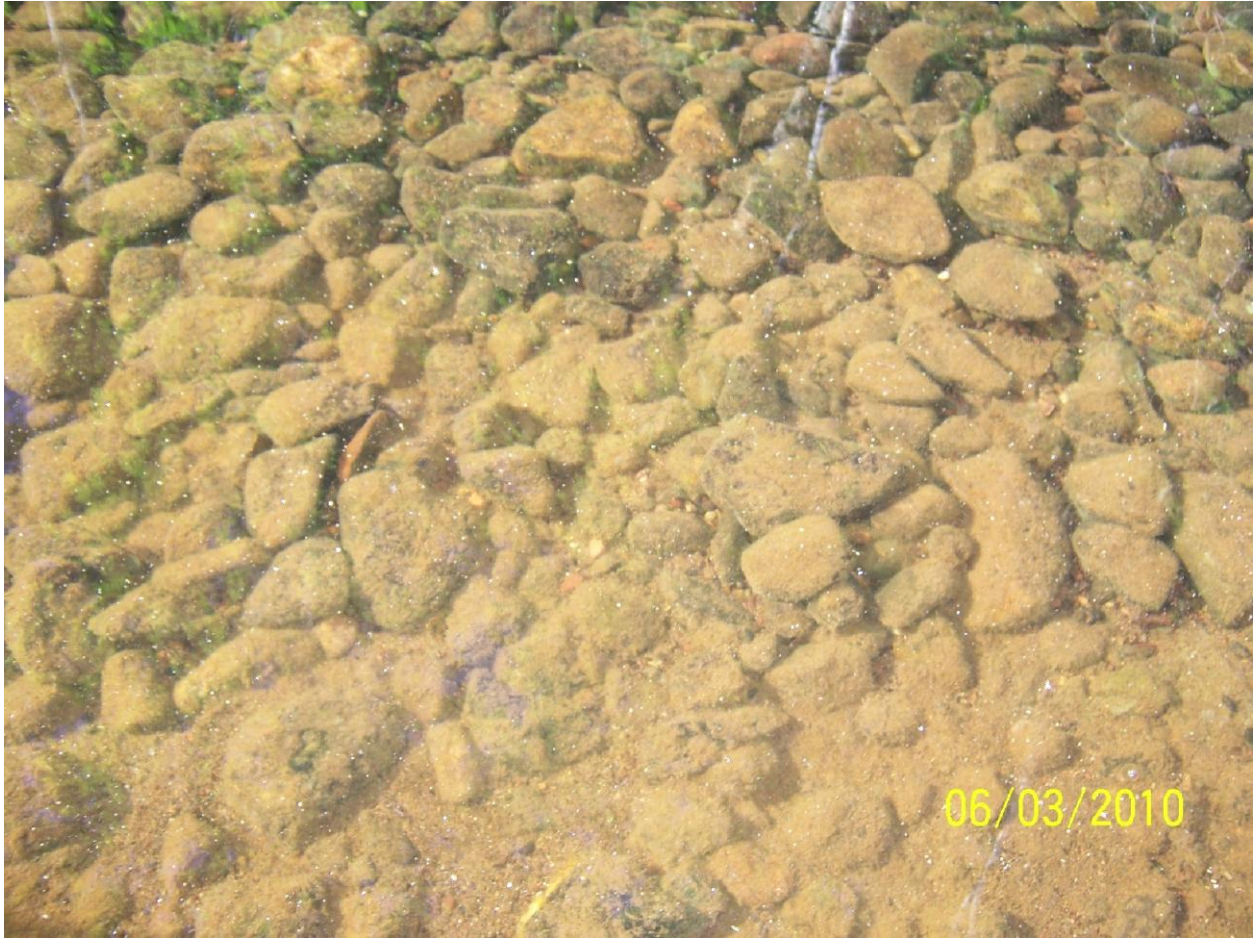
Figure 8-1. Photograph showing the accumulation of sediment on rocks in Dead Pike Lake.
