## 2015 Assessment of Aquatic Plants in Treated Plots

Spring Endothall Treatment to Control Curlyleaf Pondweed

Red Cedar Lake (#2109600) and Hemlock Lake (#2109800)  
Barron County, WI

Pretreatment Surveys – April 23, 2015  
Posttreatment Surveys – June 1, 2015  
Sediment Turion Surveys – Oct 22, 2015

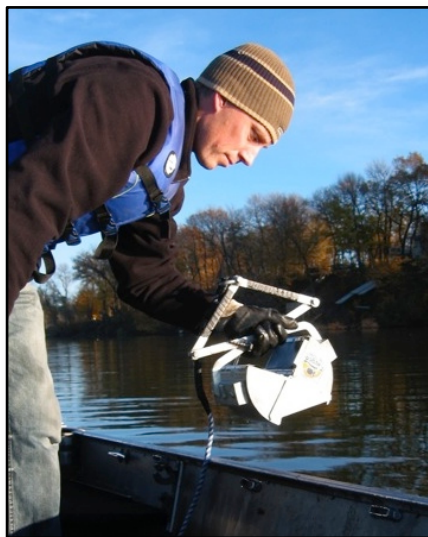
**Figure 3.** JA Johnson (Freshwater Scientific Services) preparing to collect a sediment sample with the Ponar dredge.

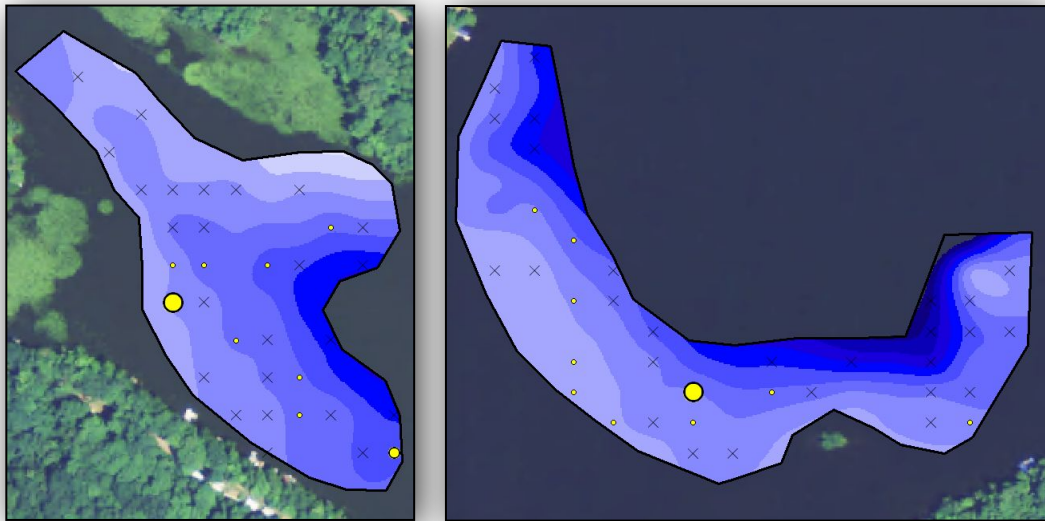
## Sediment Turion Abundance

Hemlock Lake – Oct 2015

Red Cedar Lake – Oct 2015

Surveyed: Oct 22, 2015  
 Surveyor: JA Johnson  
 Affiliation: Freshwater Scientific Services  
 Methods: Sediment Sampling/Ponar grab
