Herbicide Treatment Analysis for *Potamogeton crispus*

Bone Lake, Polk County WI

2015

Surveys, mapping and analysis provided by: Ecological Integrity Service, LLC

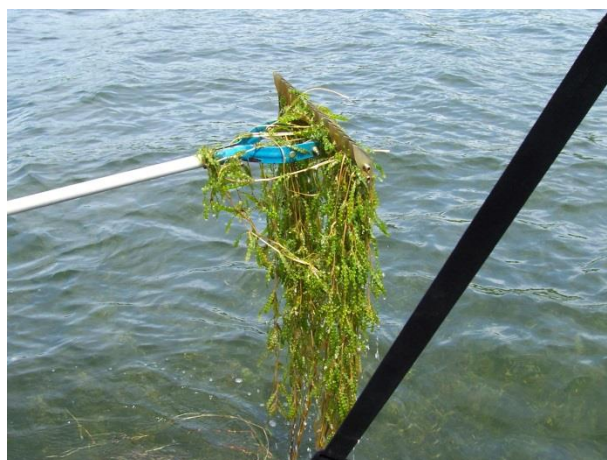
Figure 4: Density rating system and example CLP rake sample.

The second survey is referred to as the post treatment survey. This survey involves going to the same GPS coordinates as the pre-treatment survey and doing a rake sample at the point. If any CLP is on the rake, the density of the CLP is recorded (see Figure 2 for reference). All other species are also recorded from the rake sample in order to verify no damage to the native plants.

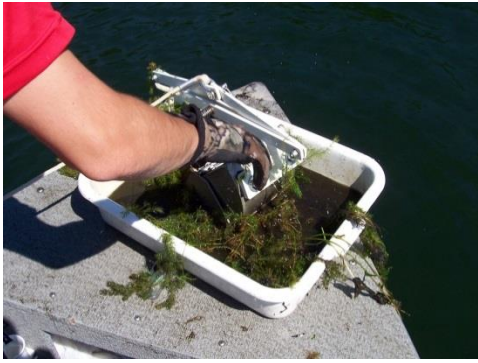
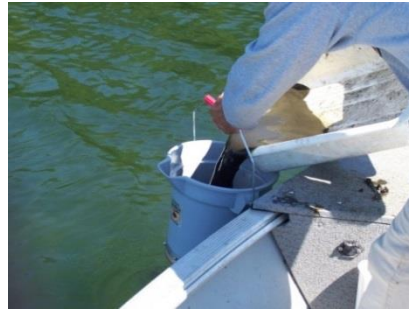
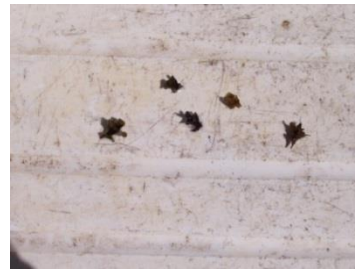
Figure 5: Pictures showing turion density methods. A shows sediment sample; b shows separation; c Shows separated turions.

In order to reflect potential future growth and the cumulative success of treatments, a turion analysis is conducted in the fall following treatment. This analysis involves going to sample points near the middle of the CLP bed (assuming this will reflect the highest density). At each sample point a sediment sampler is lowered to the lake sediment and a sediment sample is obtained. Two samples are obtained from each side of the boat at each location. The samples are then sifted with a screened bucket to isolate the turions. The turions are then counted and the density of turions is calculated in turions/square meter. Consistently successful treatments should show a trend of reduced turion density each year. This way we know the treatments are killing plants prior to turion production, resulting in overall reduction in CLP in those beds.

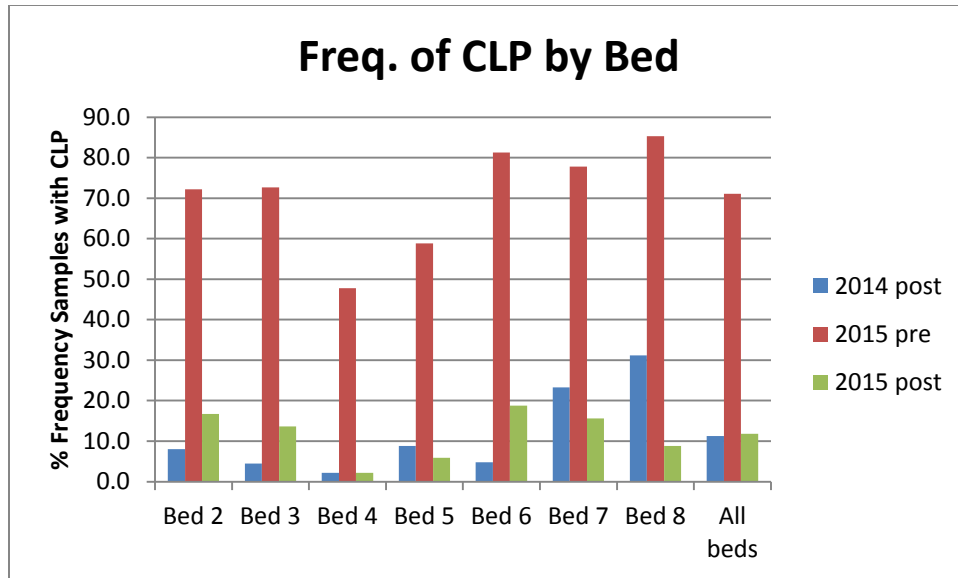
Figure 6: Frequency of occurrence of CLP 2014 to 2015 in each treatment bed.

A pre-treatment survey was conducted on April 19, 2015 and a post treatment survey was conducted on June 12 (in bed treated May 20) and June 16 (in bed treated June 4). Bed 2 was reduced significantly due to no CLP in the north portion of the bed. The comparison of the various surveys in 2014 and 2015 indicate some reductions that were significant and some not significant (and one small increase). Table 3 and Figures 6 and 7 summarize the frequency of occurrence from the various surveys. Table 4 summarizes the reductions and/or increases in frequency with chi-square results.

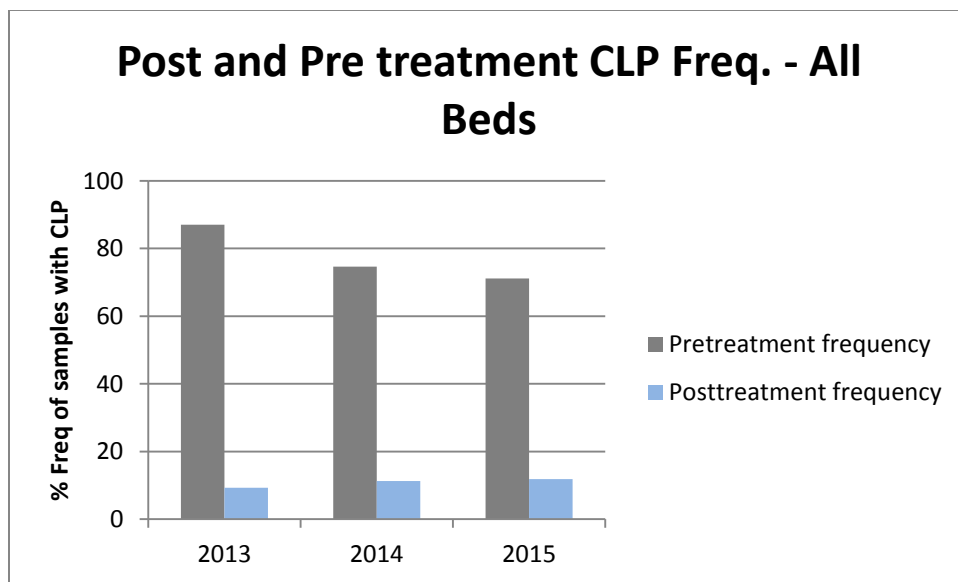
Figure 7: Frequency of occurrence of CLP in all beds pre and post treatment 2013-2015.

As the data shows, there was a significant reduction in CLP when comparing the pretreatment survey of 2015 and the post treatment survey of 2015. After the 2014 treatment, the CLP growth returned filling in much of the treatment polygons leading to a high frequency in the April pretreatment survey. After treatment occurred, the post treatment survey in June showed the frequency was significantly reduced.

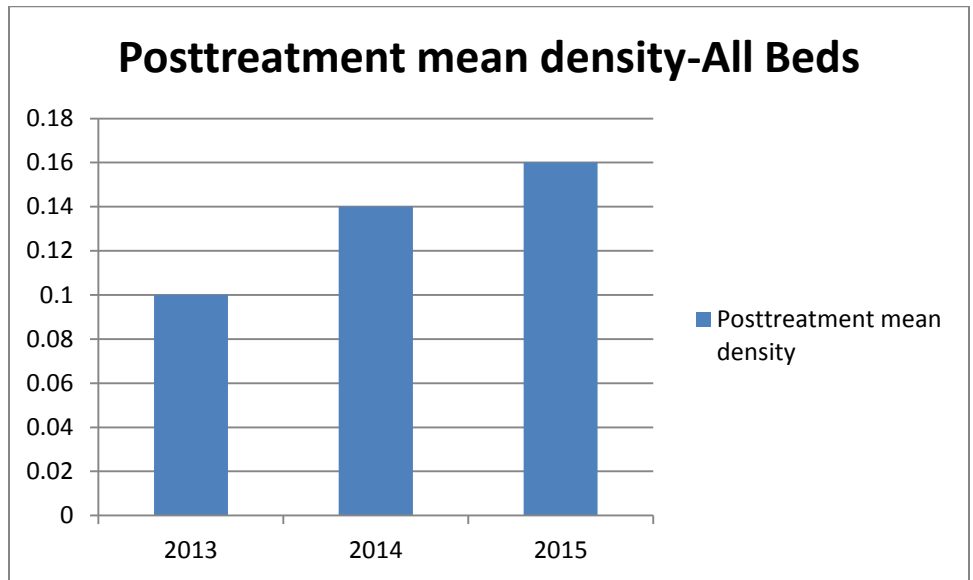
Figure 8: CLP mean density 2013-2015, all treatment beds.

Density is also determined in the post treatment surveys only. Table 5 and Figure 8 show changes in mean density from the last three post treatment survey years.

The density in CLP in the post treatment surveys has shown small increases. The 2015 treatment occurred very late in the east side beds and appears to not have responded to herbicide as well as the west side beds, which got treated much earlier in the spring. This is likely reflected in the increased density values, especially in Bed 6.

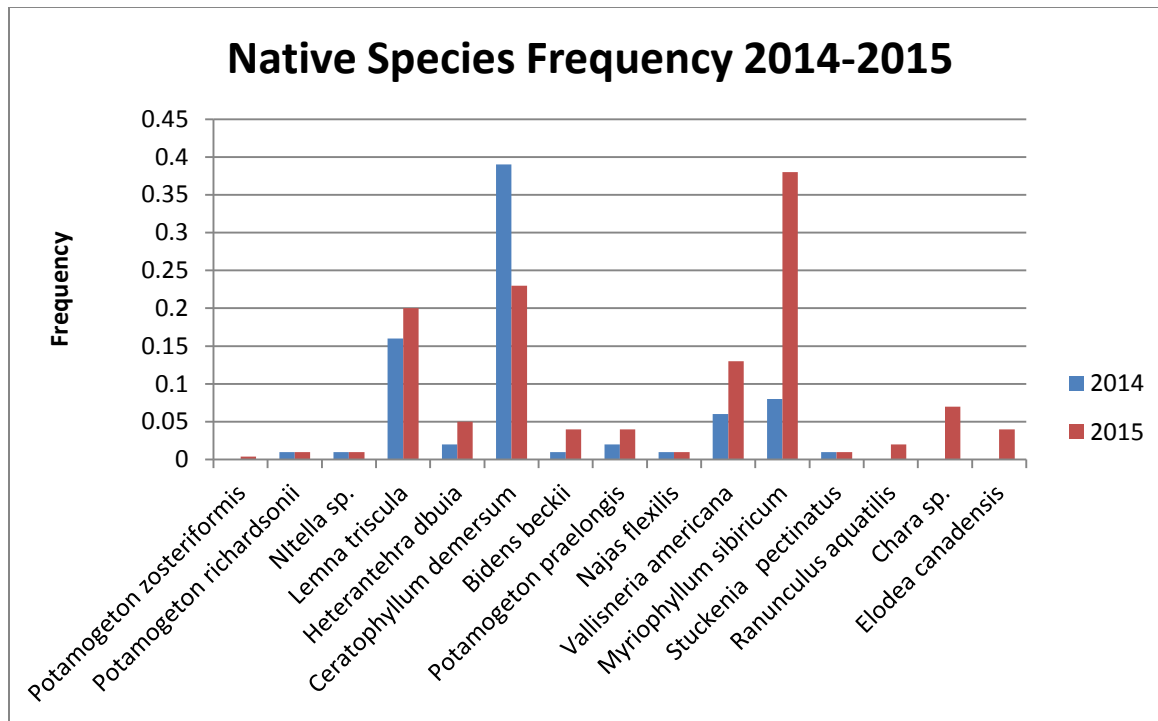
Figure 13: Native plant species frequency, all beds, 2014 and 2015 for comparison.

In addition to the evaluation of the CLP changes, the native plant species are evaluated for any reductions, potentially due to herbicide application. Table 5 shows the frequency of native species in 2014 and 2015. A chi-square analysis is calculated to determine if the changes are statistically significant. One native species had a significant reduction; *Ceratophyllum demersum*-coontail. It is possible this reduction is due to the herbicide as coontail could have been out of dormancy at the time of treatment. Endothall is a broad spectrum herbicide so it can affect most plant species. There were also increases in seven native species, so the herbicide had minimal impact on the native plants. Table 6 and Figure 13 summarize the native species data.

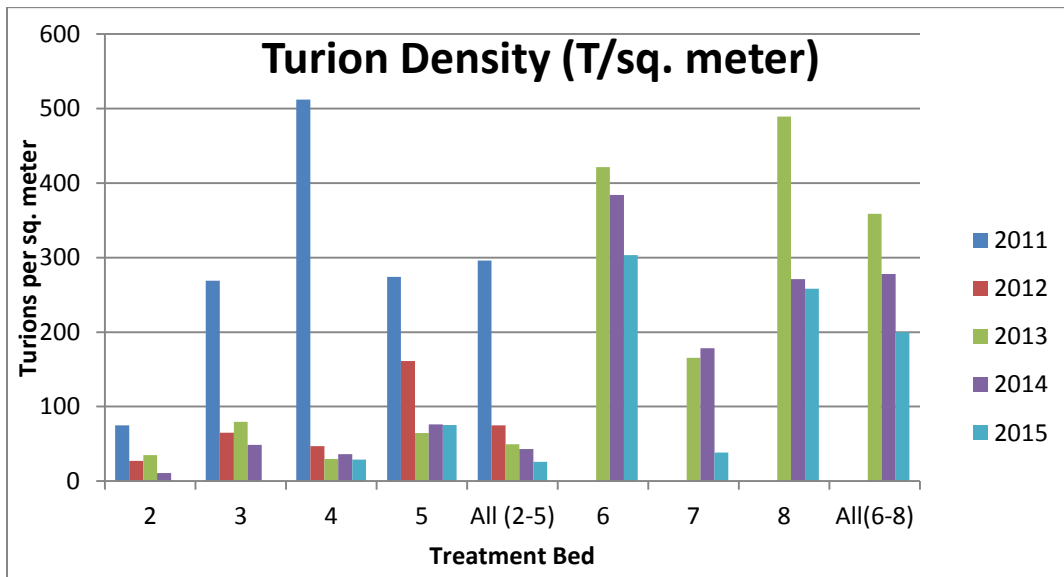
Figure 17: Turion density by bed 2011-2015.

Figure 17 is a bar graph of the turion density by bed and all beds combined (separated as beds 2-5 and 6-8 due to total years of treatment).

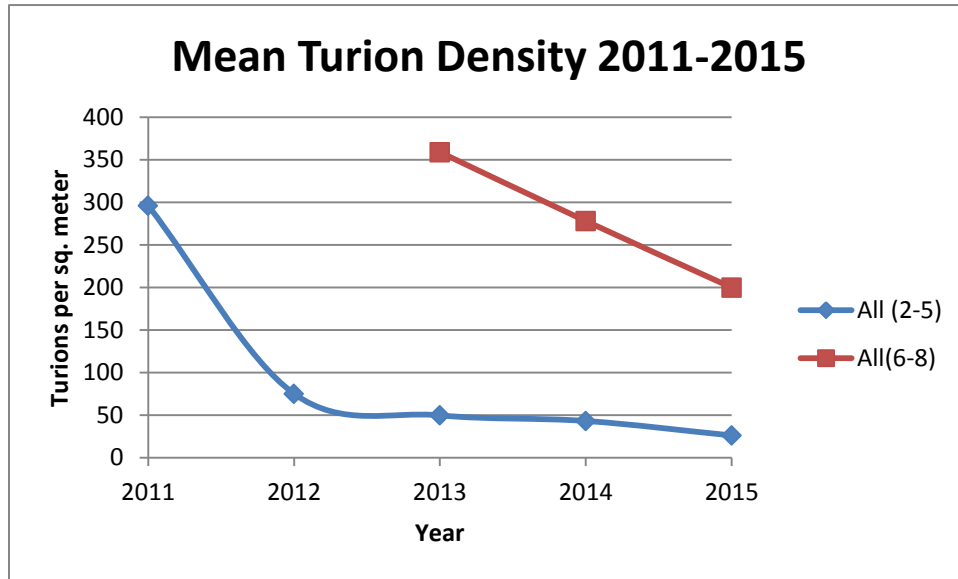
Figure 18: Mean turion density change, 2011-2015.

Figure 18 graphically shows the turion density that has been occurring in all beds. As successful treatments continue, the turion density should continue to decrease, resulting in less CLP growing each spring within these treatment beds.
