**Eurasian water milfoil (*Myriophyllum spicatum*)  
Pre/Post Herbicide and Fall Bed Mapping Surveys  
Sand Lake - WBIC: 2661100  
Barron County, Wisconsin**

Project Initiated by:  
Sand Lake Management District, Short Elliot Hendrickson Inc., and the  
Wisconsin Department of Natural Resources

Survey Conducted by and Report Prepared by:  
Endangered Resource Services, LLC  
Matthew S. Berg, Research Biologist  
St. Croix Falls, Wisconsin  
May 17, July 18, and October 12, 2012

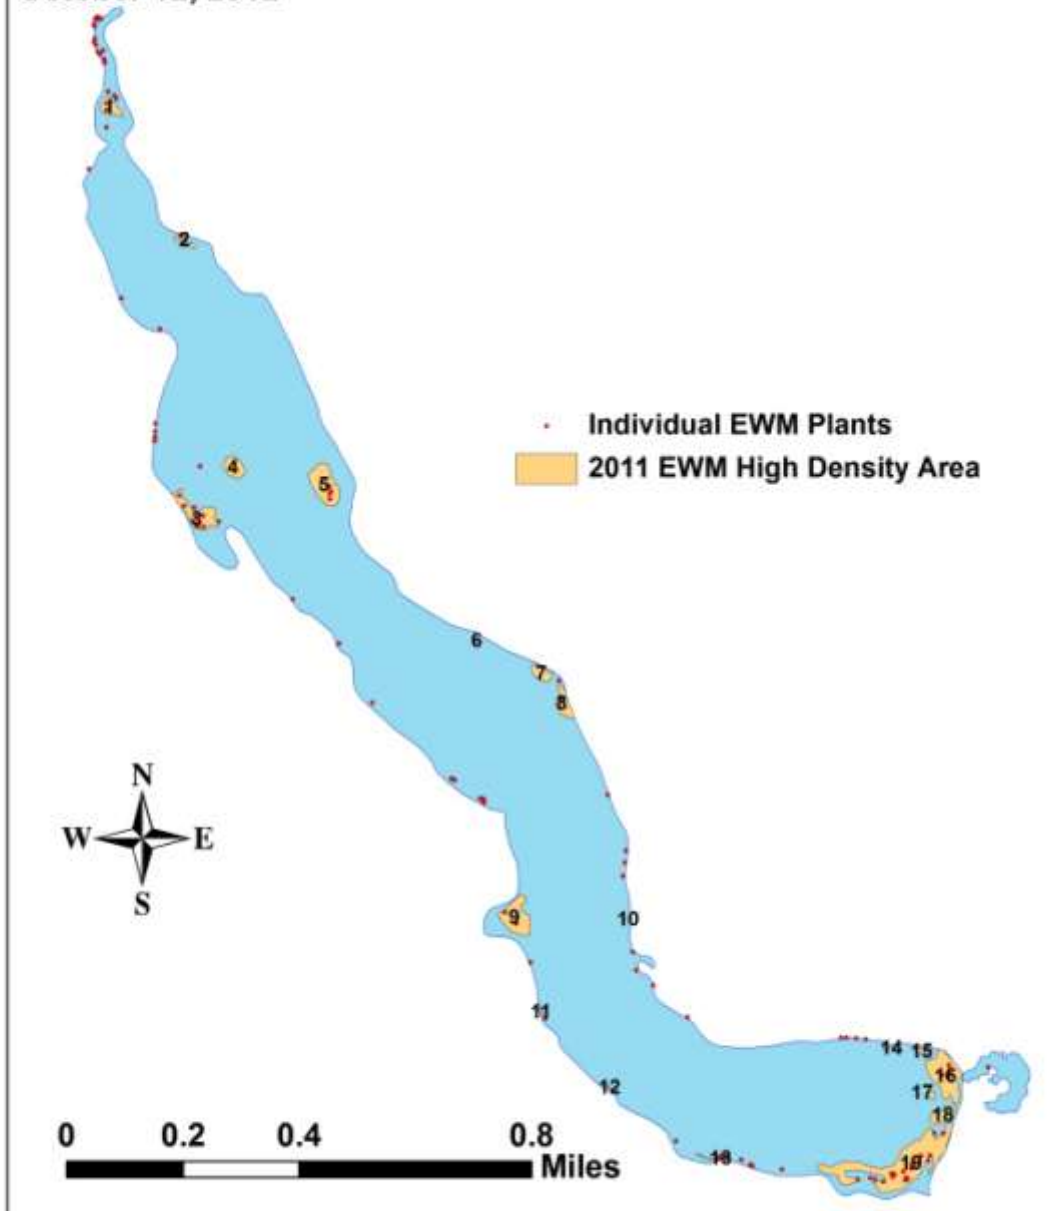
# Eurasian water milfoil (*Myriophyllum spicatum*)

Fall EWM Bed Mapping Survey  
Sand Lake  
Barron County, WI  
October 12, 2012

The 2011 survey found 19 high EWM density areas totaling 15.25 acres (Table 5). In 2012, the 18.1km transect survey located and mapped a total of **122 individual plants**. No beds of any kind were found despite extensive raking at the edge of the littoral zone and in areas that had large numbers of EWM in 2011 (Figure 12) (Appendix VIII).
