Presque Isle Wilderness Waters Program

Aquatic Plant Management Plan – Averill Lake

White Water Associates, Inc.
Dean Premo, Ph.D.
429 River Lane, P.O. Box 27
Amasa, Michigan 49903

Date: December 2015

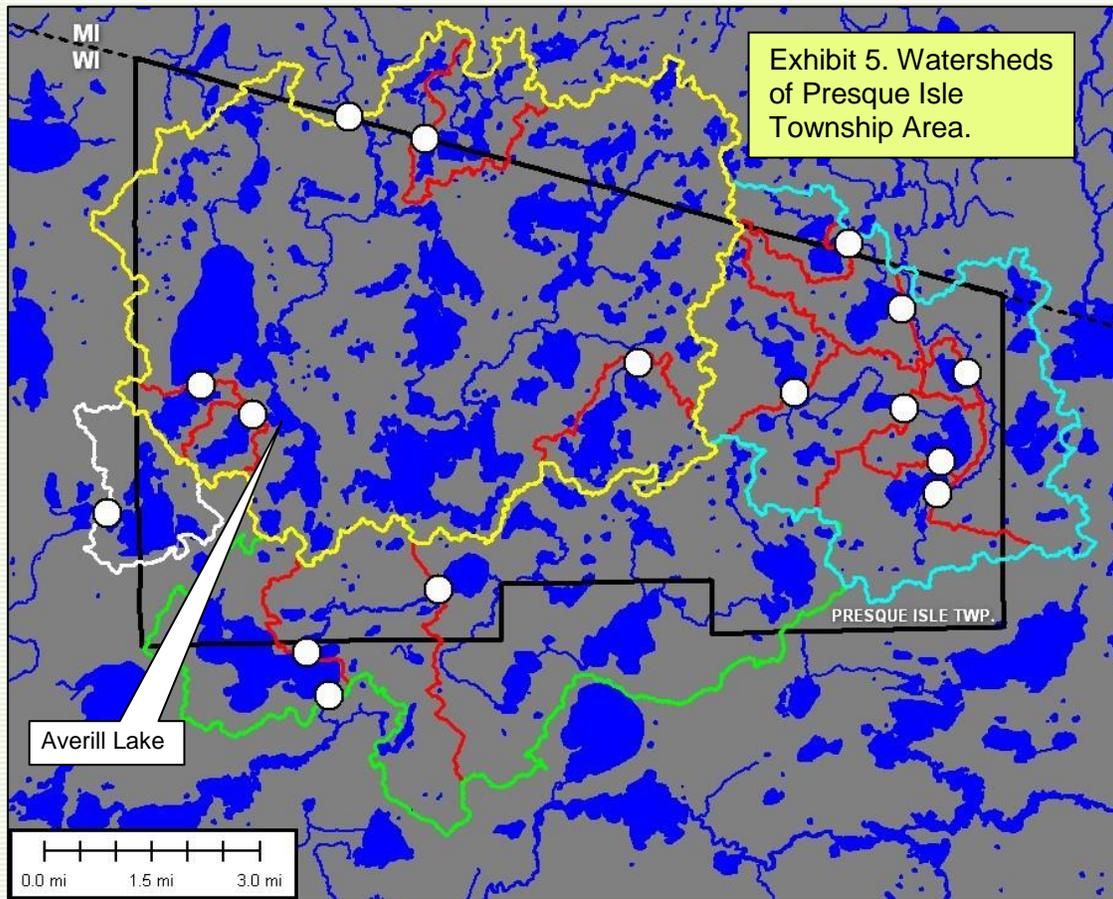
Description: Portions of 3 federal hydrologic sub-watersheds are illustrated: (1) S.Br. Presque Isle River (bounded by yellow), (2) Pomeroy Cr-E.Br. Presque Isle River (bounded by blue and yellow), and (3) Rice Cr. (bounded by green, yellow, and blue). Also shown are the smaller watersheds of individual water bodies subject to the Wilderness Waters studies (bounded by red and, in the case of Papoose Lake, bounded by white). White dots show outlet points for the smaller watersheds.

The Presque Isle Township waterscape sits on a large-scale watershed divide. Some of the water drains north through the Presque Isle River system and eventually enters Lake Superior. Some of the water drains into the Wisconsin River system to the Mississippi River and to the Gulf of Mexico. In fact there are two federal hydrologic sub-basins (designated by 8-digit HUC codes) that include Presque Isle Township. The Black-Presque Isle Rivers sub-basin (HUC#04020101) drains north to Lake Superior and the Flambeau River sub-basin (HUC#0705002) drains southwesterly to the Mississippi River. The Black-Presque Isle Rivers sub-basin contains two federal hydrologic sub-watersheds within Presque Isle Township: the South Branch Presque Isle River sub-watershed (HUC#040201010303) and the Pomeroy Creek-East Branch Presque Isle River sub-watershed (HUC#040201010301). The Flambeau River sub-basin contains one sub-watershed within Presque Isle Township: the Rice Creek sub-watershed (HUC#07050020103). Exhibit 5 illustrates these watersheds and the watersheds of the water bodies subject to the Wilderness Waters Program studies. Averill Lake is contained within the South Branch Presque Isle River sub-watershed (Exhibit 5).

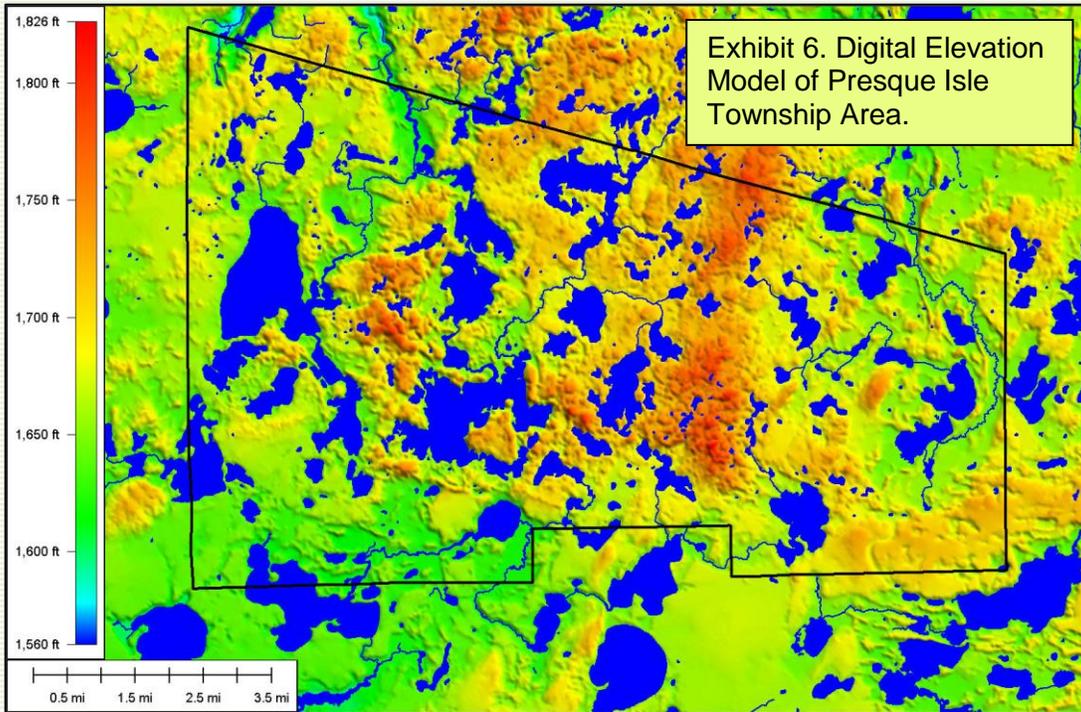
The elevation in Presque Isle Township ranges from around 1,550 feet above sea level to 1,750 feet above sea level. A digital elevation model is provided as Exhibit 6 and shows the relative elevations for the area with orange areas of the landscape being the highest elevations and greens and blues being the lowest elevations.

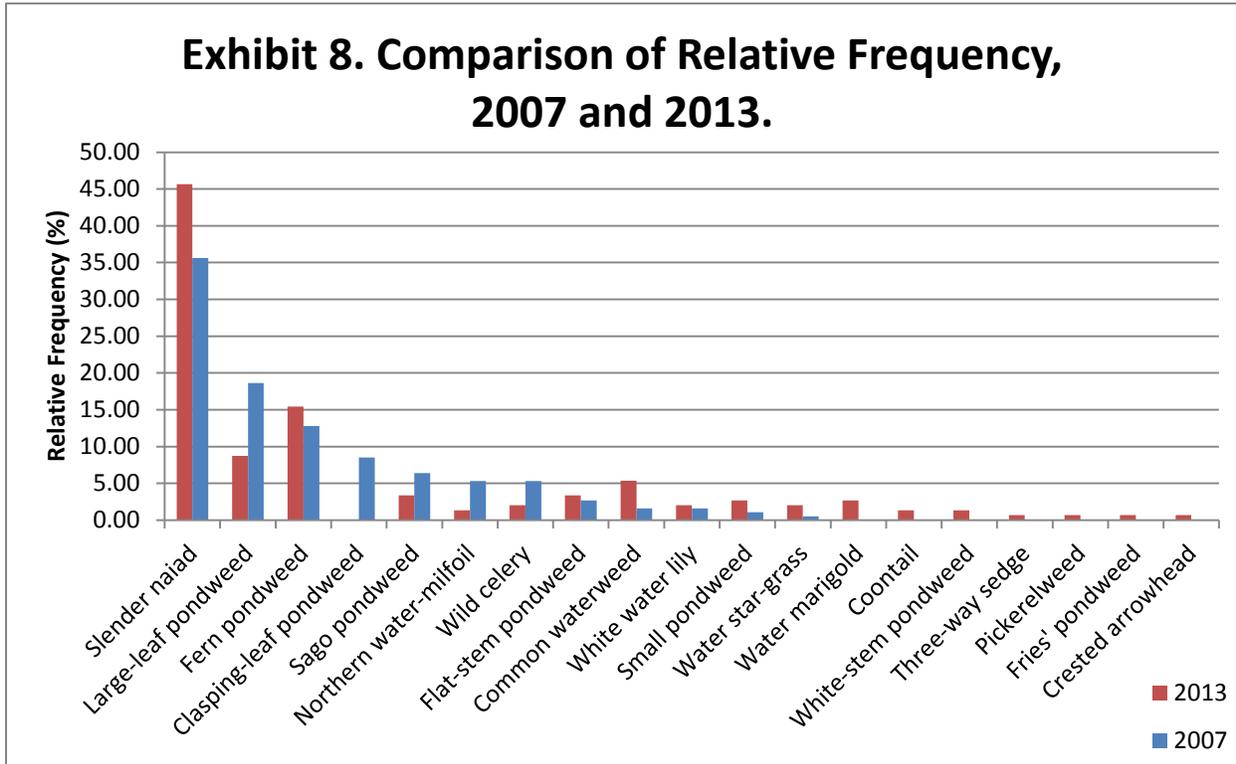
Exhibit 8. Comparison of Relative Frequency, 2007 and 2013.

Exhibit 8 displays the relative frequency of plants found in 2007 and 2013. Here it is evident that slender naiad has increased greatly in Averill Lake since 2007, leaving other species numbers to decrease. We can also observe that many new species were seen in 2013. This trend is worthy of monitoring with future aquatic plant surveys.

In the 2007 aquatic plant survey, an average 2.02 species were observed per site (vegetated sites only), while in 2013, the average species per site was only 1.63. The maximum depth of plants was 2 feet in 2007 and was 6 feet in 2013. In 2007, the frequency of occurrence of plants at sites shallower than the maximum depth of plants was 79.5% which is much higher than in 2013 (52.3%). Slender naiad (*Najas flexilis*) and large-leaf pondweed (*Potamogeton amplifolius*) had the highest relative frequencies in 2007. In 2013, slender naiad again had the highest frequency, but was instead followed by fern pondweed (*Potamogeton robbinsii*) with the second highest frequency (Exhibit 8). The Simpson Diversity Index, which takes into account both richness and evenness in estimating diversity, was 0.80 in 2007, meaning that the lake had a diverse aquatic plant community. The 2013 SDI (0.75) demonstrates a similar diversity as 2007. In 2007, the FQI was 19.1; lower than state and regional averages, and lower than the FQI from the 2013 survey (26.2). This spike in FQI is likely due to the increase of newly found species in 2013. Exhibit 8 displays these new species, most of which have high *coefficient of conservatism* values. A comparison of 2007 and 2013 aquatic plant statistics can be viewed in Appendix B.

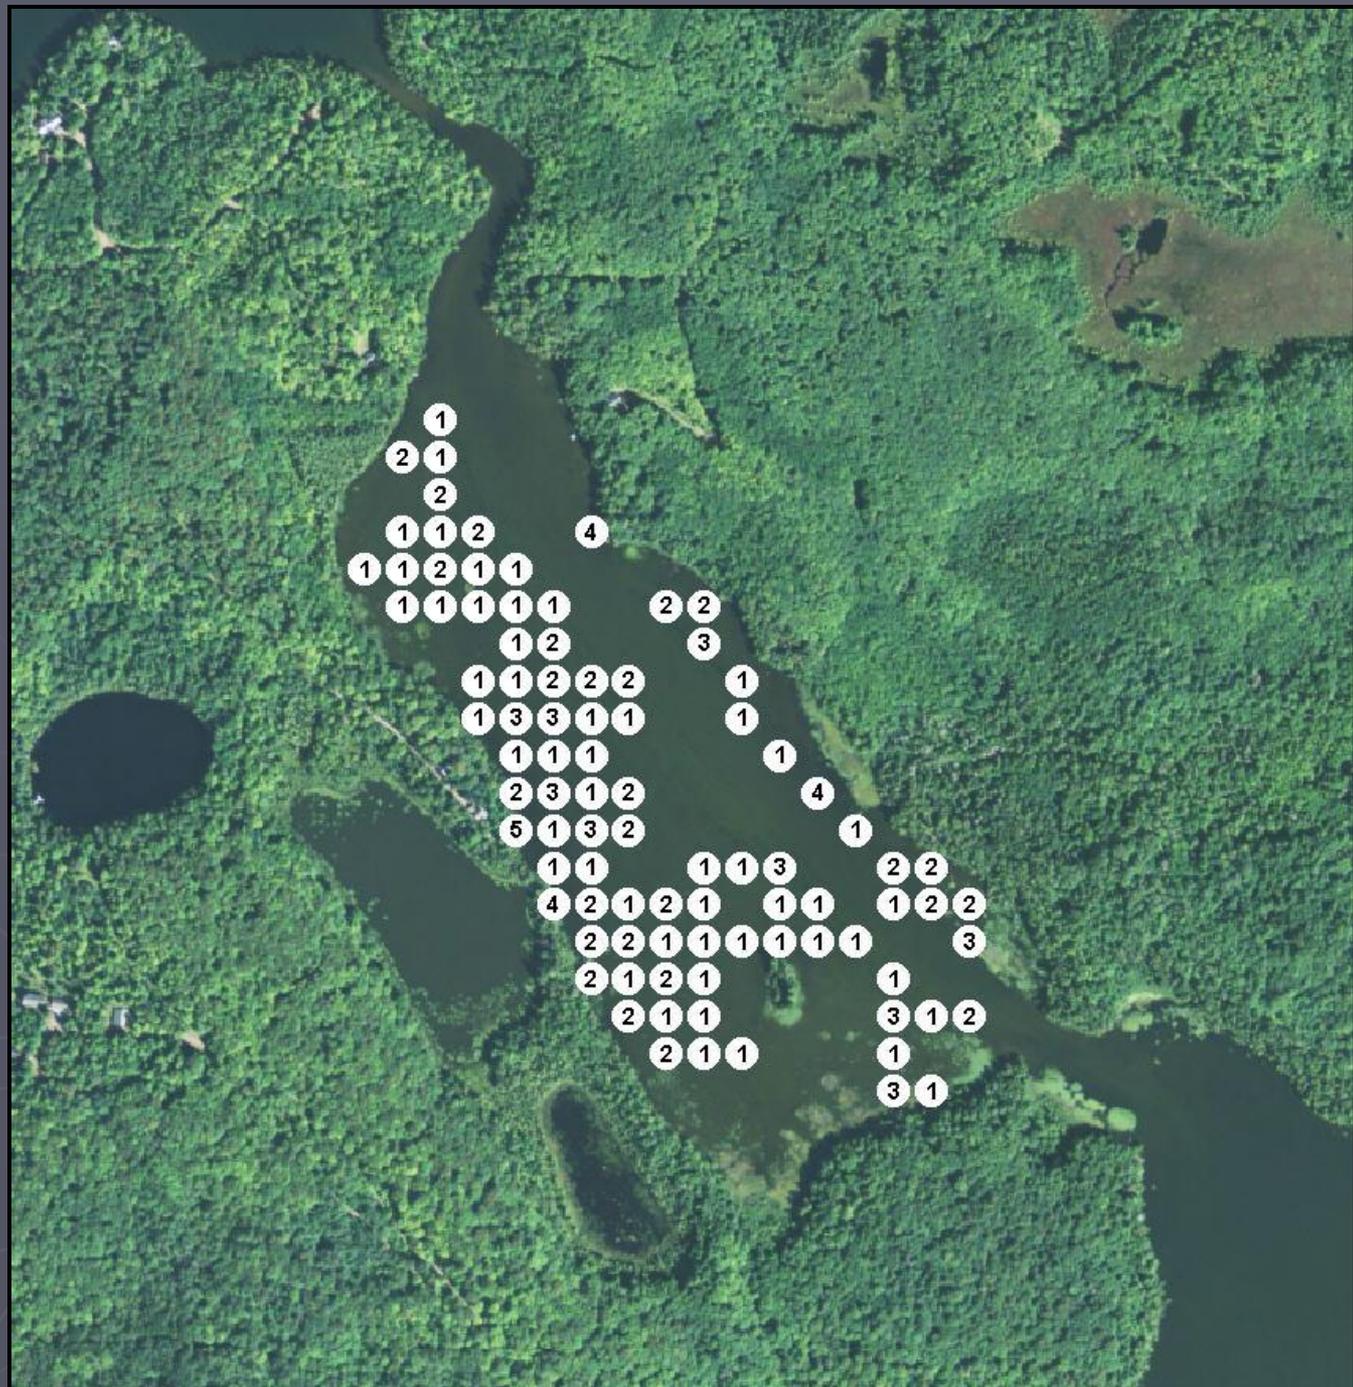
Figure 1. Number of plant species recorded at Averill Lake sample sites (2013).

Species richness refers to the total number of species recorded. We recorded 20 species of aquatic plants. Of these, 18 were collected at sampling sites and the others were observed from the boat. Table 1 displays summary statistics for the survey. Table 2 provides a list of the species encountered, including common and scientific name along with summarizing statistics.² The number of species encountered at any given sample point ranged from 0 to 5 and 92 sample points were found to have aquatic vegetation present. The average number of species encountered at these vegetated sites was 1.62. The actual number of species encountered at each

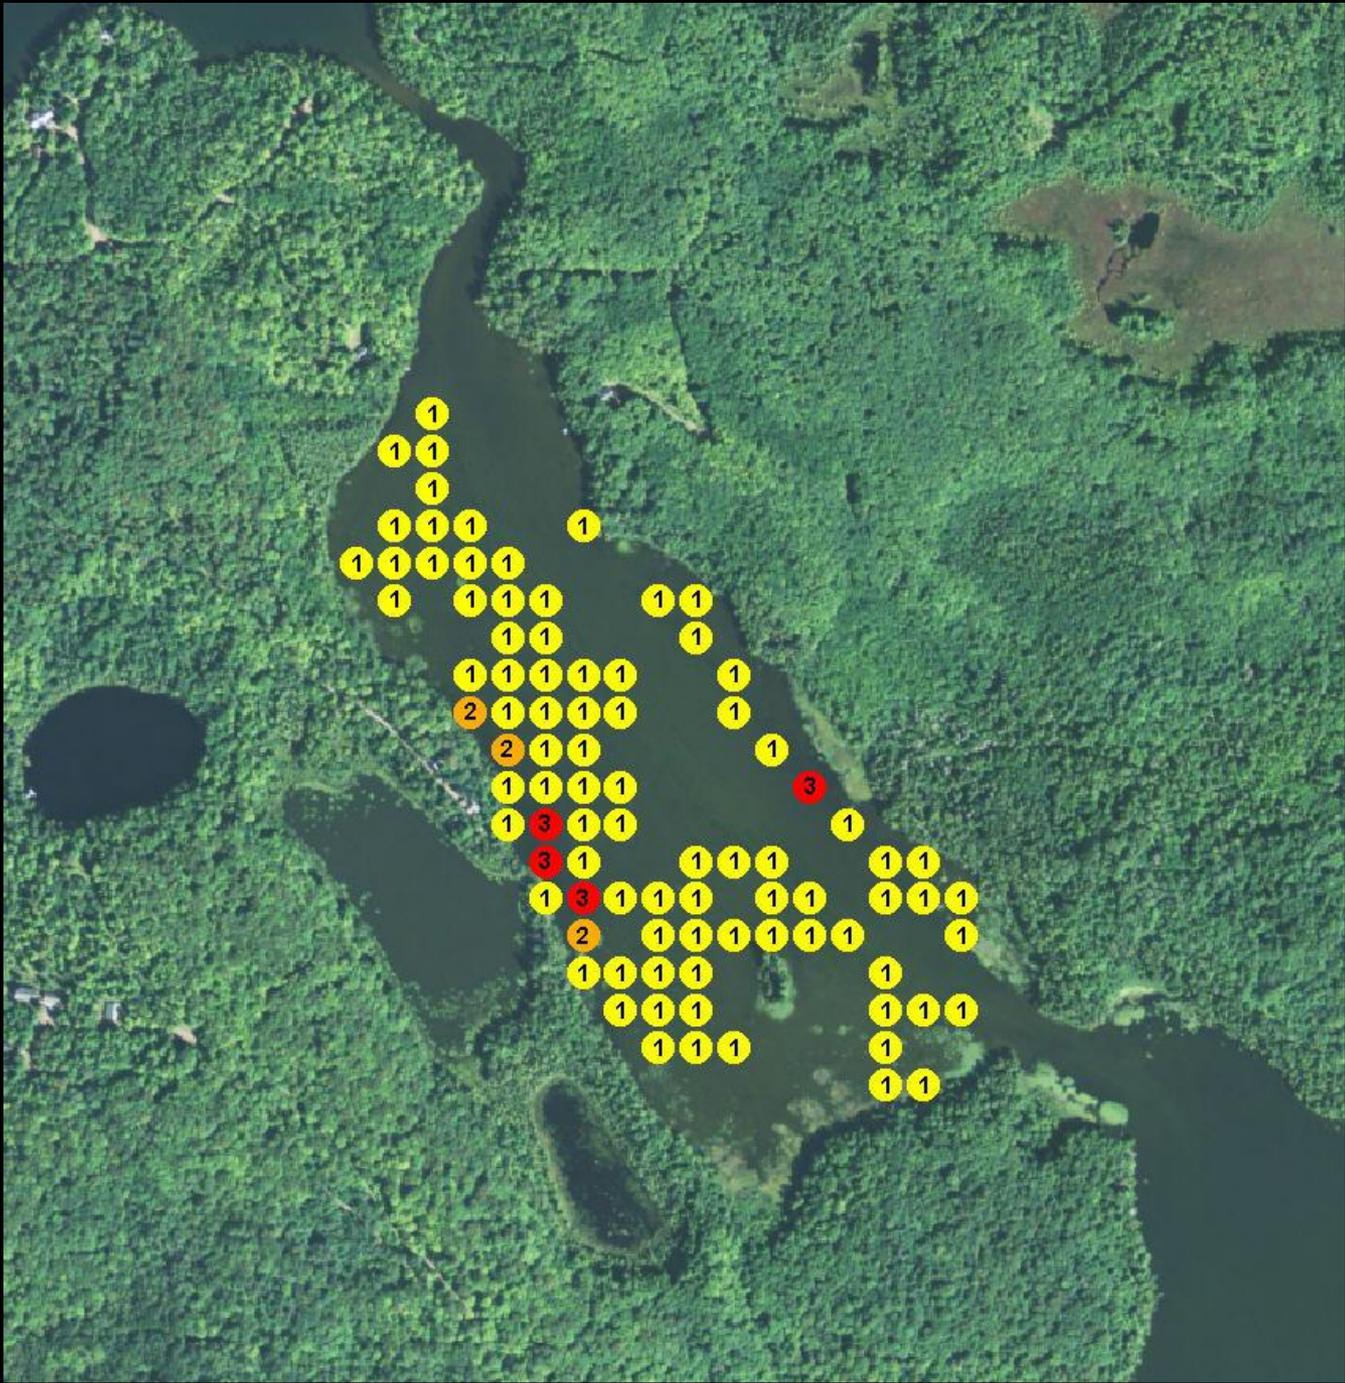
Figure 2. Rake fullness ratings for Averill Lake sample sites (2013).

- 1 (Yellow circle)
- 2 (Orange circle)
- 3 (Red circle)

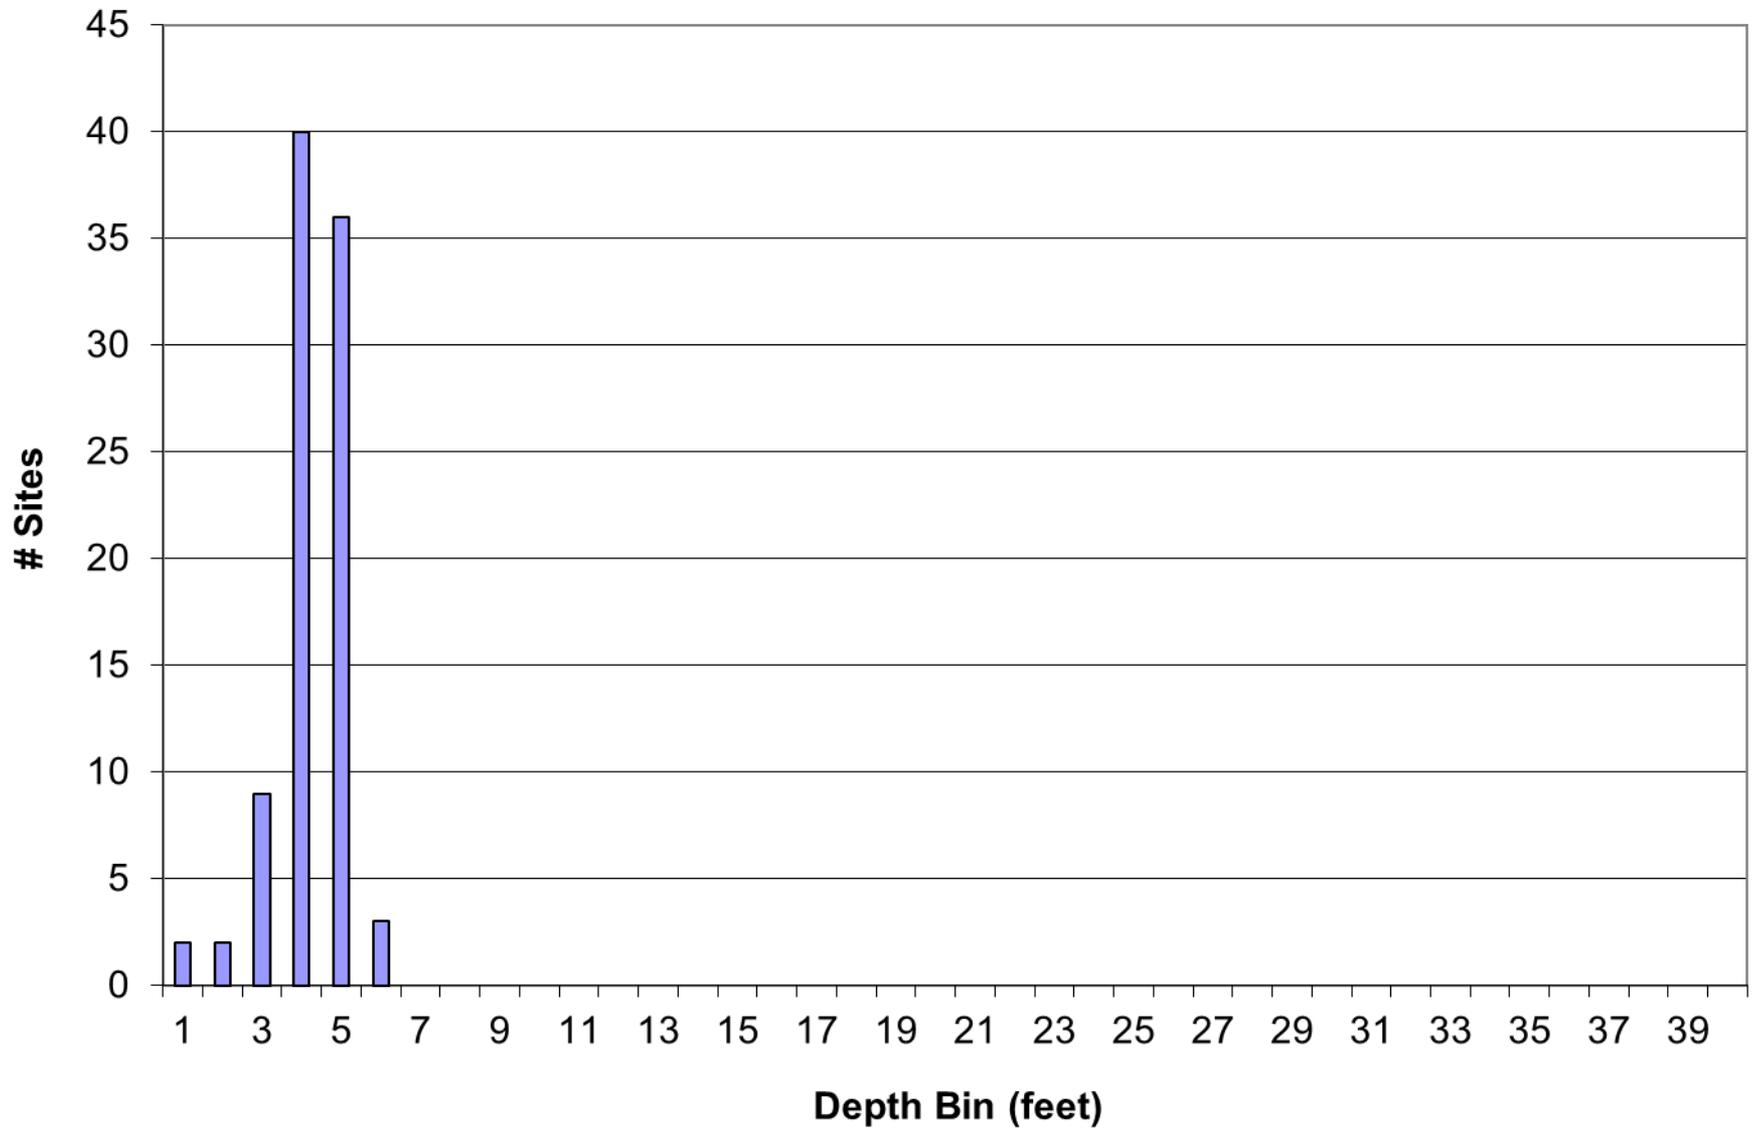
Figure 3. Maximum Depth of Plant Colonization in Averill Lake, 2013.

The maximum depth of plant colonization is 6 feet (Table 1 and Figure 3). Rooted vegetation was found at 92 of the 176 sample sites with depth \leq the maximum depth of plant colonization (52.3% of sites). These sites are displayed as a black dot within a circle on Figure 4. This indicates that although availability of appropriate depth may limit the distribution of plants, it is not the only habitat factor involved. Substrate is another feature that influences plant distribution (e.g., soft substrate often harbors more plants than hard substrate). Figure 5 presents the substrates encountered during the aquatic plant survey (mud, sand, or rock).

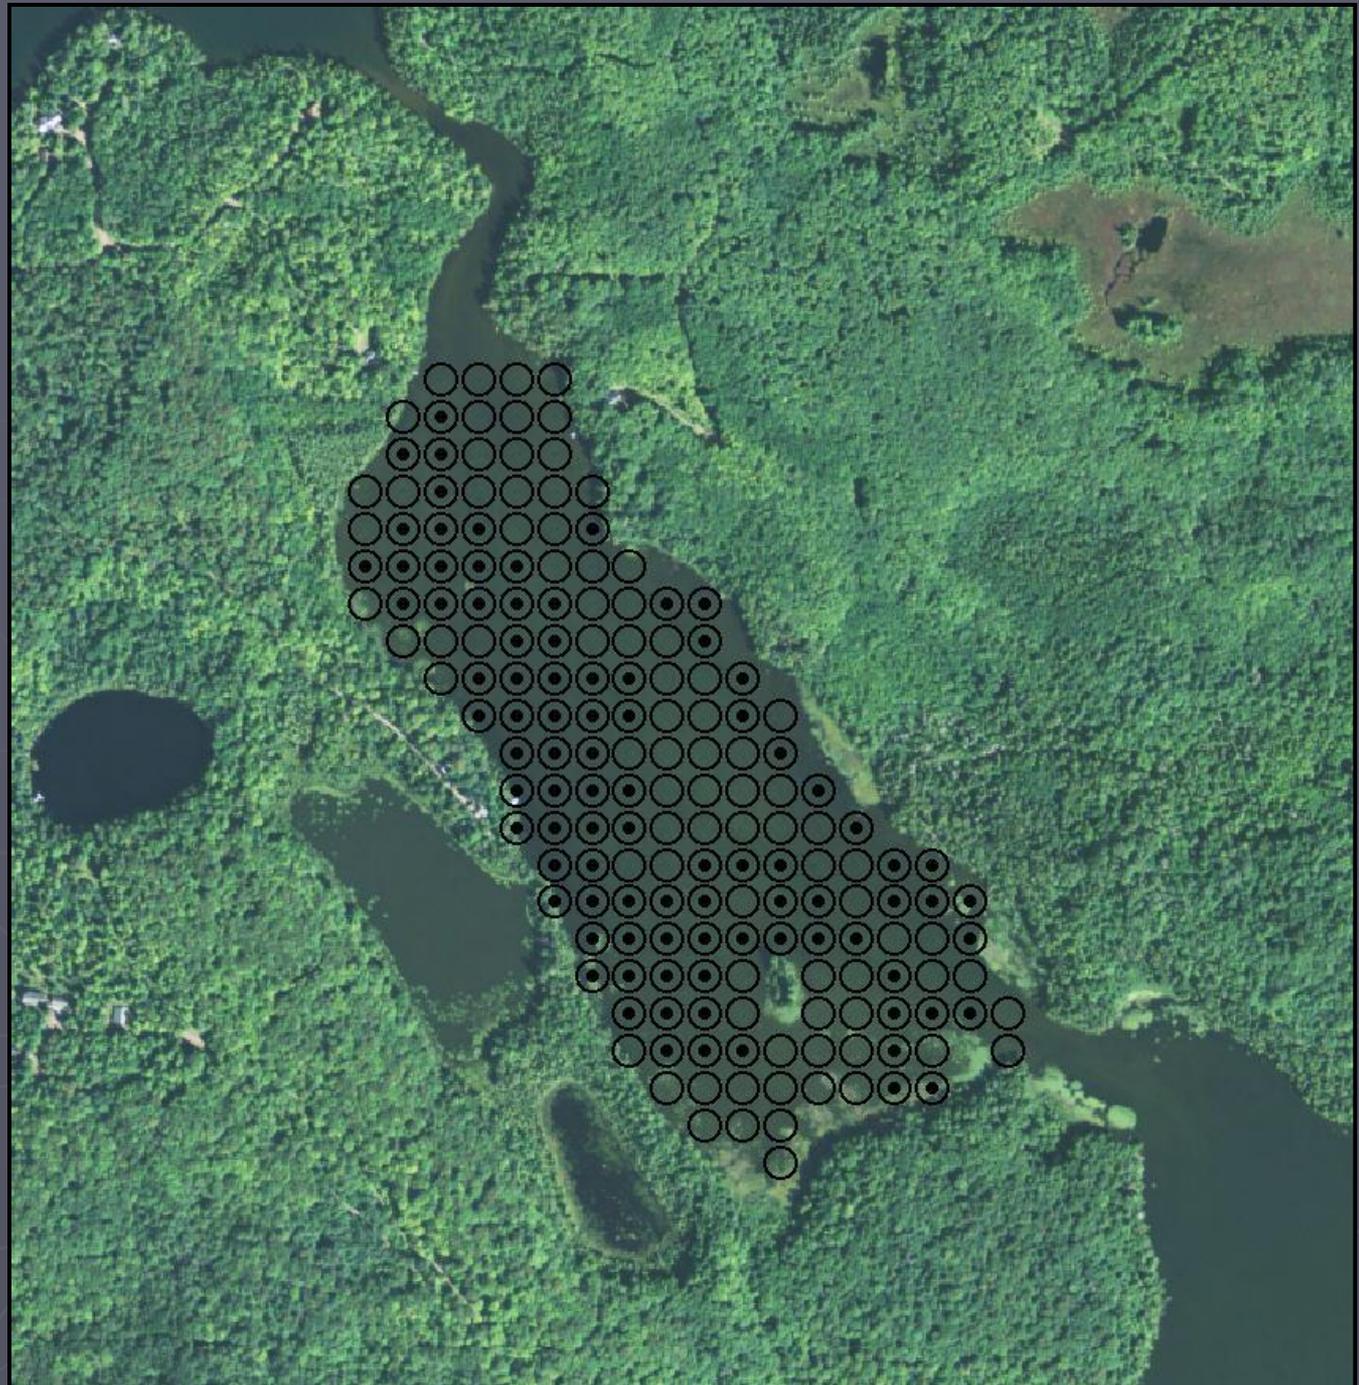
Figure 4. Averill Lake sampling sites less than or equal to maximum depth of rooted vegetation (2013).

- Site less than or equal to maximum depth of plant colonization (MDC).
- Plant find(s) at site less than or equal to MDC.

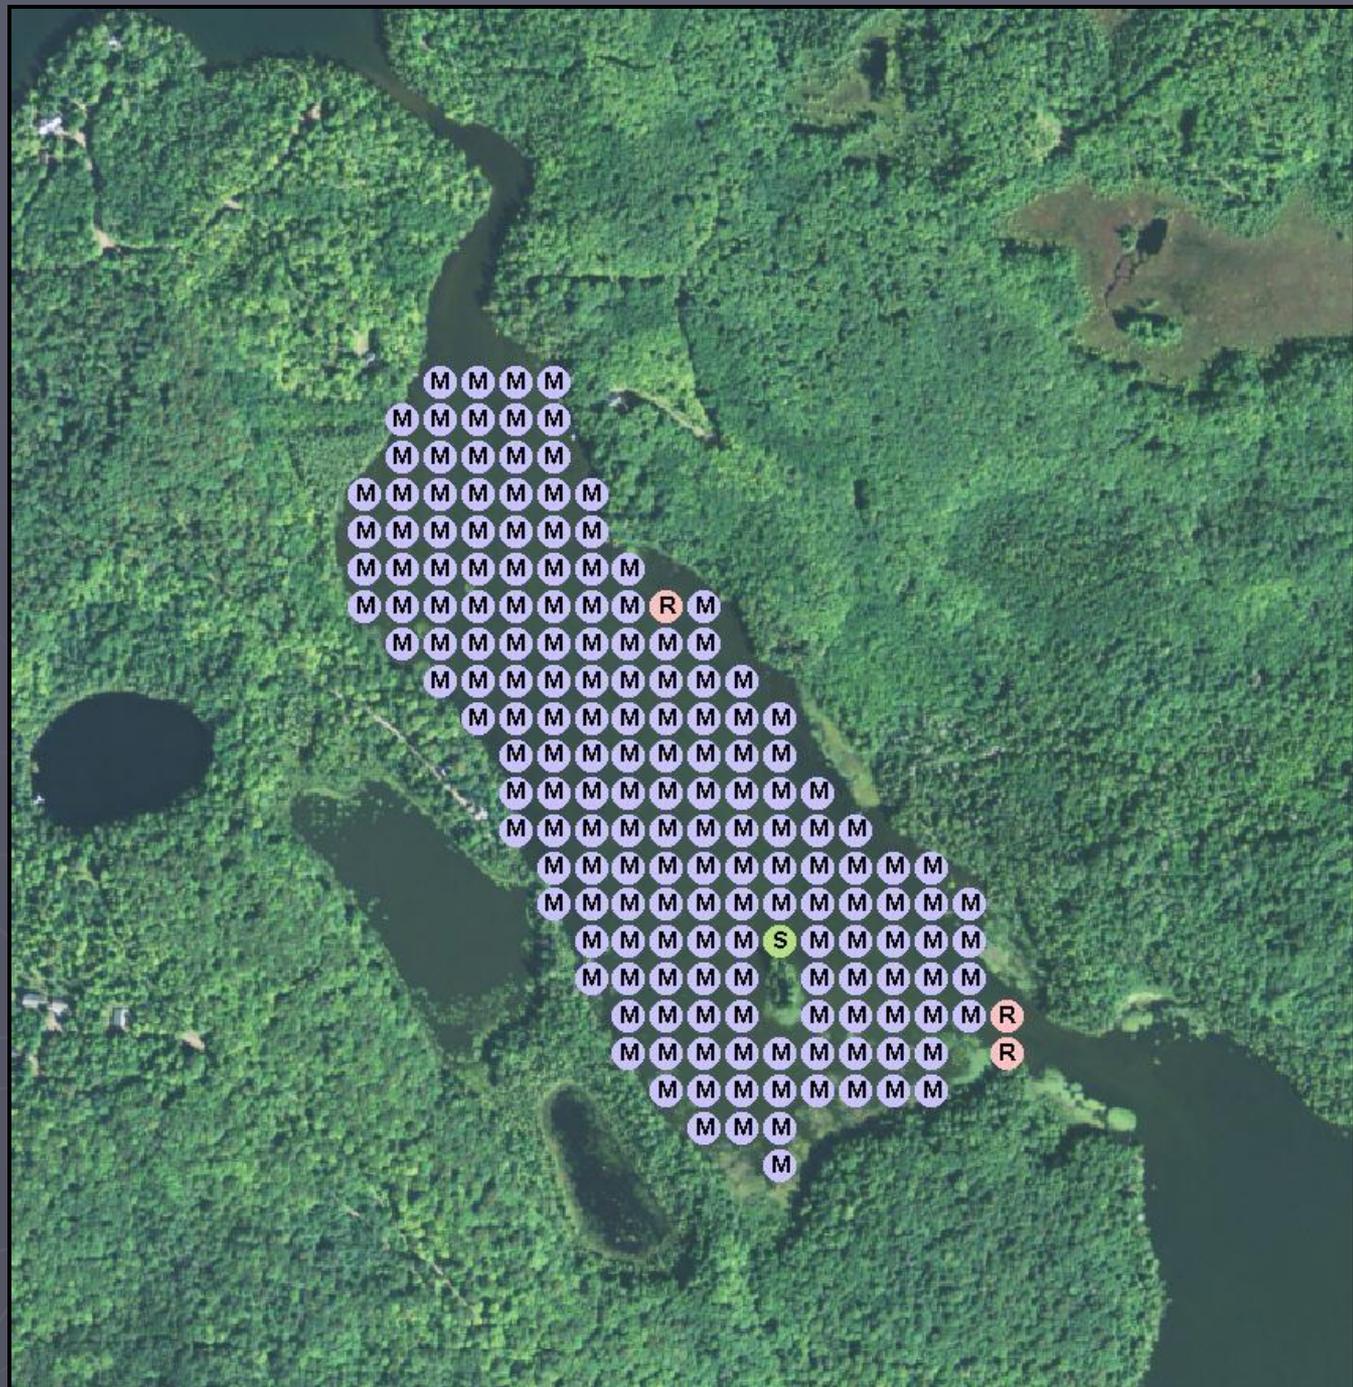
Figure 5. Averill Lake substrate encountered at point-intercept plant sampling sites (2013).

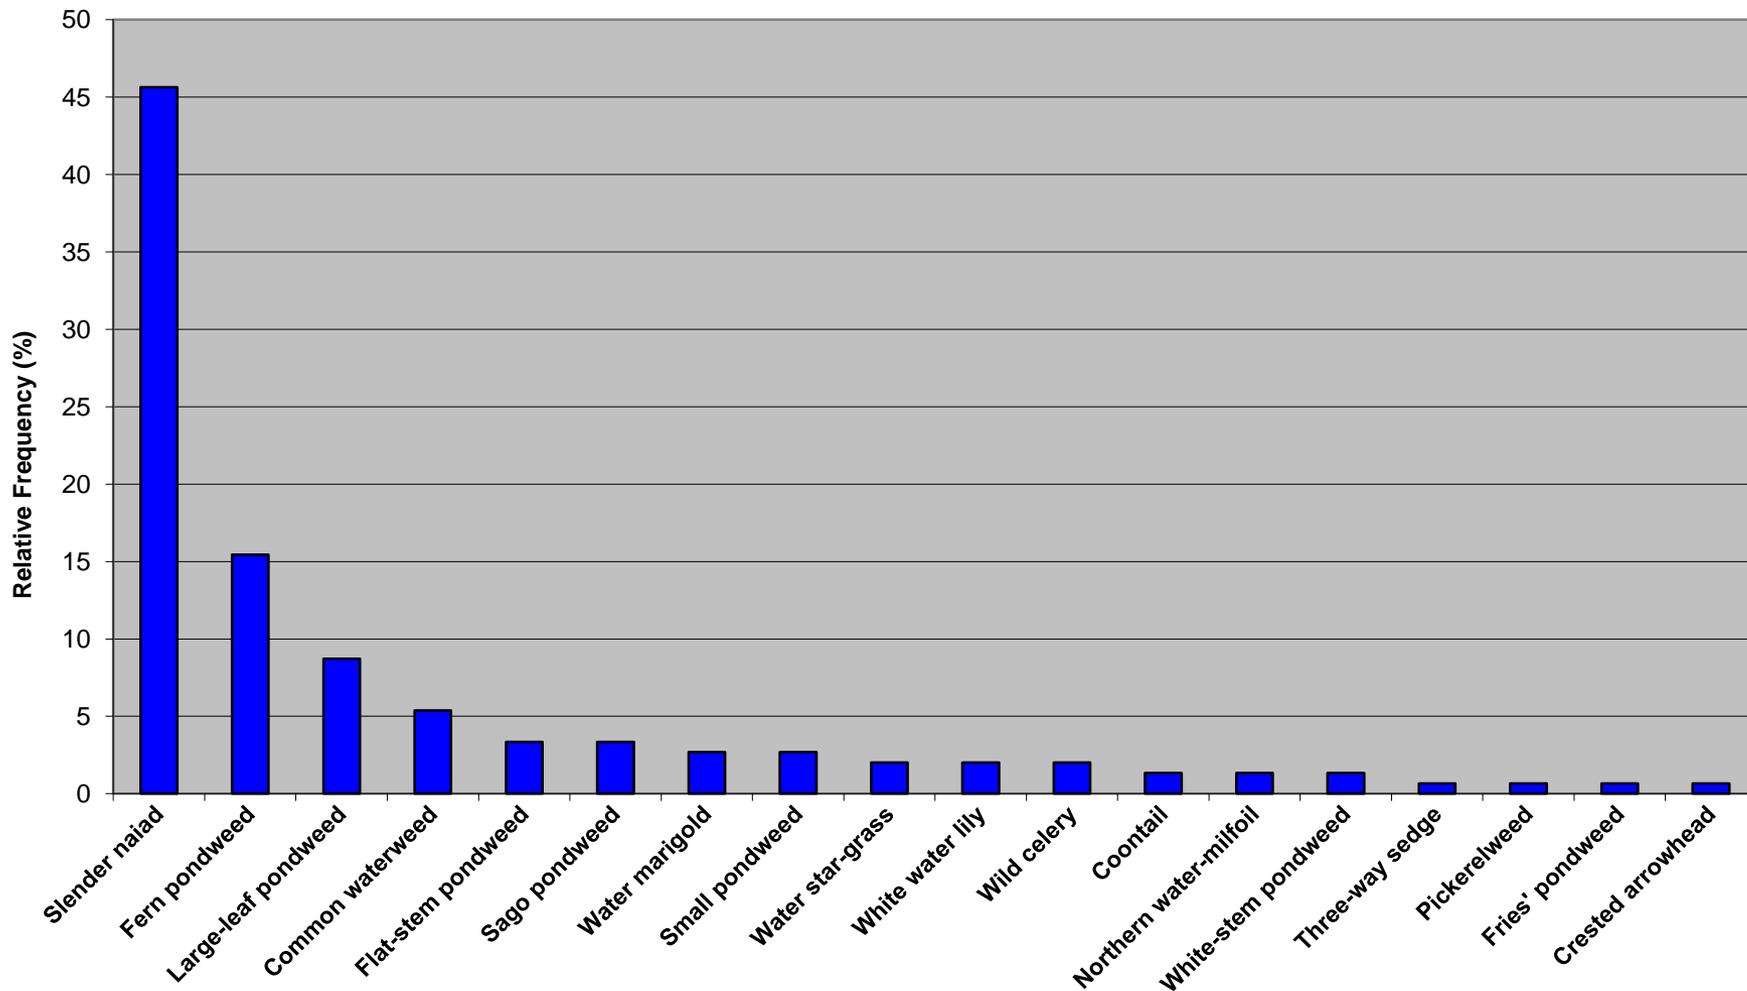
Figure 6. Averill Lake aquatic plant occurrences for 2013 point-intercept survey data.

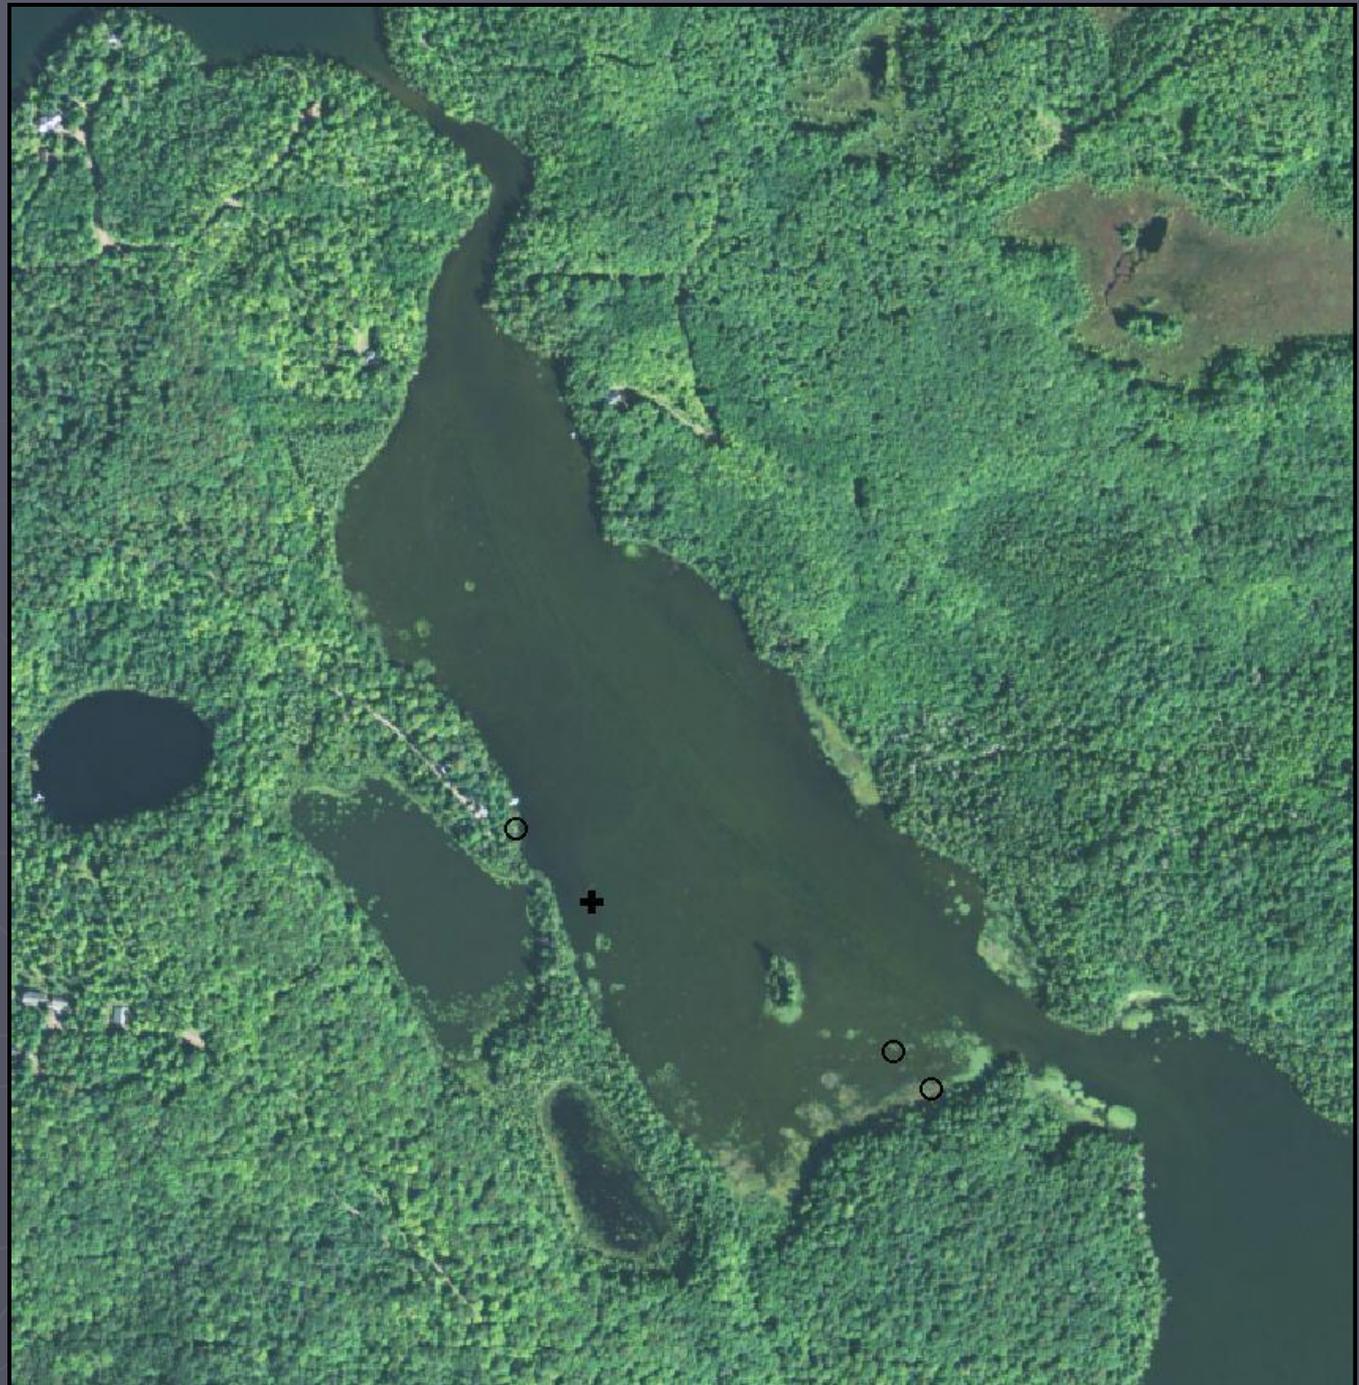
Figure 7. Averill Lake point-intercept plant sampling sites with emergent and floating aquatic plants (2013).

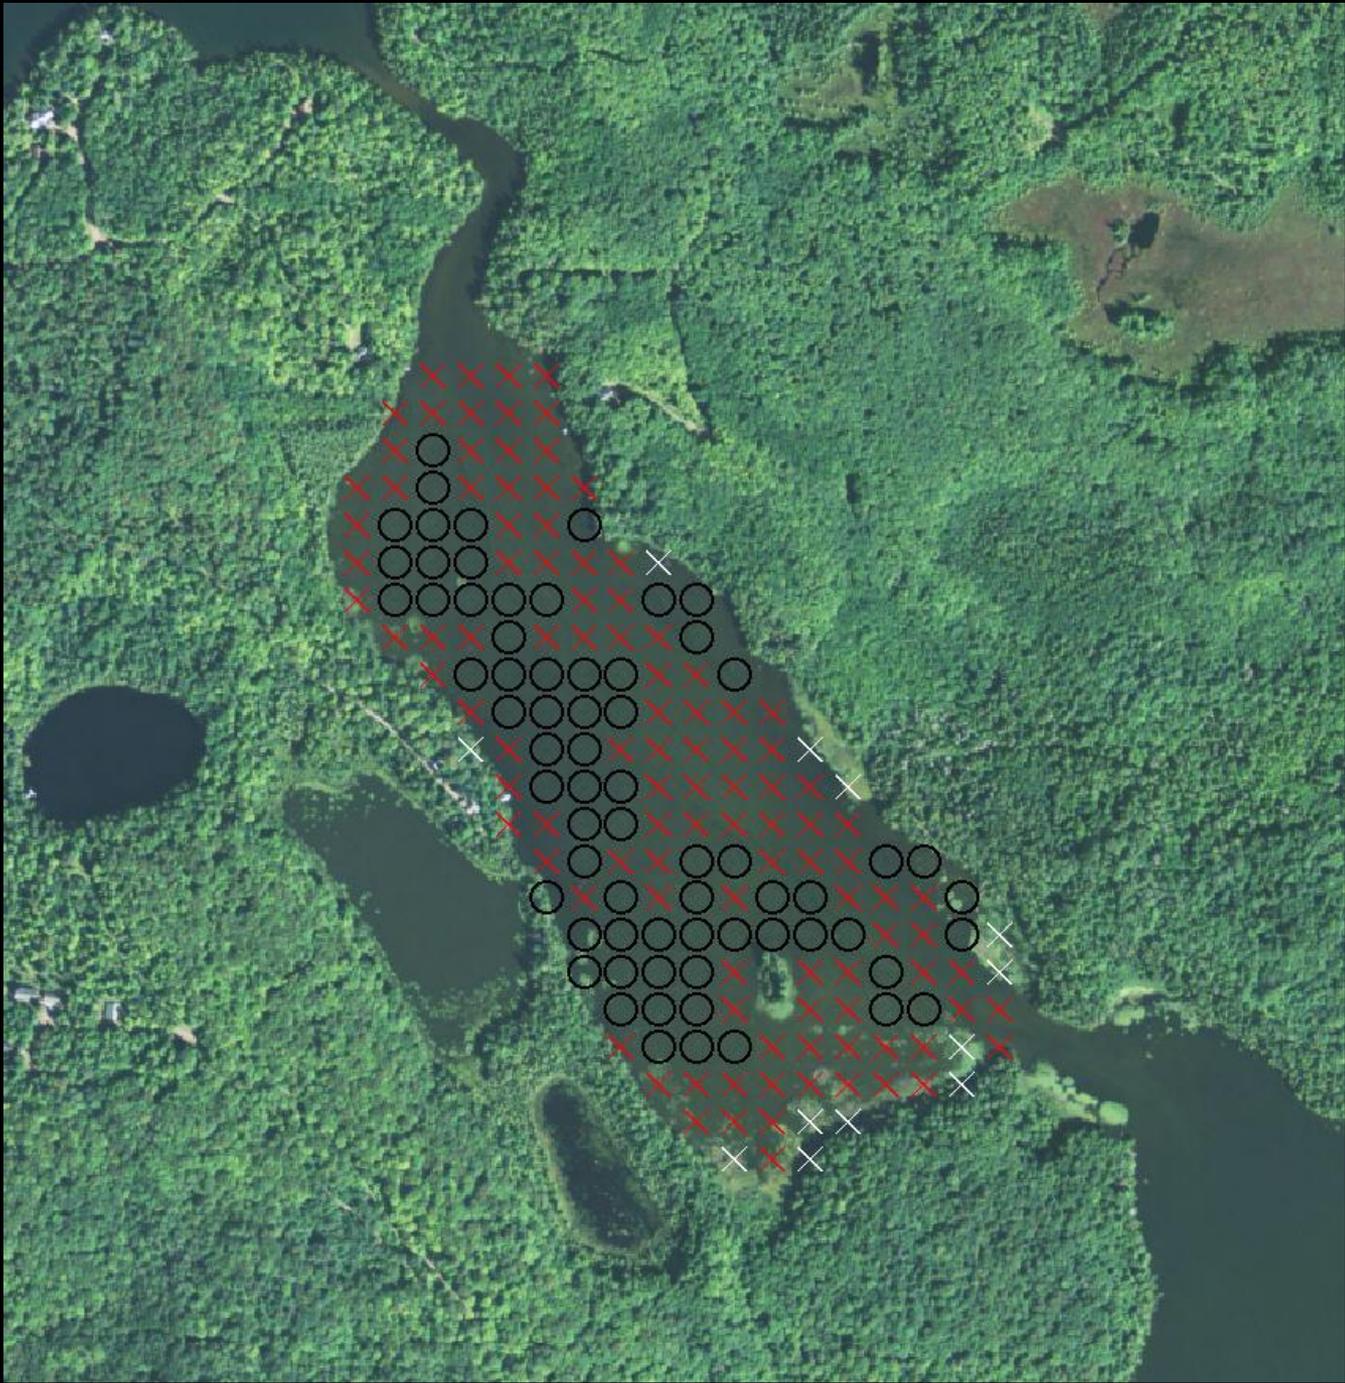
Figure 8. Distribution of plant species, Averill Lake (2013).

Najas flexilis,
Slender naiad

Table 2 provides information about the frequency of occurrence of the plant species recorded in the lake. Several metrics are provided, including total number of sites in which each species was found and frequency of occurrence at sites \leq the maximum depth of rooted vegetation. This frequency metric is standardized as a “relative frequency” (also shown in Table 2) by dividing the frequency of occurrence for a given species by the sum of frequency of occurrence for all plants and multiplying by 100 to form a percentage. The resulting relative frequencies for all species total 100%. The relative frequencies for the plant species collected with a rake are graphically displayed in descending order on Figure 6. This display shows that slender naiad (*Najas flexilis*) had the highest relative frequency followed by fern pondweed (*Potamogeton robbinsii*). The lowest relative frequencies are at the far right of the graph. As examples of individual species distributions, we show the occurrences of a few of the most frequently and least frequently encountered plants in Figures 8-15.

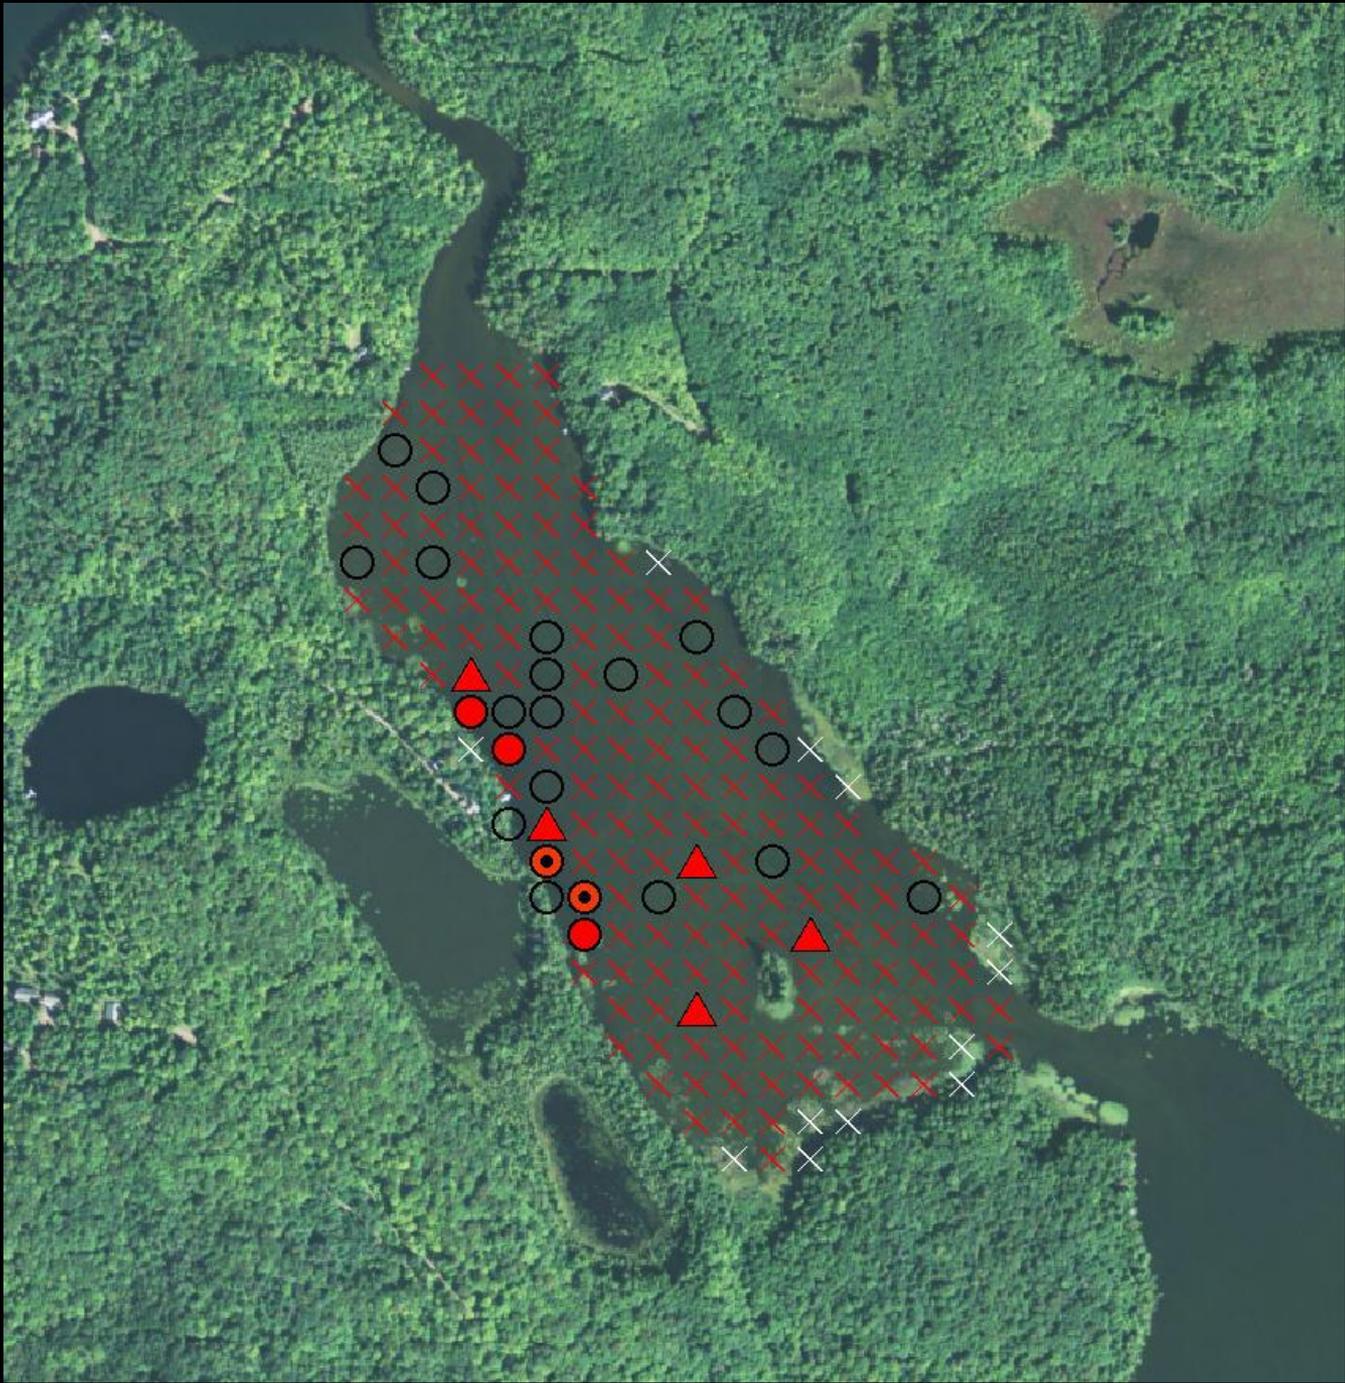
Figure 9. Distribution of plant species, Averill Lake (2013).

Potamogeton robbinsii,
Fern pondweed
