Presque Isle Wilderness Waters Program

Aquatic Plant Management Plan – Averill Lake

White Water Associates, Inc.
Dean Premo, Ph.D.
429 River Lane, P.O. Box 27
Amasa, Michigan 49903

Date: December 2015

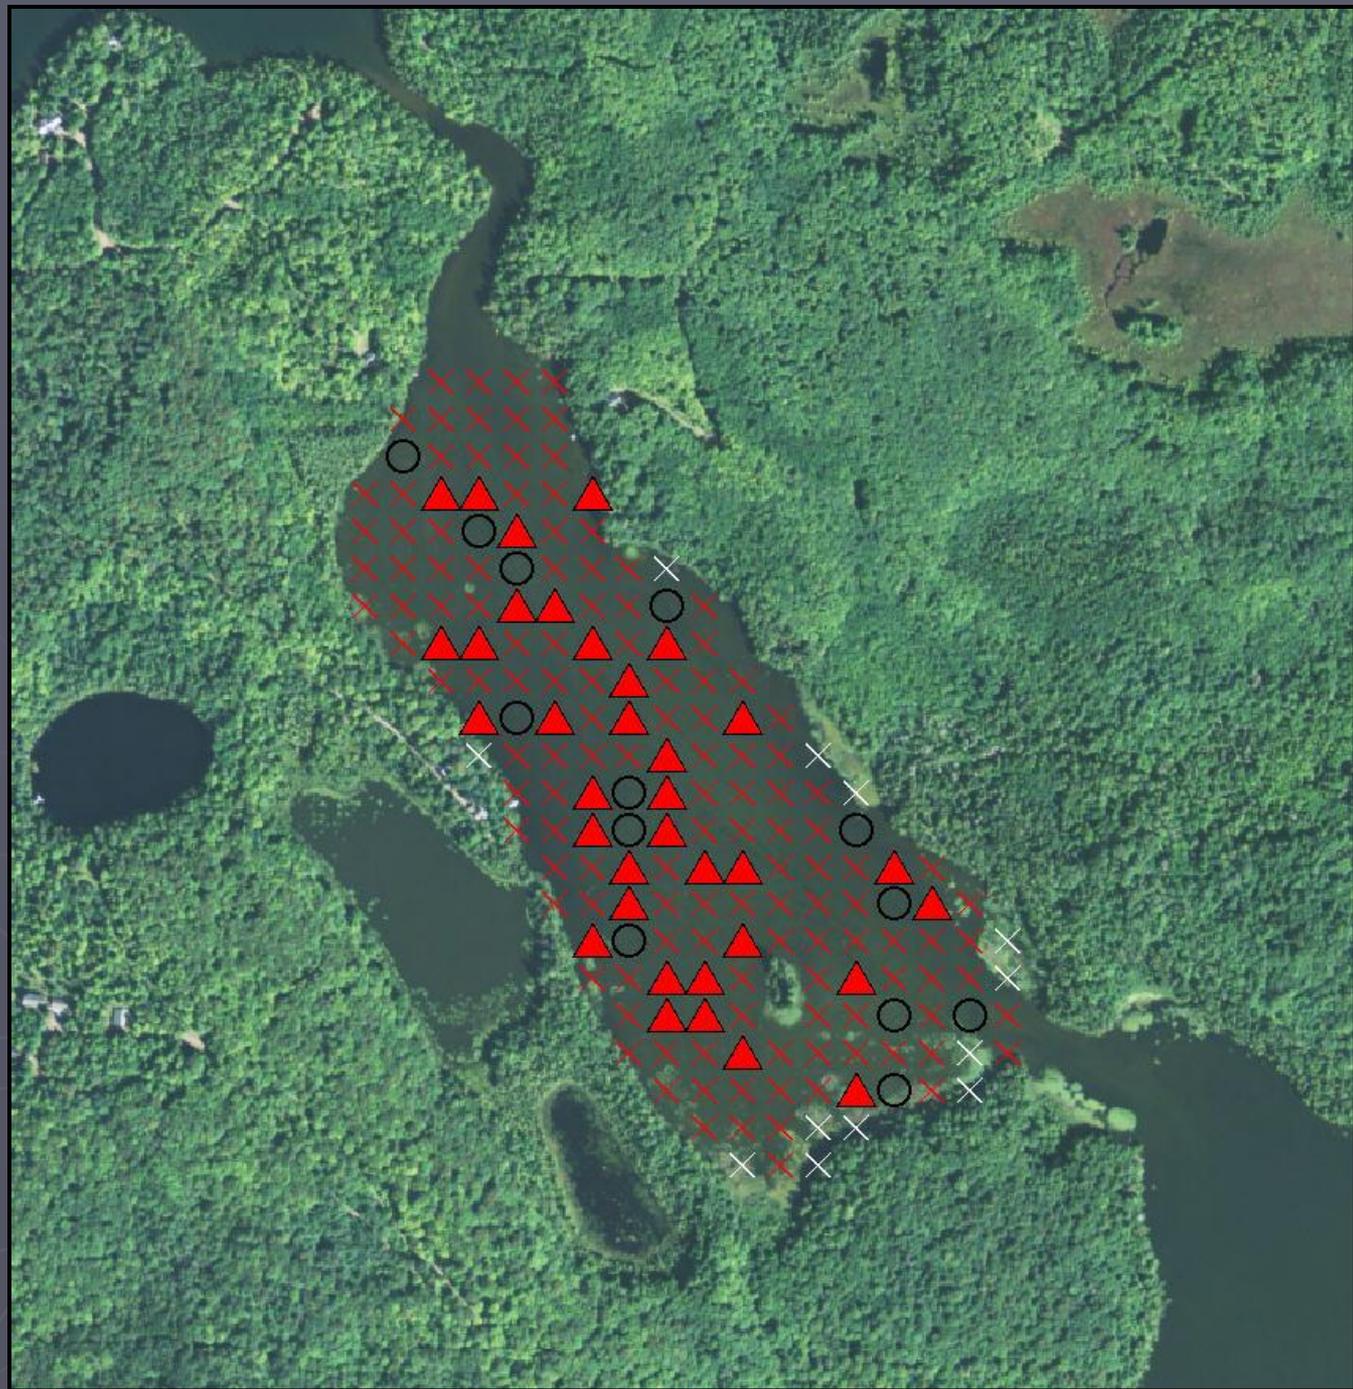
Figure 10. Distribution of plant species, Averill Lake (2013).

Table 2 provides information about the frequency of occurrence of the plant species recorded in the lake. Several metrics are provided, including total number of sites in which each species was found and frequency of occurrence at sites \leq the maximum depth of rooted vegetation. This frequency metric is standardized as a “relative frequency” (also shown in Table 2) by dividing the frequency of occurrence for a given species by the sum of frequency of occurrence for all plants and multiplying by 100 to form a percentage. The resulting relative frequencies for all species total 100%. The relative frequencies for the plant species collected with a rake are graphically displayed in descending order on Figure 6. This display shows that slender naiad (*Najas flexilis*) had the highest relative frequency followed by fern pondweed (*Potamogeton robbinsii*). The lowest relative frequencies are at the far right of the graph. As examples of individual species distributions, we show the occurrences of a few of the most frequently and least frequently encountered plants in Figures 8-15.

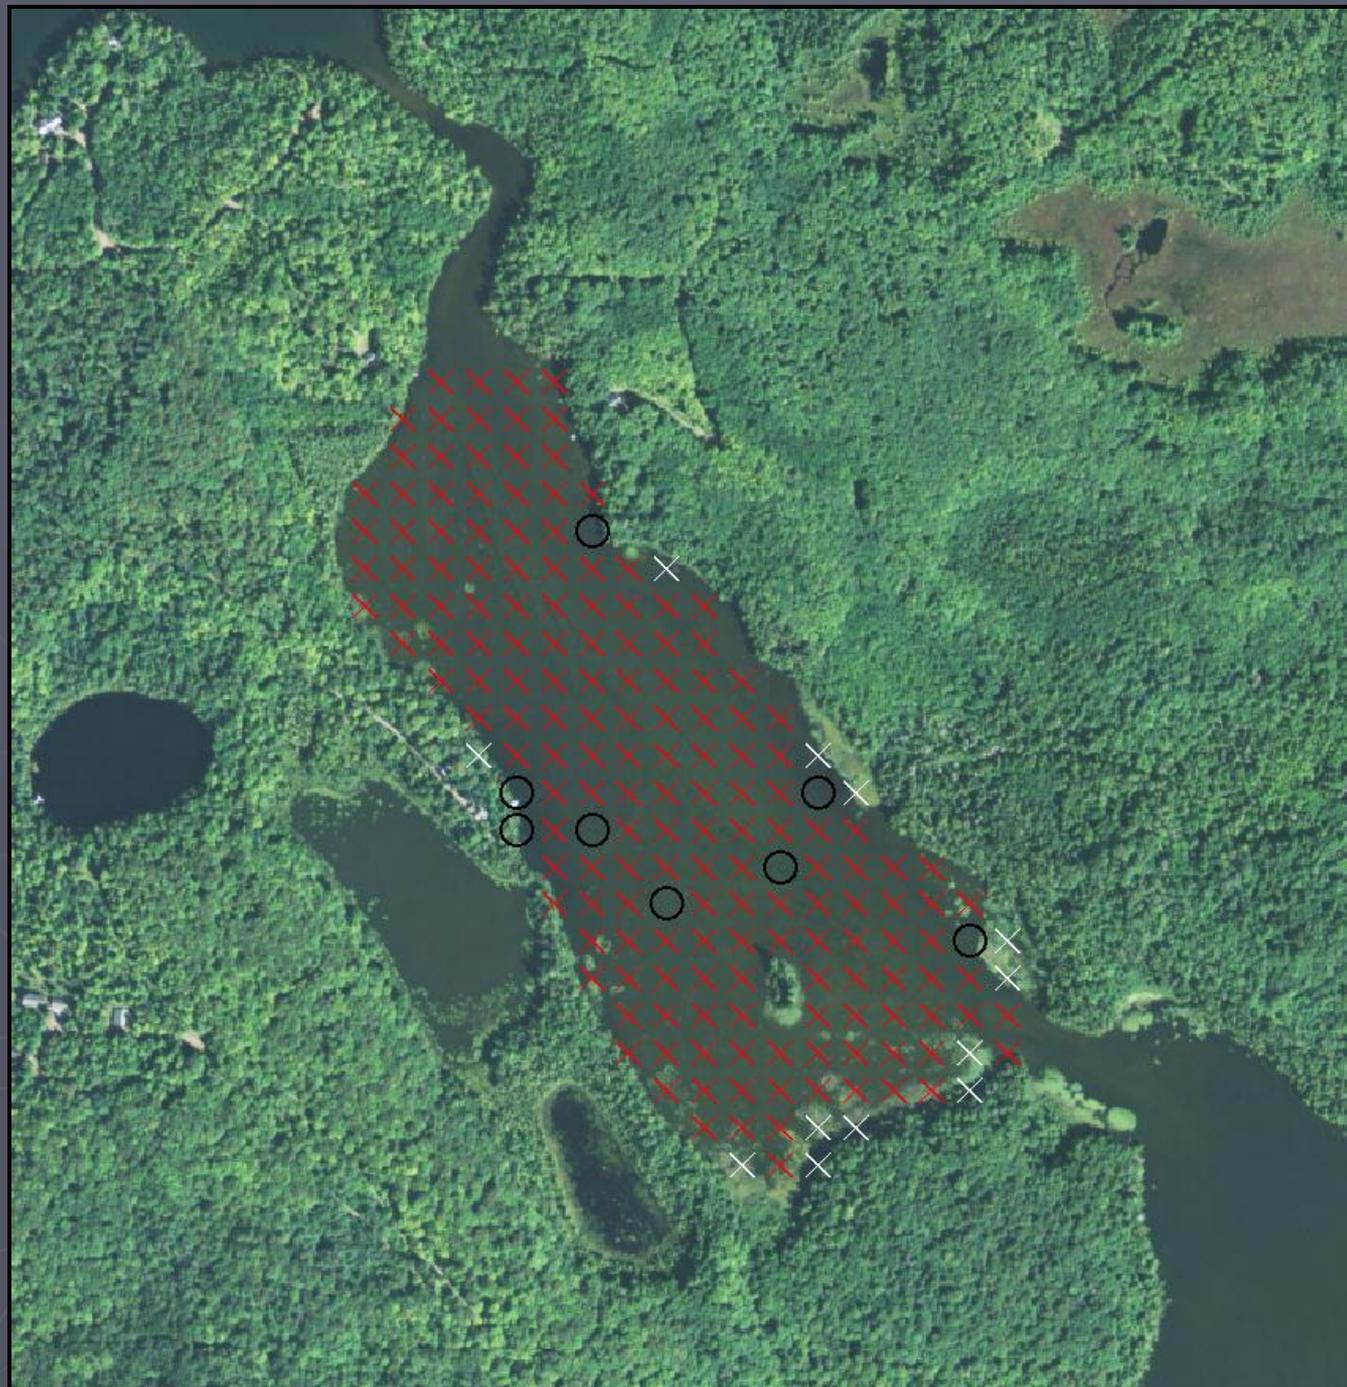
Figure 11. Distribution of plant species, Averill Lake (2013).

Elodea canadensis,
Common waterweed

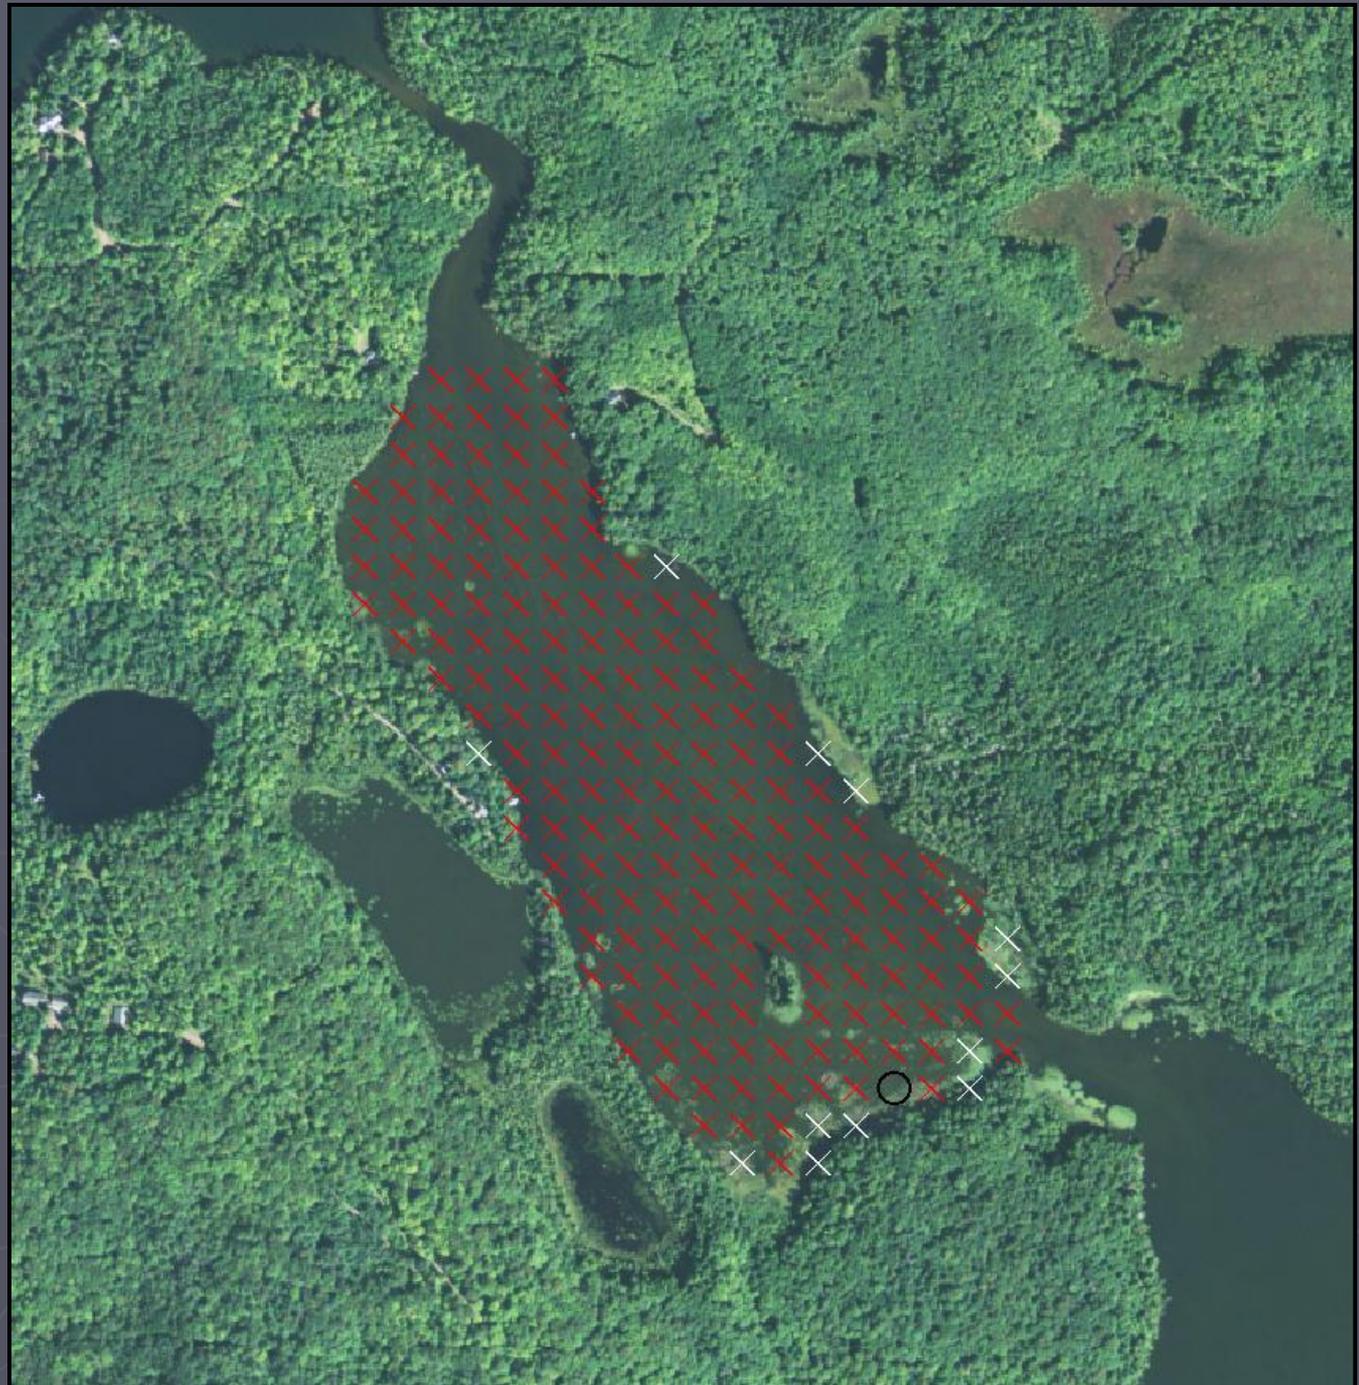
Figure 12. Distribution of plant species, Averill Lake (2013).

***Dulichium arundinaceum*, Three-way sedge**

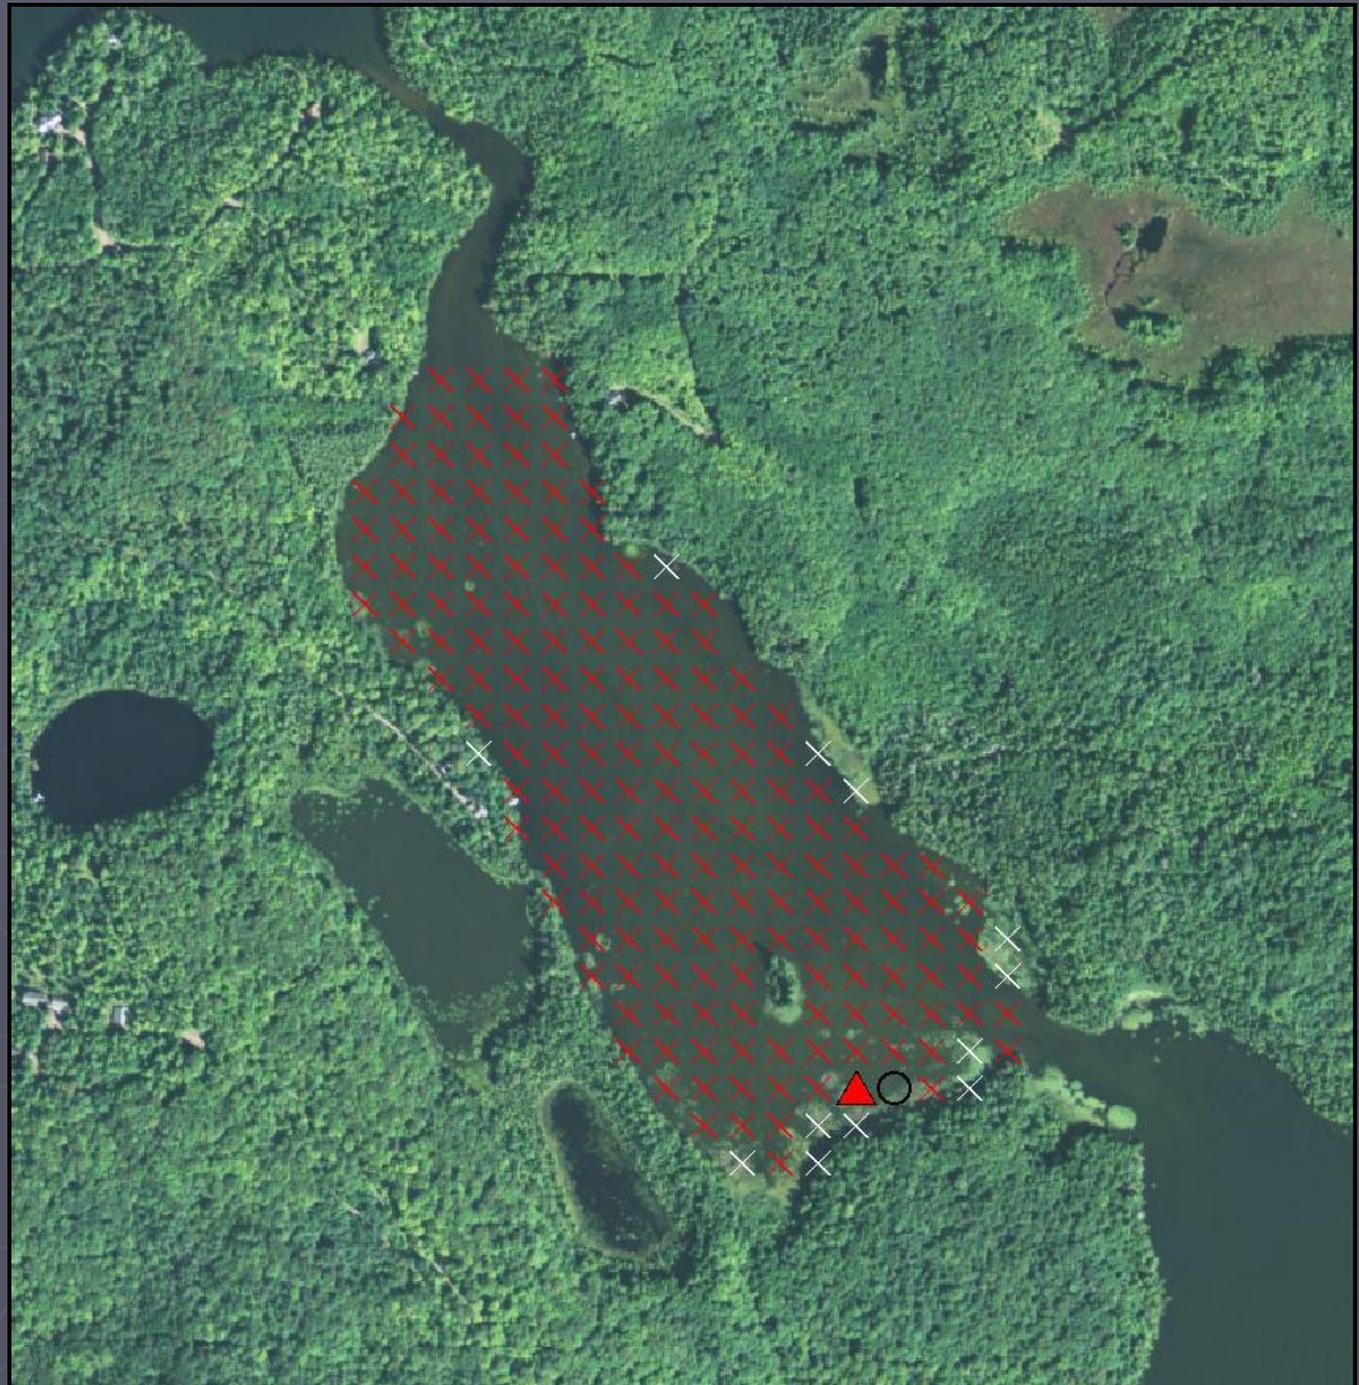
Figure 13. Distribution of plant species, Averill Lake (2013).

***Pontederia cordata*,
Pickerelweed**

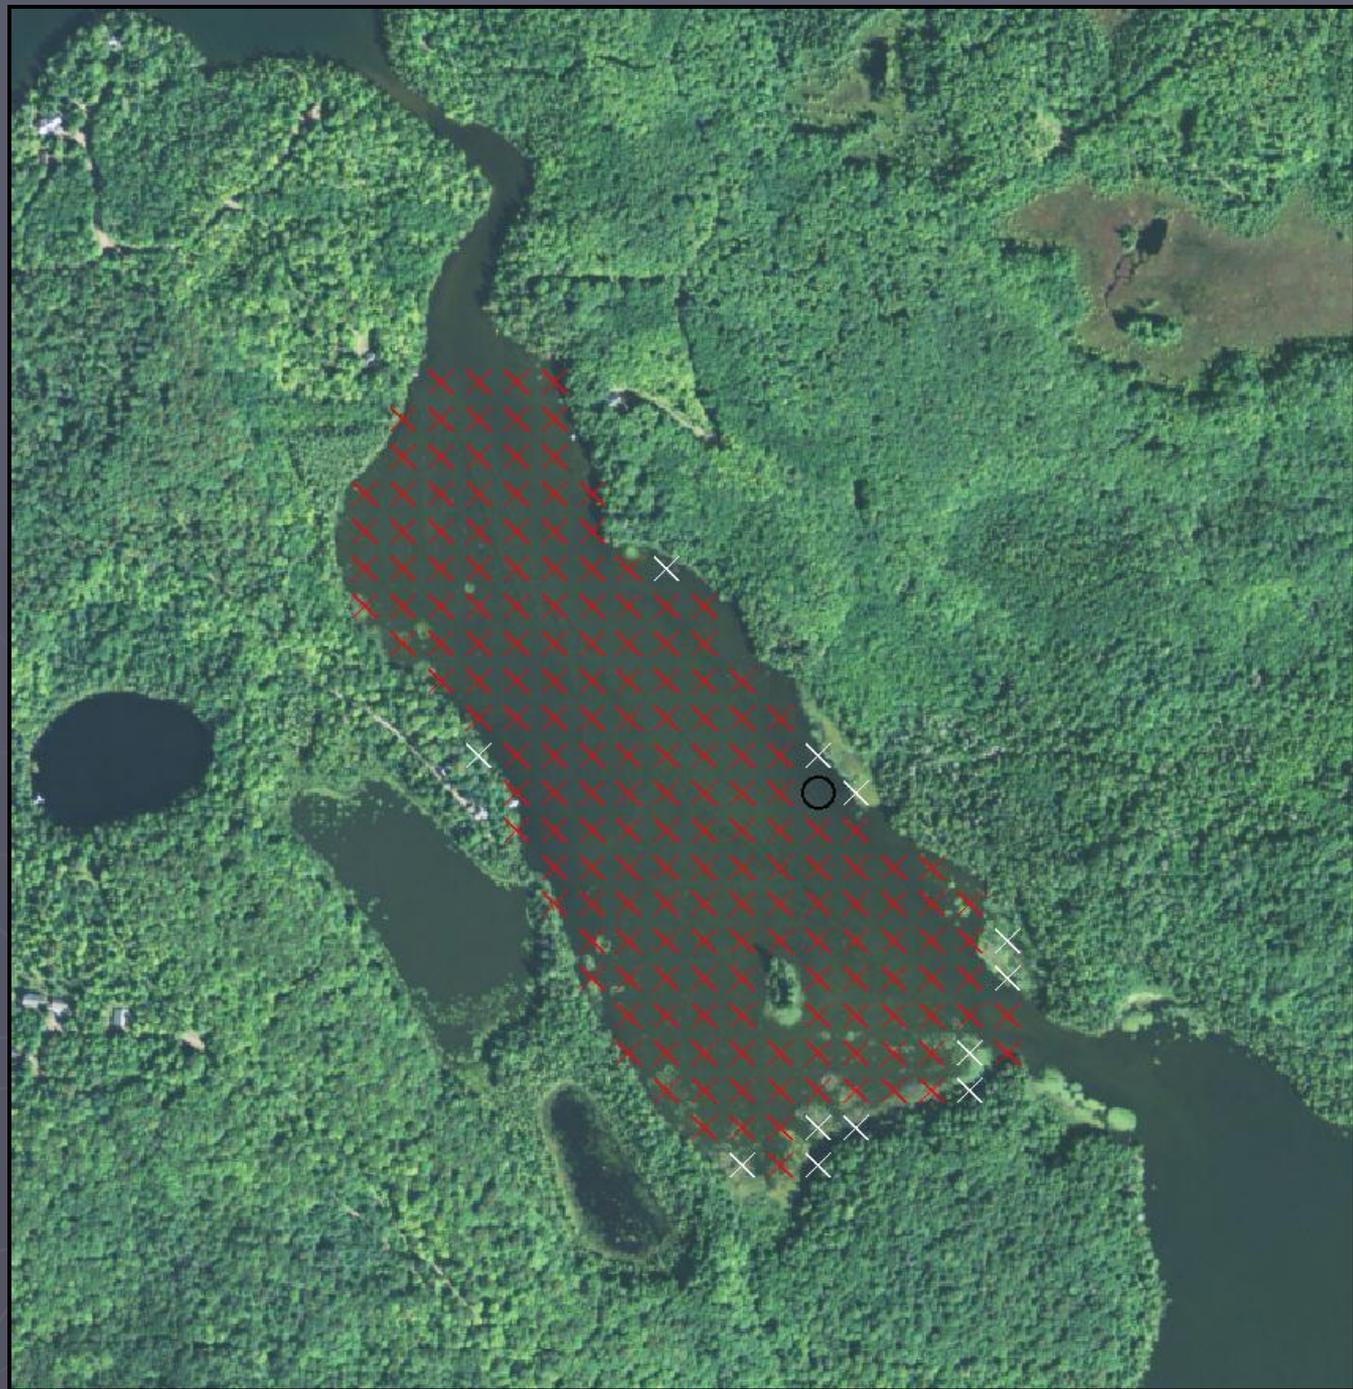
Figure 14. Distribution of plant species, Averill Lake (2013).

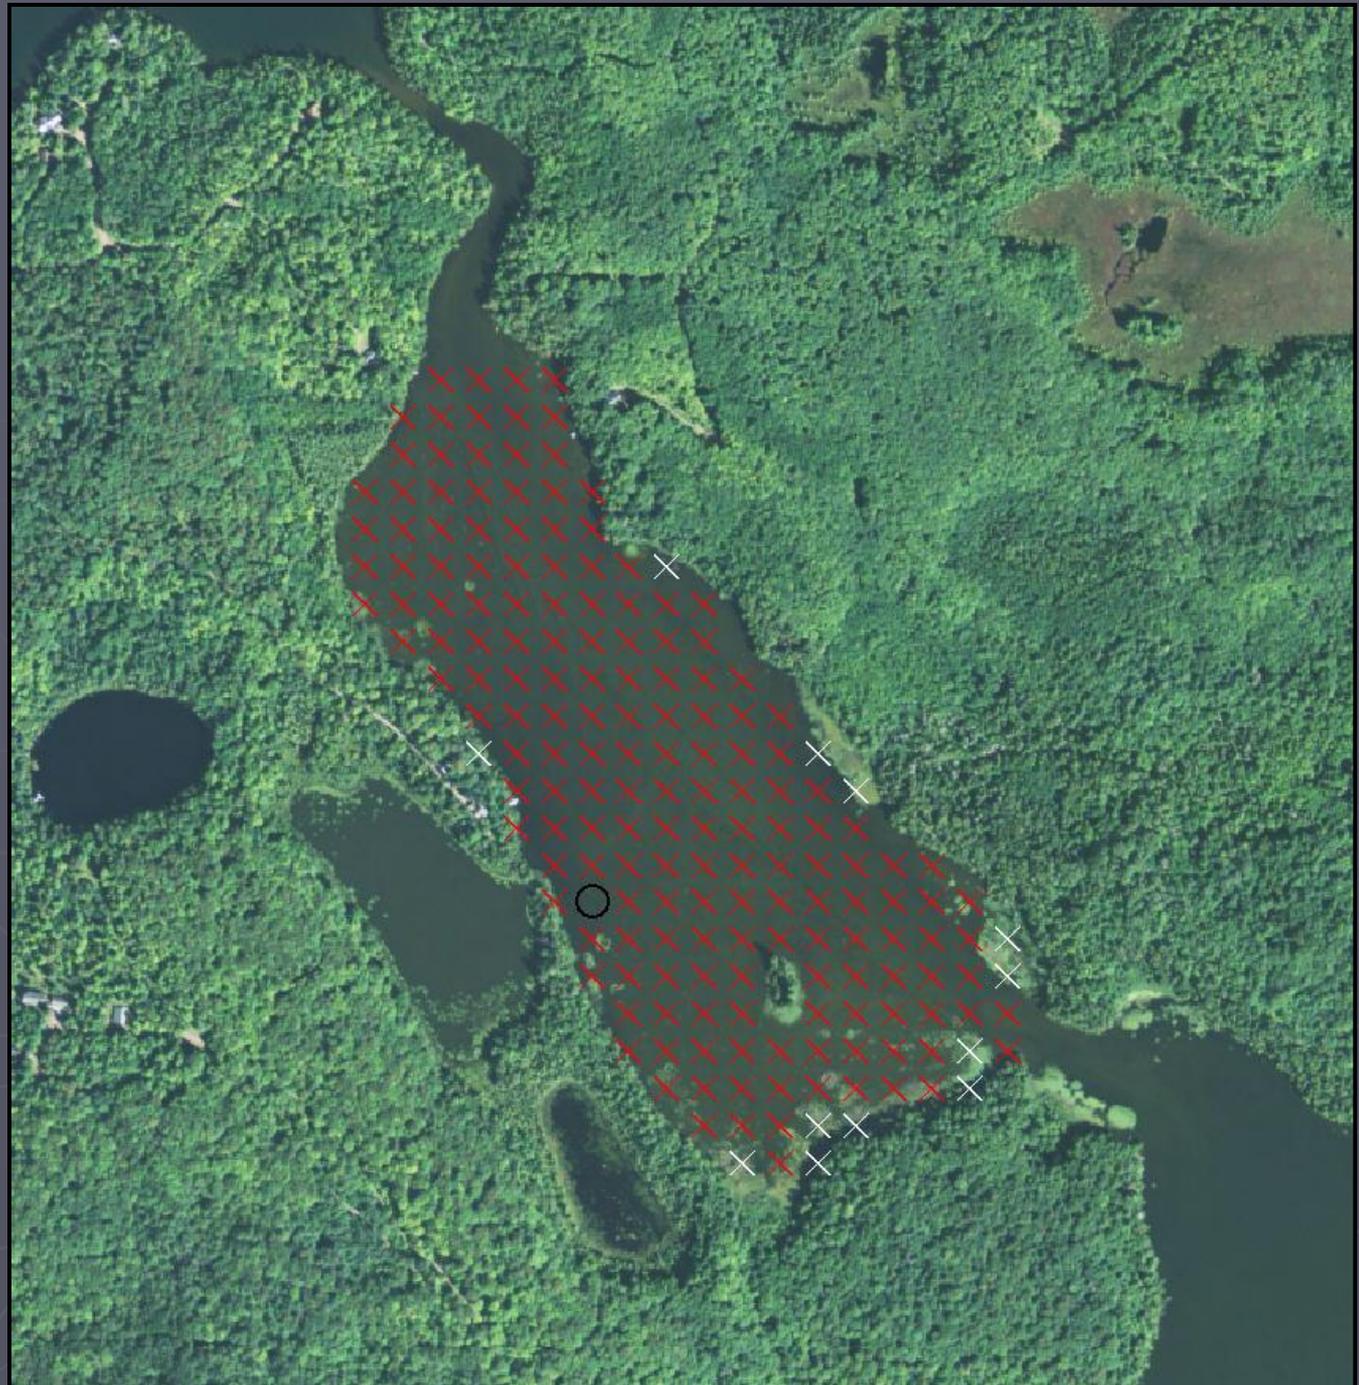
Figure 15. Distribution of plant species, Averill Lake (2013).

Sagittaria cristata,
Crested arrowhead

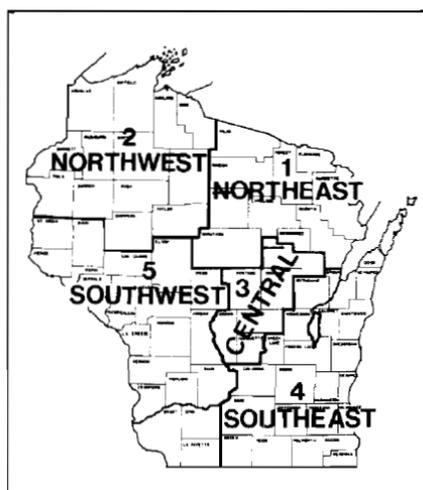
Figure 1. Wisconsin regions in terms of water quality.

Lillie and Mason's *Limnological Characteristics of Wisconsin Lakes* (1983) is a great source to compare lakes within our region to a subset of lakes that have been sampled in Wisconsin. Wisconsin is divided into five regions of sampling lakes. Vilas County lakes are in the Northeast Region (Figure 1) and were among 243 lakes randomly selected and analyzed for water quality.

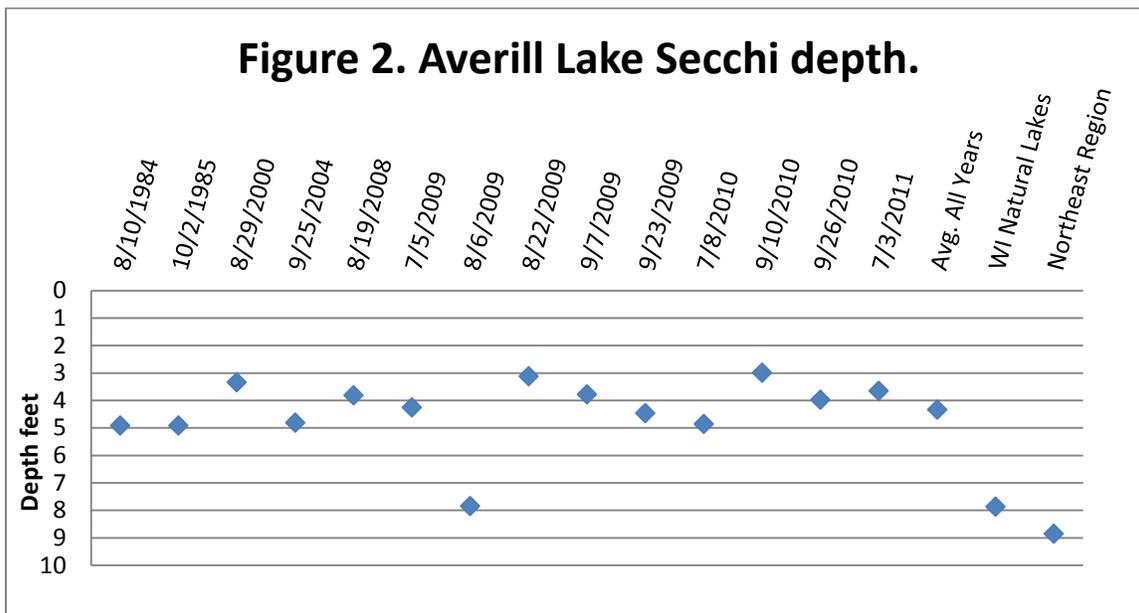
Figure 2. Averill Lake Secchi depth.

Figure 2 shows Averill Lake's Secchi depths from 2000-2010. The shallowest Secchi depth was 3.0 feet in September, 2010 and the deepest reading was at 7.8 feet¹ in August, 2009 (Figure 2). Since 1984 the average Secchi depth is 4.4 feet. According to Table 1, Averill Lake's average Secchi depth can be considered "very poor" to "poor," with respect to water clarity. It should be noted that the max depth of Averill Lake is 6 feet, and that the water clarity index does not take into account how deep a lake is. Therefore, classifying Averill Lake's water clarity as "very poor," is not necessarily accurate.

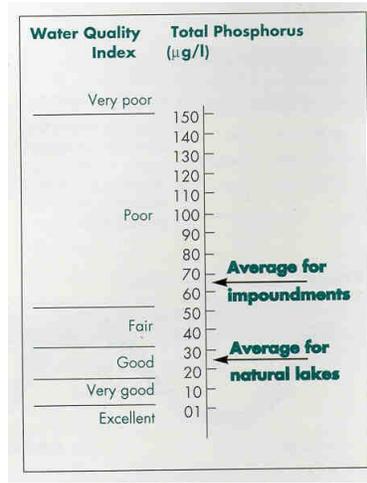
Figure 3. Total phosphorus concentrations for Wisconsin's natural lakes and impoundments (Shaw et al., 2004).

Total phosphorus was analyzed in October, 1985 and was 12 µg/L. Based on this value, Averill Lake's total phosphorus can be classified as "very good" (Figure 3). Long term monitoring should be conducted to determine any trends in total phosphorus.
