LOWER TURTLE LAKE BARRON COUNTY, WISCONSIN

2016 NATIVE AQUATIC PLANT
MANAGEMENT ADDENDUM TO THE 2010
AQUATIC PLANT MANAGEMENT PLAN
WDNR WBIC: 2079700

Prepared by: Dave Blumer, Lake Educator
October 2015

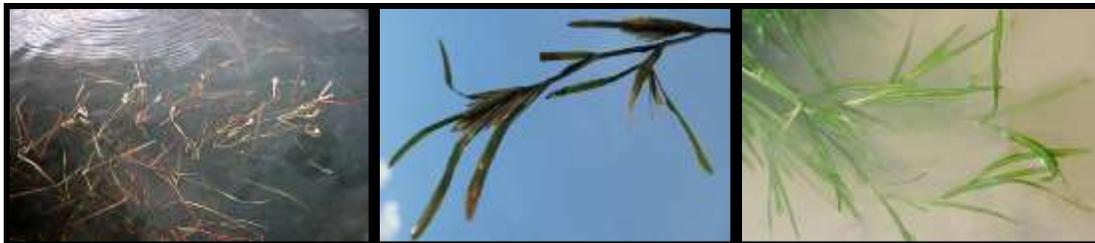
Figure 6: Stringy pondweeds – flat-stem (left), Fries (center), and small (right)

Four native aquatic plant species make up the majority of plant biomass (actual plant material) on these flats during the summer months. They are flat-stem pondweed, small pondweed, Fries pondweed, and wild celery. Of these species, small pondweed showed highly significant increases in distribution and density in 2014 when compared to 2008. Wild celery actually showed a somewhat significant decline, and Fries and flat-stem showed little change from 2008 to 2014. All of these species can cause issues because of the type of plant they are: long and stringy. “Stringy” pondweed is a generic term for several different pondweeds including but not limited to small, flat-stem, and Fries (Figure 6). While these species provide excellent food and habitat in a lake, their growth characteristics (many long narrow stems with limited large leafy material) makes them easy to get wrapped around boat motor propellers, paddles, fishing lures, and limbs, impairing boating, fishing, swimming, and other lake uses. Along the southeastern shore these beds of vegetation are located between docks and the open water, making navigation difficult. Water celery is not a pondweed, but has similar characteristics: long and stringy with no large, leafy material, so it to can impair lake use and open water access (Figure 7).

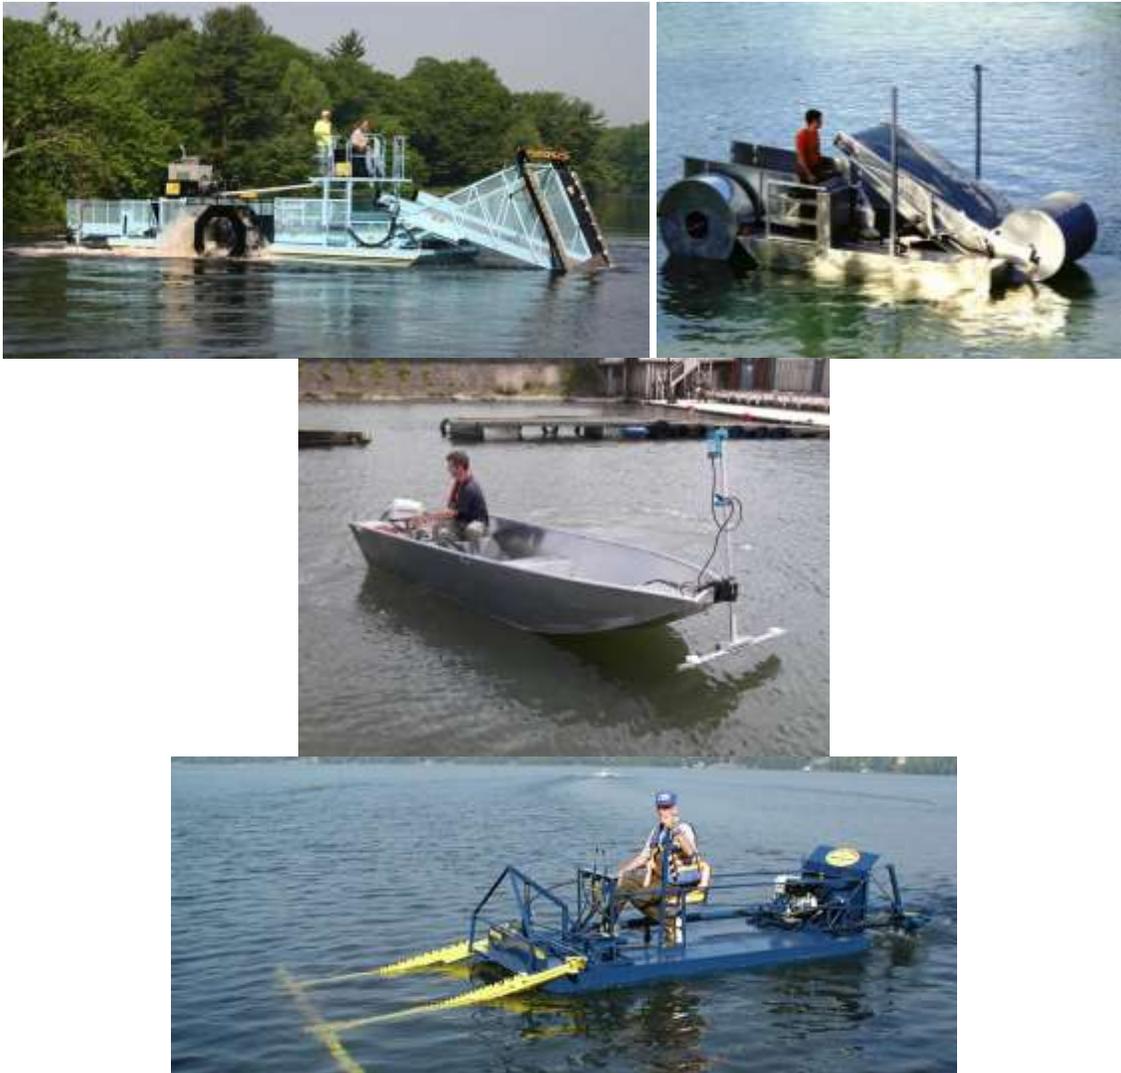
Figure 12: Examples of different size and type of aquatic plant harvesters (Aquarius Systems, Eco-Harvester, Jenson Lake Mower, Hockney Weed Cutter)

Mechanical harvesting assumes that vegetation is cut and removed from the waterbody after cutting. Mechanical harvesting machines can be relatively simple or highly technical. Machines can be purchased that mount to the front of a pontoon boat that just cut the plant material and then require additional effort to remove the cut material from the water. More complex machines can be purchased that cut, store, and remove the plant material from the water all at the same time. Cutting widths can be from 3-4 ft to as much as 10 or more feet. Depending on the size of the unit, the harvesters may be driven by paddle wheel, regular boat motor, or depend on an external source to move around. The depth at which these machines can cut and operate depends on the type of machine it is. Most will allow for skimming of the surface and/or cutting down to as much as five or more feet into the water (Figure 12).

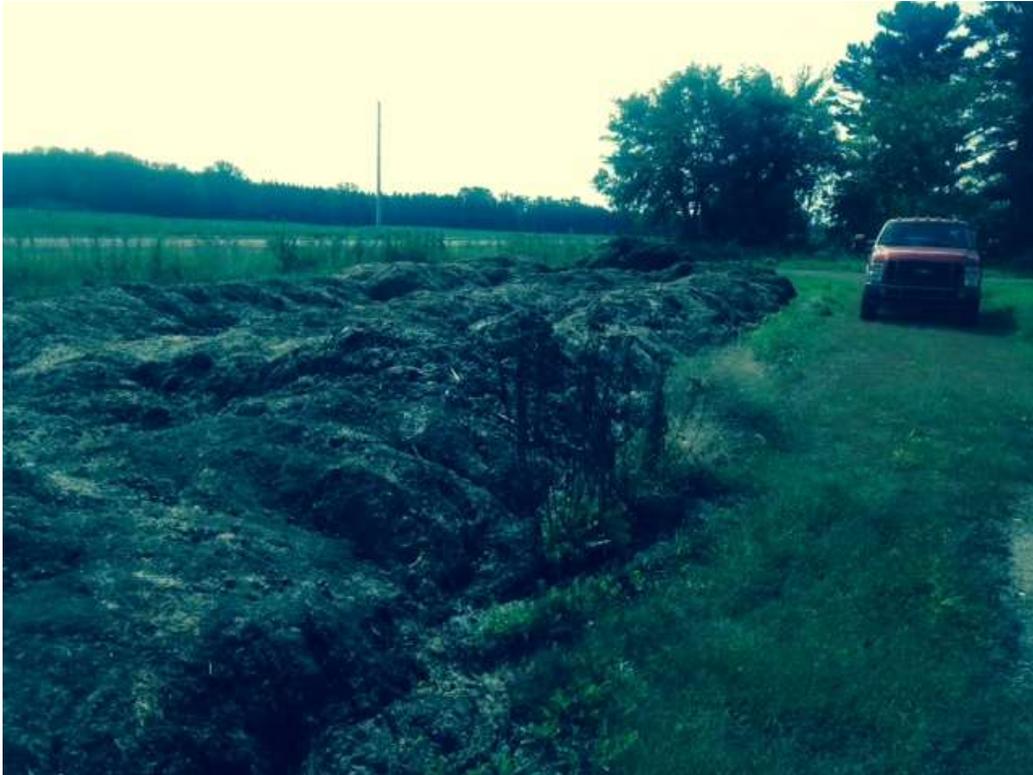
Figure 15: Rice Lake Protection and Rehabilitation District harvested aquatic plant dump site (Photo taken on 9/16/2015). Plant material built deposited from the last six weeks of harvesting. The highest pile of vegetation at the back of the photo had been deposited only a day or two before this photo. (LEAPS, 2015)

The Rice Lake – Lake Protection and Rehabilitation District harvests native aquatic plants for navigation and nuisance relief. Depending on the aquatic plant growth in a given year they harvest 2.75-3.5 tons of native aquatic vegetation annually (2015 Rice Lake Aquatic Plant Management Plan, LEAPS). It is estimated that as much as 95% of the biomass of aquatic plants is water, so 3 tons of harvested vegetation would only amount to 300 lbs. of actual plant material once it has been dewatered (Aquatic Ecosystems Restoration Foundation (AERF), 2009). A more conservative estimate, based on observations at the Rice Lake Protection and Rehabilitation aquatic plant dump site, is 50-75% of the harvested material goes away, leaving around 1,500 lbs. of actual plant material annually (Figure 15).

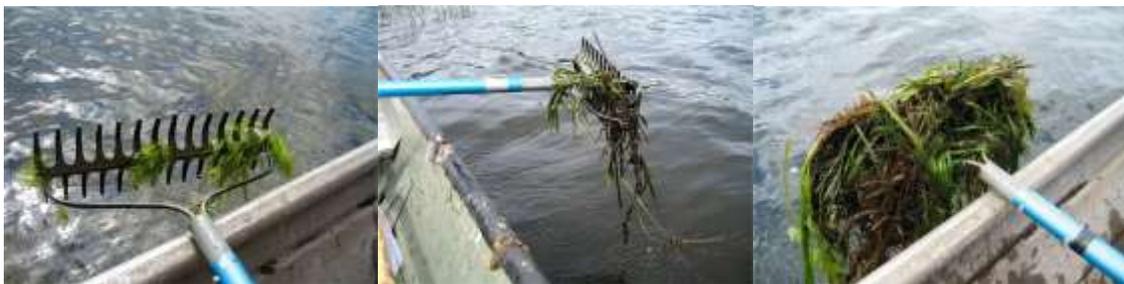
Figure 16: Rake Head Density 1 (left); 2 (middle); and 3 (right)

Action One – Establish navigation and access lanes that are 10-20 ft. wide in areas of the lake where summer native aquatic plant growth reaches or exceeds a rake head density 3 on a 0-3 scale (Figure 16) and is either at or within in 6 inches of the surface.
