8.1 Rest Lake

An Introduction to Rest Lake

Lake at a Glance* – Rest Lake

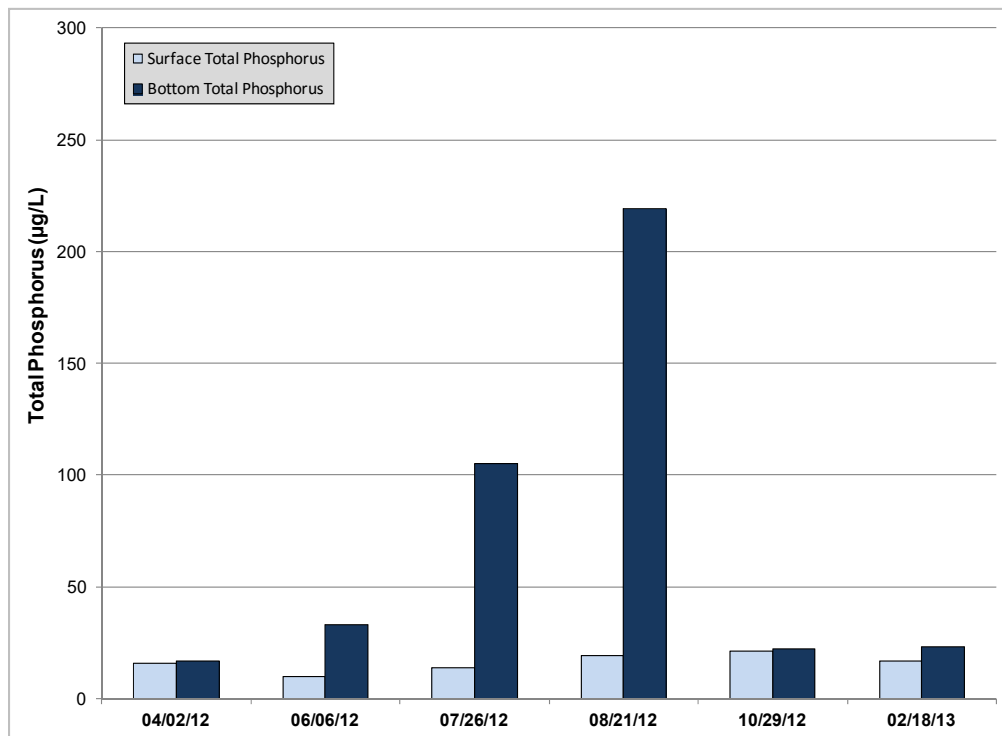
Figure 8.1.1-2. Rest Lake surface and bottom total phosphorus values, 2012-2013. Anoxia was observed in the hypolimnion of the lake during July and August sampling visits.

Total phosphorus surface values from 2012 are compared with bottom-lake samples collected during this same time frame in Figure 8.1.1-2. As displayed in this figure, on several occasions surface and bottom total phosphorus concentrations were similar. However on some occasions, namely during July and August of 2012, the bottom phosphorus concentrations were much greater than the relatively low surface concentrations. During these periods, anoxic conditions were recorded near the bottom of the lake through measurement of dissolved oxygen (refer to Figure 8.1.1-6 and associated text). This is an indication of hypolimnetic nutrient recycling, or internal nutrient loading, which is a process discussed further in the Manitowish Waters Chain-wide document. While this process may be contributing some phosphorus to Rest Lake's water column, the impacts of nutrient loading are not apparent in the lake's overall water quality; as previously mentioned, Rest Lake's surface water total phosphorus values are slightly lower than the median value for comparable lakes in Wisconsin.

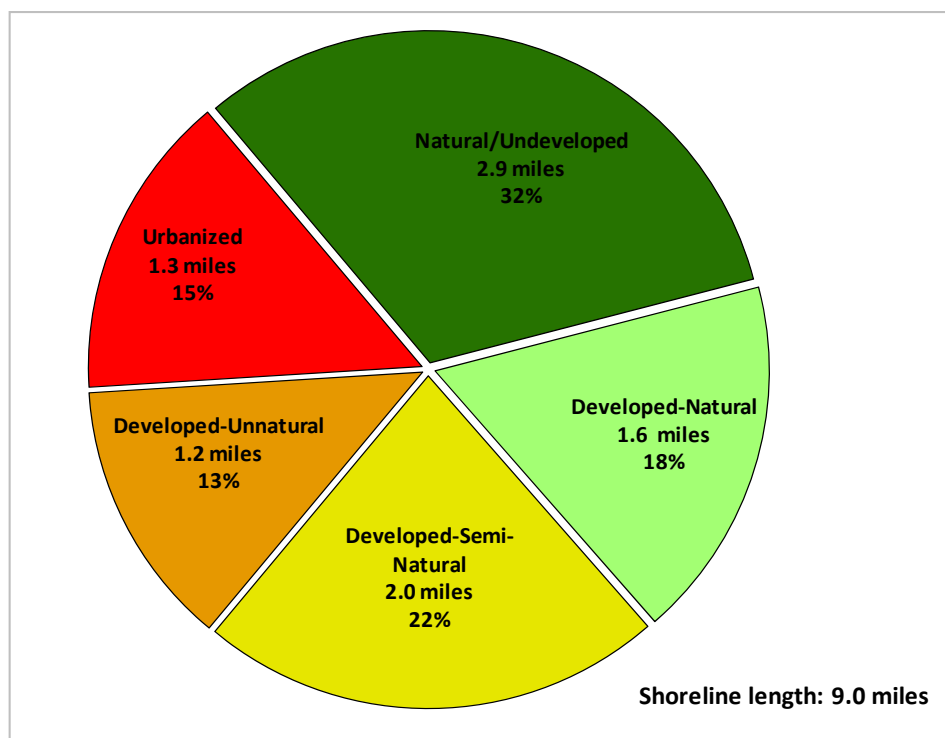
Figure 8.1.3-1. Rest Lake shoreland categories and total lengths. Based upon a late summer 2012 survey. Locations of these categorized shorelands can be found on Rest Lake Map 1.

As mentioned previously in the Chain-wide Shoreland Condition Section, one of the most sensitive areas of the watershed is the immediate shoreland area. This area of land is the last source of protection for a lake against surface water runoff, and is also a critical area for wildlife habitat. In late summer of 2012, Rest Lake's immediate shoreline was assessed in terms of its development. Rest Lake has stretches of shoreland that fit all of the five shoreland assessment categories. In all, 4.5 miles of natural/undeveloped and developed-natural shoreline were observed during the survey (Figure 8.1.3-1). This constitutes about 50% of Rest Lake's shoreline. These shoreland types provide the most benefit to the lake and should be left in their natural state if at all possible. During the survey, 2.5 miles of urbanized and developed-unnatural shoreline (28%) was observed. If restoration of the Rest Lake shoreline is to occur, primary focus should be placed on these shoreland areas as they currently provide little benefit to, and actually may harm, the lake ecosystem. Rest Lake Map 1 displays the location of these shoreline lengths around the entire lake.

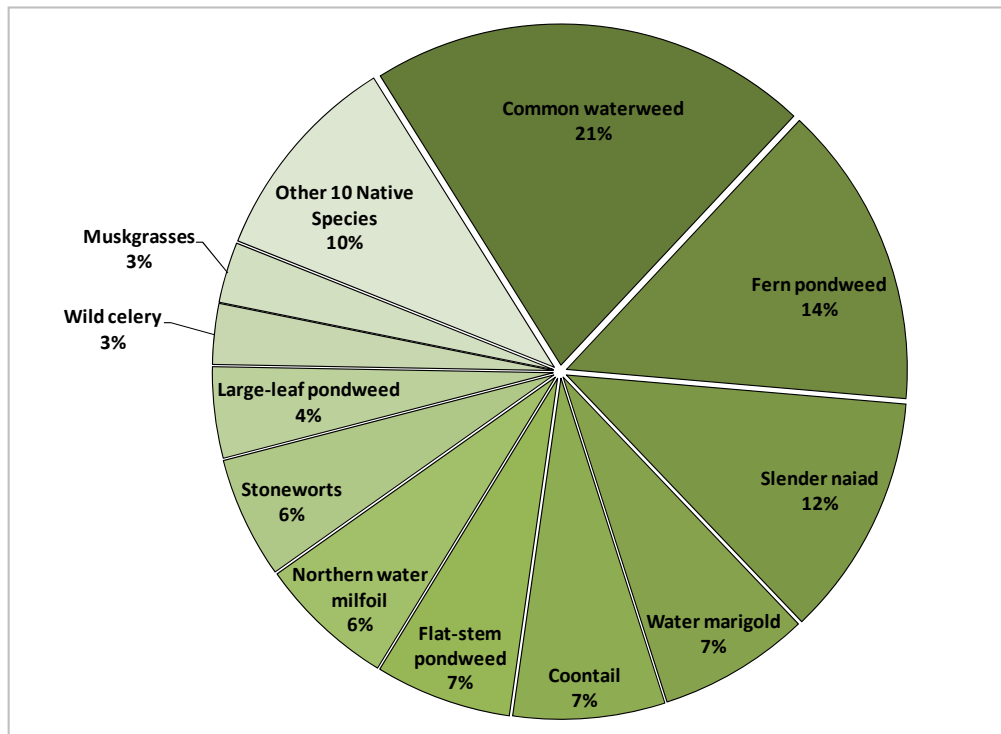
Figure 8.1.4-6. Rest Lake 2012 aquatic plant relative frequency of occurrence analysis. Created using data from 2012 point-intercept survey.

As explained earlier in the Manitowish Waters chain-wide document, the littoral frequency of occurrence analysis allows for an understanding of how often each of the plants is located during the point-intercept survey. Because each sampling location may contain numerous plant species, relative frequency of occurrence is one tool to evaluate how often each plant species is found in relation to all other species found (composition of population). For instance, while common waterweed was found at 7% of the littoral sampling locations in Rest Lake in 2012, its relative frequency of occurrence is 21%. Explained another way, if 100 plants were randomly sampled from Rest Lake, 21 of them would be common waterweed. This distribution can be observed in Figures 8.1.4-6 and 8.1.4-7.

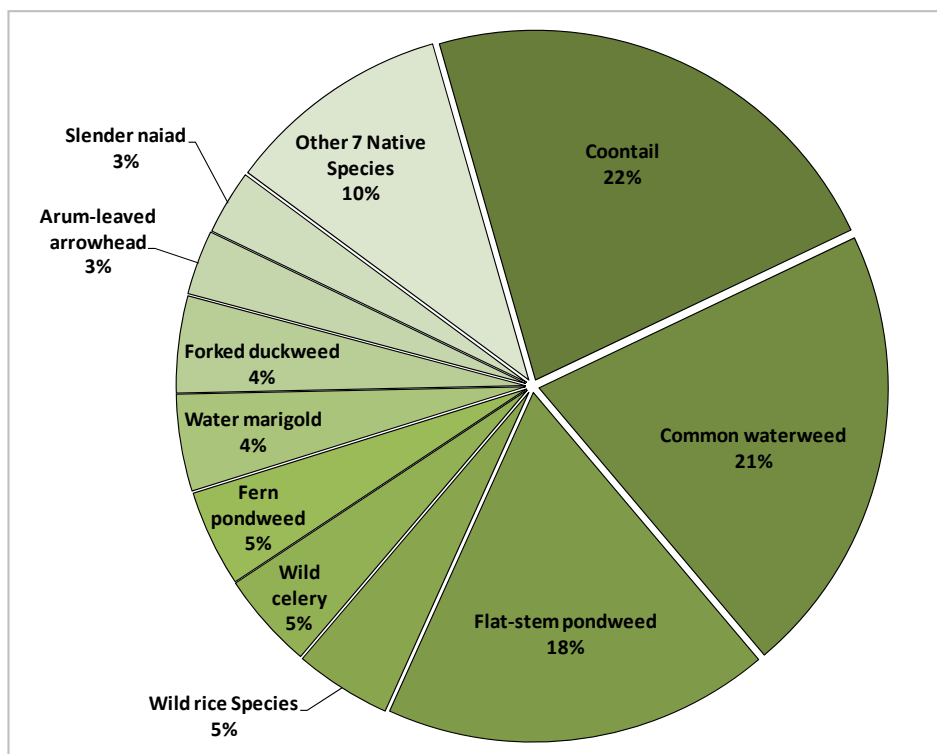
Figure 8.1.4-7. Papoose Bay 2012 aquatic plant relative frequency of occurrence analysis. Created using data from 2012 point-intercept survey.

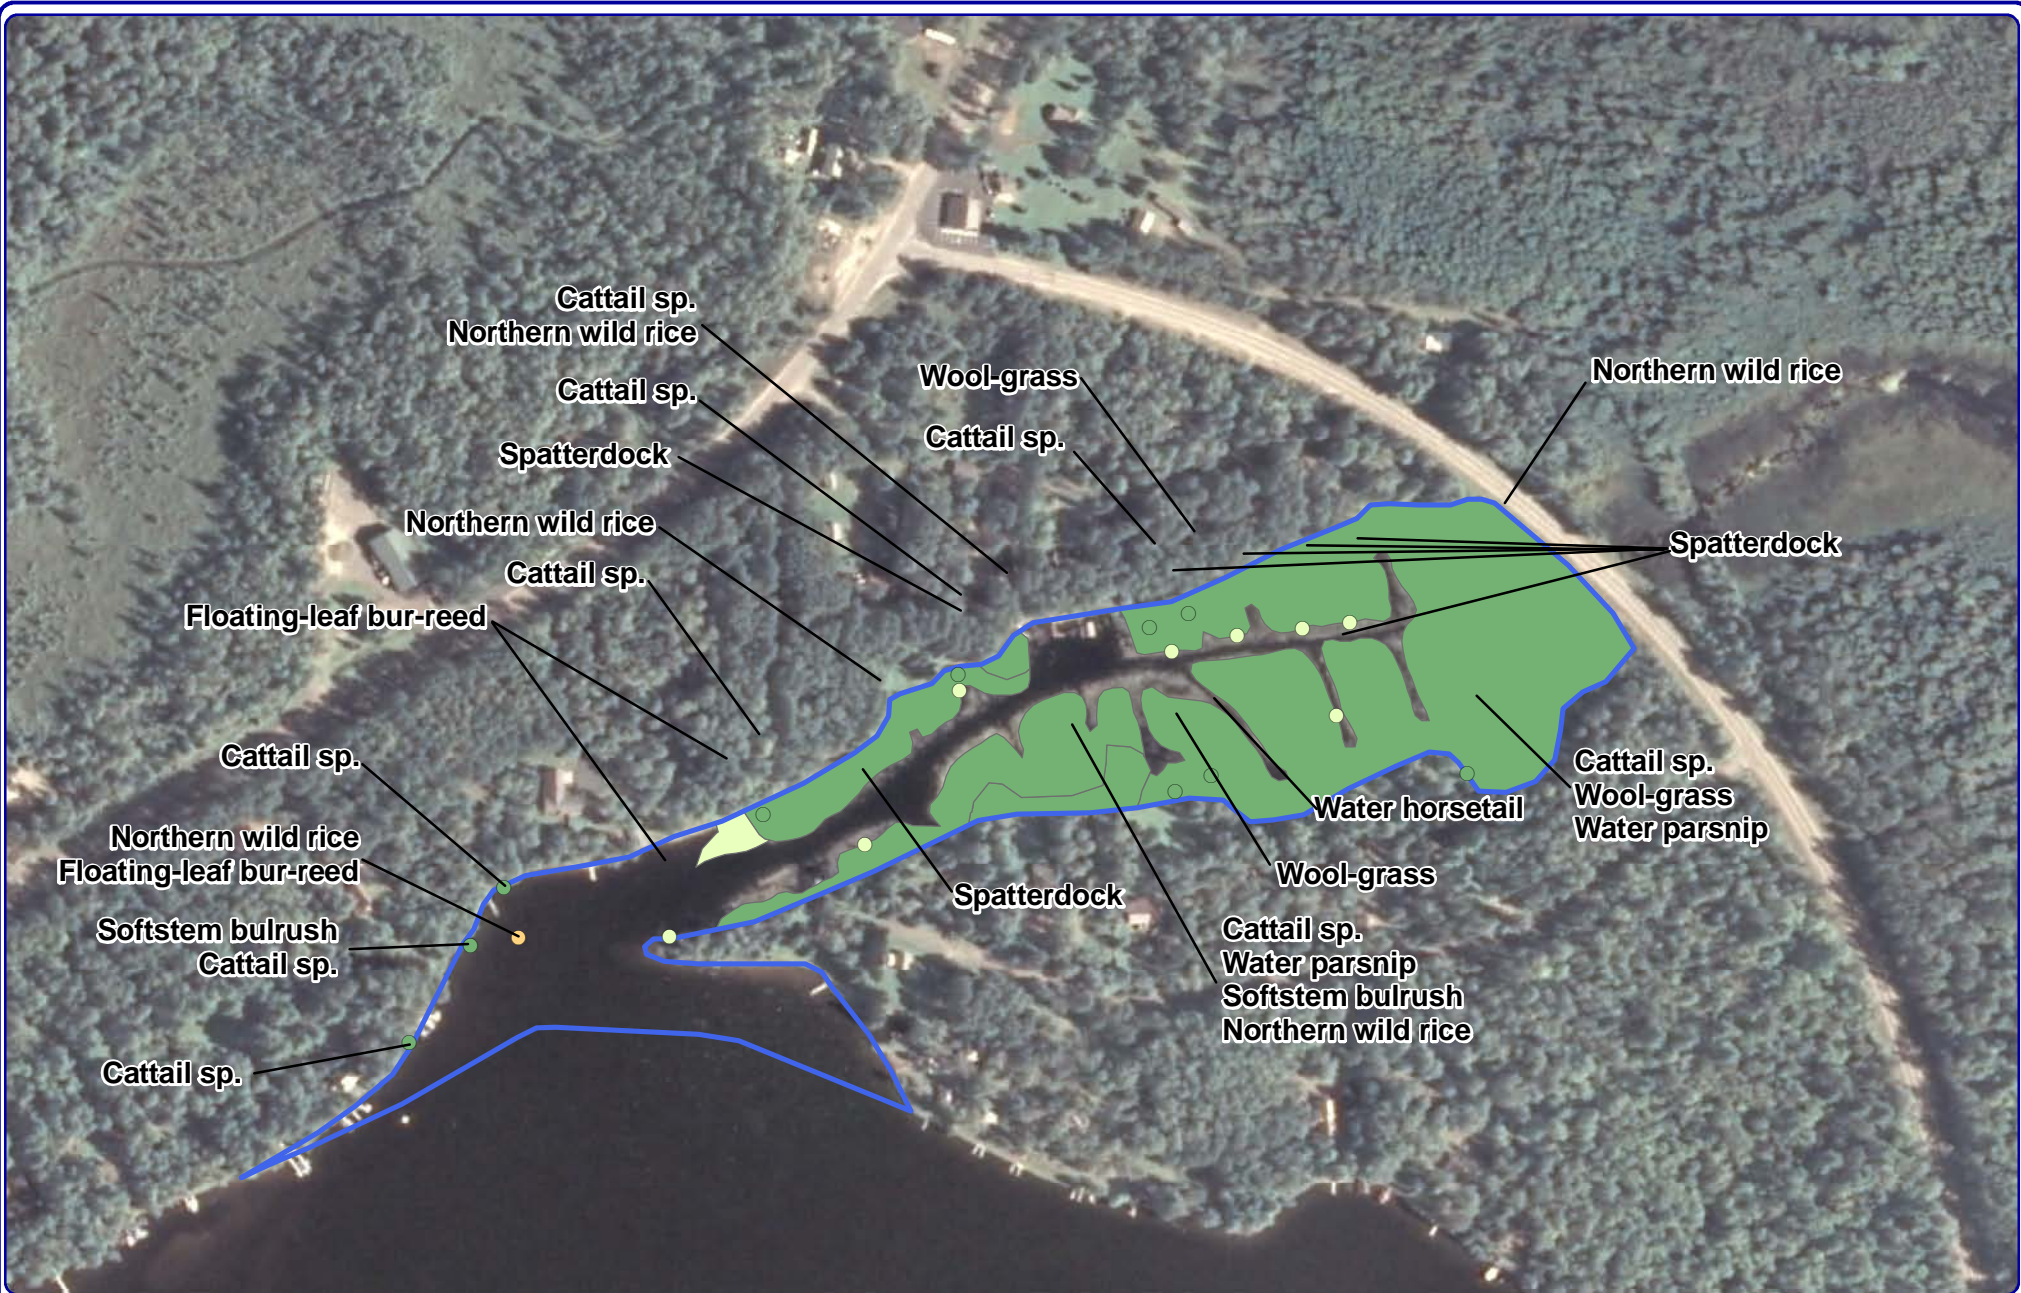
Papoose Bay - Map 2
 Manitowish Waters
 Chain of Lakes
 Vilas County, Wisconsin
**Emergent & Floating-leaf
 Aquatic Plant Communities**

- Emergent
- Floating-leaf
- Mixed Floating-leaf & Emergent
