Note: Methodology, explanation of analysis and biological background on Cranberry Lake studies are contained within the Eagle River Chain-wide Management Plan document.

8.1 Cranberry Lake

An Introduction to Cranberry Lake

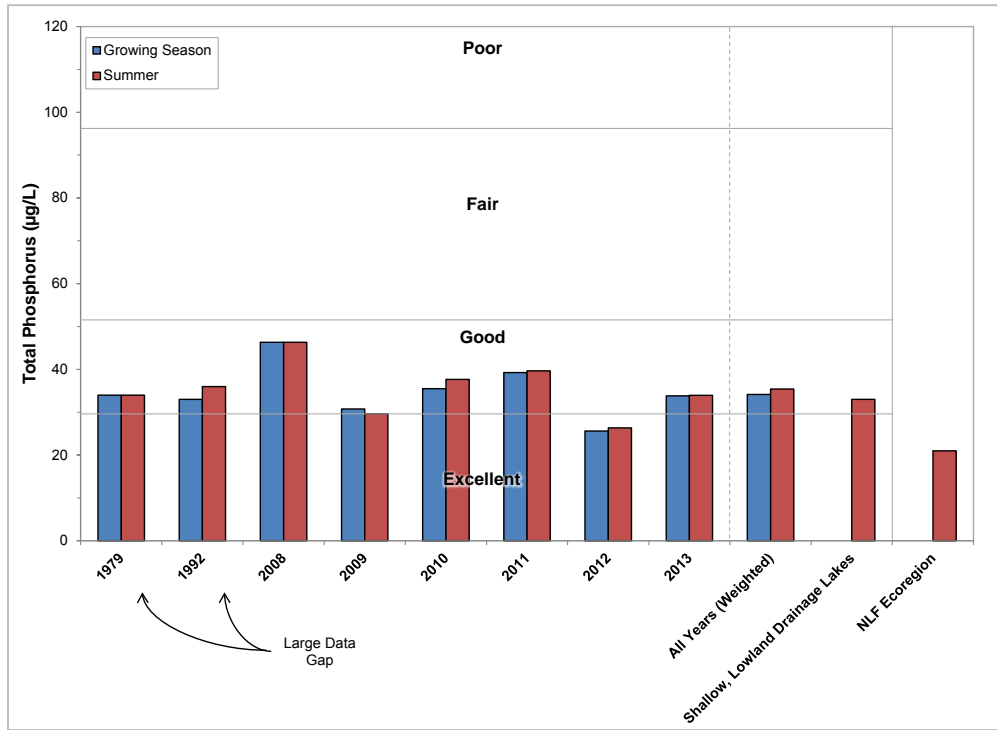
Figure 8.1.1-1. Cranberry Lake, statewide shallow, lowland drainage lakes, and regional total phosphorus concentrations. Mean values calculated with summer month surface sample data. Water Quality Index values adapted from WDNR PUB WT-913.

A fair amount of data exists for two water quality parameters of interest – total phosphorus and chlorophyll-*a* concentrations. In 2013, average summer phosphorus concentrations (35.4 µg/L) were only slightly higher than the median value (33.0 µg/L) for other shallow, lowland drainage lakes in the state (Figure 8.1.1-1) The values measured through this management planning process are similar to several data points which were collected in years past. A weighted value from all available data ranks as *Good* for a shallow, lowland drainage lake.

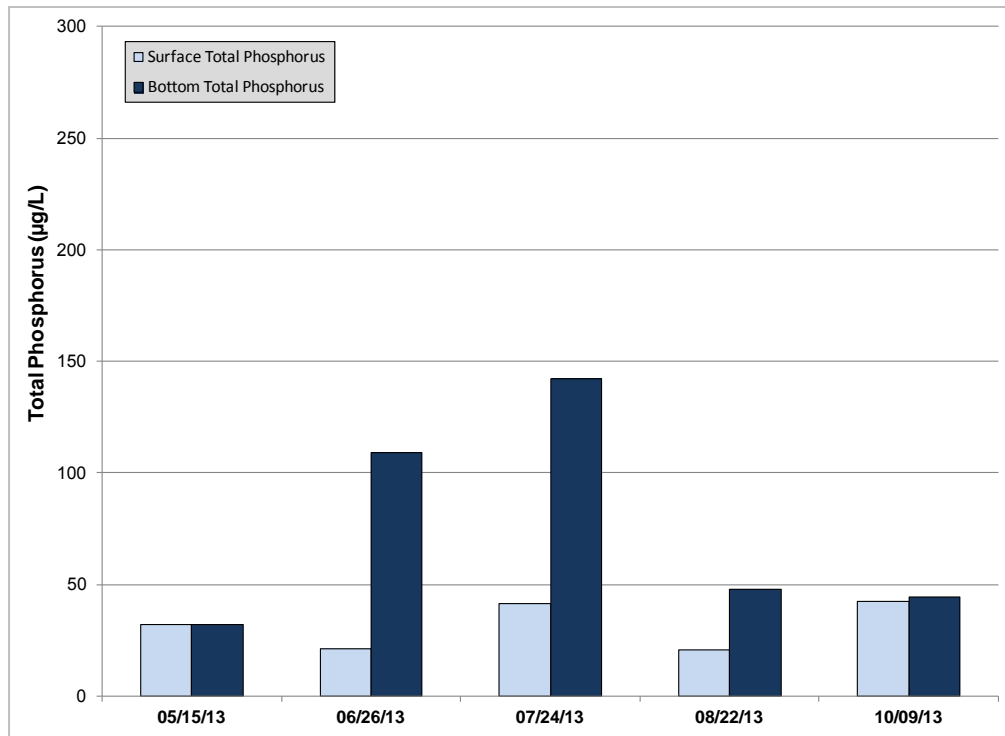
Figure 8.1.1-2. Cranberry Lake surface and bottom total phosphorus values, 2013. Anoxia was observed in the hypolimnion of the lake during summer sampling visits.

Total phosphorus surface values from 2013-2014 are compared with bottom-lake samples collected during this same time frame in Figure 8.1.1-2. As displayed in this figure, on several occasions surface and bottom total phosphorus concentrations were similar. However on some occasions, namely during June, July and August of 2013, the bottom phosphorus concentrations were much greater than the relatively low surface concentrations. During these periods, anoxic conditions were recorded near the bottom of the lake through measurement of dissolved oxygen (refer to Figure 8.1.1-6 and associated text). This is an indication of hypolimnetic nutrient recycling, or internal nutrient loading, which is a process discussed further in the Eagle River Chain-wide document. While this process may be contributing some phosphorus to Cranberry Lake's water column, the impacts of nutrient loading are not apparent in the lake's overall water quality; as previously mentioned, Cranberry Lake's surface water total phosphorus values are about the same as the median value for comparable lakes in Wisconsin.

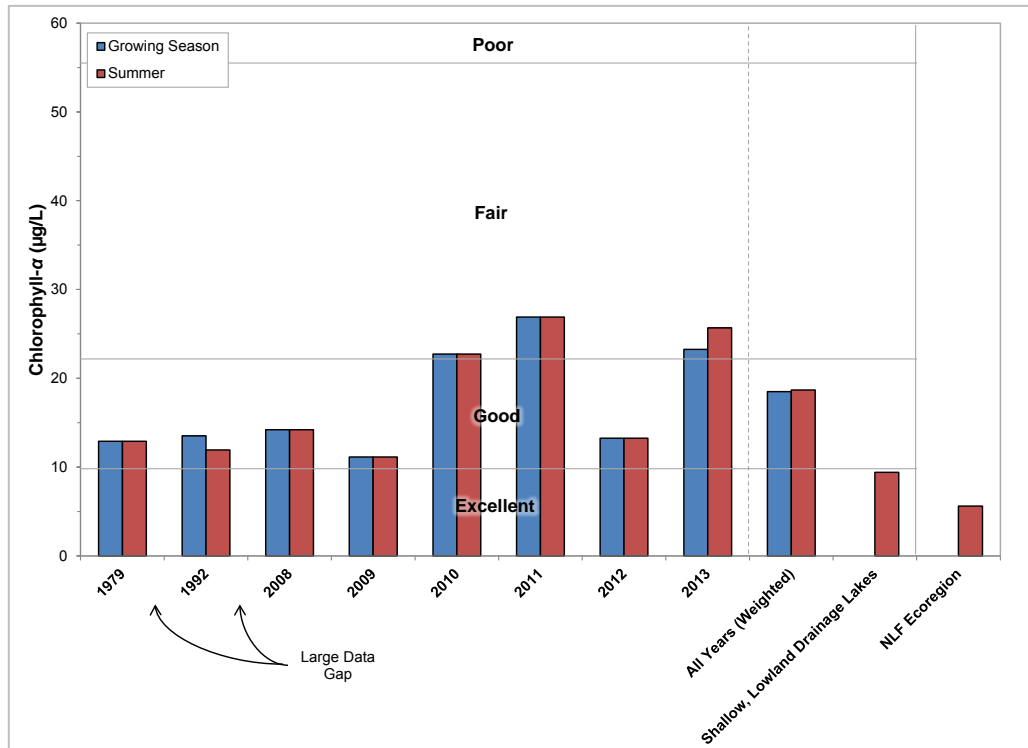
Figure 8.1.1-3. Cranberry Lake, statewide shallow, lowland drainage lakes, and regional chlorophyll-a concentrations. Mean values calculated with summer month surface sample data. Water Quality Index values adapted from WDNR PUB WT-913.

2013 summer average chlorophyll-*a* concentrations (25.7 µg/L) were roughly 2.5 times the median value (9.4 µg/L) for chlorophyll-*a* in other lakes of this type (Figure 8.1.1-3). The 2013 value is almost five times higher than the median for all lakes in the Northern Lakes and Forests ecoregion. A weighted value over all years is considerably higher than these two comparables as well. Despite the higher chlorophyll-*a* reading, the highest of average values in the dataset remain in the lower portion of the *Fair* category for shallow, lowland drainage lakes.

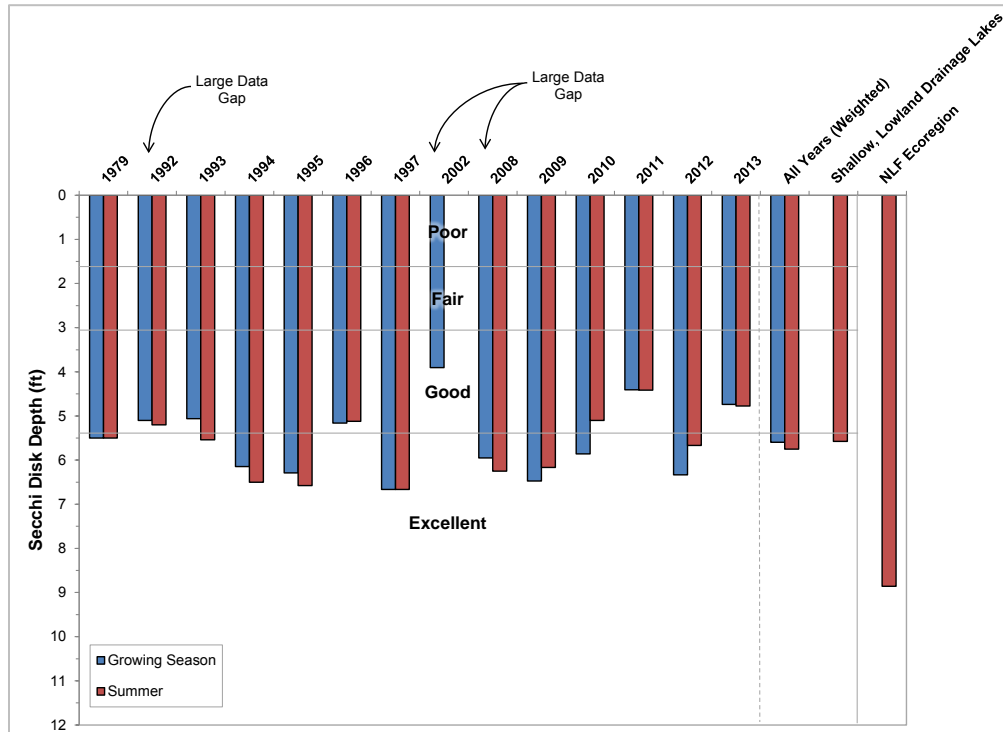
Figure 8.1.1-4. Cranberry Lake, statewide shallow, lowland drainage lakes, and regional Secchi disk clarity values. Mean values calculated with summer month surface sample data. Water Quality Index values adapted from WDNR PUB WT-913.

From the examination of nearly three decades worth of intermittent Secchi disk clarity data, several conclusions can be drawn. First, the clarity of Cranberry Lake’s water can be described as between *Good* and *Excellent* in most years (Figure 8.1.1-4). A weighted average over this timeframe is about the same as the median value for other shallow, lowland drainage lakes in the state but lower than the median value for lakes within the ecoregion. Secondly, there is no apparent trend in the clarity of the water in Cranberry Lake; the data indicate that clarity may differ from one year to the next, but has not gotten “worse” or “better” over this time period. Annual variation is however apparent.

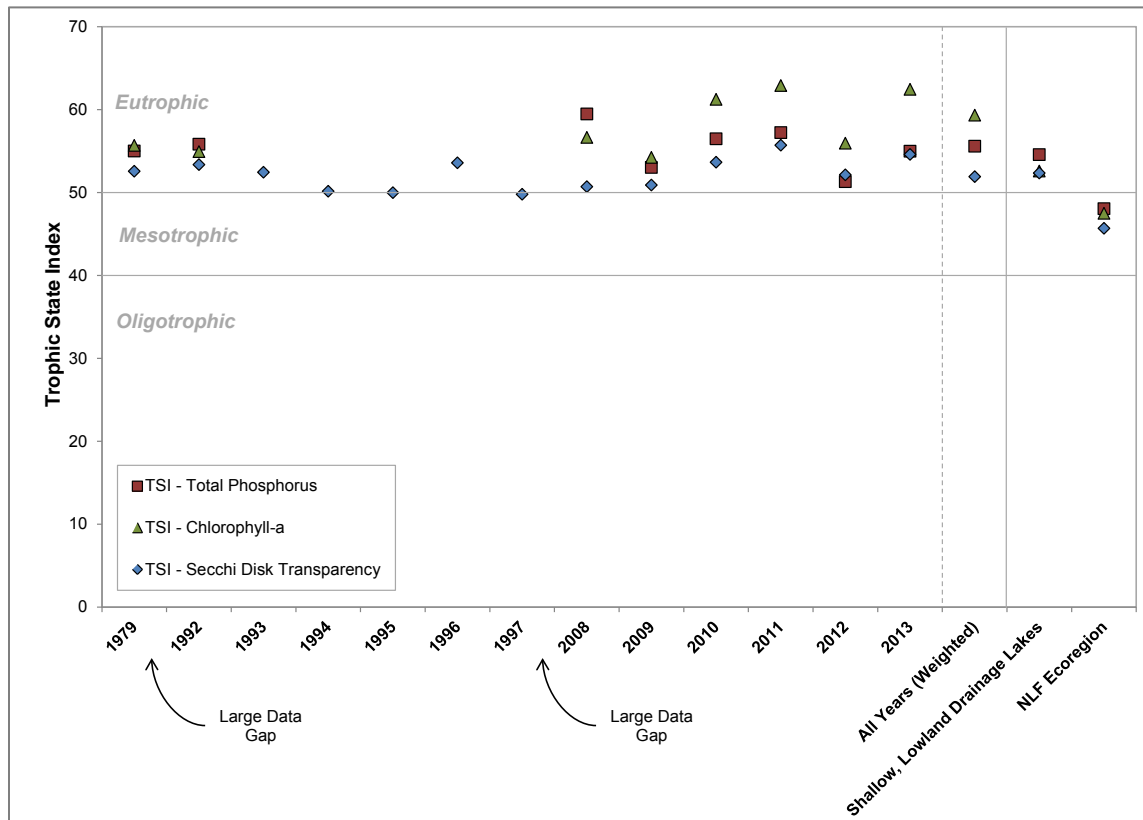
Figure 8.1.1-5. Cranberry Lake, statewide shallow, lowland drainage lakes, and regional Trophic State Index values. Values calculated with summer month surface sample data using WDNR PUB-WT-193.

The TSI values calculated with Secchi disk, chlorophyll-*a*, and total phosphorus values range in values spanning the eutrophic category (Figure 8.1.1-5). In general, the best values to use in judging a lake’s trophic state are the biological parameters; therefore, relying primarily on total phosphorus and chlorophyll-*a* TSI values, it can be concluded that Cranberry Lake is in a eutrophic state.

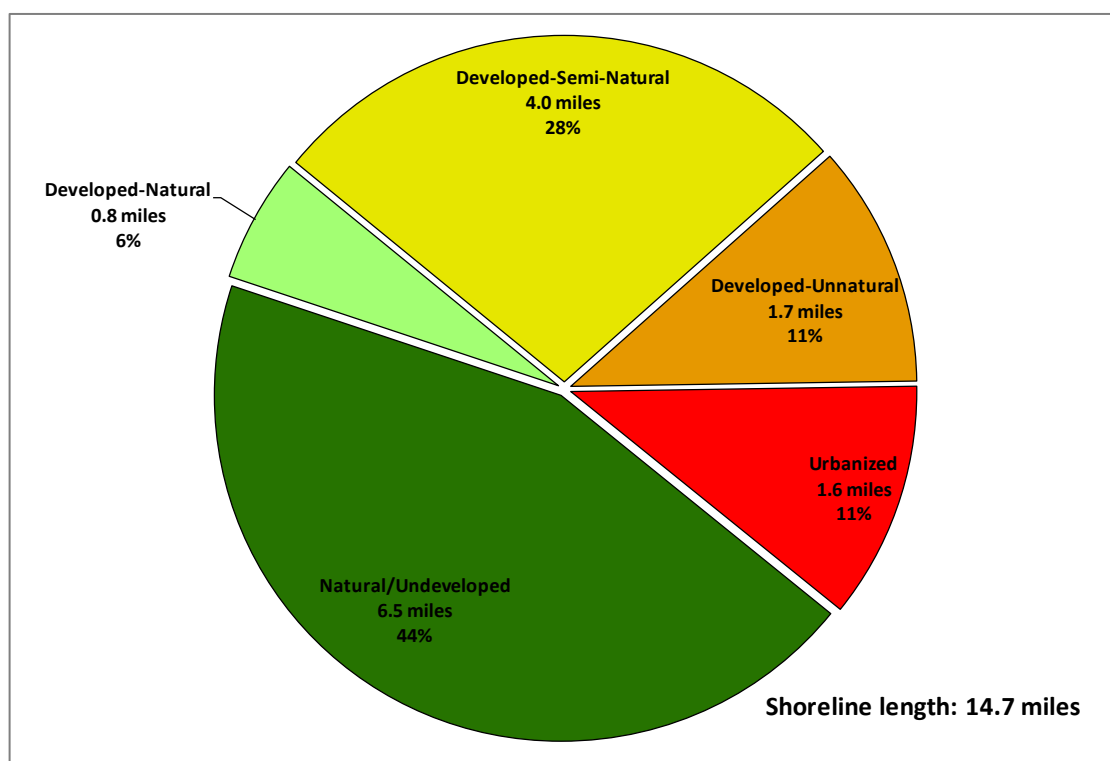
Figure 8.1.3-1. Cranberry Lake shoreland categories and total lengths. Based upon a late summer 2013 survey. Locations of these categorized shorelands can be found on Cranberry Lake - Map 1.

As mentioned previously in the Chain-wide Shoreland Condition Section, one of the most sensitive areas of the watershed is the immediate shoreland area. This area of land is the last source of protection for a lake against surface water runoff, and is also a critical area for wildlife habitat. In late summer of 2013, Cranberry Lake's immediate shoreline was assessed in terms of its development. Cranberry Lake has stretches of shoreland that fit all of the five shoreland assessment categories. In all, 7.3 miles of natural/undeveloped and developed-natural shoreline were observed during the survey (Figure 8.2.3-1). This constitutes about 50% of Cranberry Lake's shoreline. These shoreland types provide the most benefit to the lake and should be left in their natural state if at all possible. During the survey, 3.3 miles of urbanized and developed-unnatural shoreline (22%) was observed. If restoration of the Cranberry Lake shoreline is to occur, primary focus should be placed on these shoreland areas as they currently provide little benefit to, and actually may harm, the lake ecosystem. Cranberry Lake - Map 1 displays the location of these shoreline lengths around the entire lake.

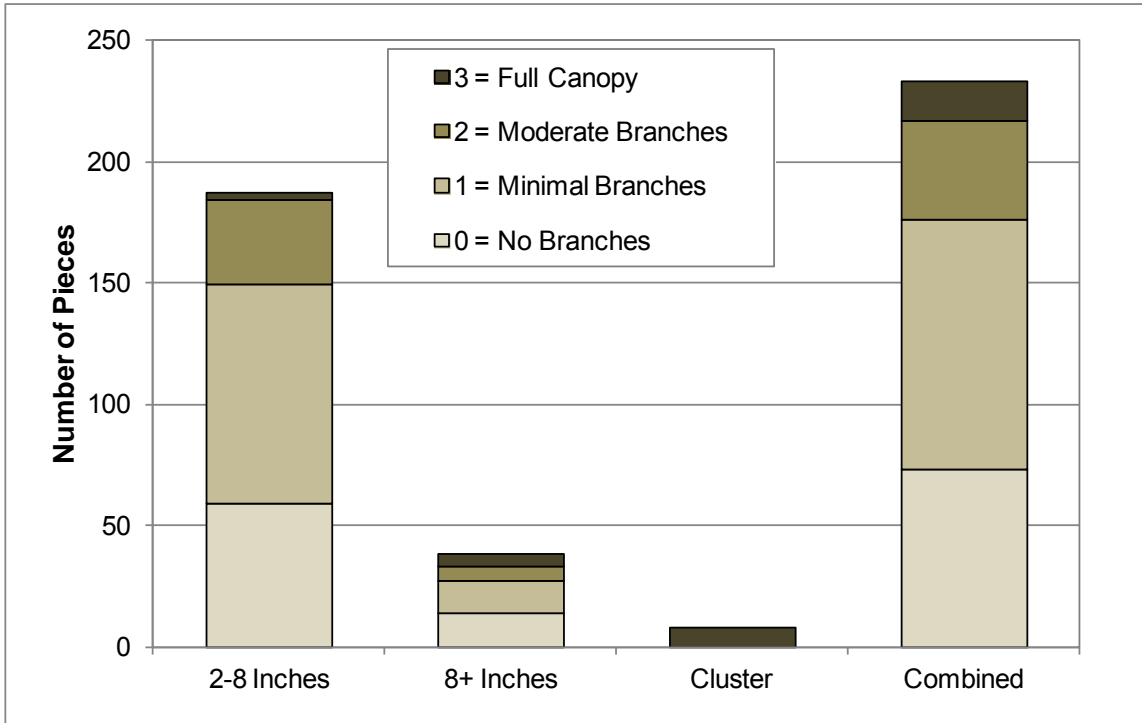
Figure 8.1.3-2. Cranberry Lake coarse woody habitat survey results. Based upon a late summer 2013 survey. Locations of Cranberry Lake coarse woody habitat can be found on Cranberry Lake - Map 2.

During this survey, 233 total pieces of coarse woody habitat were observed along 14.7 miles of shoreline, which gives Cranberry Lake a coarse woody habitat to shoreline mile ratio of 16:1. Locations of coarse woody habitat are displayed on Cranberry Lake - Map 2. To put this into perspective, Wisconsin researchers have found that in completely undeveloped lakes, an average of 345 coarse woody habitat structures may be found per mile (Christensen et al. 1996).

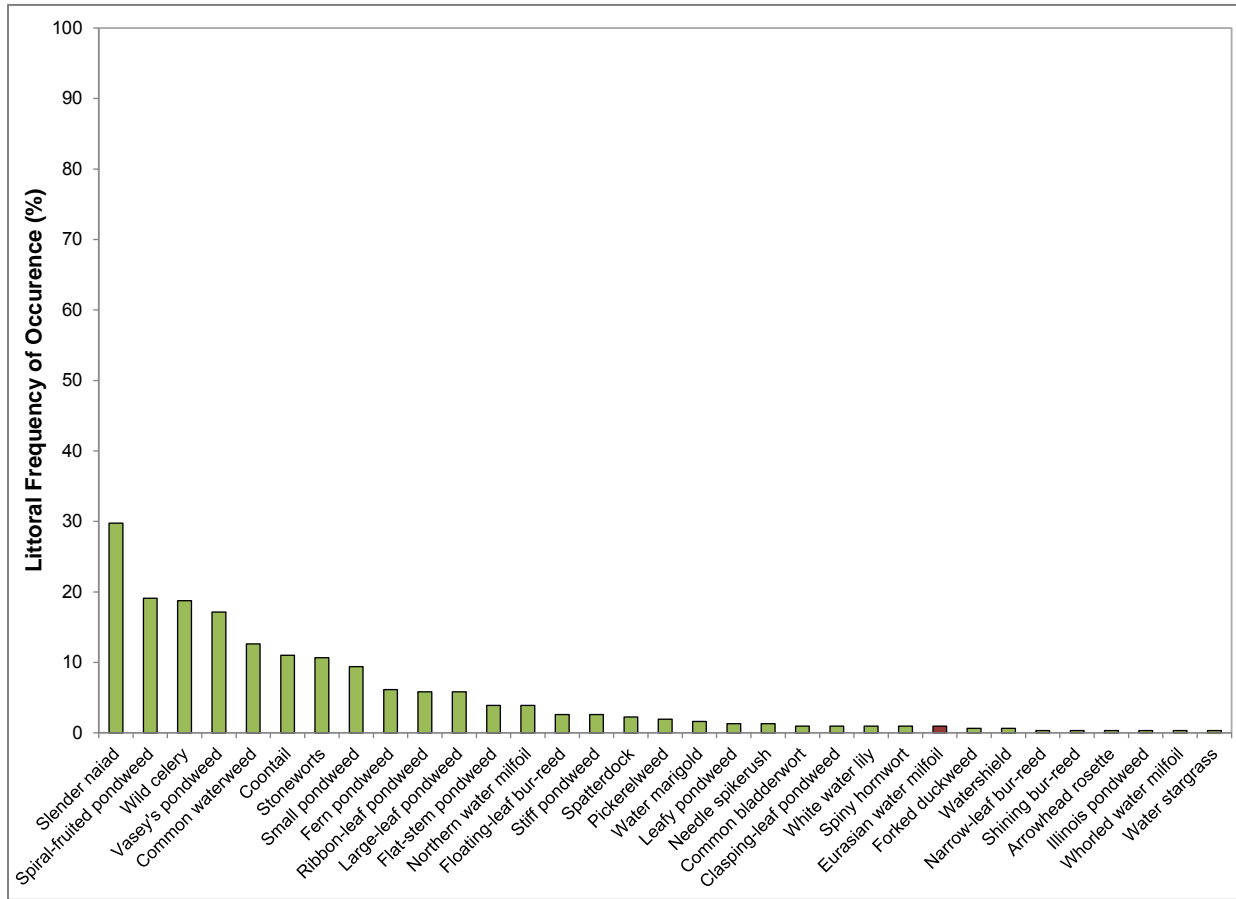
Figure 8.1.4-2. Cranberry Lake 2012 aquatic plant littoral frequency of occurrence. Created using data from 2012 aquatic plant point-intercept survey. Non-native species are indicated in red.

Of the 33 aquatic plant species recorded on the rake during the 2012 point-intercept survey, slender naiad, spiral-fruited pondweed, wild celery, and Vasey's pondweed were the four-most frequently encountered (Figure 8.1.4-2). Slender naiad, the most abundant aquatic plant in Cranberry Lake in 2012 with a littoral occurrence of nearly 30%, is one of three native naiads that can be found in Wisconsin. Being an annual, it produces numerous seeds on an annual basis and is considered to be one of the most important food sources for a number of migratory waterfowl species (Borman et al. 1997). In addition, slender naiad's small, condensed network of leaves provide excellent habitat for aquatic invertebrates.

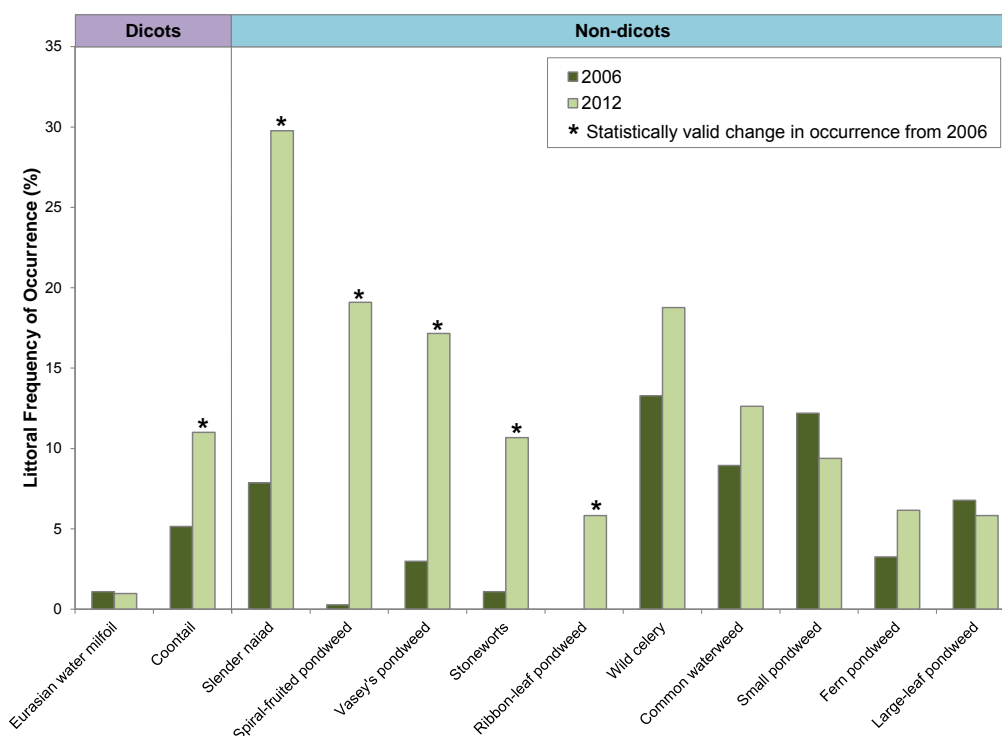
Figure 8.1.4-3. Cranberry Lake littoral frequency of occurrence of select aquatic plant species from 2006 and 2012 point-intercept surveys. Please note that only those native species with an occurrence of at least 5% in one of the two surveys are displayed. Created using data from 2006 and 2012 point-intercept surveys.

As illustrated, the occurrence of Eurasian water milfoil in Cranberry Lake was found to be not statistically different from 2006 to 2012, and had a littoral occurrence of around 1% in both surveys. However, from the annual Eurasian water milfoil mapping surveys, it is clear that Eurasian water milfoil within Cranberry Lake did increase since 2006. Had point-intercept surveys been conducted on an annual basis, this likely would have been captured. It is believed that the herbicide treatments have been effective at reducing and maintaining a low population of Eurasian water milfoil in Cranberry Lake. Five of the native aquatic plant species that had an occurrence of at least 5% in 2006 or 2012 saw statistically valid increases in their littoral occurrence, while the other five did not have statistically different occurrences from 2006 to 2012 (Figure 8.1.4-3). From these data, it appears that the Eurasian water milfoil control program has not had any detectable adverse effects on any of the aquatic plant species' populations in Cranberry Lake.

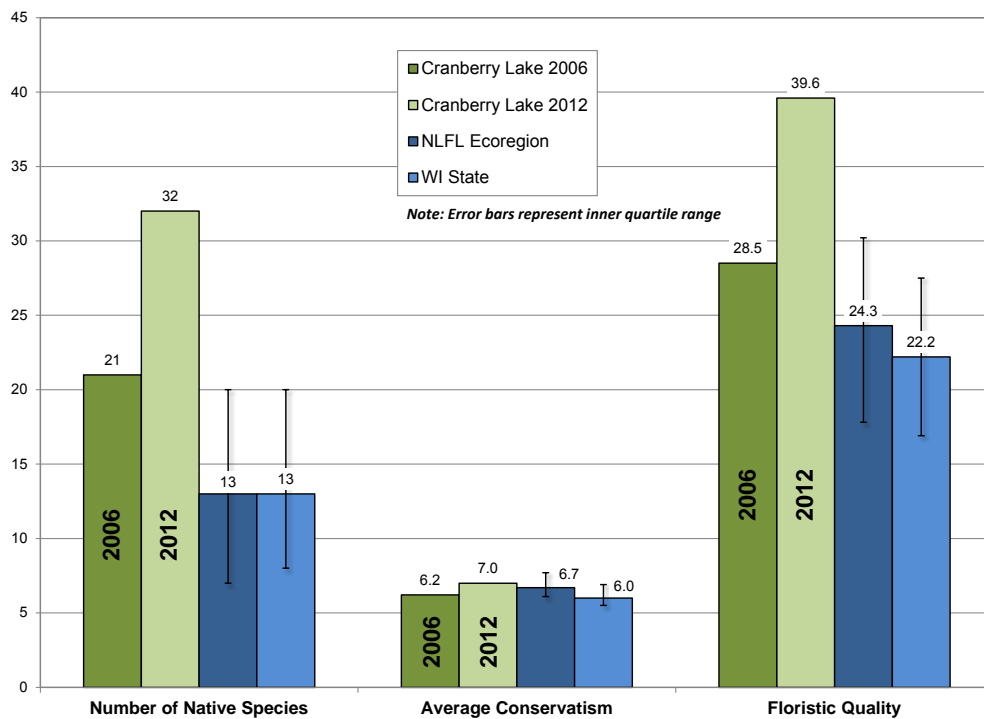
Figure 8.1.4-4. Cranberry Lake Floristic Quality Index values. Created using data from 2006 and 2012 point-intercept surveys. Analysis follows Nichols (1999) where NLFL = Northern Lakes and Forests Lakes Ecoregion.

Figure 8.1.4-4 compares the FQI components of Cranberry Lake from the 2006 and 2012 point-intercept surveys to median values of lakes within the Northern Lakes and Forests Lakes (NLFL) Ecoregion as well as the entire State of Wisconsin. In 2012, Cranberry Lake’s native species richness (32) is significantly higher than the median values for lakes within the ecoregion and the state. The average conservatism value in 2012 (7.0) is also exceeds the ecoregional and state medians. Combining Cranberry Lake’s 2012 native species richness and average conservatism values yields an exceptionally high FQI value of 39.6, which greatly exceeds the ecoregional and state median values (Figure 8.1.4-4). The FQI values from 2012 are also much higher than those calculated from point-intercept survey in 2006, indicating that the quality of Cranberry Lake’s aquatic plant community has not been diminished by the Eurasian water milfoil control project. This analysis indicates that Cranberry Lake’s aquatic plant community is of higher quality than the majority of lakes within the ecoregion and the entire state.

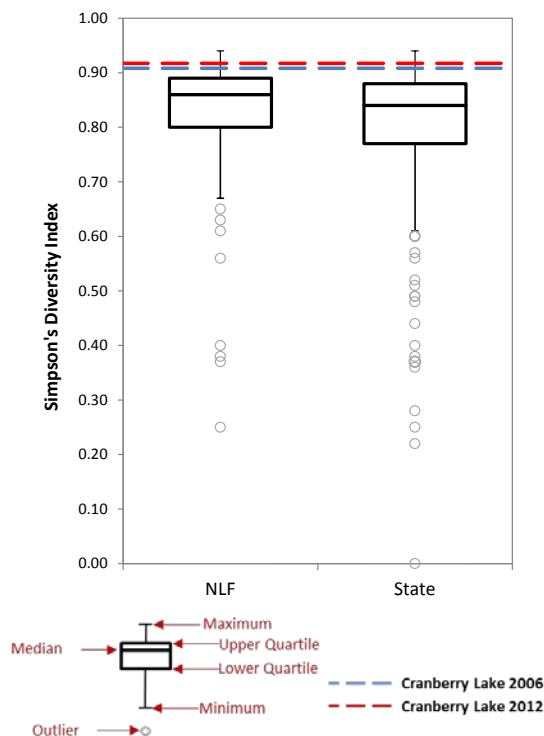
Figure 8.1.4-5. Cranberry Lake species diversity index. Created using data from 2006 and 2012 point-intercept surveys. Ecoregion data provided by WDNR Science Services.

While a method for characterizing diversity values of fair, poor, etc. does not exist, lakes within the same ecoregion may be compared to provide an idea of how Cranberry Lake's diversity value ranks. Using data obtained from WDNR Science Services, quartiles were calculated for 109 lakes within the NLF Ecoregion (Figure 8.1.4-5). Using the data collected from the 2012 point-intercept survey, Cranberry Lake's aquatic plant community was shown to have exceptionally high species diversity with a Simpson's diversity value of 0.92, falling above the upper quartile value for lakes in both the ecoregion and the state. Cranberry Lake's 2012 diversity was very similar to the diversity calculated from data collected during the 2006 point-intercept survey (0.91).

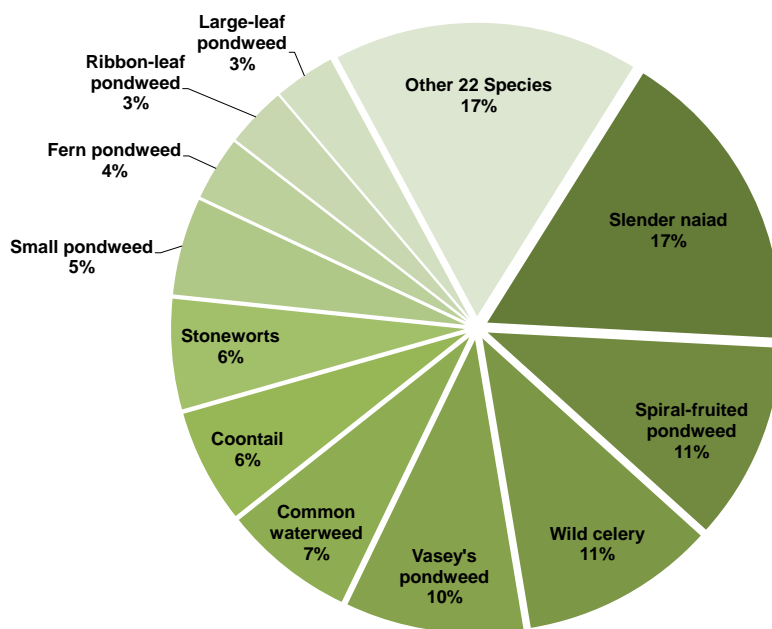
Figure 8.1.4-6. Cranberry Lake 2012 aquatic plant relative frequency of occurrence. Created using data from 2012 aquatic plant point-intercept survey.

Figure 8.1.4-6 displays the relative frequency of occurrence of aquatic plant species in Cranberry Lake from the 2012 point-intercept survey and illustrates relative abundance of species within the community to one another; the aquatic plant community is not overly dominated by a single or few species, which would create a less-diverse community.
