8.4 Eagle Lake

Eagle Lake, Vilas County, is a deep, lowland drainage lake with a maximum depth of 34 feet, a mean depth of 16 feet, and a surface area of approximately 575 acres. The lake is fed via upstream Voyageur Lake (Eagle River) and Scattering Rice Lake (Deerskin River) and drains into downstream Otter Lake. Eagle Lake's surficial watershed encompasses approximately 147,735 acres. Aquatic plant studies conducted by Onterra in 2012 and 2014 located 29 native aquatic plant species, of which slender naiad was the most common. One non-native plant, Eurasian water-milfoil is present within Eagle Lake.

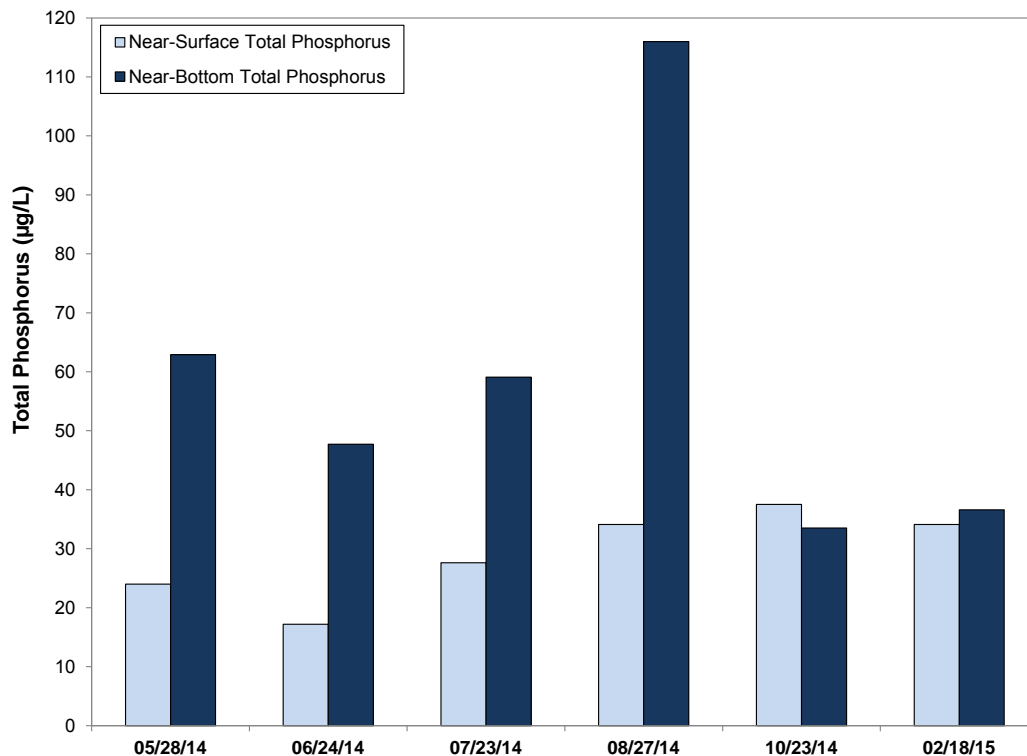
Figure 8.4.1-2 displays near-surface and near-bottom total phosphorus concentrations collected from Eagle Lake in 2014 and the winter of 2015. As illustrated, near-bottom phosphorus concentrations in the late-May and during the summer months was approximately two to three times the concentrations measured near the surface. The higher concentrations of phosphorus measured near the bottoms during these sampling events is an indication that phosphorus is being released from bottom sediments and into the hypolimnion, or the colder, bottom layer of water. During these sampling events the lake was found to be stratified with little or no oxygen measured within the hypolimnion. The absence of oxygen in the water near the sediments allows phosphorus to be released from the sediment and into the water. Most of the time, this process is likely contributing minimal amounts of phosphorus to Eagle Lake. As discussed within the Chain-Wide Section, internal nutrient loading generally becomes a concern when near-bottom phosphorus concentrations exceed 200 $\mu\text{g/L}$.

Figure 8.4.1-2. Eagle Lake growing season 2014 and winter 2015 near-surface and near-bottom total phosphorus concentrations.

However, periodically, like in 2004, conditions that either increase the period of stratification or increase the size of the anoxic hypolimnion may allow for higher amounts of phosphorus to build up within the hypolimnion over the course of the summer. In the fall as surface water temperatures cool, the entire water column of the lake mixes, or turns over, and the phosphorus-rich water near the bottom is mixed throughout the water column delivering phosphorus to the surface. Using the total phosphorus data collected in 2004 and the temperature and dissolved oxygen profiles collected in 2014, it was estimated that the concentration of phosphorus within the hypolimnion in 2004 needed to be around 650 $\mu\text{g/L}$ to create the measured concentration of 185 $\mu\text{g/L}$ throughout the water column at turnover. A hypolimnetic phosphorus concentration of 650 $\mu\text{g/L}$ is high, but is within the realm of possibility. However, as the data indicate, this magnitude of internal nutrient loading on Eagle Lake is relatively rare, and likely only occurs when conditions are ideal.

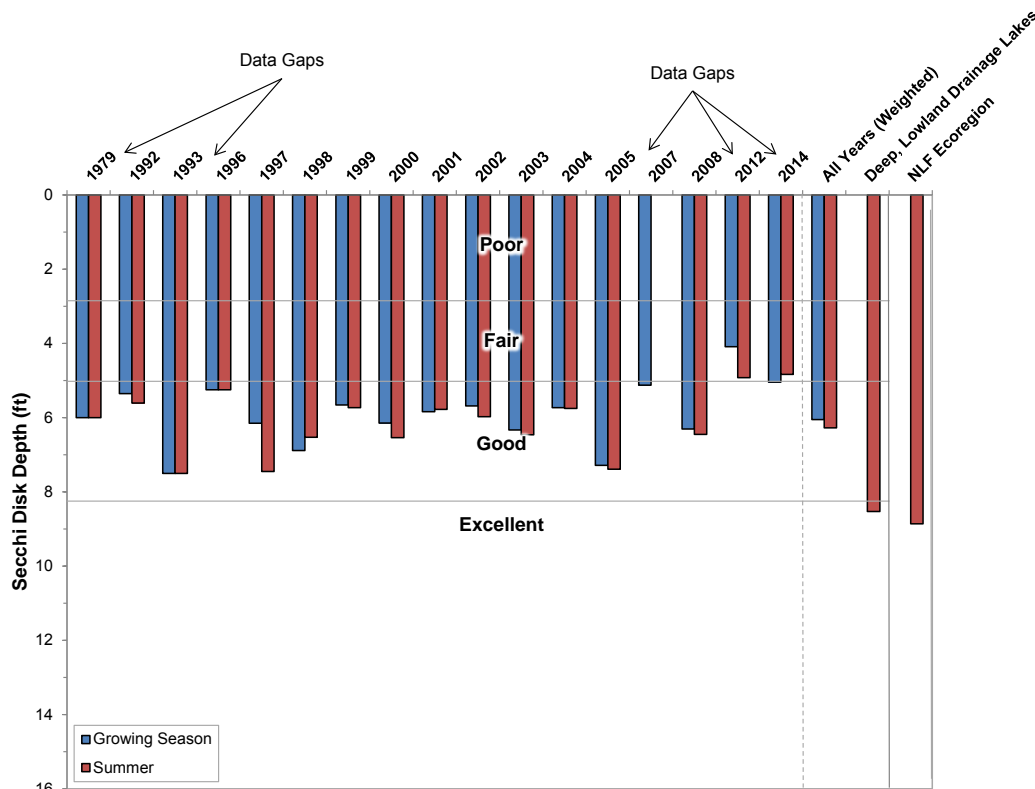
Secchi disk transparency data are available from Eagle Lake from 1979, 1992, 1993, 1996-2005, 2007, 2008, 2012, and 2014 (Figure 8.4.1-4). The average summer Secchi disk transparency value is 6.3 feet, slightly lower than the median values for other deep, lowland drainage lakes in Wisconsin and for lakes within the NLF ecoregion. While water clarity varies between years, trends analysis indicates water clarity has remained relatively consistent over the time period for which data are available. Overall, water clarity in Eagle Lake falls within the *good* category for deep, lowland drainage lakes.

Figure 8.4.1-4. Eagle Lake, statewide deep, lowland drainage lakes, and regional Secchi disk clarity values. Mean values calculated with summer month surface sample data. Water Quality Index values adapted from WDNR PUB WT-913.

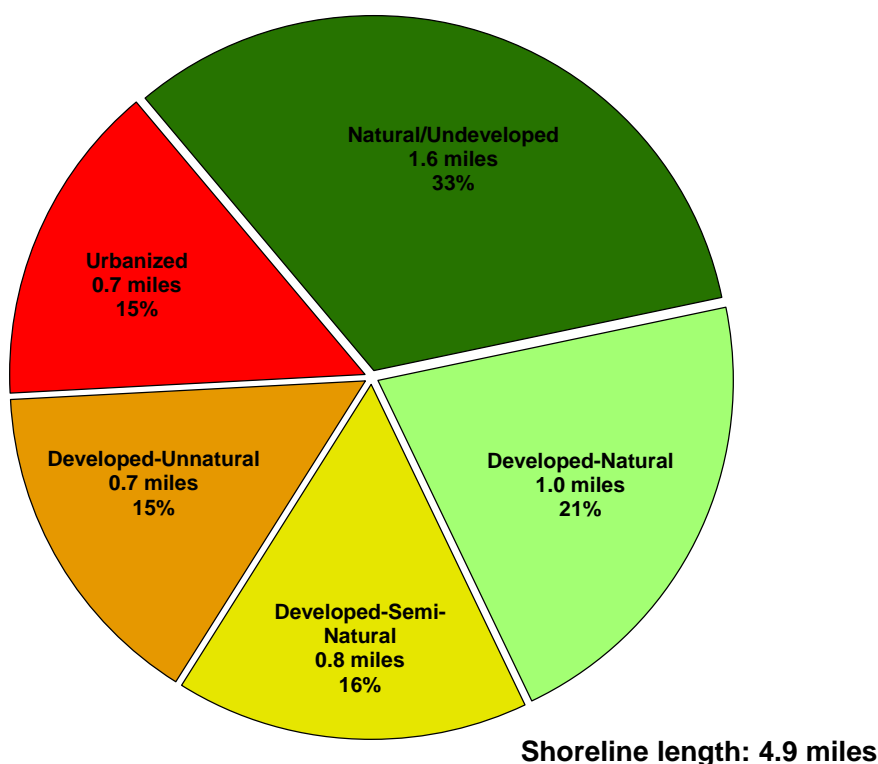
As mentioned previously in the Chain-wide Shoreland Condition Section, one of the most sensitive areas of the watershed is the immediate shoreland area. This area of land is the last source of protection for a lake against surface water runoff, and is also a critical area for wildlife habitat. In late summer of 2014, Eagle Lake's immediate shoreline was assessed in terms of its development. Eagle Lake has stretches of shoreland that fit all of the five shoreland assessment categories. In all, 2.6 miles of natural/undeveloped and developed-natural shoreline were observed during the survey (Figure 8.4.3-1). This constitutes about 54% of Eagle Lake's shoreline. These shoreland types provide the most benefit to the lake and should be left in their natural state if at all possible. During the survey, 1.4 miles of urbanized and developed-unnatural shoreline (30%) was observed. If restoration of the Eagle Lake shoreline is to occur, primary focus should be placed on these shoreland areas as they currently provide little benefit to, and actually may harm, the lake ecosystem. Eagle Lake – Map 1 displays the location of these shoreline lengths around the entire lake.

Figure 8.4.3-1. Eagle Lake shoreland categories and total lengths. Based upon a late summer 2014 survey. Locations of these categorized shorelands can be found on Eagle Lake – Map 1.

Description: As part of the planning project, the entire shoreline of Eagle Lake was categorized based on the amount of development present. The results of this survey revealed that approximately 30% (1.4 miles) of the shoreline are in an urbanized or developed-unnatural state, 16% (0.8 miles) is in a developed-semi-natural state, and 54% (2.6 miles) is in a developed-natural or natural/undeveloped state. Continuing research indicates that the shoreland zone is a critical component of a lake's ecology through providing both pollutant buffering and wildlife habitat. In addition, natural shoreland areas also increase the lake's aesthetic appeal.
