Lost Lake, Vilas County is a 544 acre lake with a maximum depth of 20 feet. During the 2013 growing season, a member of the district found a suspicious milfoil plant which was later confirmed by the Vilas County Land and Water Conservation Department to be Eurasian water milfoil (*Myriophyllum spicatum*, EWM). Onterra, LLC was contracted by the Lost Lake Protection and Rehabilitation District (LLPRD) to complete a focused EWM survey in October 2013 within the area of the lake where EWM had been located. Onterra ecologists located two colonized areas of *dominant* and *scattered* EWM as well as numerous occurrences of *clumps of plants* or *single or few plants* during this survey.

Map 1  
Lost Lake  
Vilas County, Wisconsin

Map 2  
 Lost Lake  
 Vilas County  
 2013-2015 EWM  
 Survey Results

Map 3  
 Lost Lake  
 Vilas County  
**2014-2015 CLP  
 Survey Results**

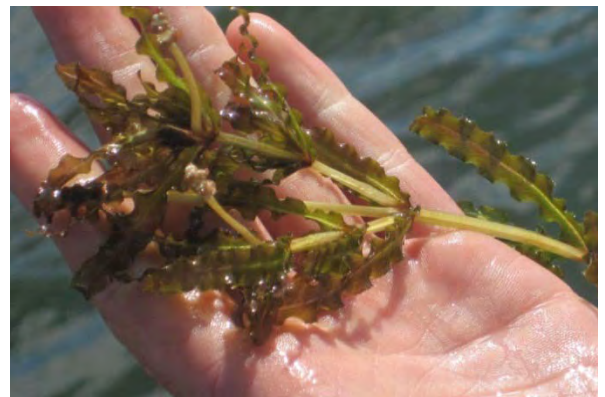
**Photo 2a. Curly-leaf Pondweed.**

Onterra ecologists located a few occurrences of curly leaf pondweed (CLP) consisting of a *small plant colony, clumps of plants and single or few plants* in the western portion of Lost Lake during June and September 2014 surveys (Map 3, top frame)(Photo 2a). This was the first recorded occurrence of CLP within Lost Lake, and given the smaller number of plants located, it was theorized that it may have been introduced to the lake relatively recently.

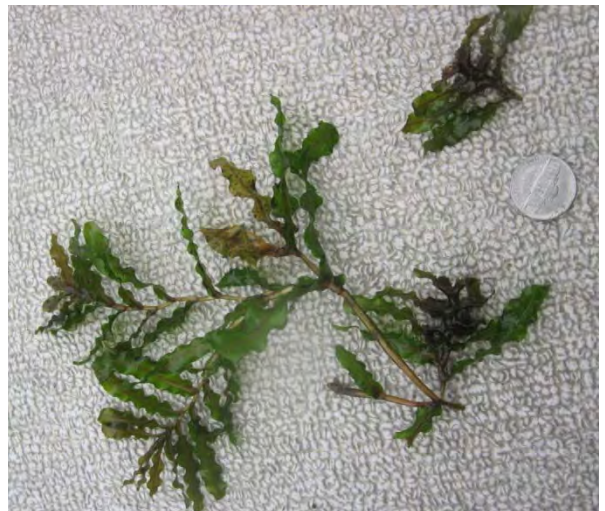
**Photo 2b. Curly-leaf Pondweed reproductive turions. Photos taken on Lost Lake 2014-2015.**

During the late-May 2015 ESAIS survey, Onterra ecologists mapped CLP when it was expected to be near its peak-biomass level in Lost Lake. The survey found a marked increase in the CLP population within the western bay of the lake in and around the previously known locations from 2014 (Map 3, middle frame). A few occurrences outside of the bay were also located during the survey near the north shore and in the eastern bay of the lake. Given the typical life-cycle of CLP, it was unexpected to find CLP growing during the September 2015 survey. Due to the amount of CLP observed during the late September EWM mapping survey, both CLP and EWM were mapped within the lake. Curly-leaf pondweed was found to have expanded beyond the west bay of the lake and numerous occurrences were mapped in various other parts of the lake (Map 3, bottom frame). The CLP observed during the late-summer survey were found with fully-formed turions in the leaf axils.

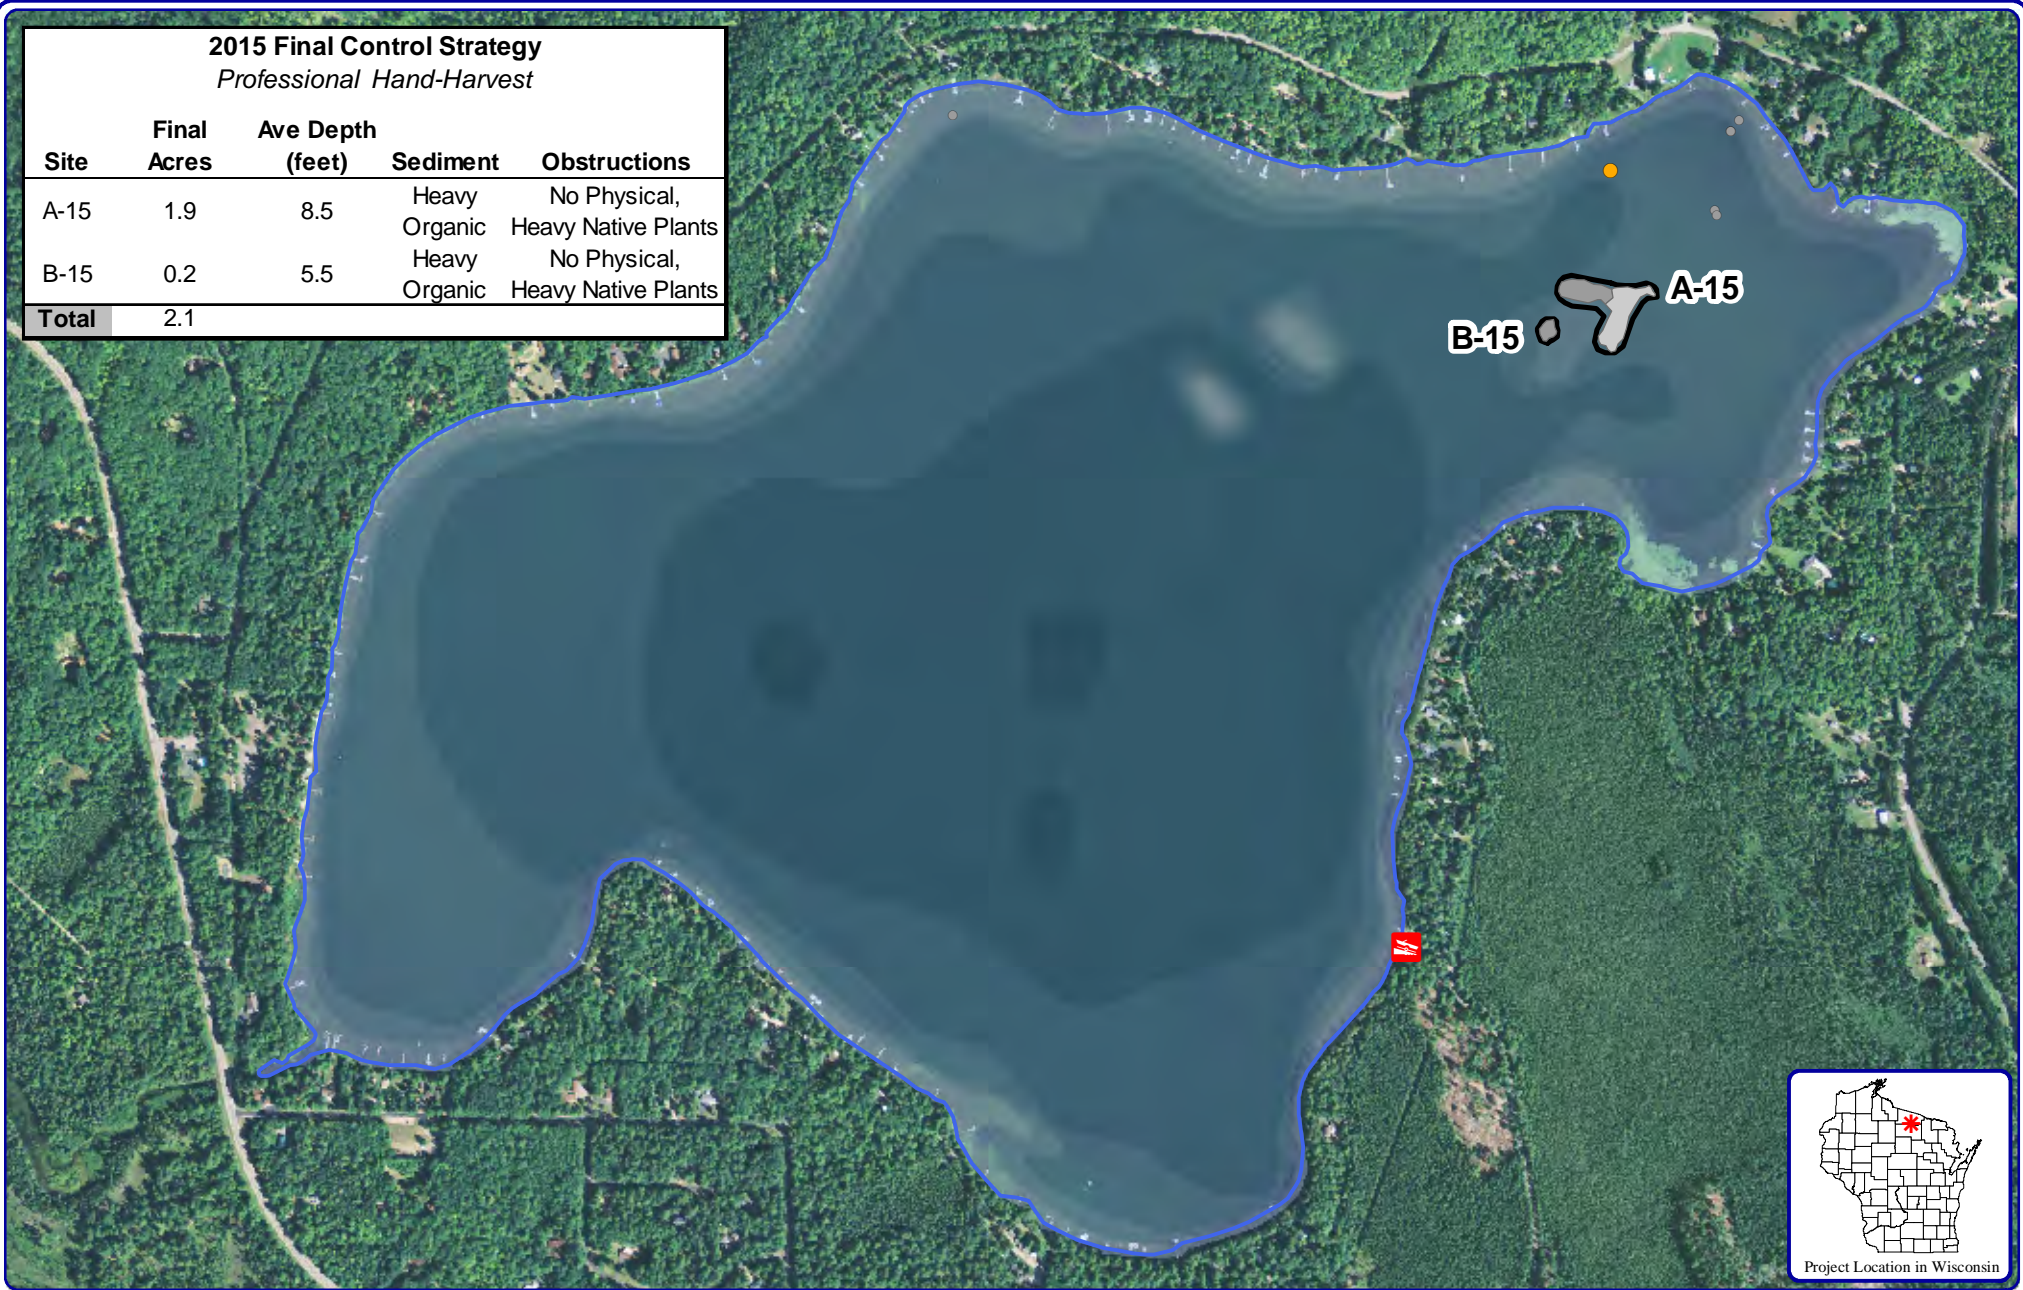
From this survey, the highest concentrations of EWM were identified and prioritized for hand removal. The largest concentration of EWM was found in the same location within the eastern bay as it was found in 2013 and 2014 with two colonies composed of *scattered* or *highly scattered* plants. These two sites totaling 2.1 acres were permitted for professional-based hand-harvesting in 2015 (Map 1). Onterra provided the spatial data from this survey to the LLPRD and the professional hand harvesting firms to aid the control efforts. A few other low density occurrences of EWM were found within the eastern portion of the lake and along the northern shoreline during the late-May ESAIS survey (Map 1). As will be discussed further in this report, CLP levels were found to have increased significantly within the western bay compared to levels observed in 2014 and was considered too expansive for control using hand removal methods.

**May 2015 EWM Locations  
& 2015 Final DASH Areas**

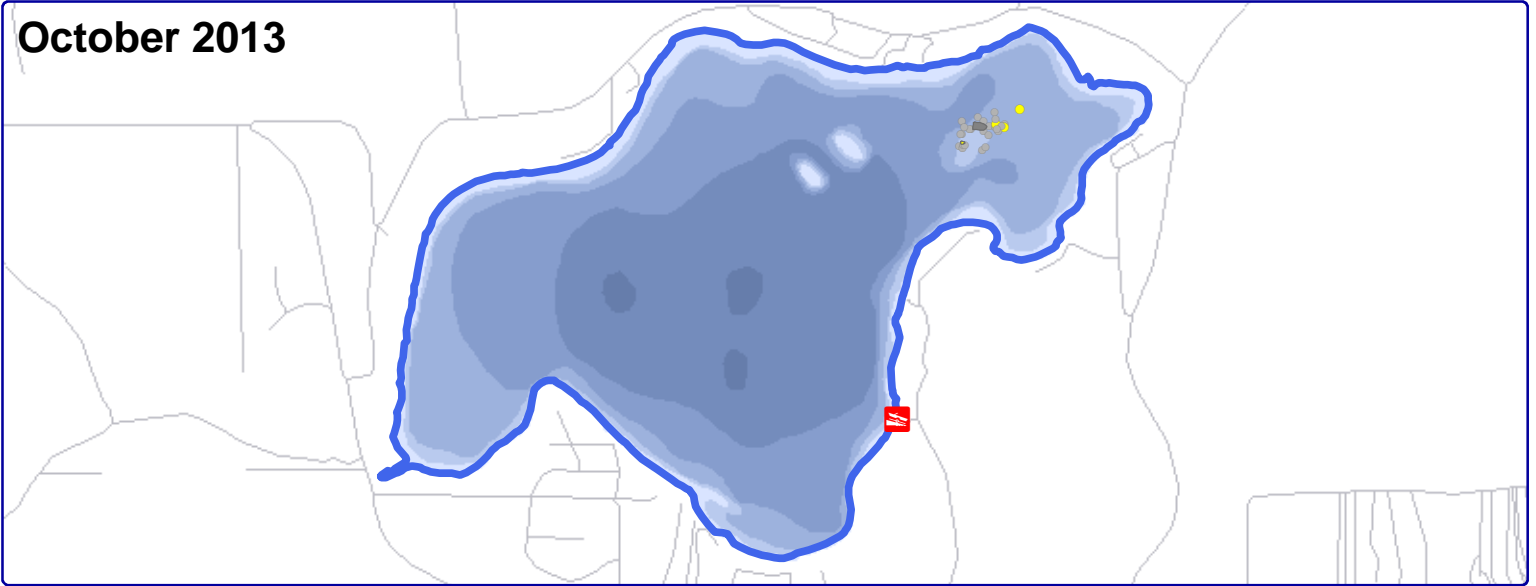
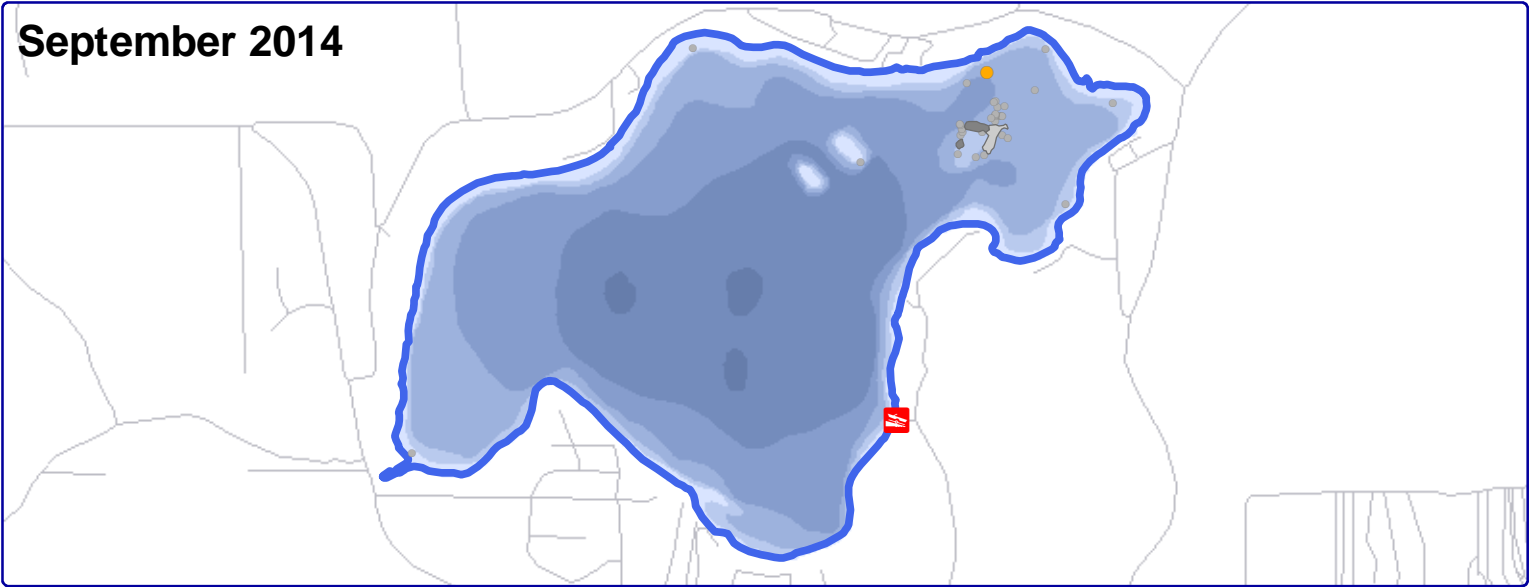
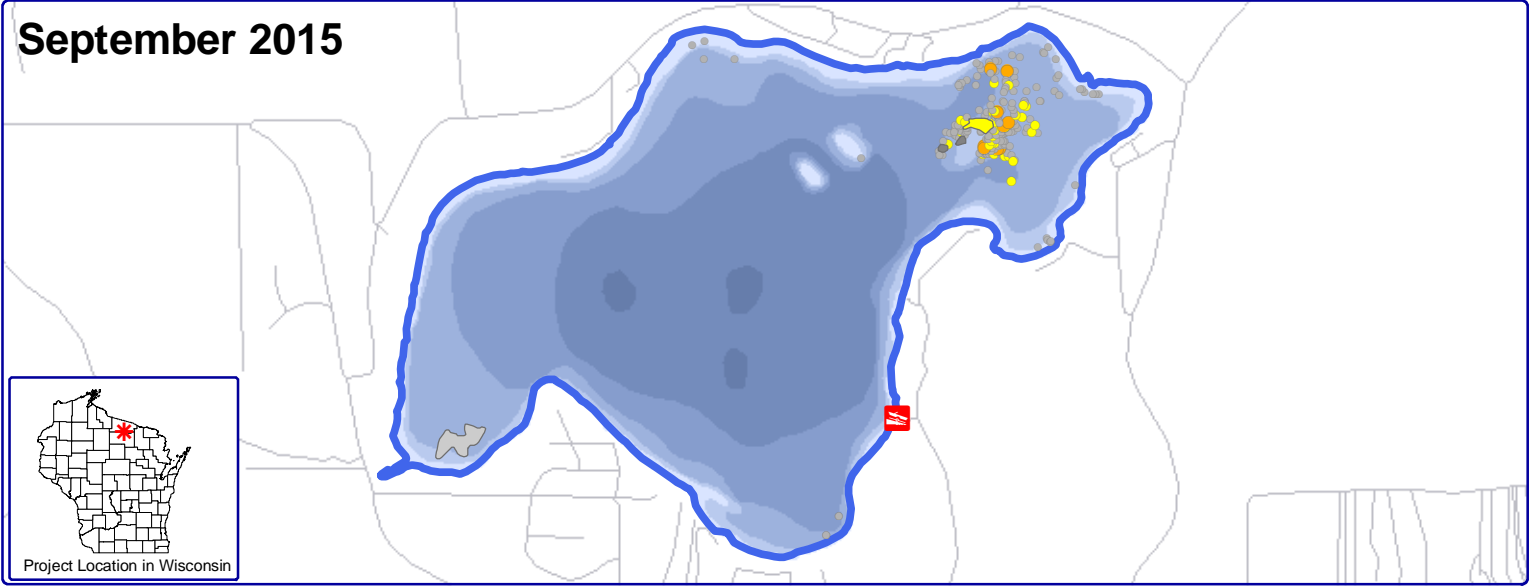
During the meander survey, EWM was found to have expanded within the lake, most notably within the eastern bay of the lake. An additional *highly scattered* colonized area of EWM was located in the western bay near the Lost Creek outlet. Several *single or few plant* occurrences were marked in additional parts of the lake during the survey as well. Map 2 displays the progression of the EWM population in Lost Lake since its initial discovery in October 2013.

October 2013

September 2014

September 2015

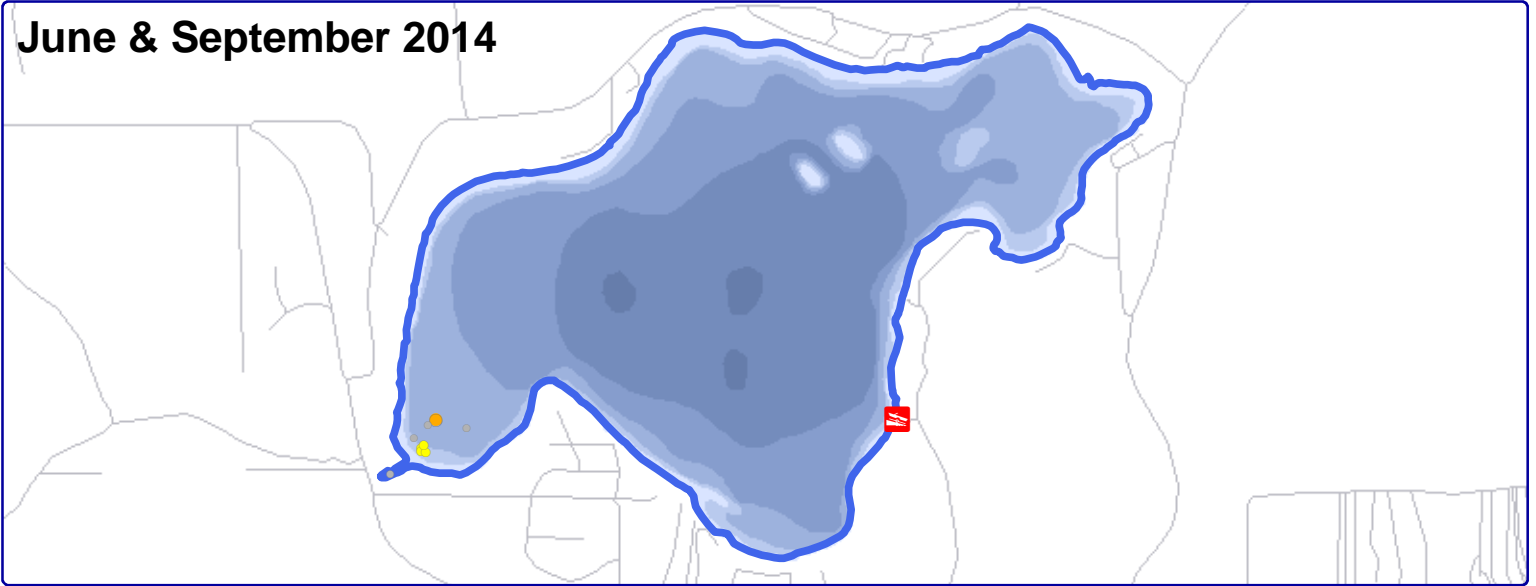
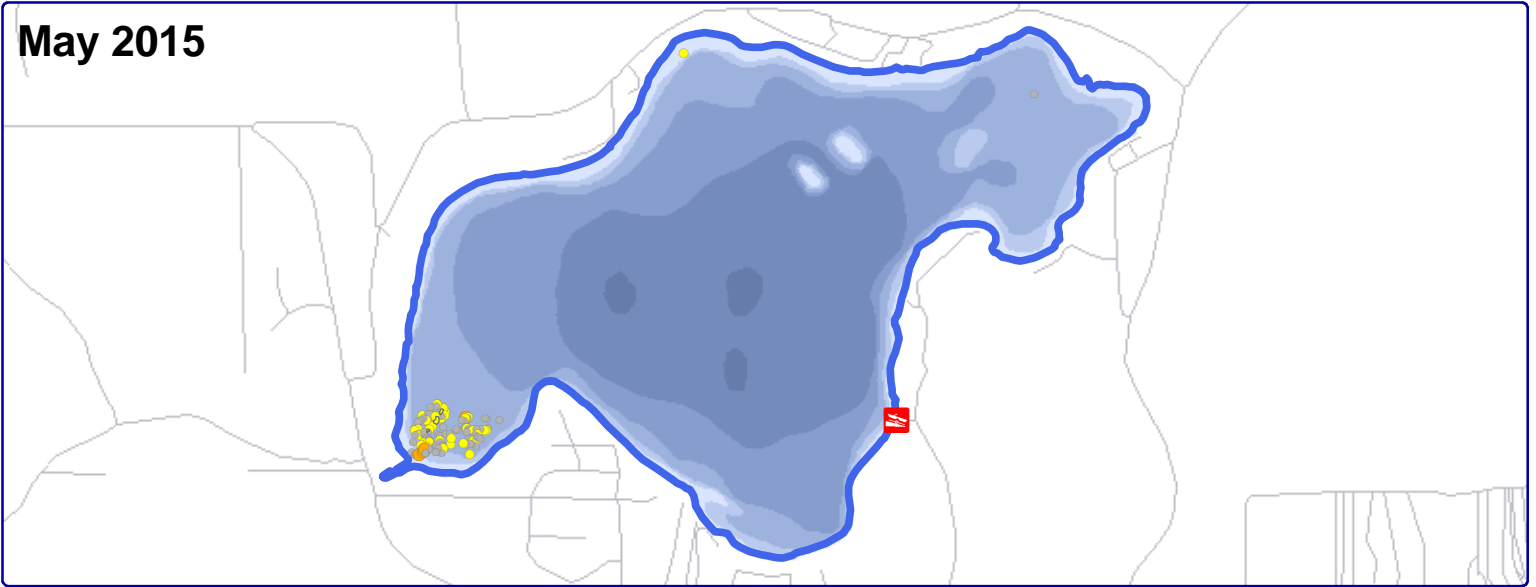
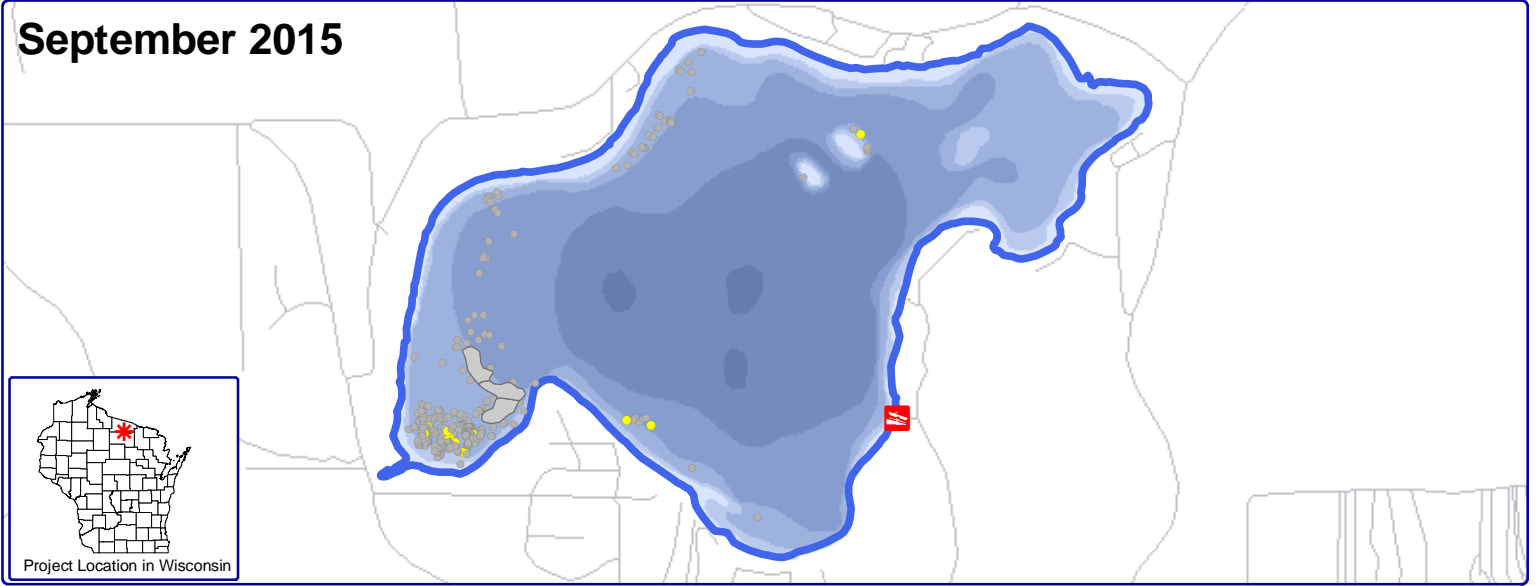
## June & September 2014

## May 2015

## September 2015
