LAKE PLANNING STUDY
FOR THE
TOWNSEND FLOWAGE

TOWNSEND FLOWAGE ASSOCIATION

MARCH 1995

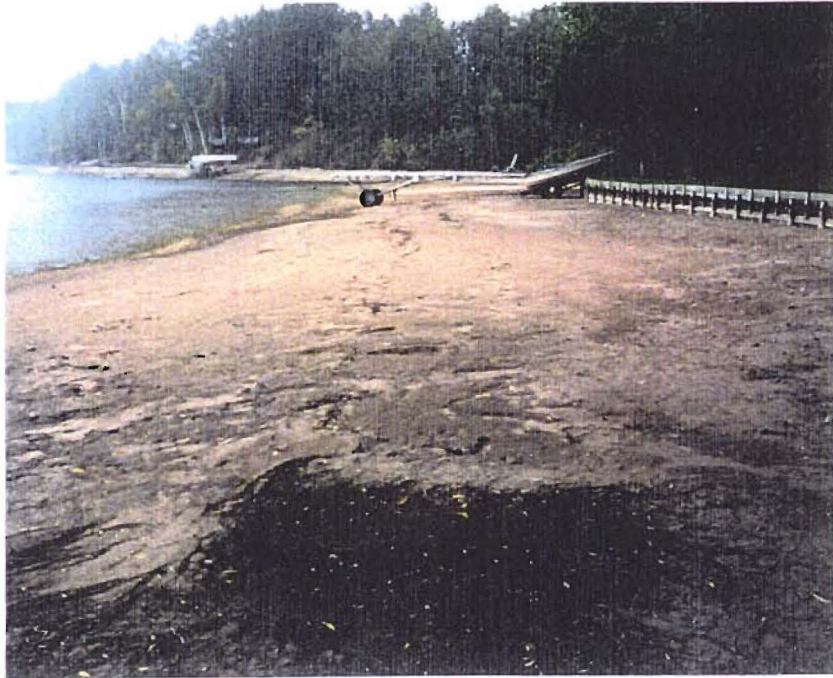
Townsend Flowage, 1993, drained to repair dam.

In August, 1993, the level on the Townsend Flowage was dropped four feet for dam repairs. At that time, many of the logs and stumps were removed from the Townsend Flowage for the safety of boaters. The Townsend Flowage was returned to normal level by the end of September, 1993. Photographs of the drawdown are included in Appendix "B".

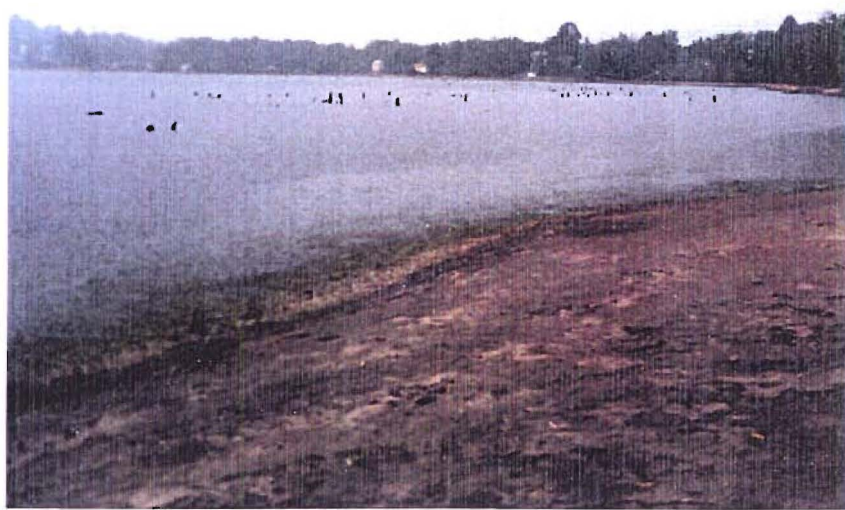
Townsend Flowage, -1993, drained to repair dam.
