# **East Alaska Lake**

Kewaunee County, Wisconsin

# **Alum Treatment Feasibility Study**

**April 2005**

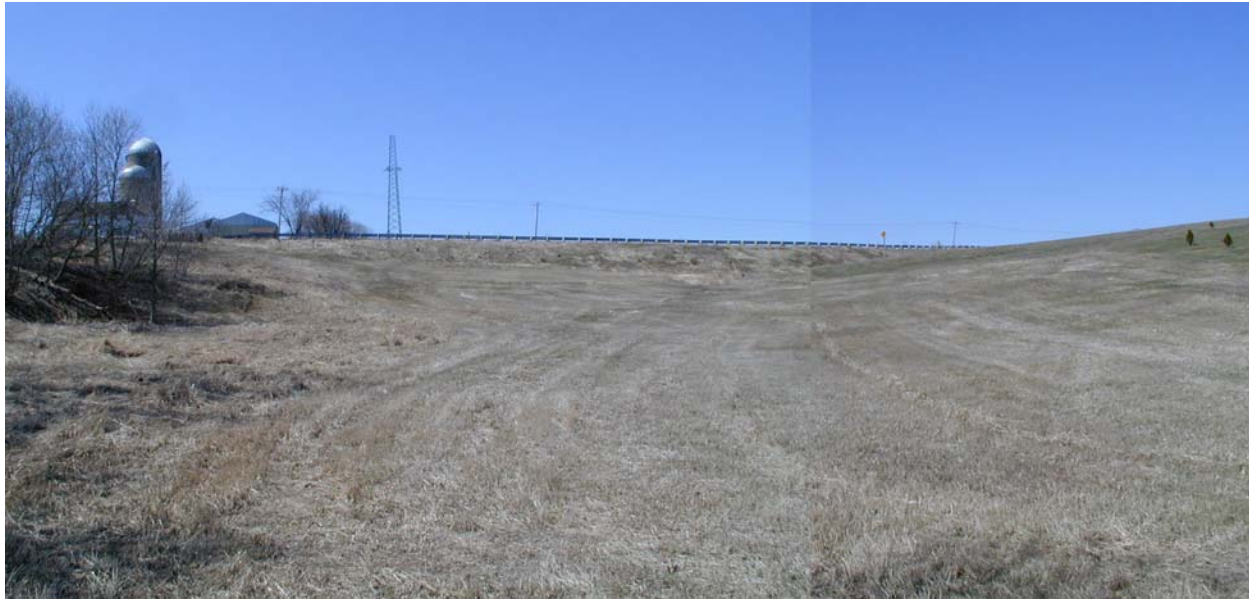
**Photo 1. Potential detention basin site to treat Drain Tile discharge.** Photo taken facing northwest at the Drain Tile site. It is likely that the tileline follows this valley as it slopes towards East Alaska Lake.

Minimizing the impact of the Drain Tile could be accomplished through the creation of a sedimentation basin to intercept and treat the discharges before they enter the lake. A study completed at English Lake, Manitowoc County, Wisconsin determined that over 60% of inflowing phosphorus was removed before it entered the lake by a newly constructed wetland detention basin (NES 2001). If a basin could be constructed at East Alaska Lake that would remove 50% of the phosphorus from the Drain Tile, it would be a significant reduction in loading. A secondary benefit to the construction of the basin would be enhanced wildlife habitat.

A suitable location for such a detention basin is located just inland from the Drain Tile outfall (Figure 1 and Photo 1). If the Tri-Lakes Association intends to pursue the construction of the basin, it is recommended that they enlist the assistance of a professional engineering firm
