Seven Island Lake

Lincoln County, Wisconsin

Comprehensive Management Plan

May 2011

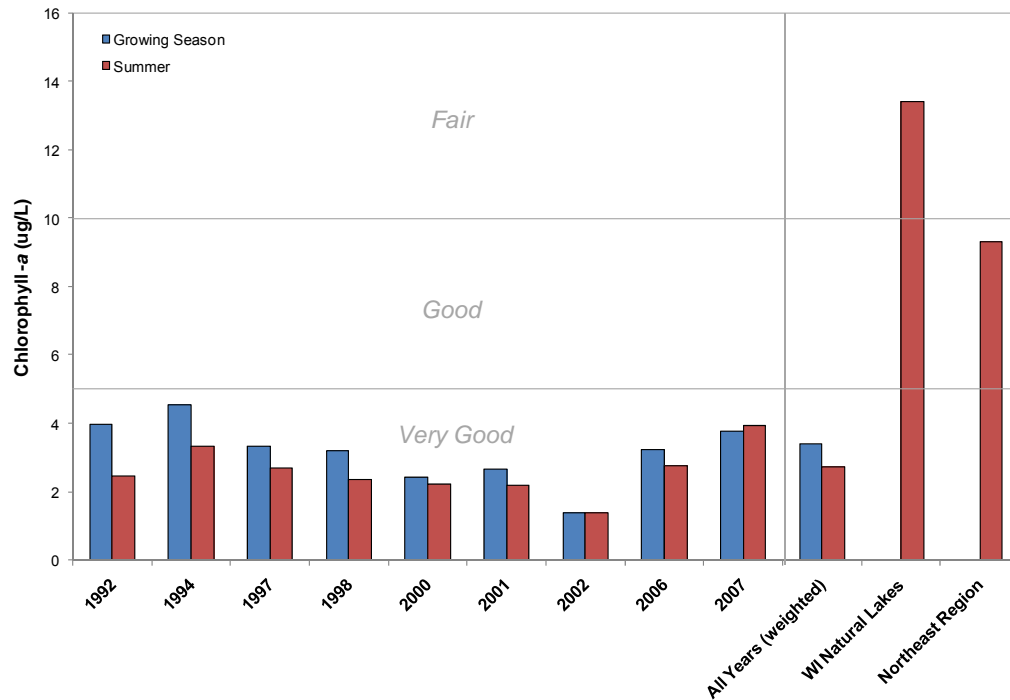
Figure 3.1-3. Seven Island Lake chlorophyll-a concentrations. Mean values calculated with summer and growing season surface sample data. Water Quality Index values adapted from Lillie and Mason (1983).

The data follows the normal phosphorus/chlorophyll-*a* relationship in that the low phosphorus values within Seven Island Lake have lead to incredibly low chlorophyll *a* values. In addition, Seven Island Lake's chlorophyll-*a* values are well below state and regional means and correspond with very good levels in the WQI.

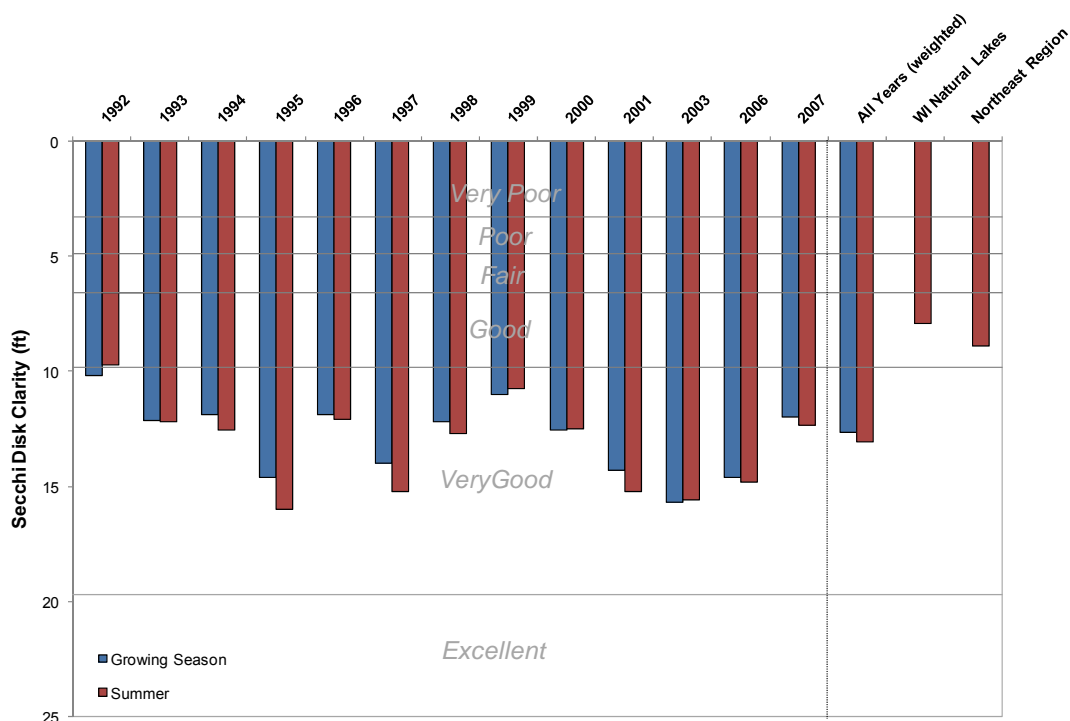
Figure 3.1-4. Seven Island Lake Secchi disk transparency values. Mean values calculated with summer and growing season sample data. Water Quality Index values adapted from Lillie and Mason (1983).

All of the Secchi disk transparency averages from Seven Island Lake surpass those of the ecoregion and the state and fall within the very good range of the WQI. As alluded to above, there really is no trend towards improved or degraded water quality within the dataset and as with most lakes, the clarity of Seven Island Lake fluctuates from year-to-year.

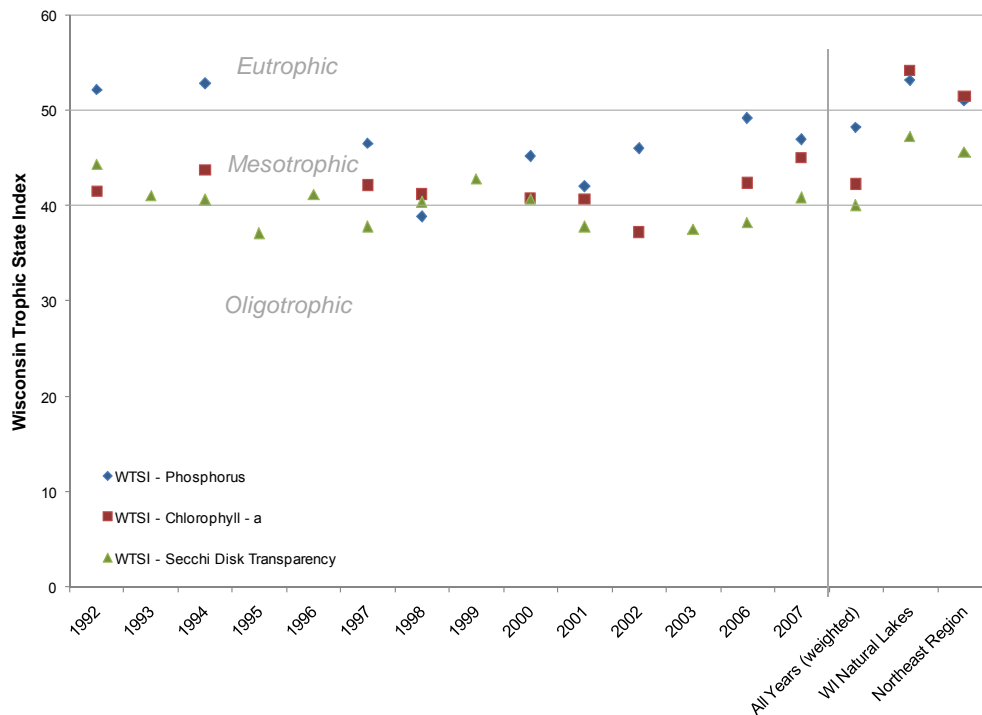
Figure 3.1-5. Seven Island Lake Wisconsin Trophic State Index values. Values calculated with summer month surface sample data using Lillie et al. (1993).

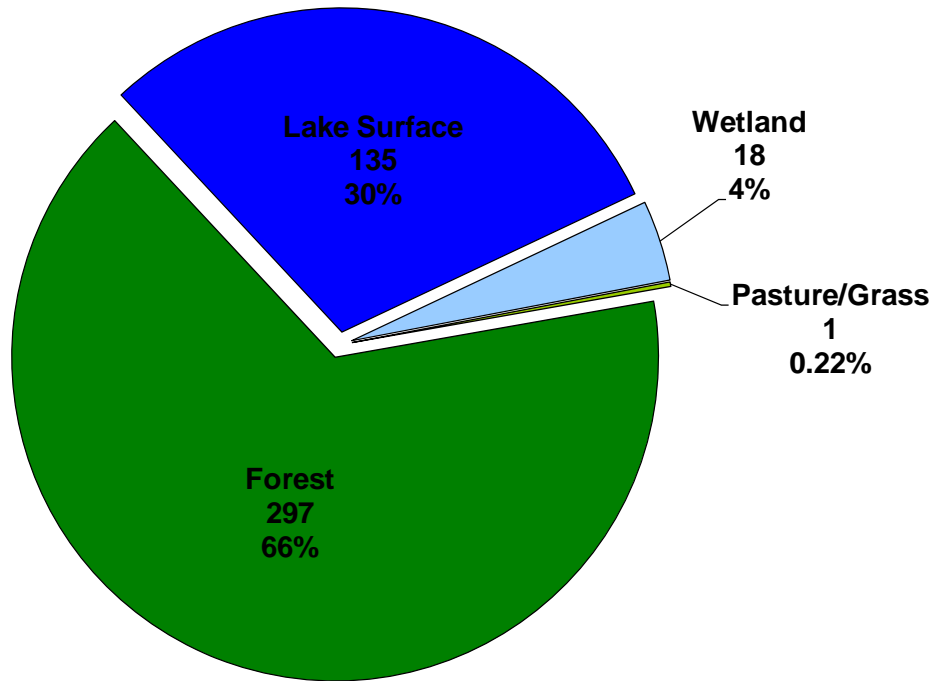
Figure 3.2-1. Seven Island Lake watershed land cover types in acres. Based upon Wisconsin Initiative for Statewide Cooperation on Landscape Analysis and Data (WISCLAND) (WDNR, 1998).

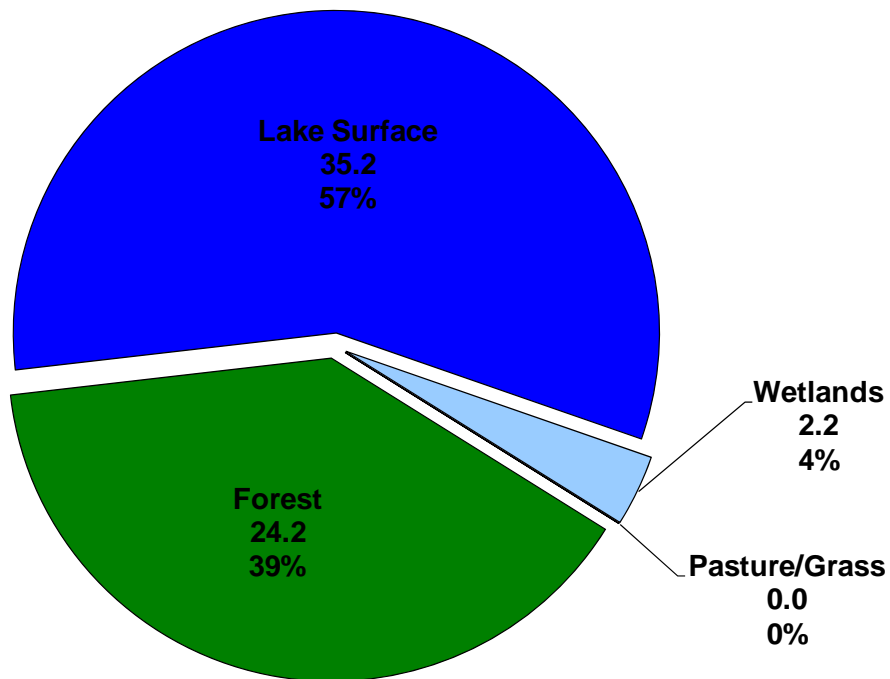
Figure 3.2-2. Seven Island Lake watershed phosphorus loading in pounds. Based upon Wisconsin Lake Modeling Suite (WiLMS) estimates.

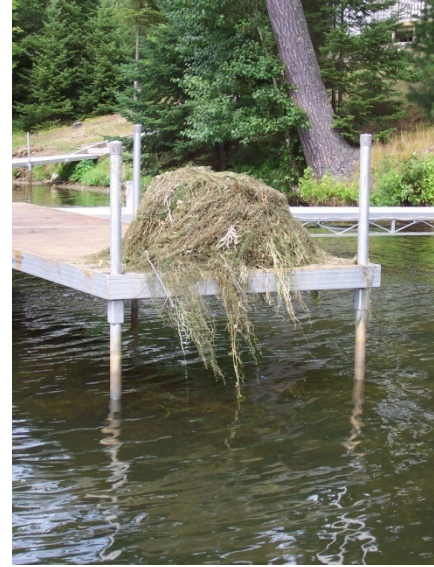
Manual removal methods include hand-pulling, raking, and hand-cutting. Hand-pulling involves the manual removal of whole plants, including roots, from the area of concern and disposing them out of the waterbody. Raking entails the removal of partial and whole plants from the lake by dragging a rake with a rope tied to it through plant beds. Specially designed rakes are available from commercial sources or an asphalt rake can be used.

Powered cutters are now available for mounting on boats. Some are mounted in a similar fashion to electric trolling motors and offer a 4-foot cutting width, while larger models require complicated mounting procedures, but offer an 8-foot cutting width. Please note that the use of powered cutters require a mechanical harvesting permit to be issued by the WDNR.

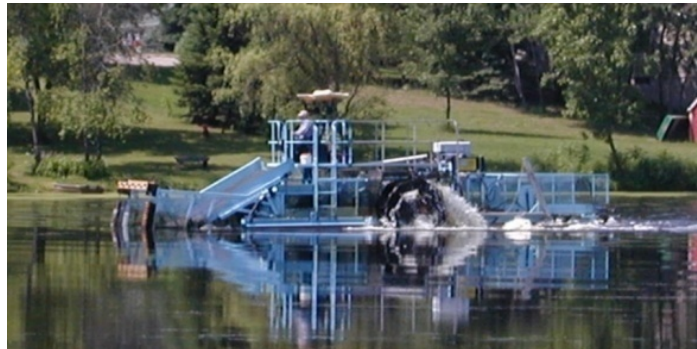
Aquatic plant harvesting is frequently used in Wisconsin and involves the cutting and removal of plants much like mowing and bagging a lawn. Harvesters are produced in many sizes that can cut to depths ranging from 3 to 6 feet with cutting widths of 4 to 10 feet. Plant harvesting speeds vary with the size of the harvester, density and types of plants, and the distance to the off-loading area. Equipment requirements do not end with the harvester. In addition to the harvester, a shore-conveyor would be required to transfer plant material from the harvester to a dump truck for transport to a landfill or compost site. Furthermore, if off-loading sites are limited and/or the lake is large, a transport barge may be needed to move the harvested plants from the harvester to the shore in order to cut back on the time that the harvester spends traveling to the shore conveyor. Some lake organizations contract to have nuisance plants harvested, while others choose to purchase their own equipment. If the latter route is chosen, it is especially important for the lake group to be very organized and realize that there is a great deal of work and expense involved with the purchase, operation, maintenance, and storage of an aquatic plant harvester. In either case, planning is very important to minimize environmental effects and maximize benefits.

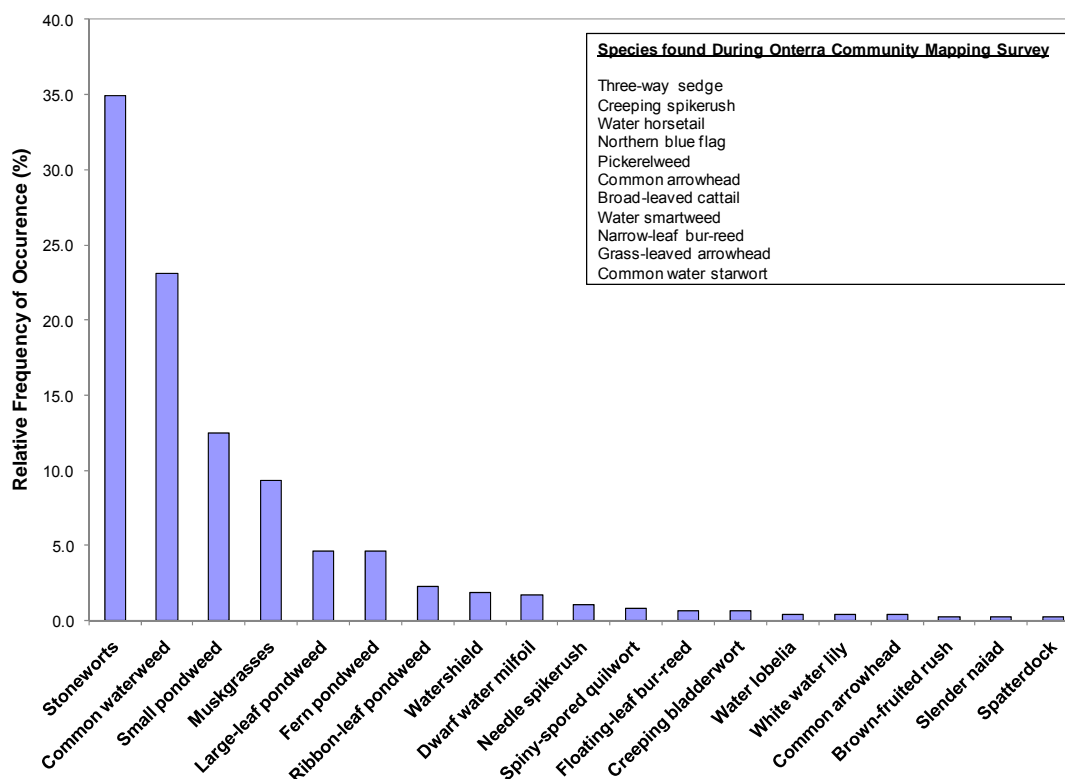
Figure 3.3-4. Seven Island Lake aquatic plant occurrence analysis of 2007 survey data..

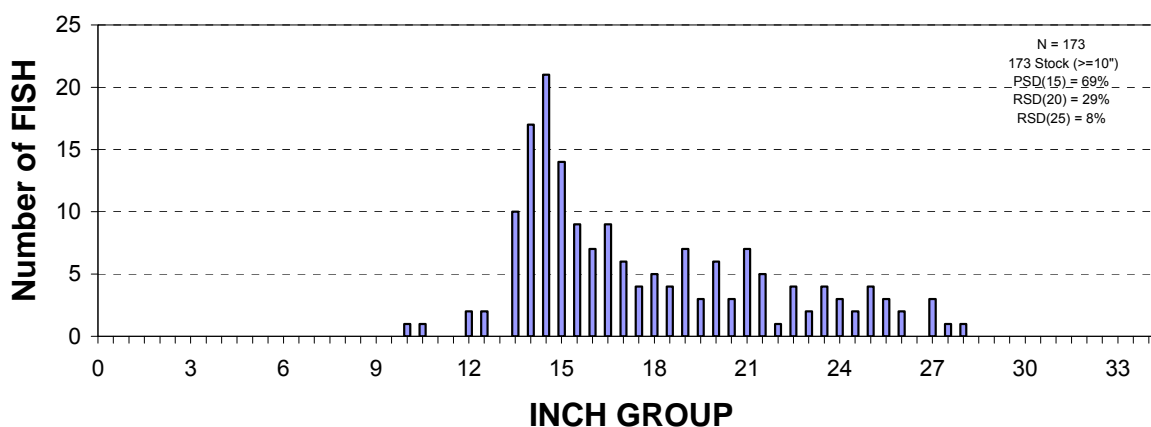
Figure 3.4-2 Walleye size distribution from 2006 electrofishing and fyke net surveys.
Figure provided by Dave Seibel, WDNR Fisheries Biologist.
