BIRCH LAKE MANAGEMENT PLAN

Prepared by Agrecol Environmental Consulting
Richard Wedepohl and David Marshall

January 2010

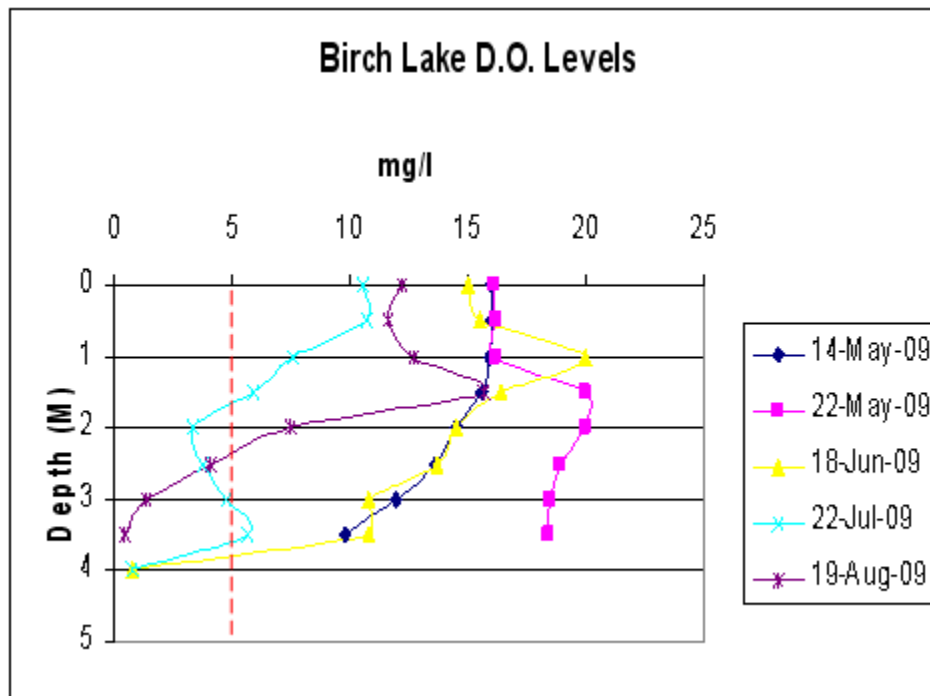
Figure 4

Dissolved oxygen (D.O.) - The minimum State water quality criterion for D.O. is 5 mg/l (ppm) and is the level established to protect fish and aquatic life in warm water habitats. This level is not maintained in the deeper areas of Birch Lake, particularly in late summer when organic decomposition occurs in the lake sediment and as aquatic plants begin to die (Figure 4). At other times, extremely high D.O. was measured and reflects photosynthesis of dense rooted plants and filamentous algae. The supersaturated levels of D.O. can be environmentally stressful for fish and aquatic life by causing gas bubble disease. The extremely high levels are measured during the daytime hours. However, at night the opposite extreme will occur as plants respire and levels can drop below the minimum criterion for warm water fisheries. Normal concentrations of D.O. range from about 5 mg/l to 12 mg/l.

Figure 4: Birch Lake Dissolved Oxygen Profiles

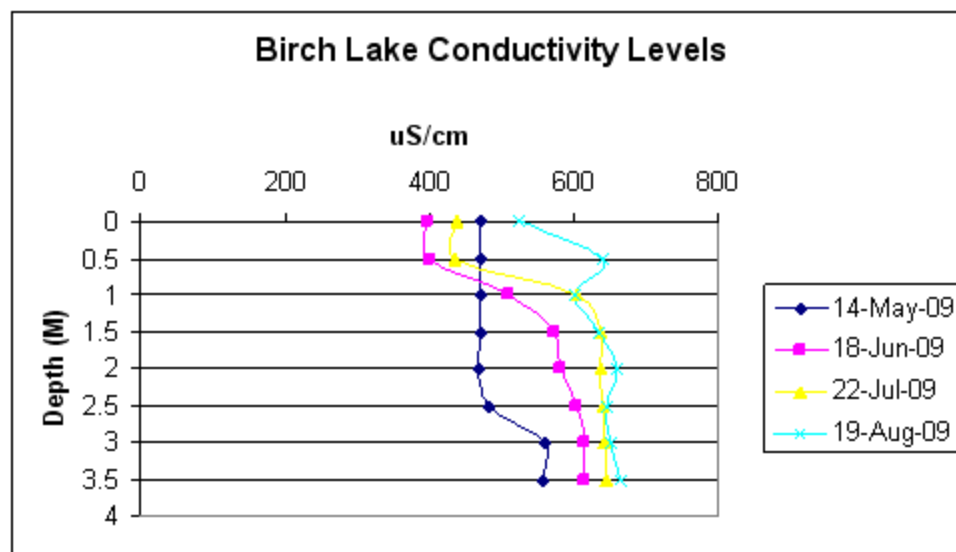
Figure 6

Specific Conductance - The conductivity level in water is a measure of electrical conductance and reflects the amount of dissolved chemicals in water. Higher conductivity indicates higher levels of dissolved chemicals. Higher conductance levels were observed near the bottom where nutrients are released from bottom mud or later in the summer as decomposing plants release nutrients (Figure 6). Groundwater also contains dissolved minerals and has higher conductivity than does soft rainwater. The higher conductivity near the bottom may reflect some of the spring flow to the lake.

Figure 6: Birch Lake Specific Conductance Profiles

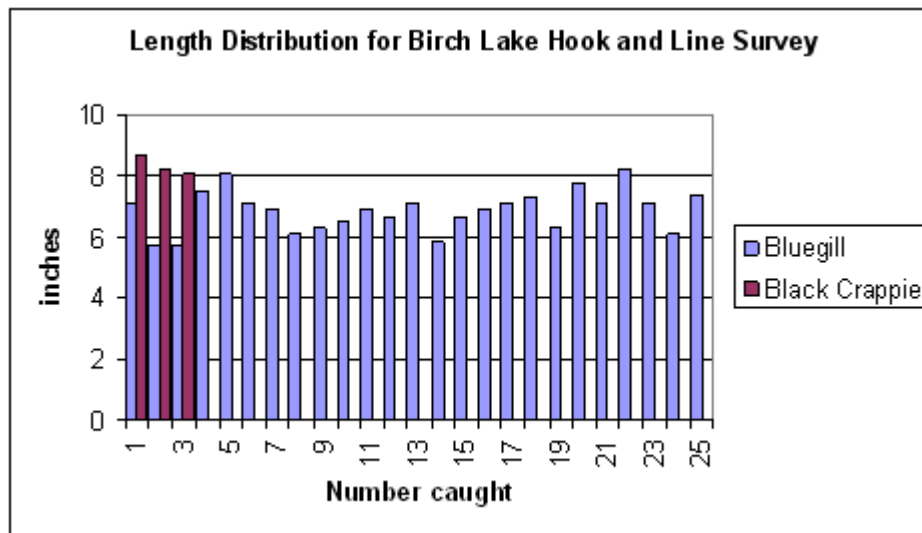
Figure 10

Angling Survey - In May 2009, Agrecol consultants and two volunteers conducted a hook and line survey of Birch Lake fishes. Twenty-eight fish specimens representing two species were caught, measured and released. The results of the survey demonstrated that bluegills, and to a lesser extent, black crappie provided favorable catch sizes (Figure 10). The panfish sizes were somewhat of a surprise given the very dense plant growths that often result in over-population and stunted growth. The environmentally stressful conditions found in the lake

may reduce recruitment and over-population but a more detailed ecological study would be needed to adequately evaluate the fisheries and reason for these results.

Figure 10: May 22, 2009 Birch Lake Hook and Line Survey (mean length bluegill = 6.9")

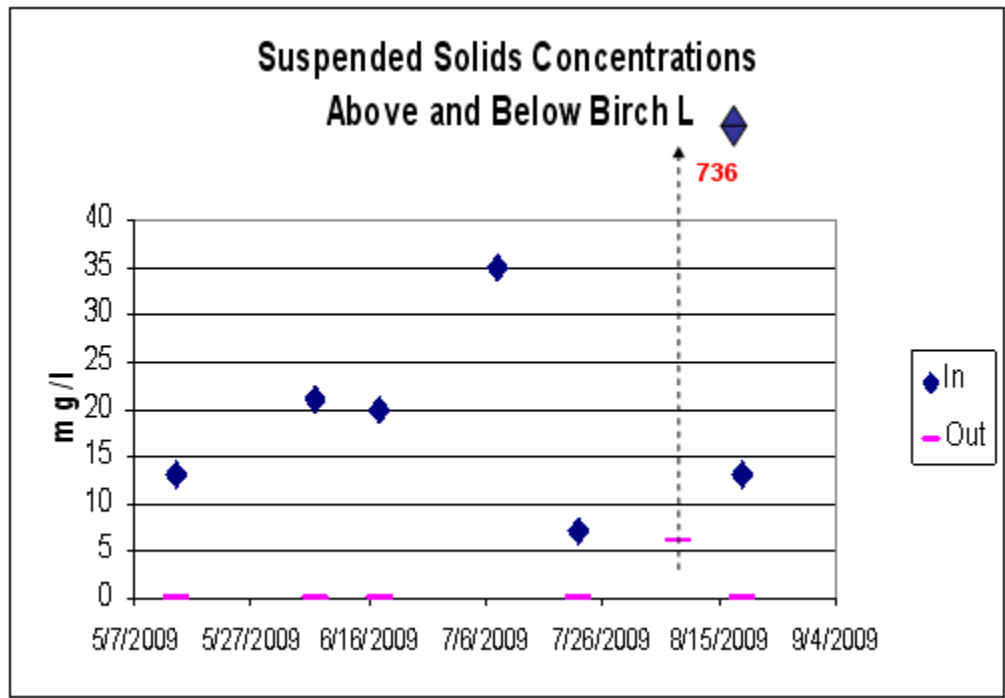
Figure 17

Suspended Solids - Floating or suspended particles in water can be quantified by measuring the suspended solids. In Trout Creek, the suspended solids typically reflect fine soil particles washed off the surrounding land. The surveys demonstrated that the stream transported sediment loads to the lake and that sediment was retained in the lake. Consistent with the highest flow rate, the highest suspended solids measurement occurred when the flow exceeded 6 cfs (Figure 17). The increase in sediment loading during rain events is graphically captured in the Figure 18 photo. It is important to mention that the suspended solids measurements did not reflect the bed load transport that can exceed suspended solids loading. The coarse bed load likely created the delta plus additional, finer material that is continuously deposited further out into the lake.

Figure 17: Trout Creek Suspended Solids Measurements

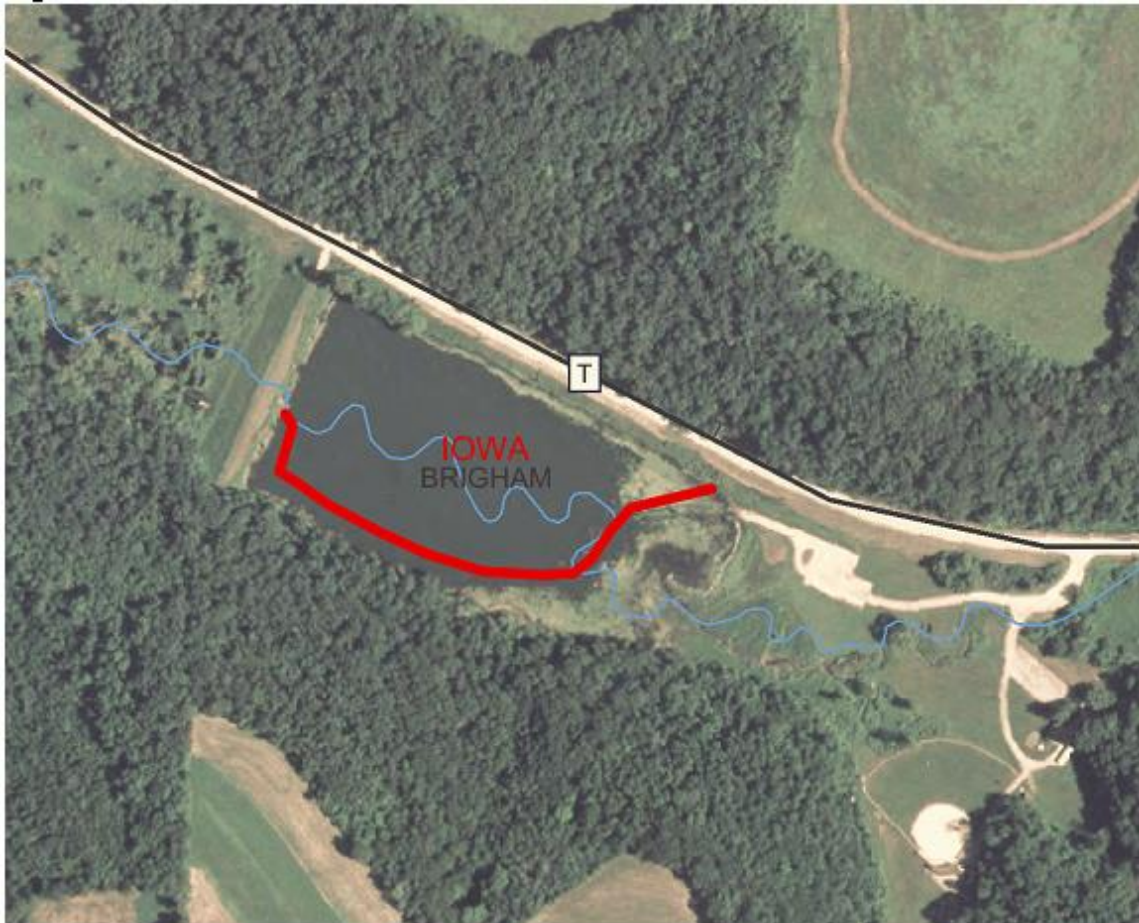
Figure 23

Watershed Diversion and Creation of Separate Lake - To separate the lake from the incoming stream, a berm approximately 1100 feet long could be constructed to pass the majority of flow events past the lake, directly to the dam's outlet (Figure 23). Minimal modification to the dam would be required with lake and stream elevations maintained at current levels.

The berm would be designed to overtop at larger flow events, e.g. once every fifty years, so that flood capacity of the impoundment would not be affected. Under normal conditions the inflow would be routed along the western edge of the lake, in essence forming a very small impoundment. Water residence times of the new channel would be reduced significantly and incoming cold water would pass out of the dam with minimal temperature increases.

Figure 23. Potential Location of Diversion Berm
