# Beaver Dam Lake

Dodge County, Wisconsin

## Comprehensive Management Plan

September 2015

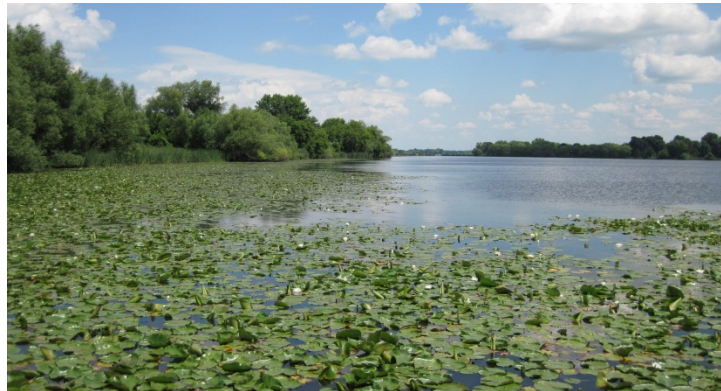
Photograph 1.0-1. Beaver Dam Lake, Dodge County.

*Submersed aquatic plants are sparse, and most of the plants that are present are tolerant of turbid conditions. Much algae and other suspended material observed within the water. However, Rakes Bay (pictured) contained the highest-quality habitat in terms of aquatic plants with large colonies of white water lily observed. The state-endangered black tern was observed nesting within these white water lily colonies. Overall, water quality appears poor and the lake is lacking aquatic plant habitat.*

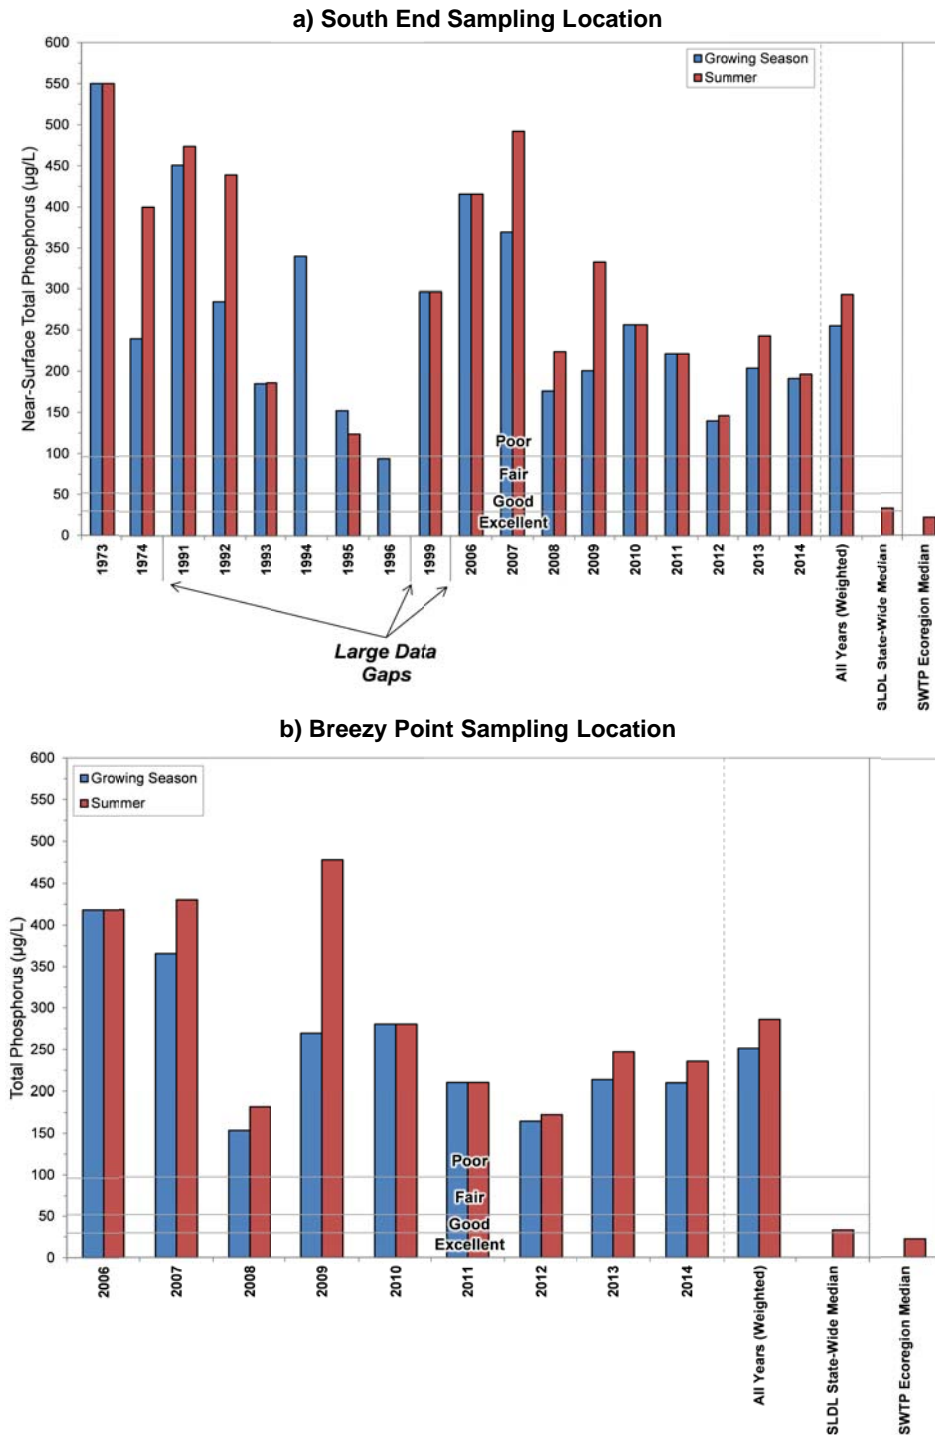
Figure 3.1-3. Beaver Dam Lake average annual near-surface total phosphorus concentrations measured from the South End sampling location (a) and the Breezy Point sampling location (b). Also displayed are the median near-surface total phosphorus concentrations for state-wide shallow lowland drainage lakes (SLDL) and Southeastern Wisconsin Till Plain (SWTP) ecoregion lakes. Water Quality Index values adapted from WDNr PUB WT-913.

approximately 13 times higher than the median value for all lakes within the SWTP ecoregion (Figure 3.1-3a and 3.1-3b).

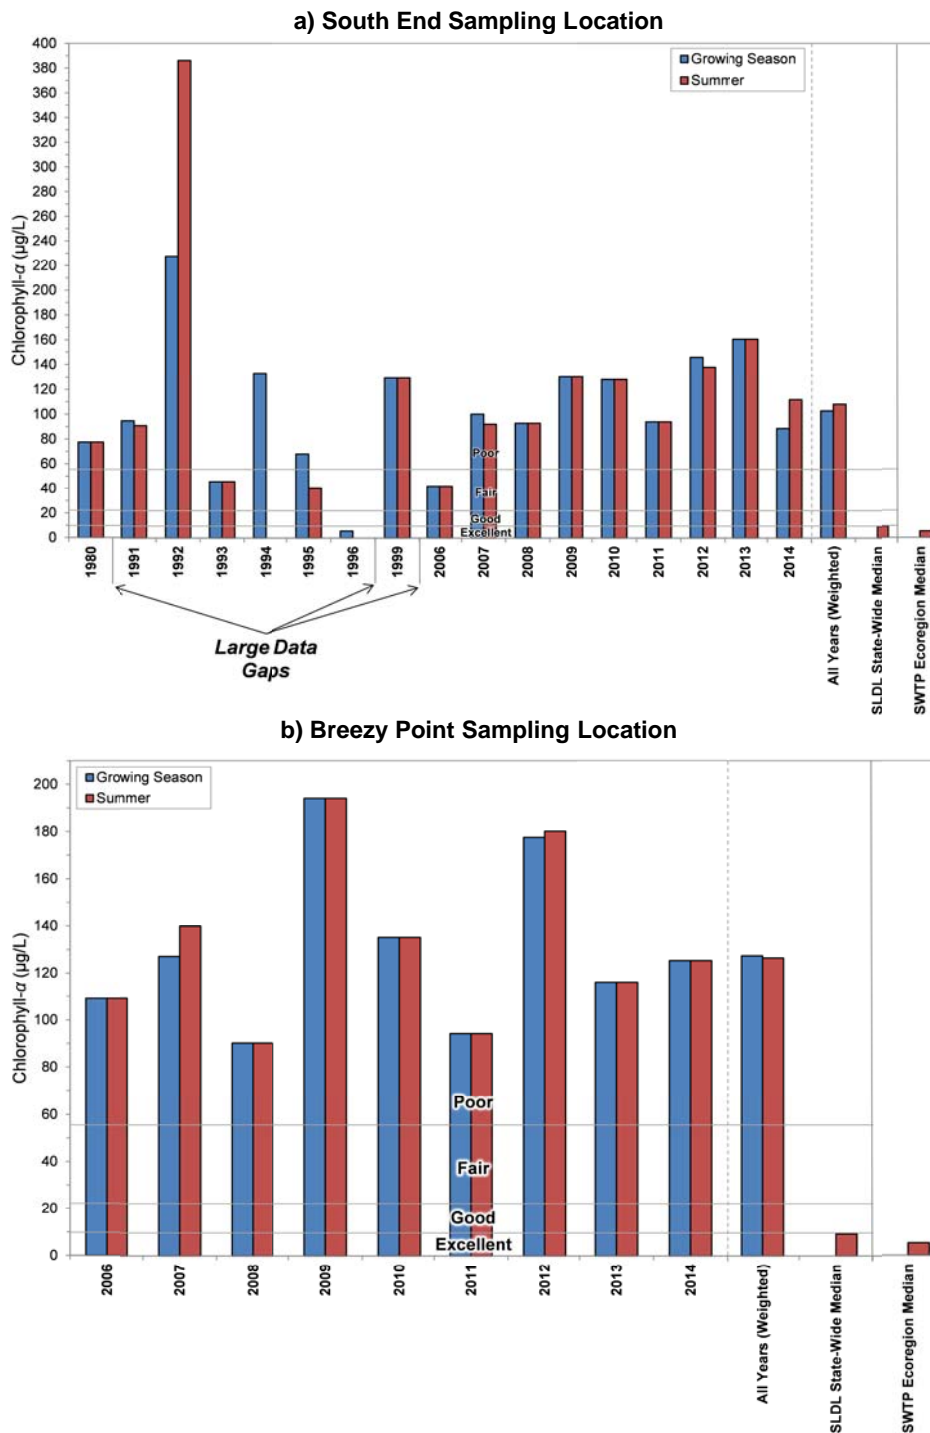
Figure 3.1-6. Beaver Dam Lake average annual chlorophyll-*a* concentrations measured from the South End sampling location (a) and the Breezy Point sampling location (b). Also displayed are the median chlorophyll-*a* concentrations for state-wide shallow lowland drainage lakes (SLDL) and Southeastern Wisconsin Till Plain (SWTP) ecoregion lakes. Water Quality Index values adapted from WDNR PUB WT-913.

Weighted averages of summer chlorophyll- $a$  concentration data are used to compare Beaver Dam Lake's chlorophyll- $a$  concentrations to median values for other shallow lowland drainage lakes throughout the state and to median values of all lake types within the SWTP ecoregion. The weighted average summer chlorophyll- $a$  concentrations from all years that data are available from the South End and Breezy Point sampling locations is 108  $\mu\text{g/L}$  and 126  $\mu\text{g/L}$ , respectively (Figure 3.1-6a and 3.1-6b). Both of these values fall into the *poor* category for shallow lowland drainage lakes in Wisconsin. These values are between 11 and 13 times higher than the median concentration for shallow lowland drainage lakes in Wisconsin and approximately 20 times higher than the median value for all lakes within the SWTP ecoregion (Figure 3.1-6a and 3.1-

6b). Perceptible algae blooms occur in reservoirs when chlorophyll-*a* concentrations reach approximately 30 µg/L, and Beaver Dam Lake’s average concentrations are approximately four times greater than this threshold.

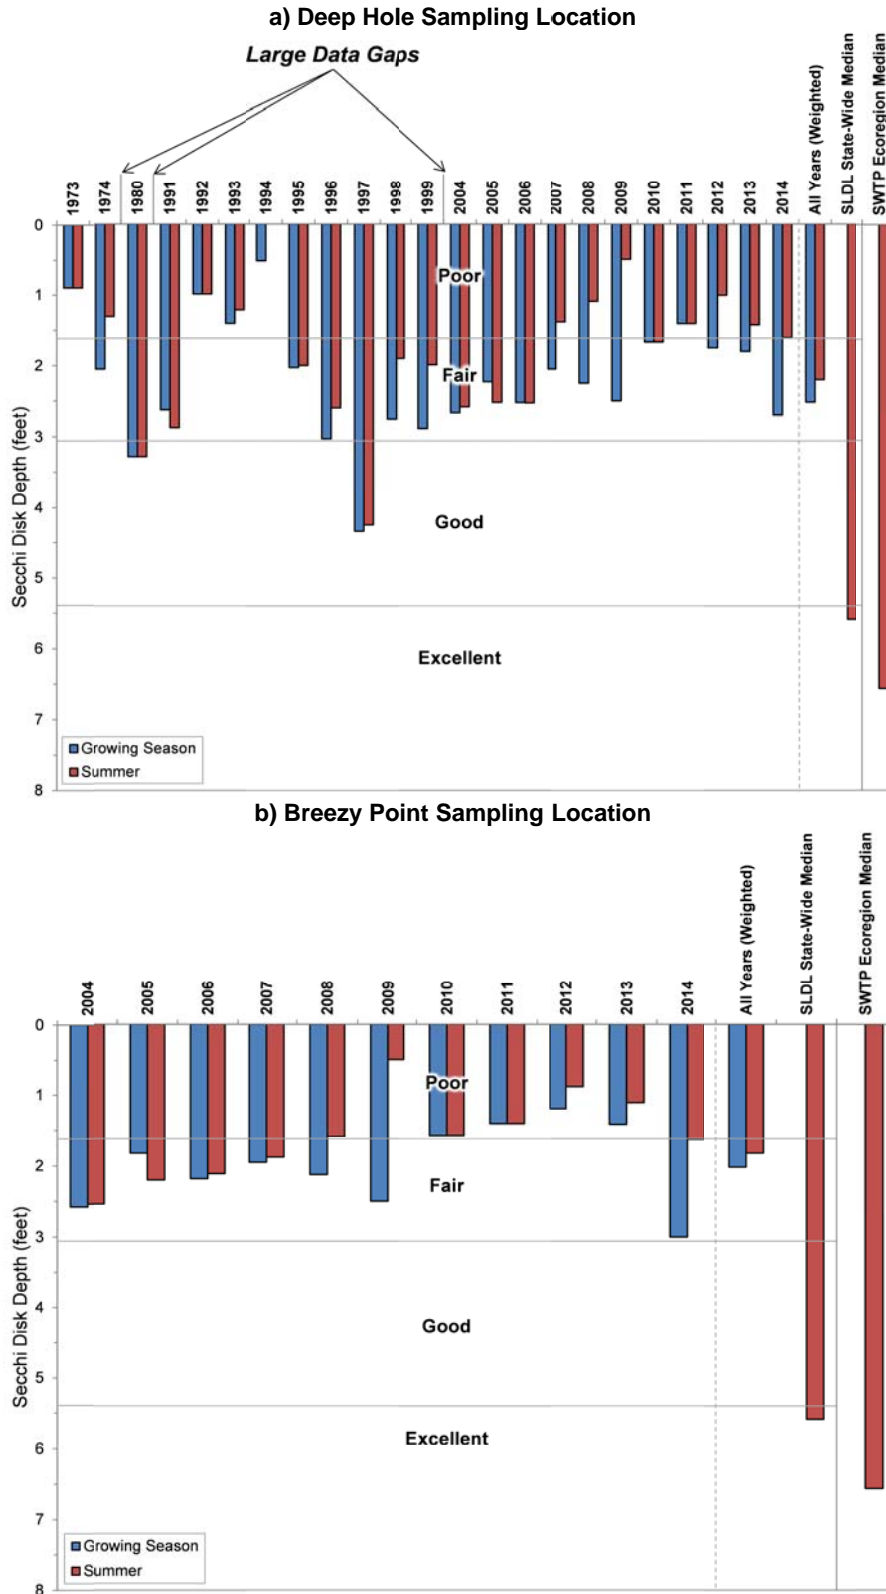
**Figure 3.1-8. Beaver Dam Lake average annual Secchi disk transparency measured from the South End sampling location (a) and the Breezy Point sampling location (b). Also displayed are median Secchi disk transparency values for state-wide shallow lowland drainage lakes (SLDL) and Southeastern Wisconsin Till Plain (SWTP) ecoregion lakes. Water Quality Index values adapted from WDNR PUB WT-913.**

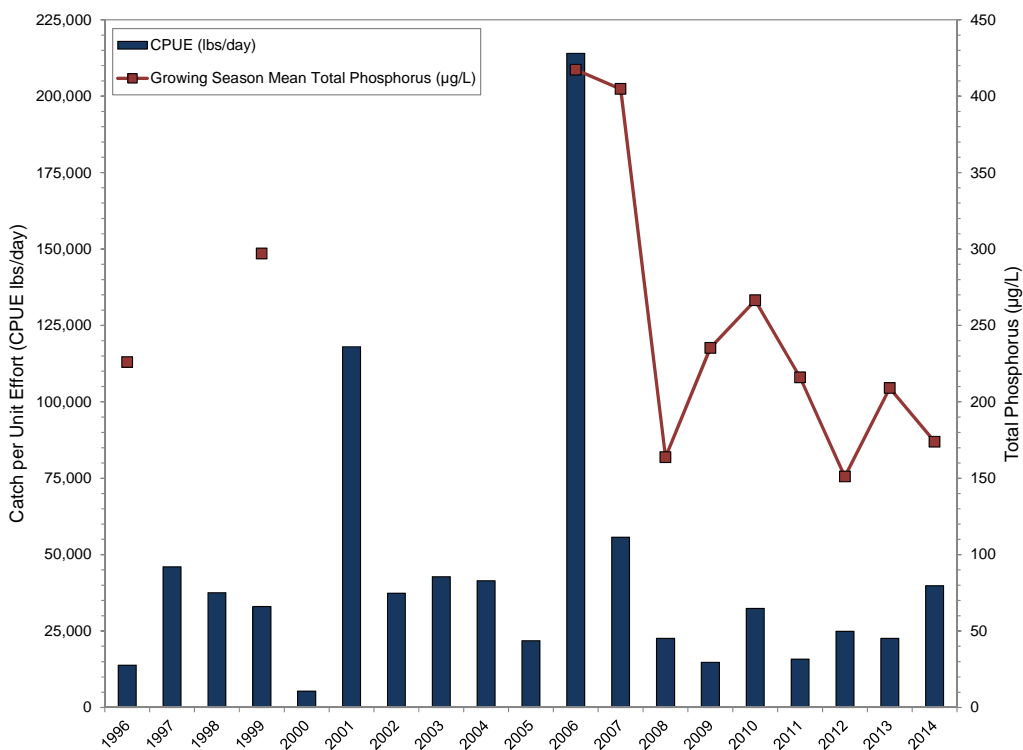
**Figure 3.3-4. Beaver Dam Lake catch per unit effort (CPUE) of common carp from 1996-2014 and growing season mean near-surface total phosphorus.**

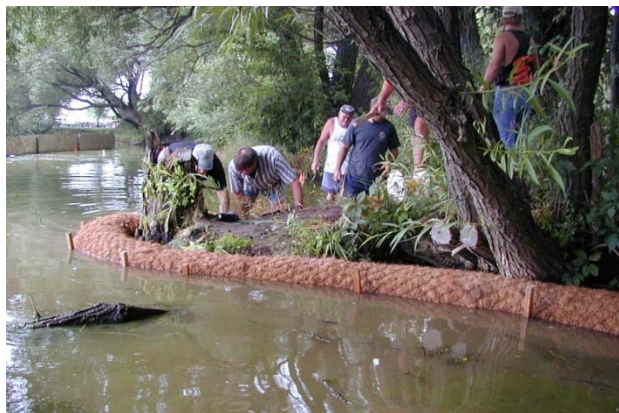
**Photograph 3.4-1. Example of a biolog restoration site.**

In recent years, many lakefront property owners have realized increased aesthetics, fisheries, property values, and water quality by restoring portions of their shoreland to mimic its unaltered state. An area of shore restored to its natural condition, both in the water and on shore, is commonly called a shoreland buffer zone. The shoreland buffer zone creates or restores the ecological habitat and benefits lost by traditional suburban landscaping. Simply not mowing within the buffer zone does wonders to restore some of the shoreland's natural function.

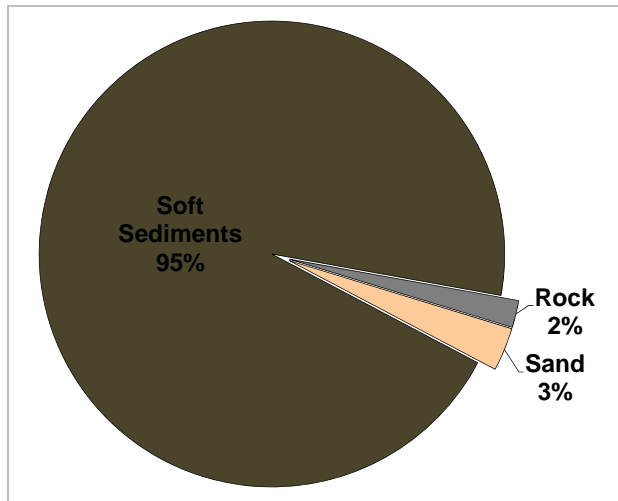
**Figure 3.5-2. Beaver Dam Lake 2014 proportion of substrate types.** Created using data from Onterra 2014 whole-lake point-intercept survey.

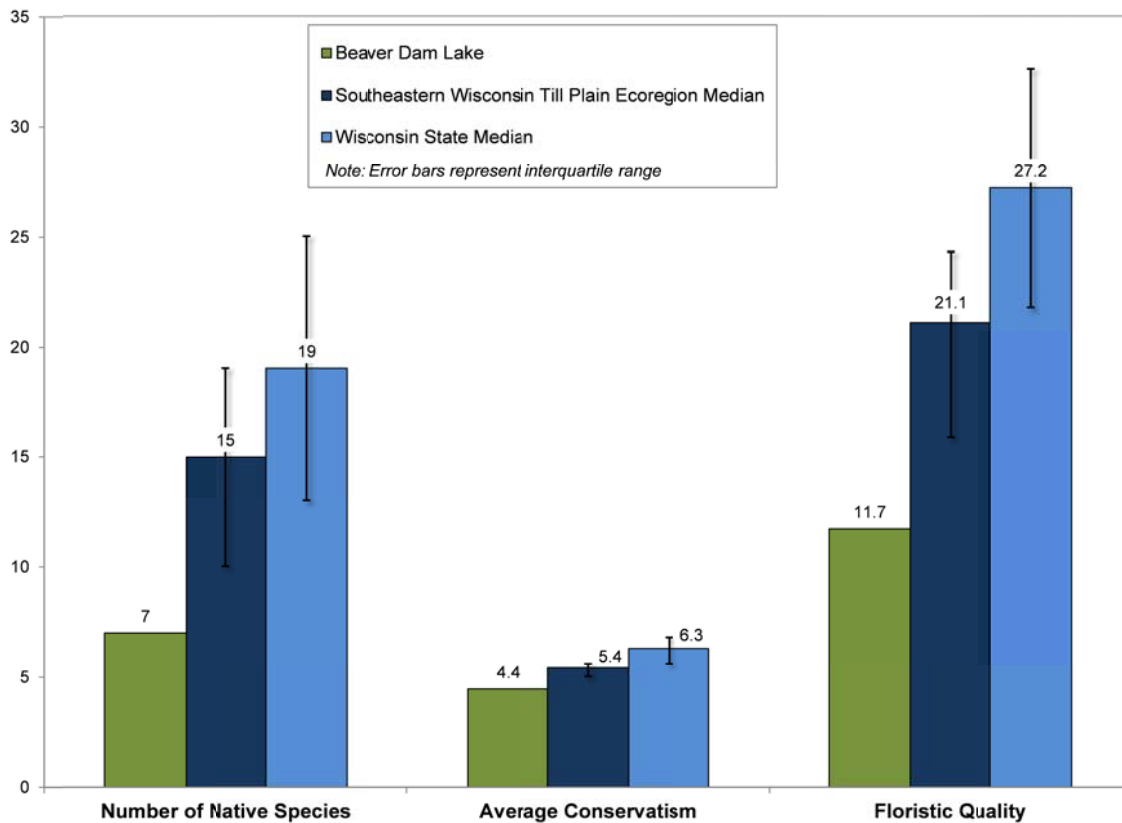
**Figure 3.5-5. Beaver Dam Lake Floristic Quality Assessment.** Created using data from 2014 whole-lake point-intercept survey. Regional and state medians calculated with Onterra and WDNR data.

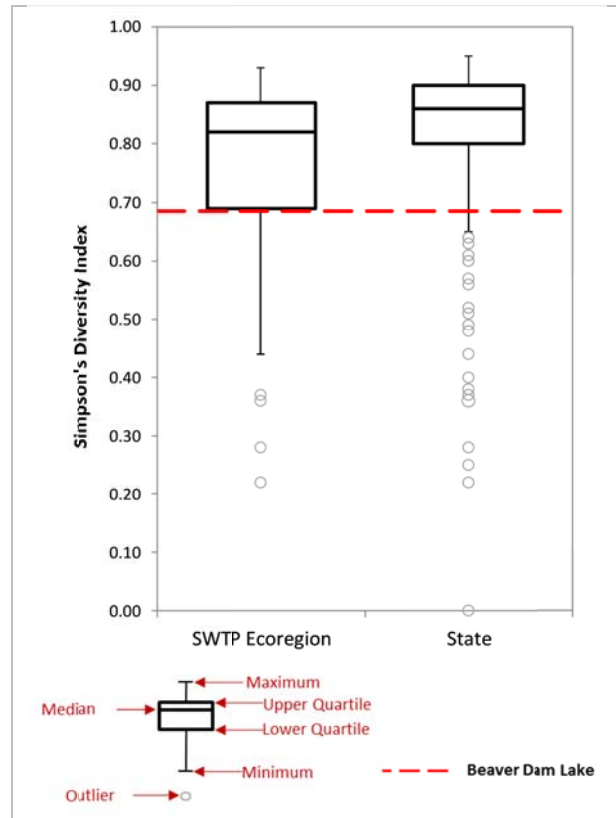
**Figure 3.5-6. Beaver Dam Lake Simpson's Diversity Index.** Created using data from WDNR 2006 and Onterra 2010, 2011, and 2014 whole-lake point-intercept surveys. Regional and state medians calculated with Onterra and WDNR data.

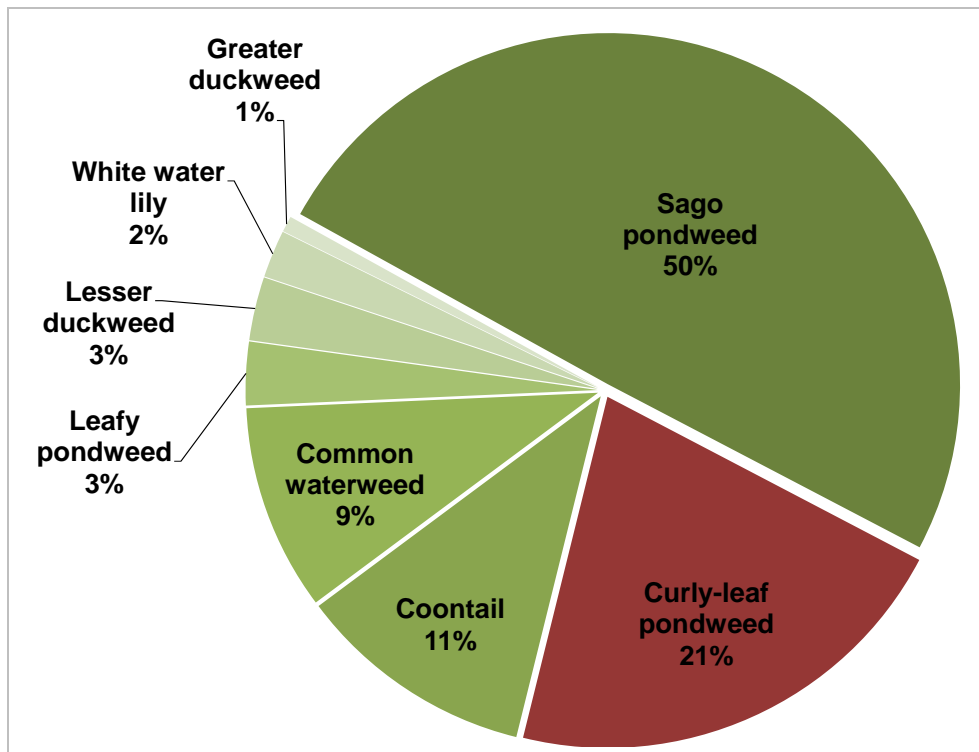
**Figure 3.5-7. Relative frequency of occurrence of aquatic plant species in Beaver Dam Lake in 2014.** Created using data from 2014 whole-lake point-intercept survey. Exotic species indicated with red.

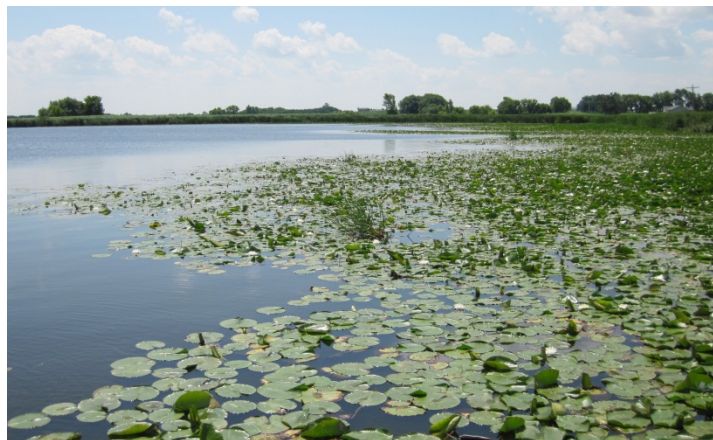
Over half of the emergent and floating-leaf aquatic plant community acreage was located in Rakes Bay where there is little shoreline development (Map 8). The majority of these communities were comprised of white water lily (Photo 3.5-2). Continuing the analogy that the community map represents a ‘snapshot’ of the important emergent and floating-leaf plant communities, a replication of this survey in the future will provide a valuable understanding of

**Photo 3.5-2. Community of white water lily (*Nymphaea odorata*) in Rakes Bay.**

In Rakes Bay, the state-endangered black tern (*Chlidonias niger*) was observed nesting within communities of white water lily (Photo 3.5-2). The black tern was listed as endangered in Wisconsin in 2014 after studies showed a 78% decline in their population since the early 1980s (WDNR 2014). According to the WDNR, this bird typically breeds in areas containing a mixed habitat of emergent vegetation and open water, and the largest threat to this species is habitat loss. The nearby Horicon Marsh is one of the primary conservation sites for this species in Wisconsin.

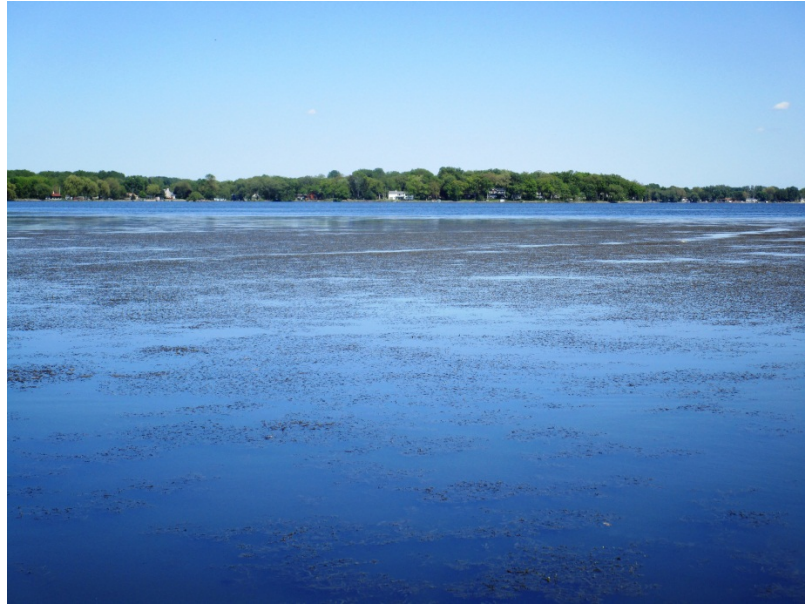
In May 2015, Bill Boettge sent images to Onterra ecologists of surface-matted aquatic plants in a bay near Derge County Park. These plants appeared to be a large colony of CLP (Photo 5.0-1). Based upon these photos and statements from Beaver Dam Lake riparians, it is believed that curly-leaf pondweed increased in 2015 compared to when the surveys were conducted in 2014. While conditions may have been ideal for curly-leaf pondweed growth in 2015, it is not clear if this growth will continue in 2016 or if it will be lower as in 2014. To monitor the CLP population, the BDLIA will seek a WDNR Education, Planning and Prevention grant in December of 2015 to aid in funding an assessment of the lake's CLP (and EWM) populations in 2016 and update the lake management plan as it pertains to the management of these plants.

**Photo 5.0-1. Surface-matted colony of what is believed to be curly-leaf pondweed in Beaver Dam Lake near Derge County Park.** Photo taken by Bill Boettge on May 22, 2015.
