A Watershed Report created by the Bureau of Water Quality in support of the Clean Water Act.

# BIG GREEN LAKE TWA WQM PLAN 2017

Big Green Lake (UF07) HUC: 040302010902, Monitored 2014

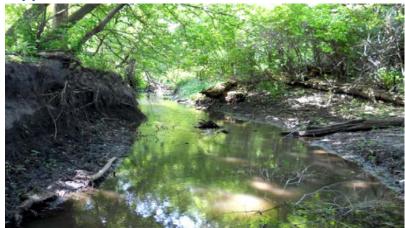
Unstable Banks in Roy Creek near County Road O (Green Lake County LCD 2012)

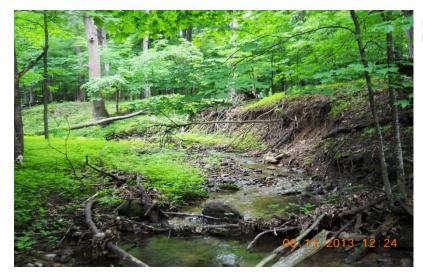
Unstable banks in White Creek (Green Lake County LCD 2013)

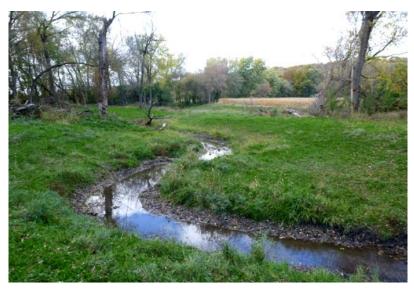
Stream bank restoration on Roy Creek near County Road O

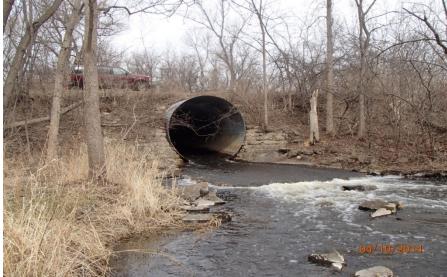
Silver Creek Facing Upstream at the Perched Culvert Under South Koro Road. Photo taken by D. Bolha on April 10th, 2014.

- Implement cover crops to reduce cropland erosion during late fall and spring.
- Replace perched culverts in the watershed to increase available fish and aquatic life habitat.

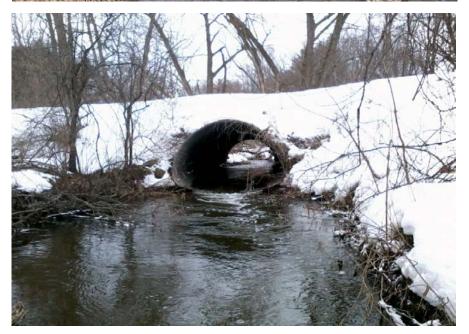
Dakin Creek Facing Upstream at the Perched Culvert Under Skunk Hollow Road. Photo taken by D. Bolha on March 14<sup>th</sup>, 2013
